**PHASE I ENVIRONMENTAL
SITE ASSESSMENT
3625 HIGHLAND AVENUE
NIAGARA FALLS, NEW YORK 14305**

PROJECT # NY601009

**GREAT LAKES METAL PRODUCTS
4625 ROYAL AVENUE
NIAGARA FALLS, NEW YORK 14303**

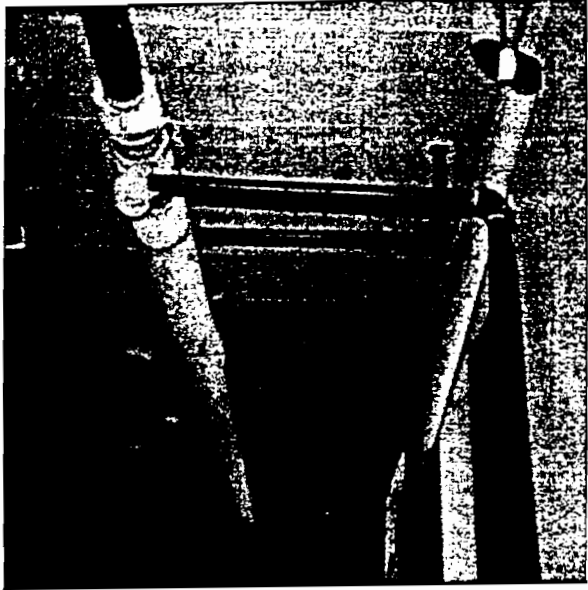
View of suspect pipe insulation
located on first floor of Office
Bldg.

It should be noted that friable suspect asbestos containing materials and large pieces of suspect lead based paint are present on the floors of the three buildings on the site, which may contaminate entrants to these buildings. A reasonable and prudent risk management task would be to have the materials sampled and analyzed by a qualified professional to determine asbestos content and lead content (if any) and proper handling and disposal contingencies, prior to allowing any persons onto the site.
