**B00080-9**

**SI/RAR Scoping Plan  
Phase I Environmental Site Assessment,  
Amadori Project Site Property,  
City of Lackawanna,  
Erie County, New York**

**May 14, 1998**

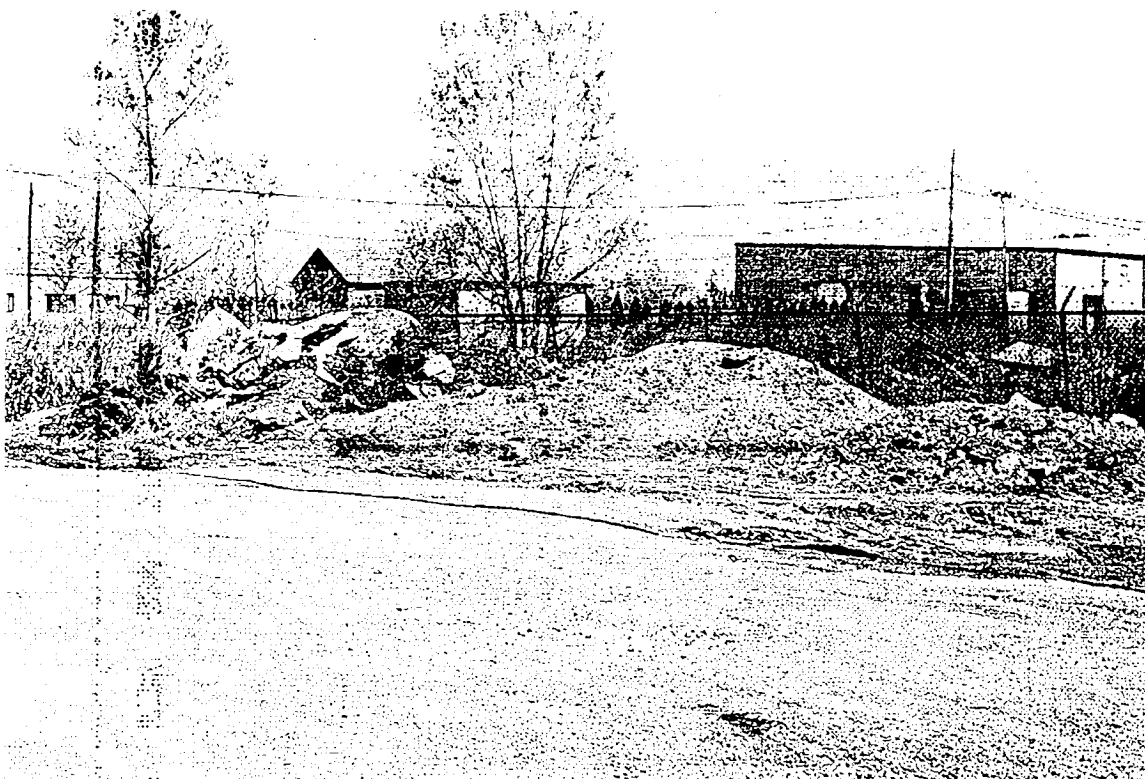
**Photograph 5. Debris northwest corner of property along/outside fence facing northeast along A Street. Pile #1 in field notes. (Peter Gorton, April 1998.)**

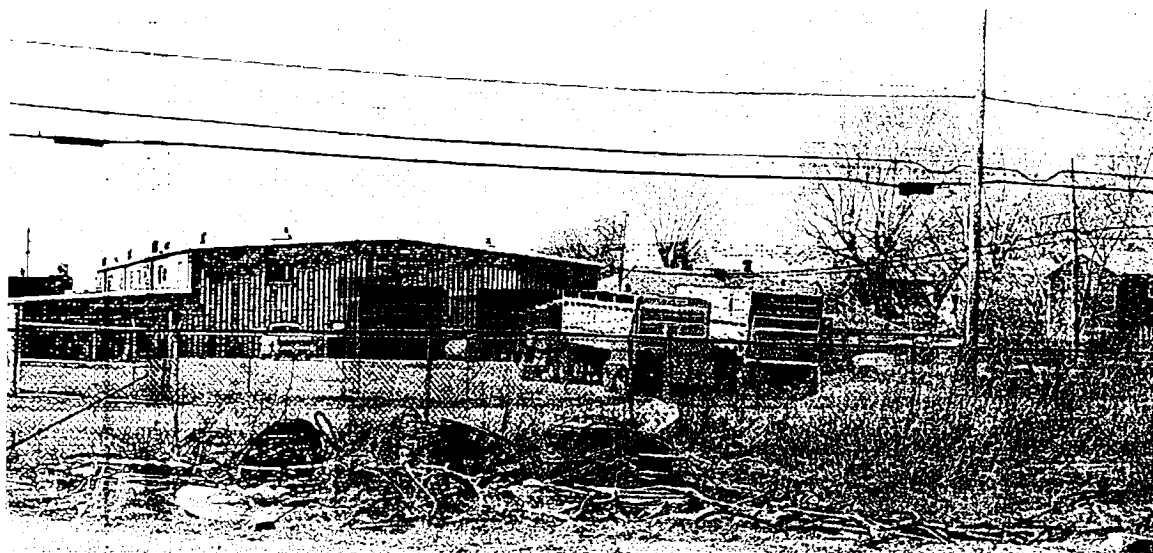
**Photograph 7. View of debris pile labeled # 2 in field notes. View from northwest facing west within the fenced-in storage lay down area. (Peter Gorton, April 1998.)**

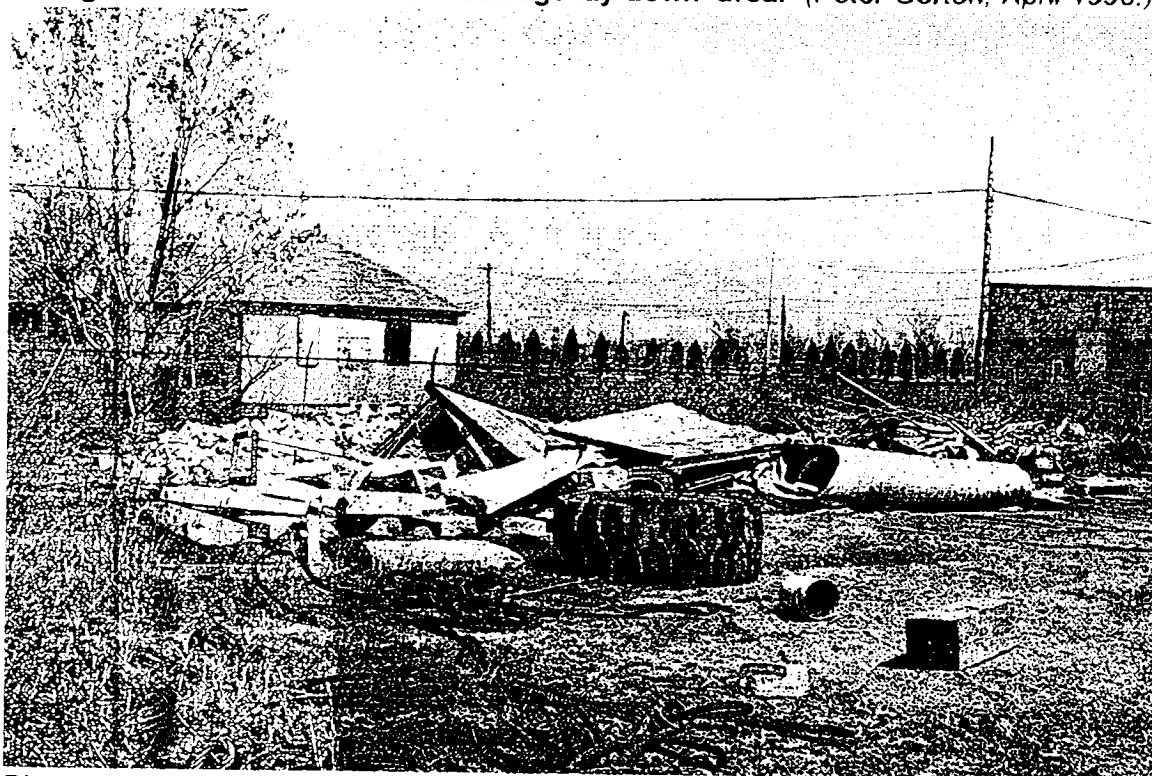
**Photograph 8. Debris pile #3 northwest corner of property within the fence facing North. Abandoned small structure, possibly old guard house in background. (Peter Gorton, April 1998.)**

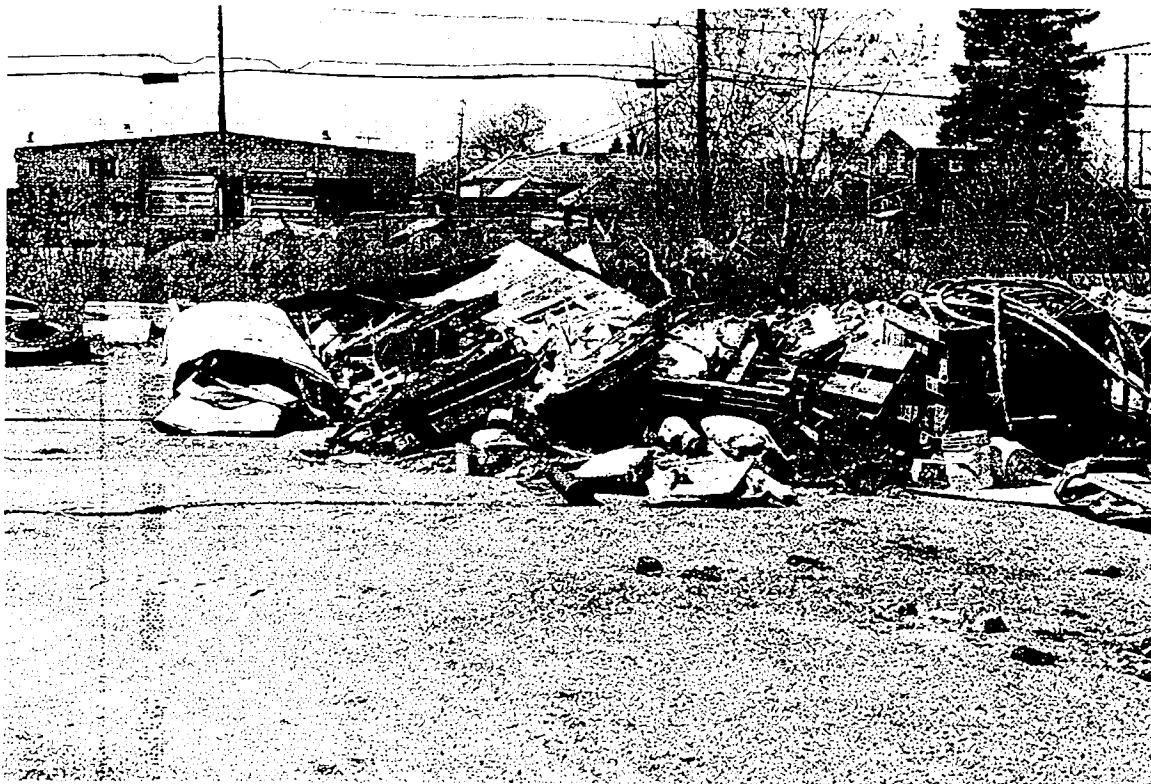
**Photograph 9. Additional view of debris pile #3, northwest corner of property within the fence facing west. Amadori building in background. (Peter Gorton, April 1998.)**

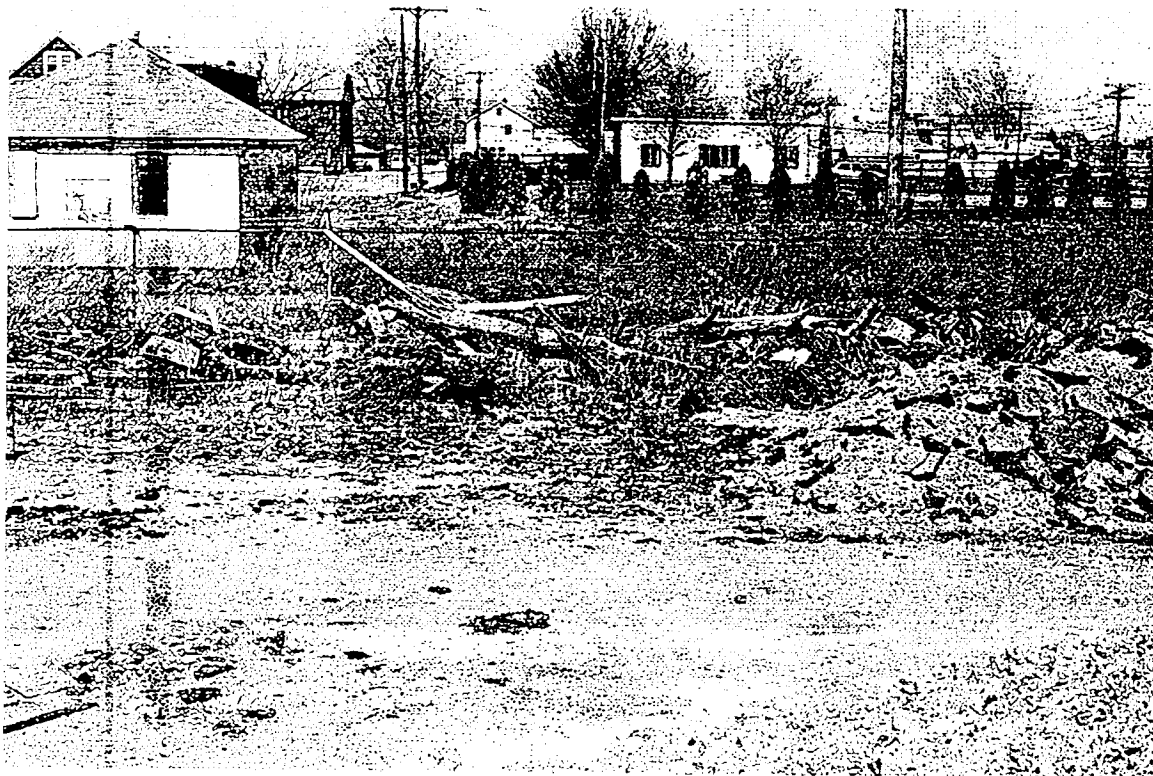
**Photograph 10. View of pile #4, northwest end of property from within fence. Note abandoned structure and debris along fence line. (Peter Gorton, April 1998.)**

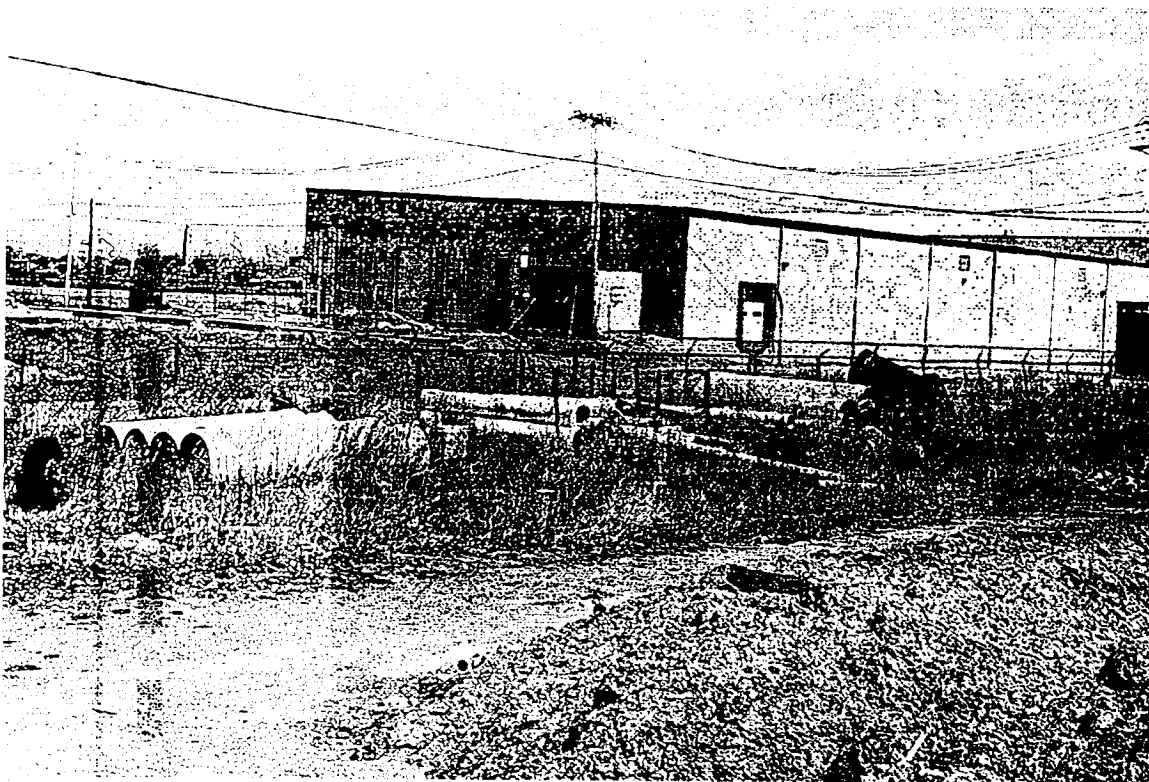
**Photograph 11. Debris pile #5 shows rubber/PVC pipe. View from northwest end of fenced-in area, facing north. (Peter Gorton, April 1998.)**

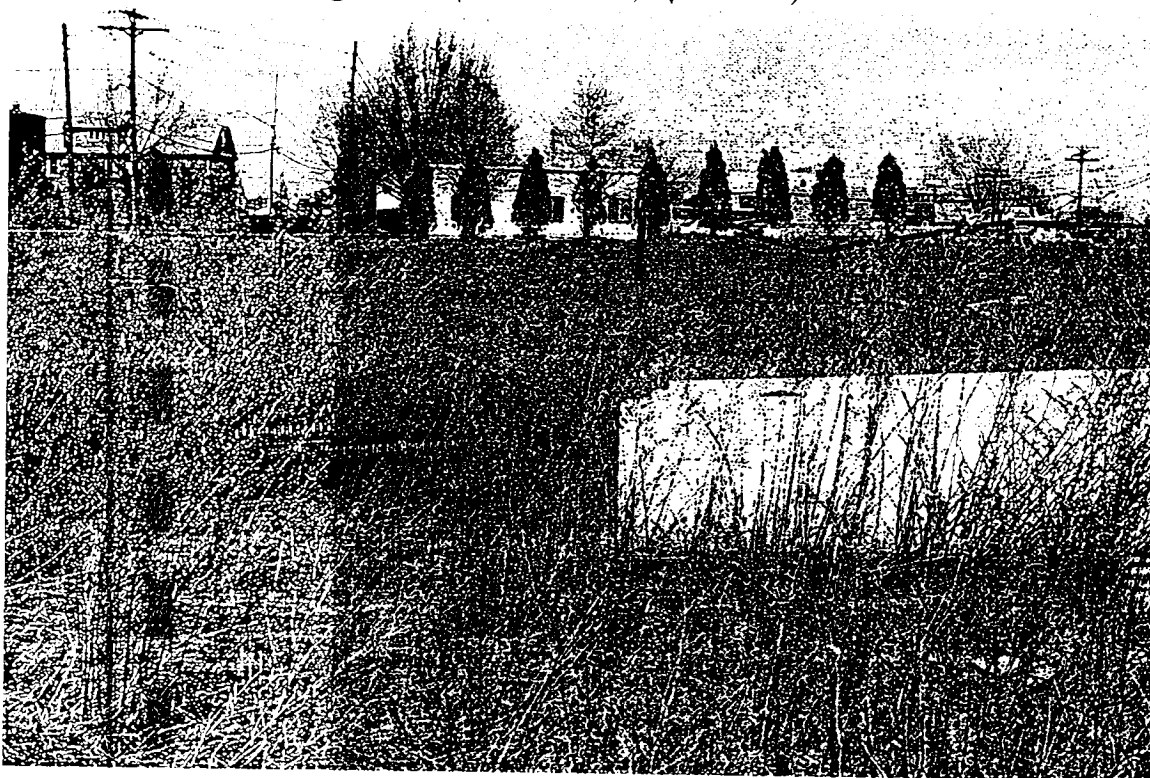
**Photograph 12. Additional view of debris pile #5. Shows black corrugated plastic pipe and white PVC pipe. Facing north. (Peter Gorton, April 1998.)**

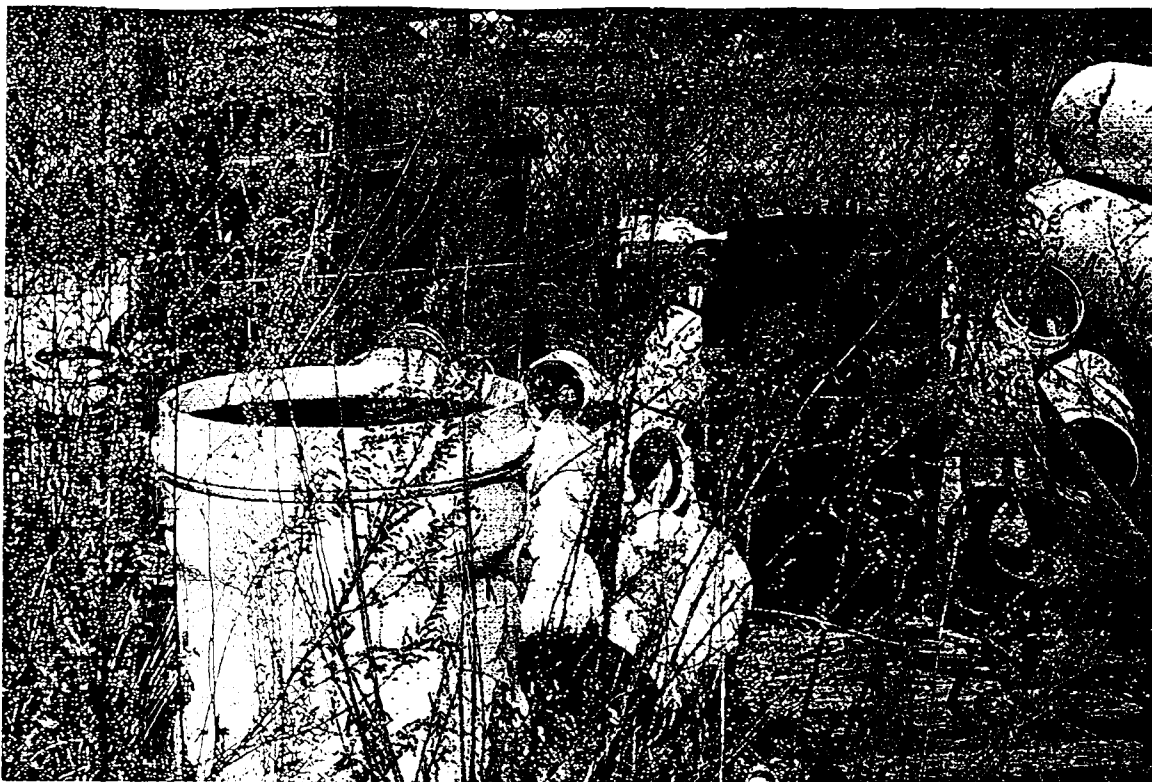
**Photograph 13. Additional view of pile #5 showing various sizes of PVC pipe and coupling as well as an old 55-gallon drum full of rubber hose. (Peter Gorton, April 1998.)**

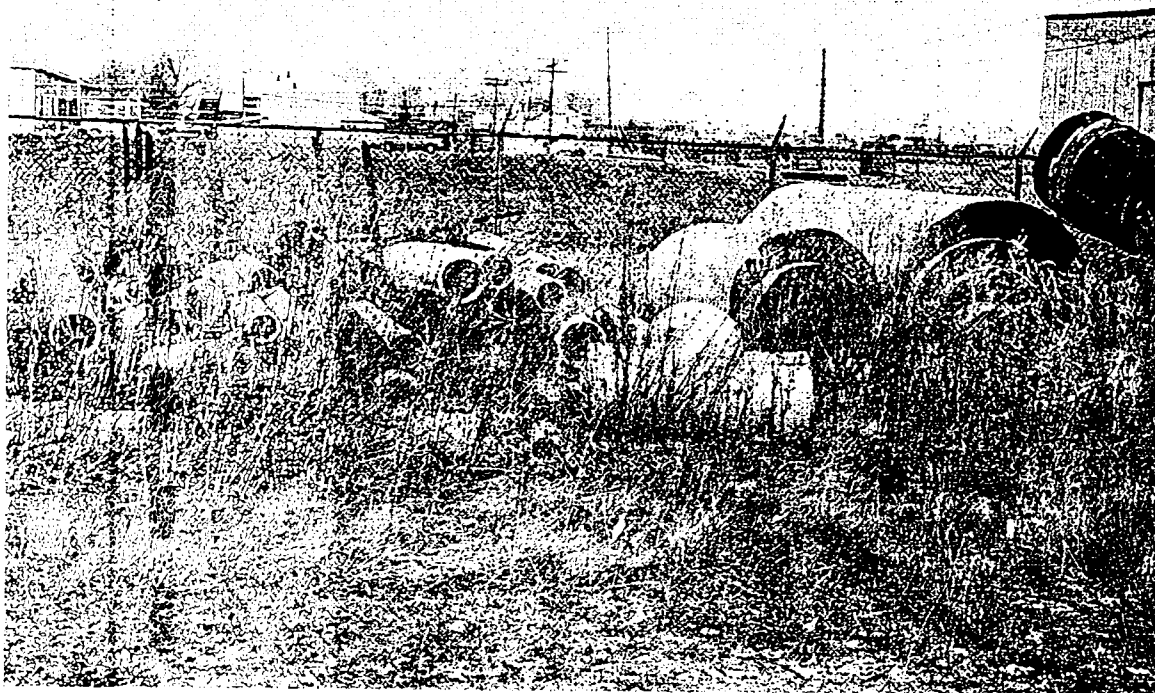
**Photograph 14. Additional view of pile #5 showing small PVC plastic pipe and large corrugated metal culvert pipe. (Peter Gorton, April 1998.)**

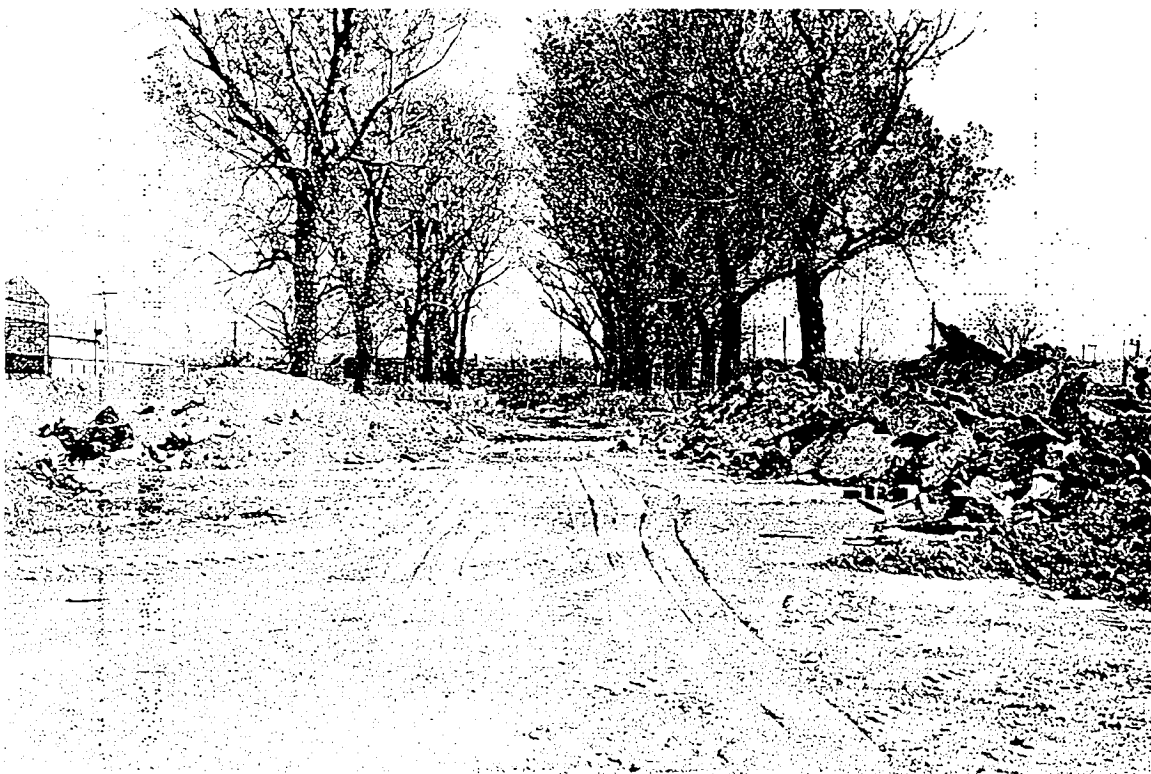
**Photograph 16. Access road south side of fenced area facing east. Note soil and asphalt debris piles and Buffalo Brake Beam facility. (Peter Gorton, April 1998.)**

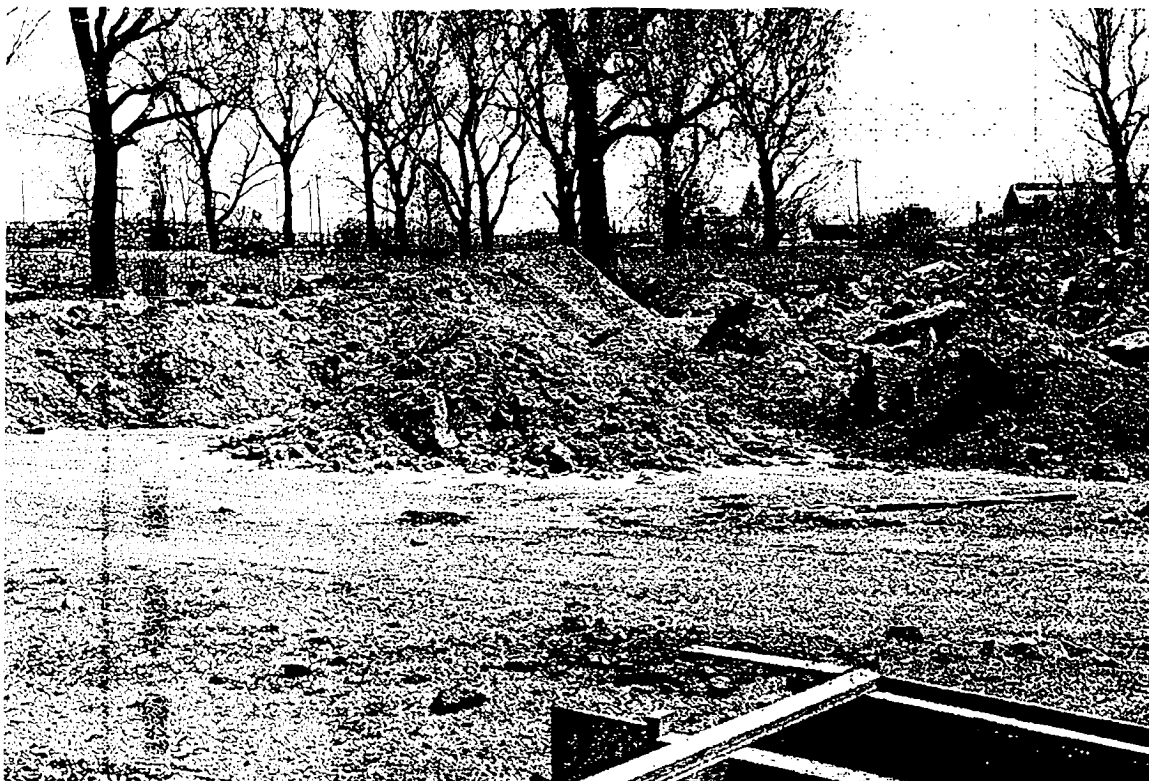
**Photograph 17.** Pile # 6 contains various piles/mounds of soil, asphalt, and cement. (Peter Gorton, April 1998.)

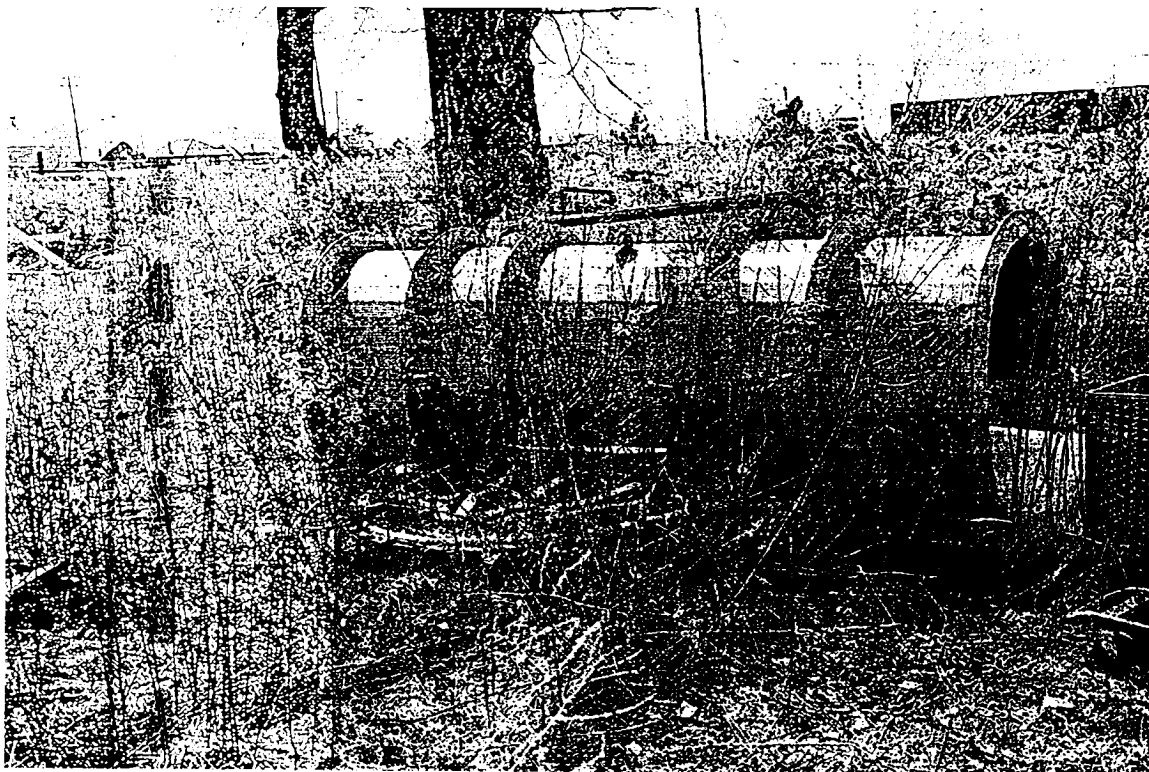
**Photograph 18.** Shows the type of miscellaneous materials in the center of the fenced area between the access road loop. A plow blade is visible. (Peter Gorton, April 1998.)

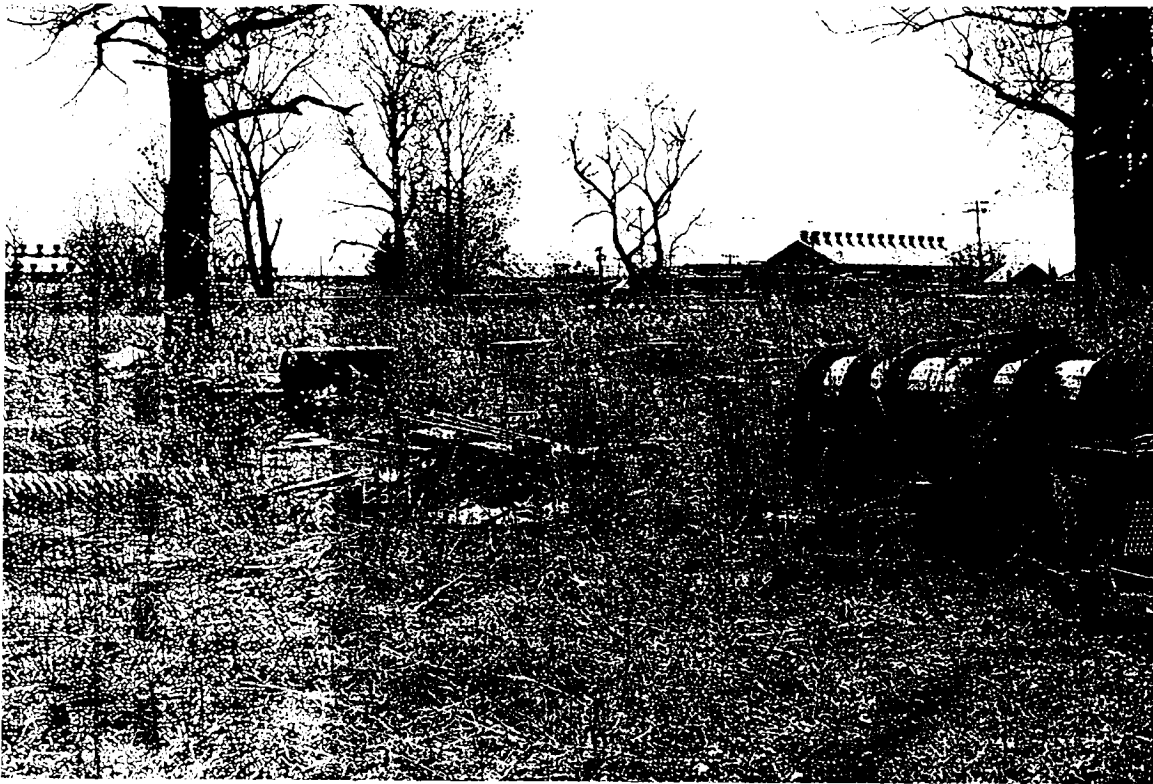
**Photograph 19. Additional view of debris in the center of the fenced area. (Peter Gorton, April 1998.)**

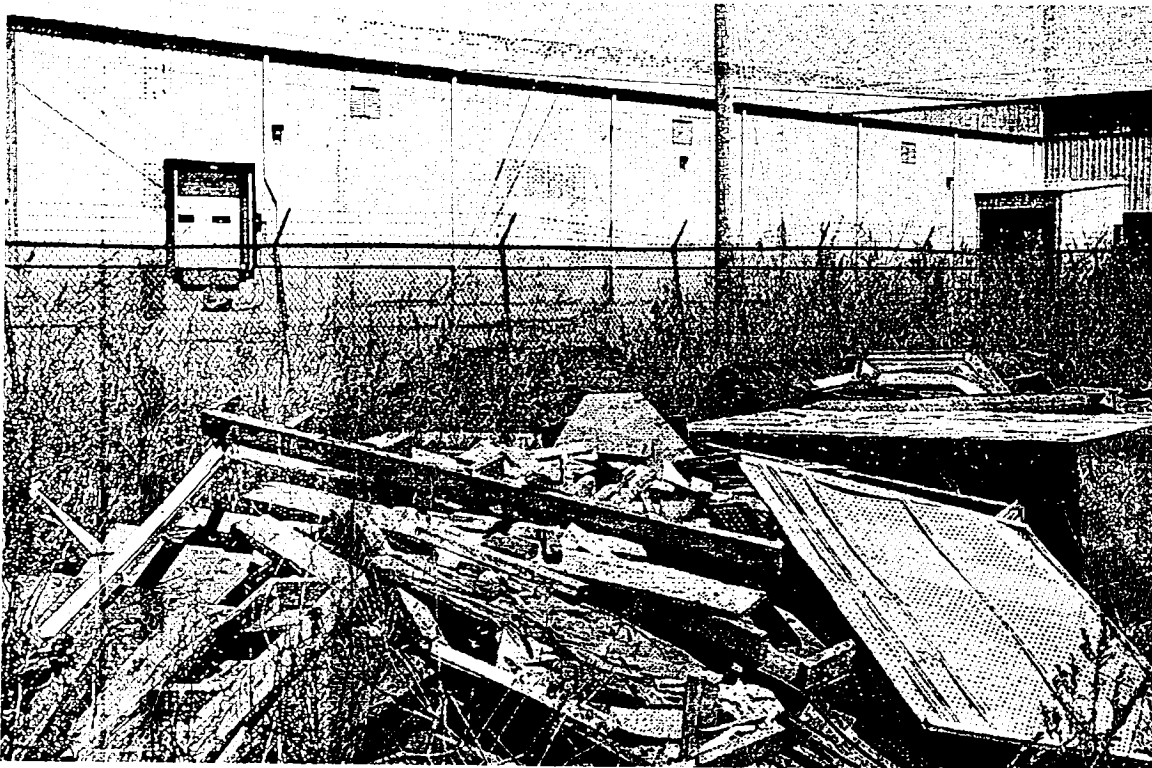
**Photograph 20. Pile of wooden debris, tire inner tubes, corrugated metal pipe and cabinets located in northeast area of fenced area facing north towards Buffalo Brake Beam. (Peter Gorton, April 1998.)**

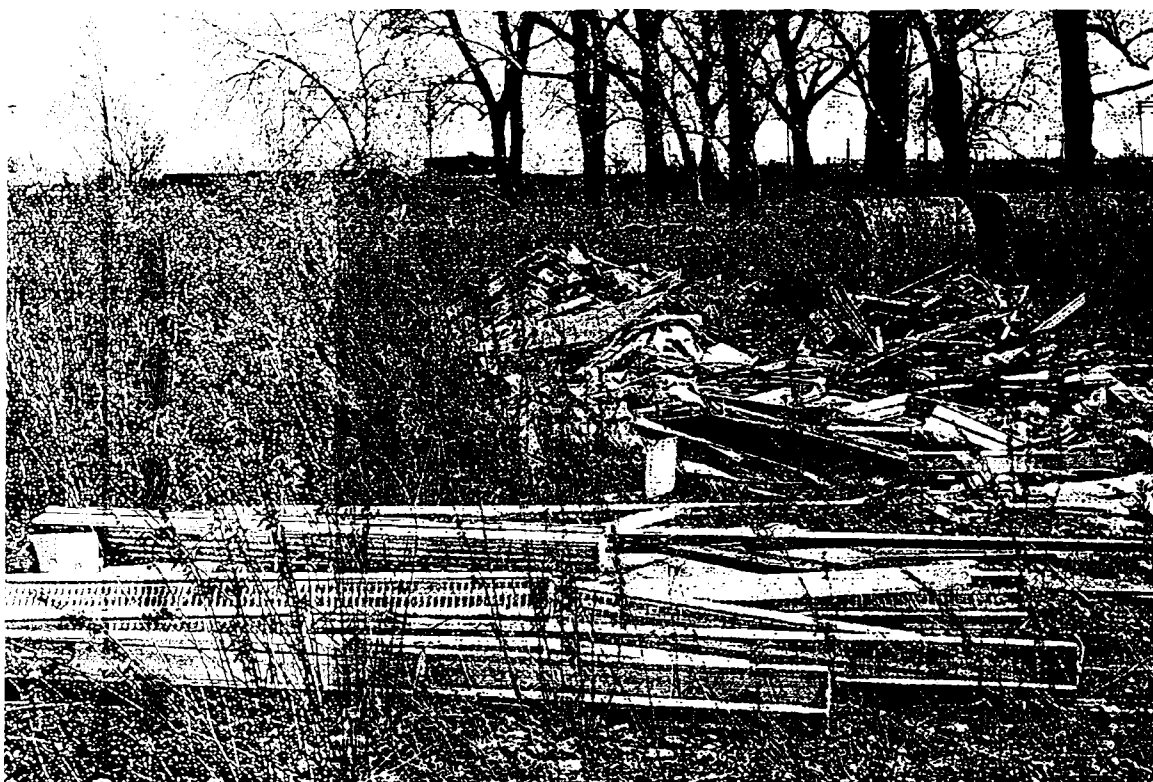
**Photograph 21. Debris pile northeast end of fenced area, showing fluorescent light fixtures. (Peter Gorton, April 1998.)**

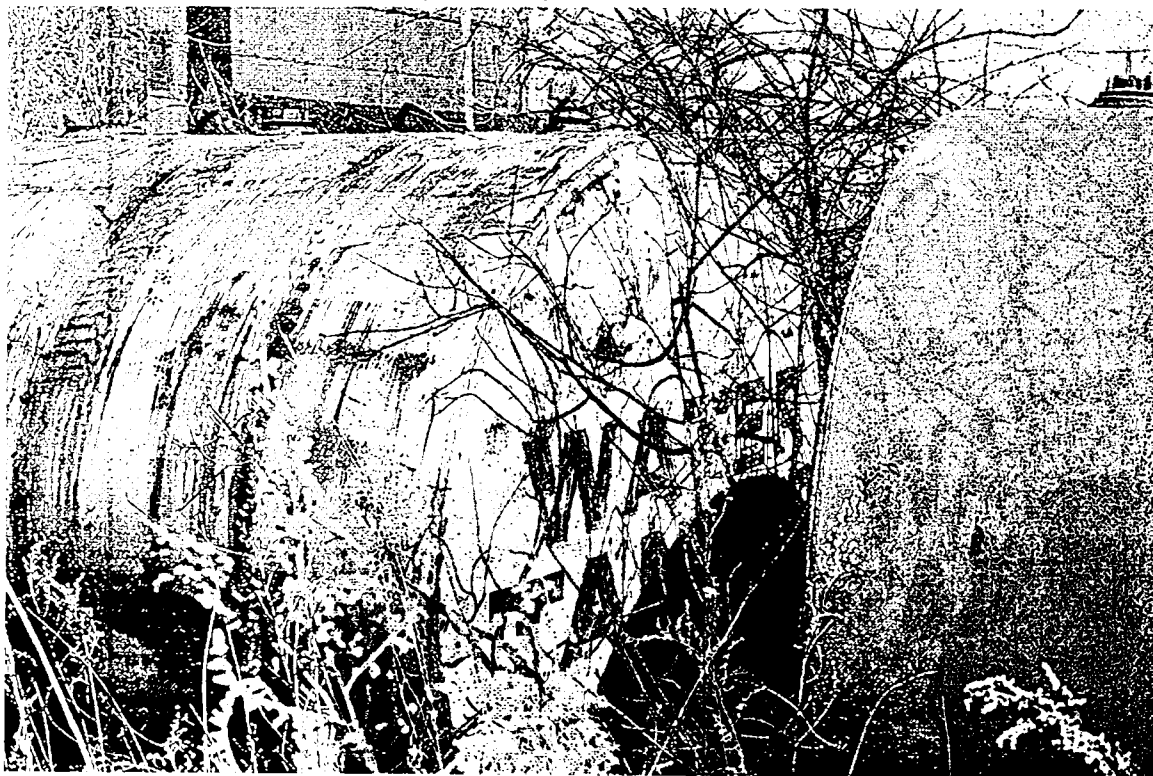
**Photograph 22. Metal tanks on skids, one labeled "water tanker". Tanks are located along the east fence line of the fenced area. (Peter Gorton, April 1998.)**

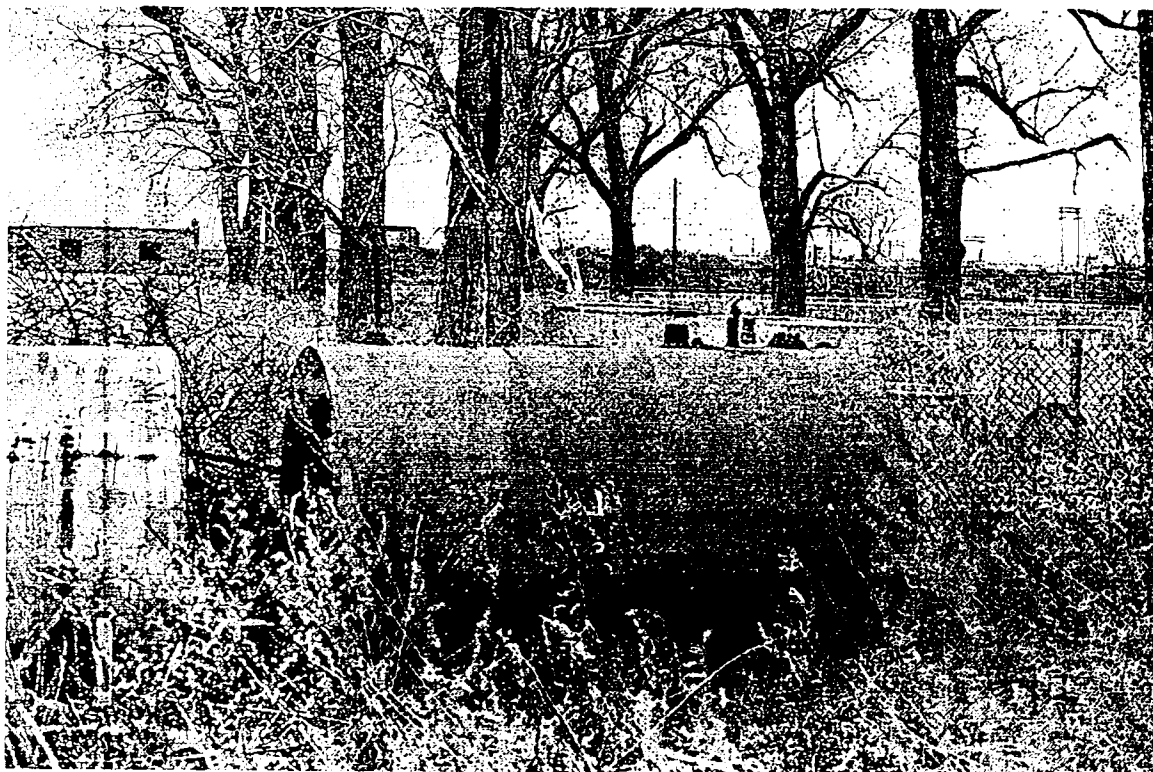
**Photograph 24. Additional view of tanks. Note sewer manholes in background. The manhole next to the tree has a drum inside – refer to later picture. (Peter Gorton, April 1998.)**

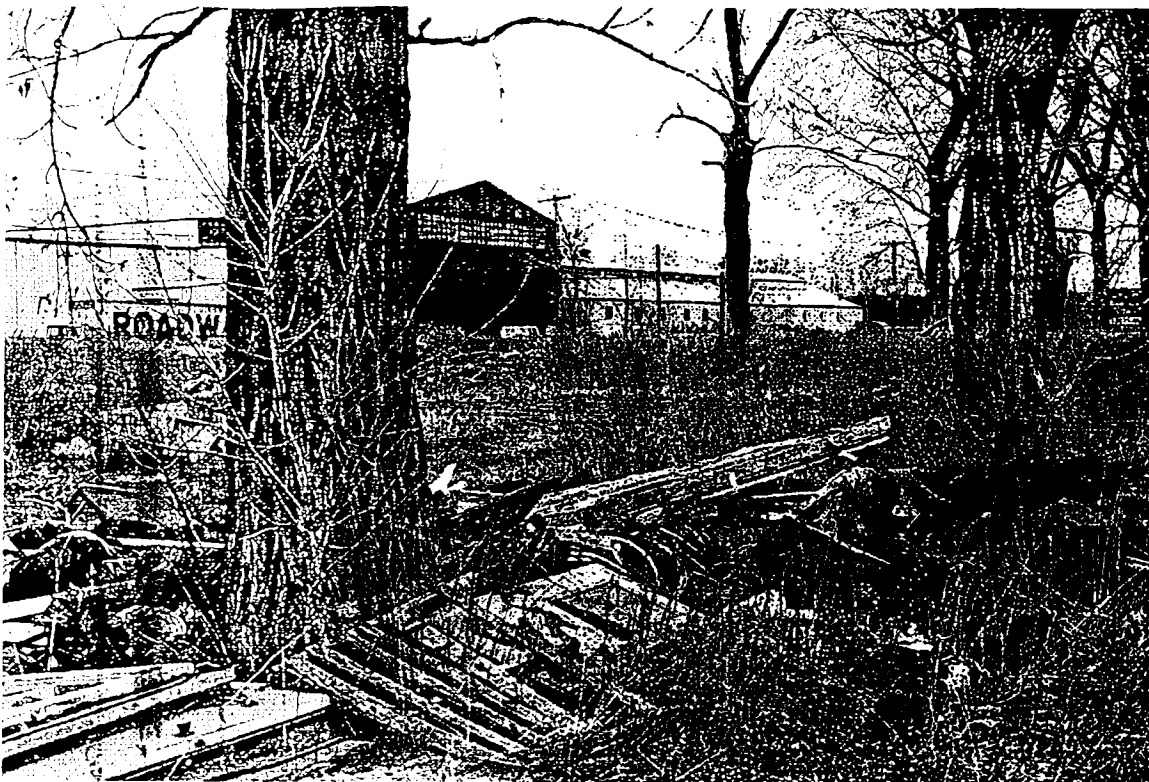
**Photograph 27. Debris pile #12 – old doors, rubber/cloth hoses, remnants of old structure. Central part of fenced area, facing northeast. (Peter Gorton, April 1998.)**

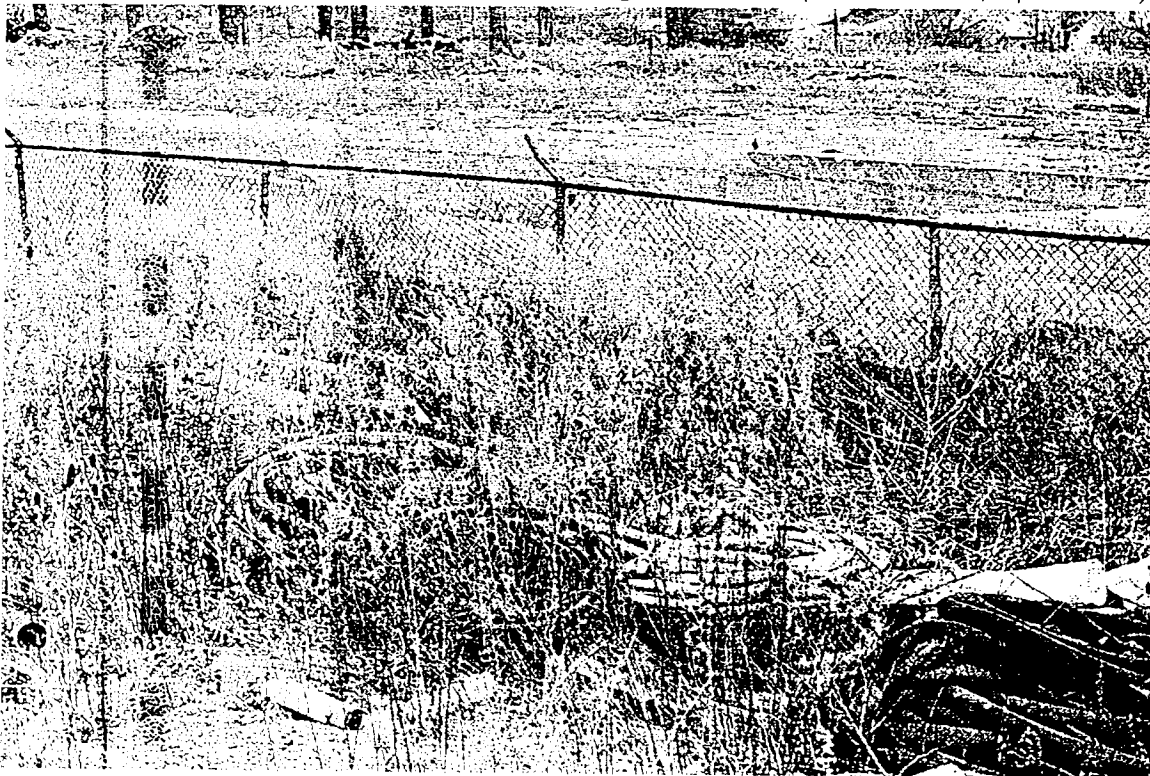
**Photograph 28. Debris pile #13: rolls of black corrugated plastic and rubber hose. Facing south. Note "jersey barriers" and debris piles along south property area in background. (Peter Gorton, April 1998.)**

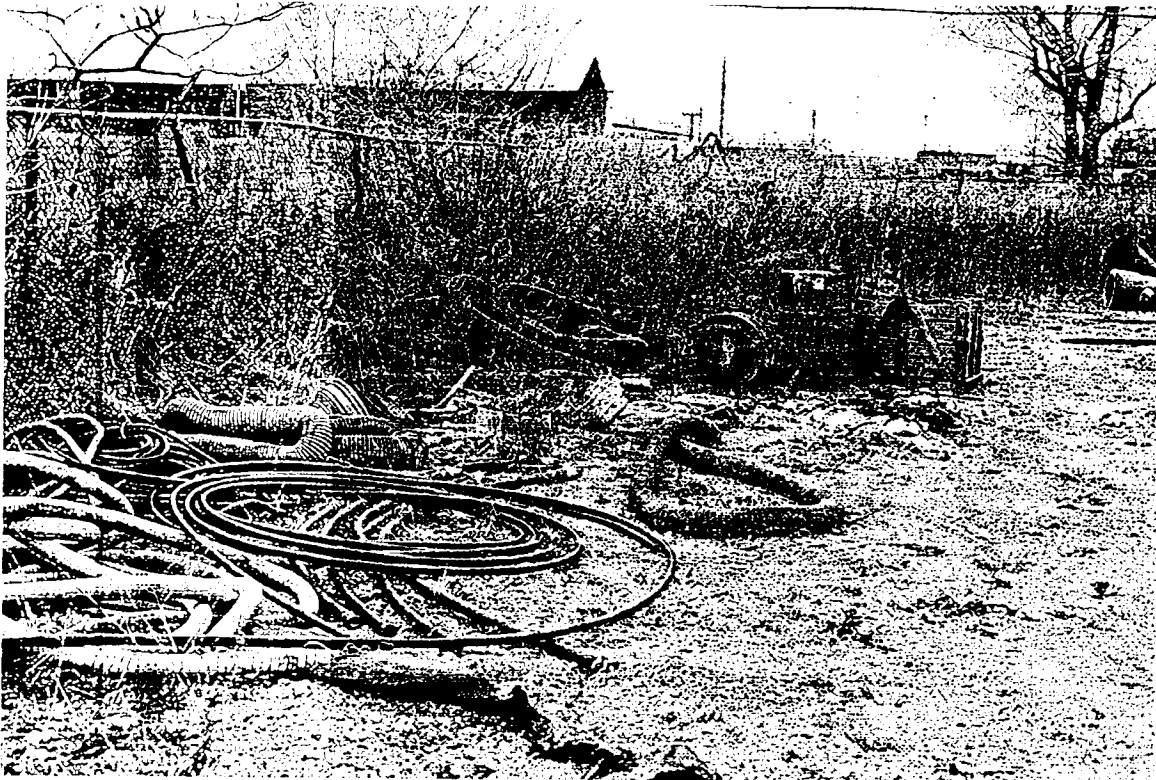
**Photograph 29. View of debris pile # 14 showing hose, two 55-gallon drums and other items. (Peter Gorton, April 1998.)**

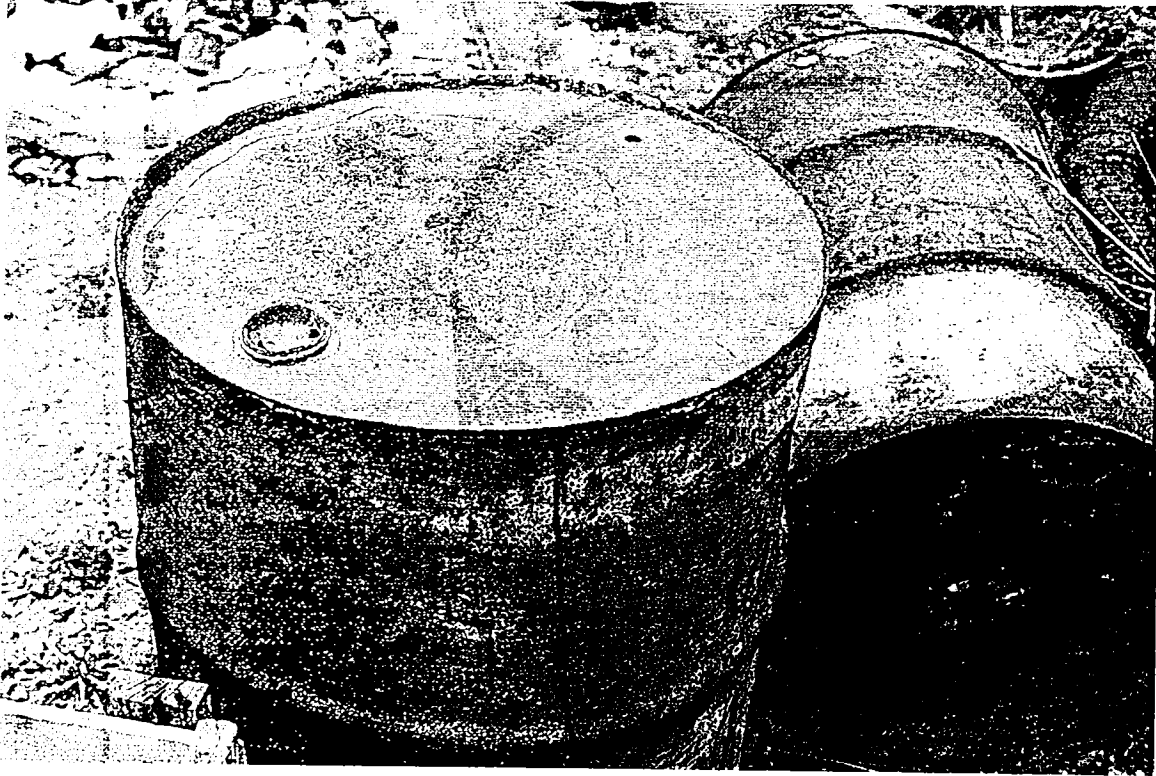
**Photograph 30. Close-up of two 55-gallon drums. (Peter Gorton, April 1998.)**

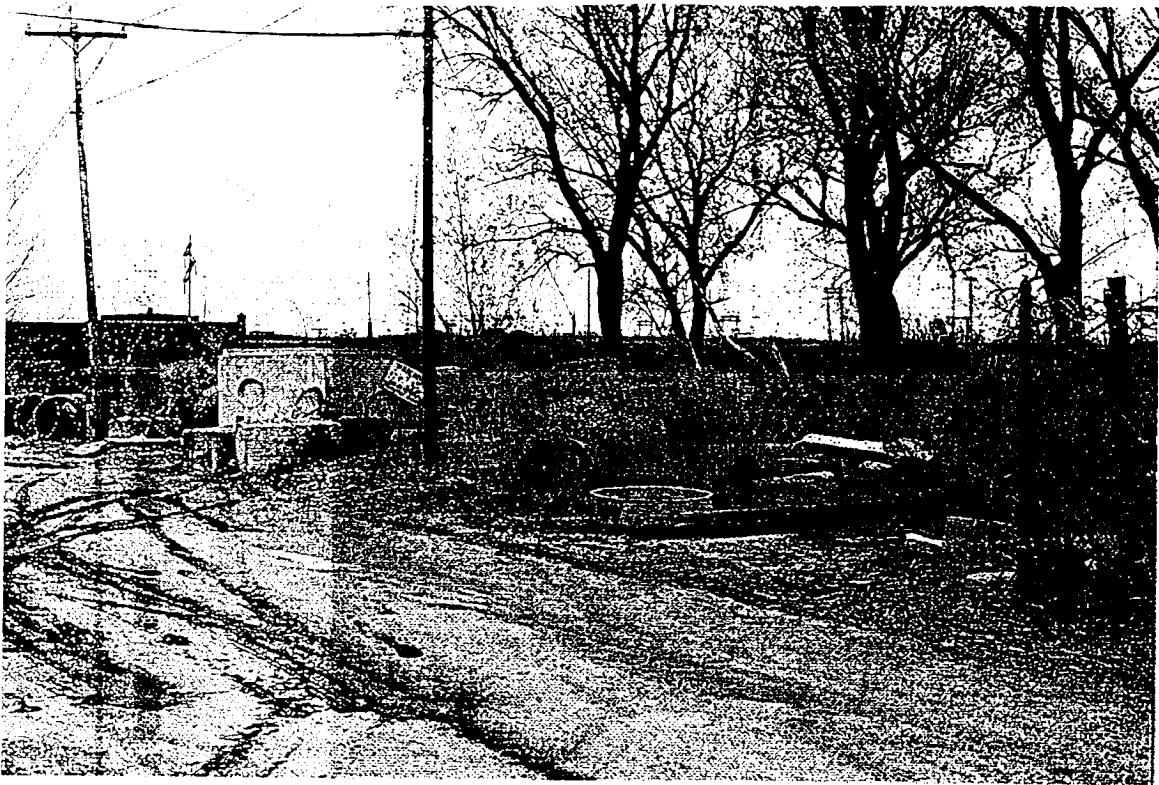
The northeast area of the property to the east of the fenced-in laydown area contains a significant quantity of large dimension concrete sewer conduits and basins (for manholes). These are scattered on the surface from the rear of the laydown area to the northeast corner of the property. Since the previous site owner, Amadori Construction, was reportedly a sewer contractor, the presence of so many of these items on the property is understandable. A few crushed and empty 55-gallon drums are also found in this area. The Buffalo Brake Beam Company is immediately adjacent to this portion of the property to the north.

**Photograph 31. View from east end of fenced area facing east towards the sewer plant. Shows curbing stone and large number of cement sewer manholes and culverts. (Peter Gorton, April 1998.)**

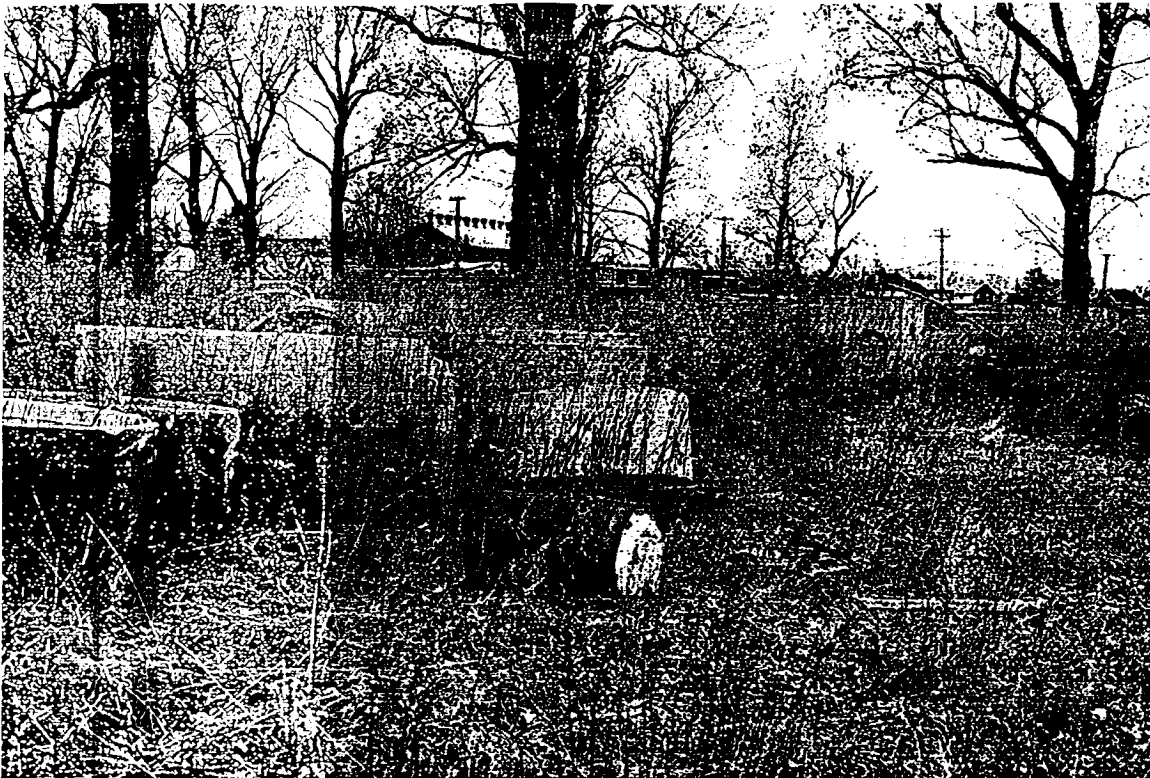
**Photograph 33. Northeast area of property facing southwest. Empty 55-gallon drum in foreground. (Peter Gorton, April 1998.)**

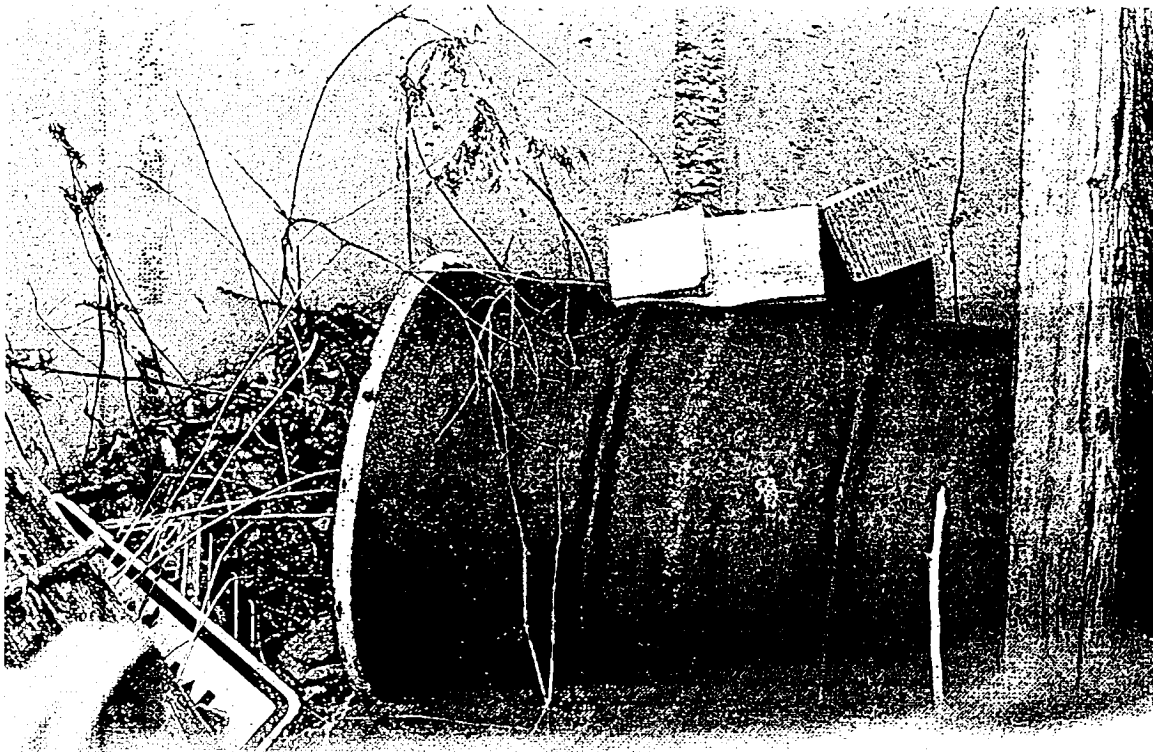
**Photograph 34. 55-gallon drum inside a sewer manhole, east of the fenced area. Refer to Photograph 24. (Peter Gorton, April 1998.)**

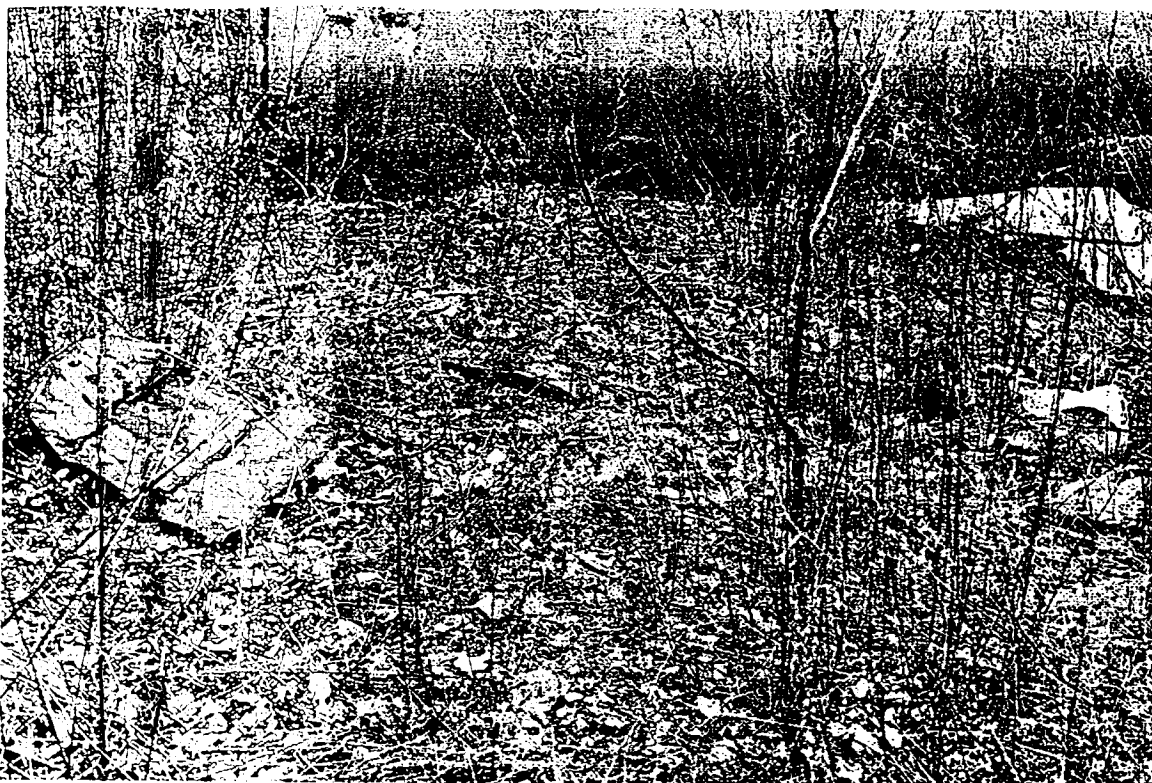
**Photograph 37. Northeast corner of property showing crushed 55-gallon drum.**  
(Peter Gorton, April 1998.)
