**B00080-9**

**SI/RAR Scoping Plan  
Phase I Environmental Site Assessment,  
Amadori Project Site Property,  
City of Lackawanna,  
Erie County, New York**

**May 14, 1998**

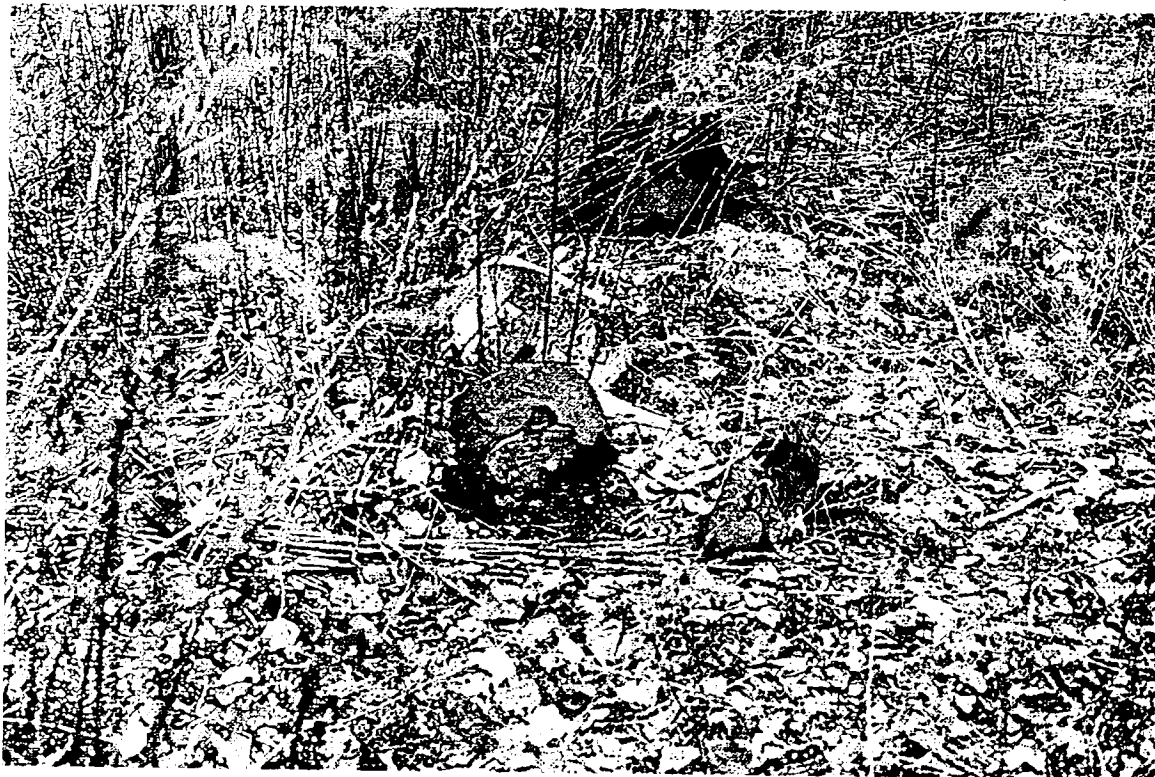
**Photograph 38. Northeast corner of property showing old rusted-out paint can and contents.** (Peter Gorton, April 1998.)

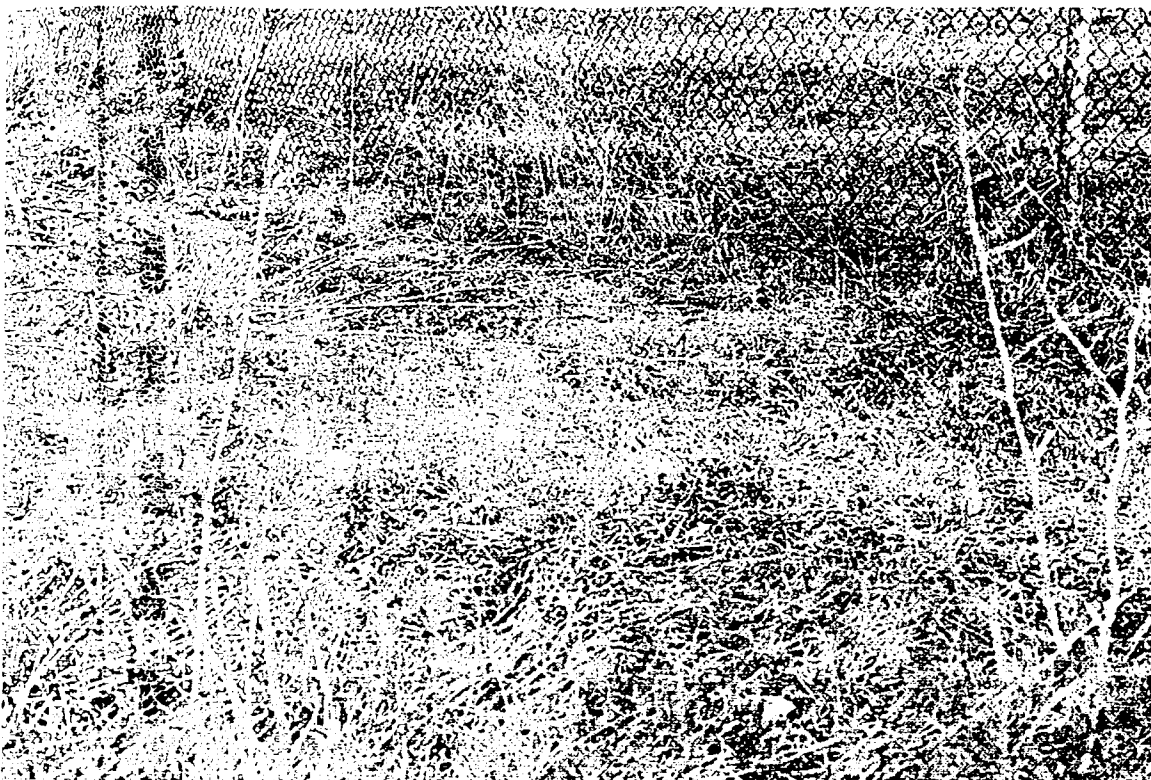
**Photograph 41. Area of discolored grass, east center portion of property along fence line with the sewer plant. (Peter Gorton, April 1998.)**

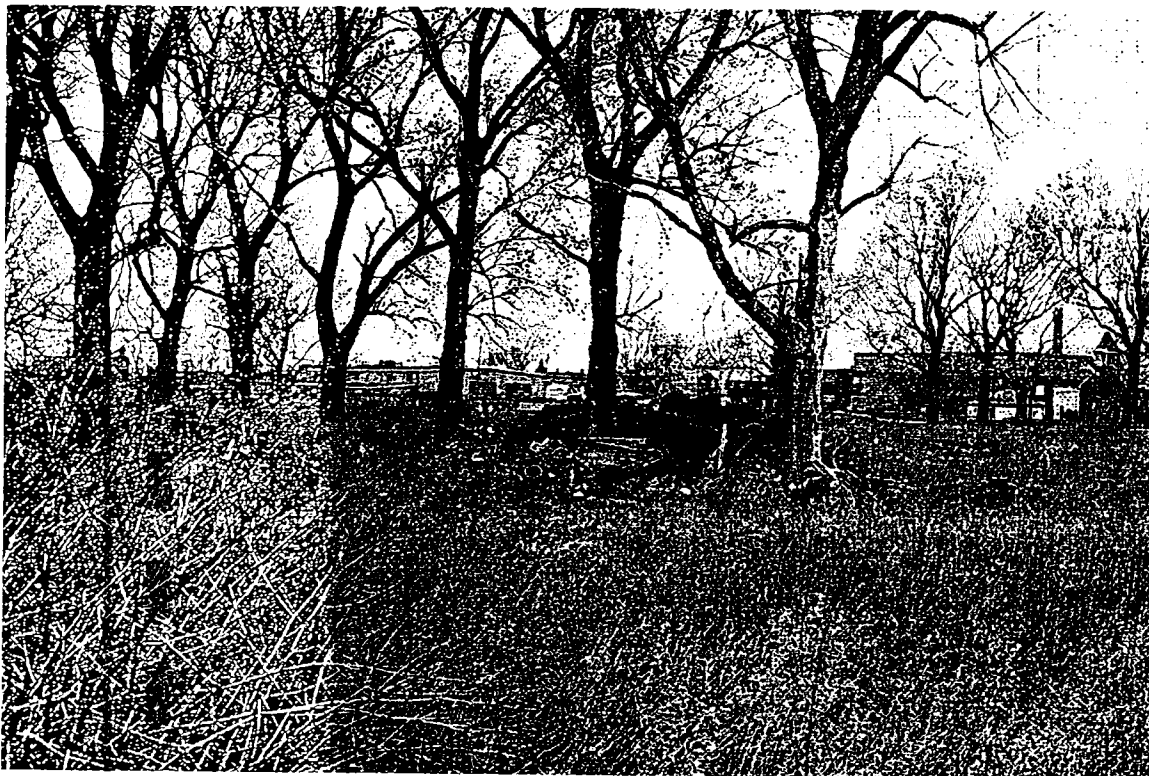
**Photograph 42. Tire pile – large debris pile south central portion of the site. From southwest facing northeast. (Peter Gorton, April 1998.)**

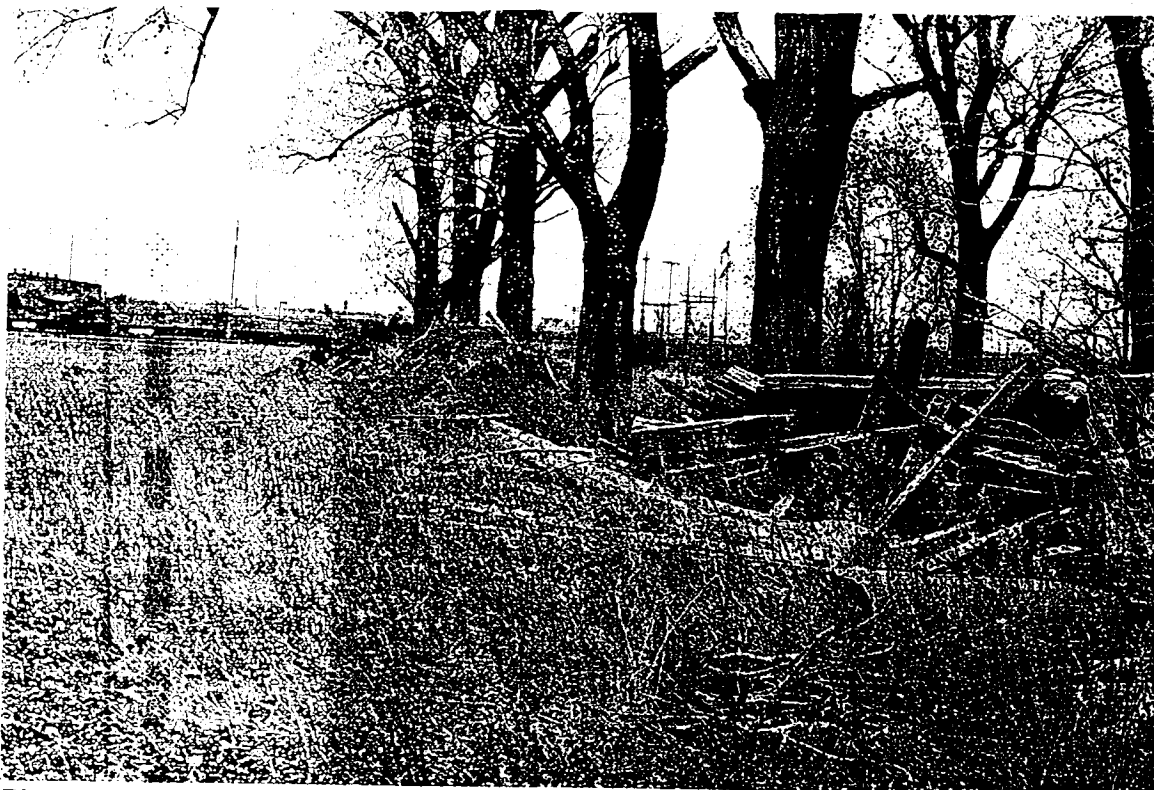
**Photograph 45.** View of waste piles along tree line on southern half of the property. View is from west facing east. *(Peter Gorton, April 1998.)*

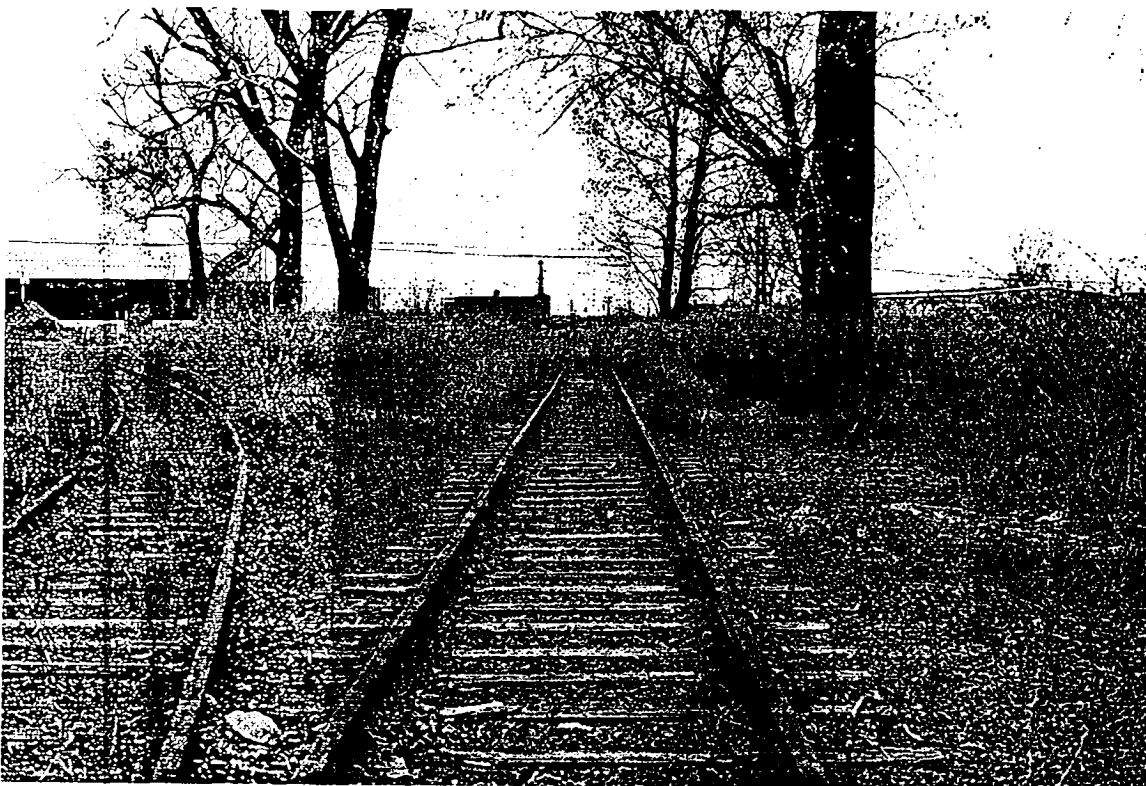
**Photograph 47. South property line from center of southern border facing west. Photo shows concrete wall or footing cut by tracks. (Peter Gorton, April 1998.)**
