PERIODIC REVIEW REPORT

PORT-GREENBELT
SHORELINE IMPROVEMENT PROJECT
CITY OF BUFFALO, ERIE COUNTY, NEW YORK

SITE No. B-00149-9

JUNE 2016

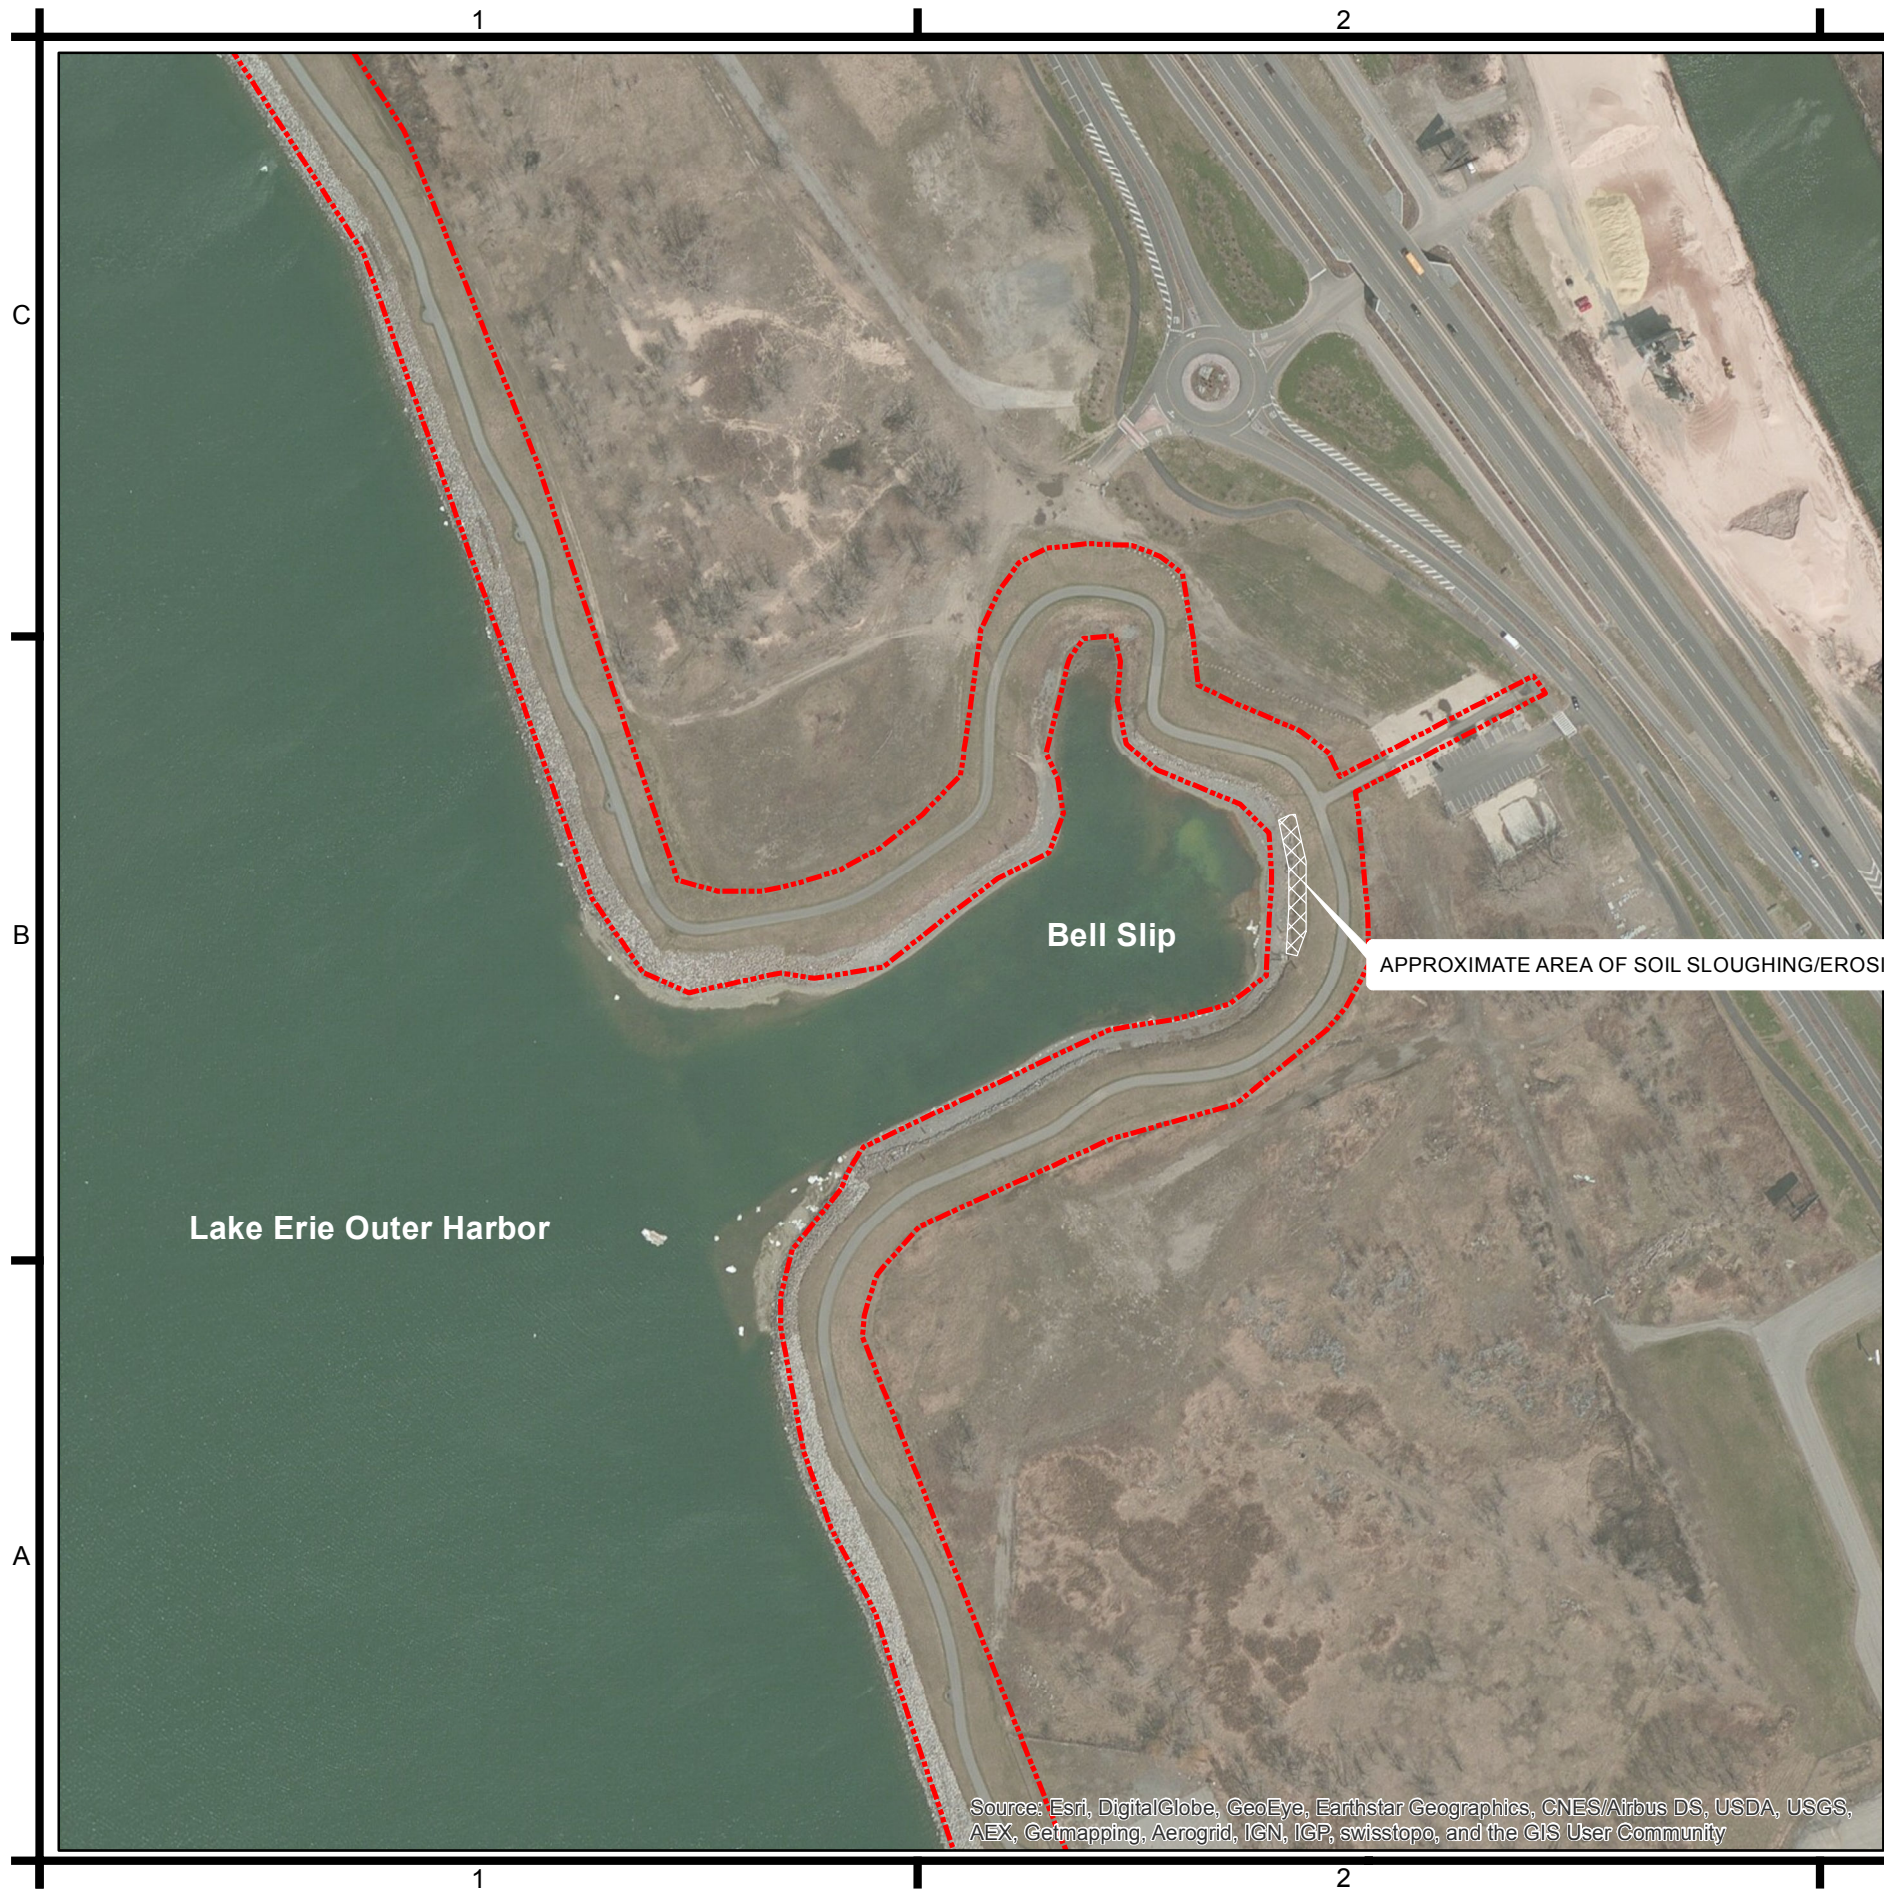
FIGURE 2

No geotextile fabric was exposed at the Bell Slip. However, there is evidence of soil erosion/sloughing in one area of the slip, which is shown in **Figure 2**. A portion of the slope in this location has a vertical face where there is no soil or vegetation in an area behind a portion of the stone revetment. The soil cover in this portion of the Bell Slip appeared darker due to possible ponding from water that has overtopped the stone barrier during periods of high lake levels. There is also erosion from water scouring the soil behind the revetment and also slight damage to the gravel-filled bag which was displaced and tangled with some netting on shore.

No changes to the Site Management Plan are needed or recommended at this time. Additional erosion protection may be considered in the Bell Slip to prevent further erosion that may threaten human health and the environment.

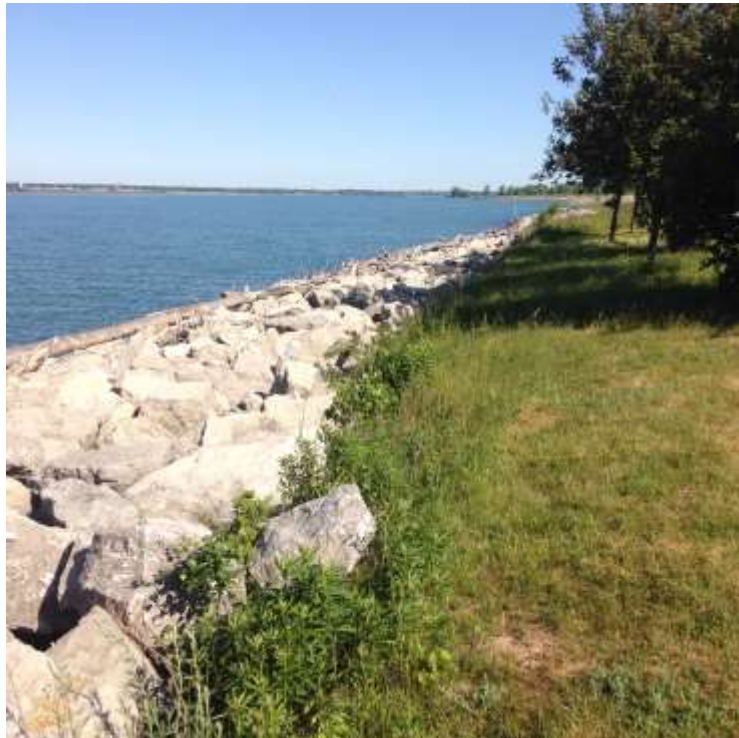
Looking north along stone revetment from southern portion of Greenbelt, south of Bell Slip.

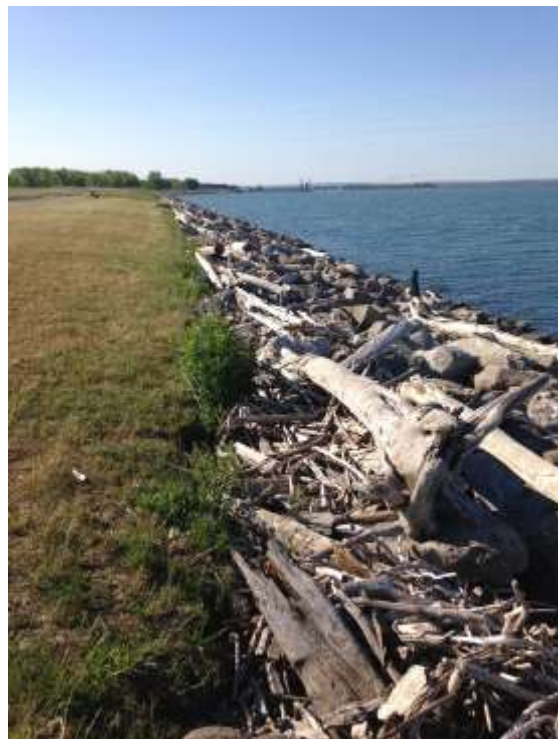
1

Looking south from northern portion of Greenbelt

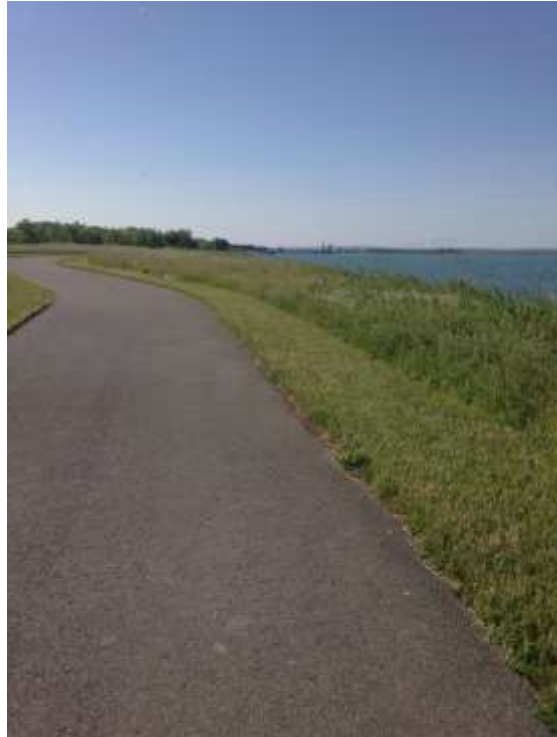
Exhibit:	Date:	Port-Greenbelt PRR
2	6/9/2016

Looking south along
bike/pedestrian path

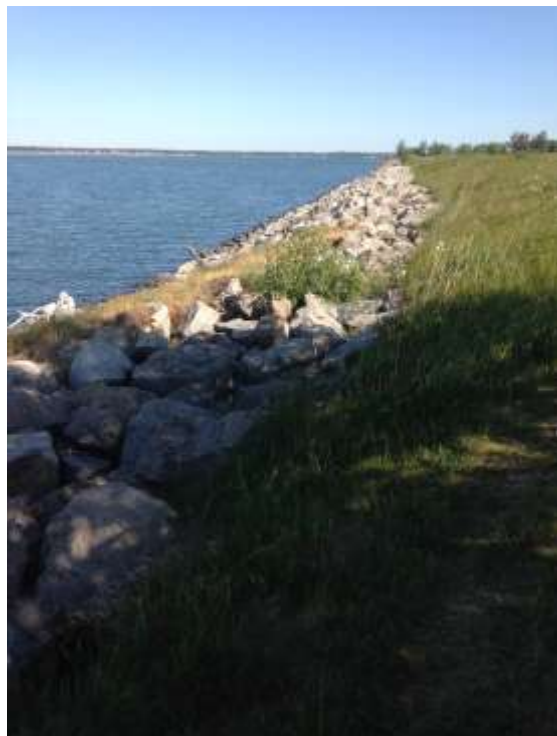
Exhibit:	Date:	Port-Greenbelt PRR
3	6/9/2016

Looking north from
middle of Greenbelt.
Stone revetment has
some soil/grass on top.

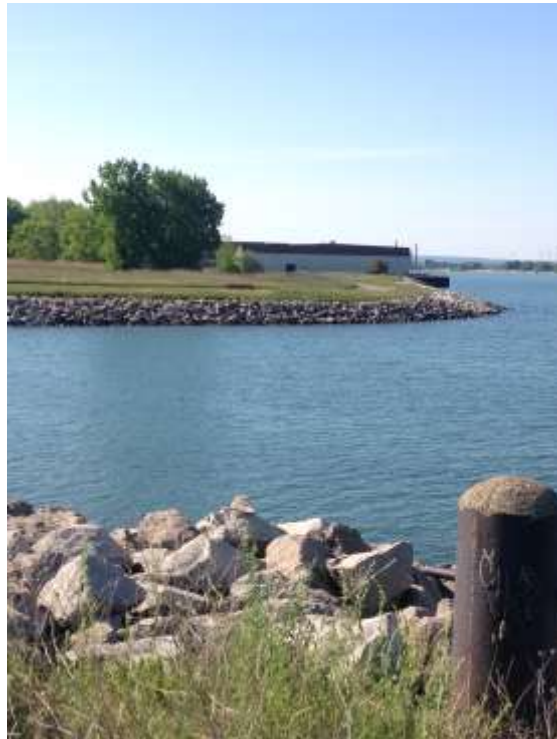
Exhibit:	Date:	Port-Greenbelt PRR
4	6/9/2016

Looking south at entrance of Bell Slip

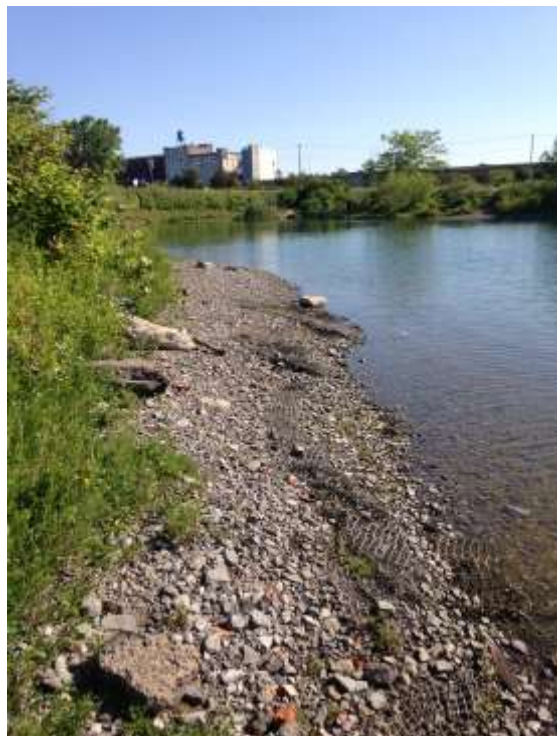
Exhibit:	Date:	Port-Greenbelt PRR
5	6/9/2016

Looking east along northern bank of Bell Slip. Netting from erosion control is visible.

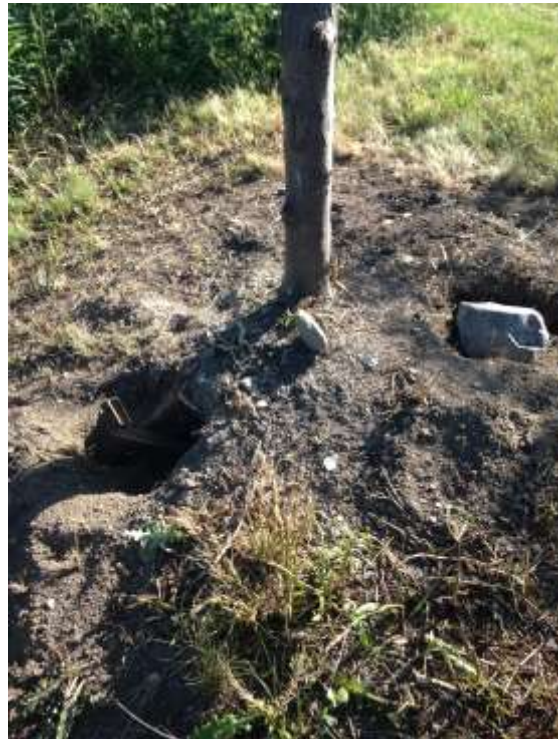
Exhibit:	Date:	Port-Greenbelt PRR
6	6/9/2016

Generally, the slip looked to be in good condition with significant portions of the area covered with stones and grass cover. There were occasional animal burrows near trees located in the Bell Slip area. There was also debris along the water's edge.

animal burrows near
tree east of Bell Slip

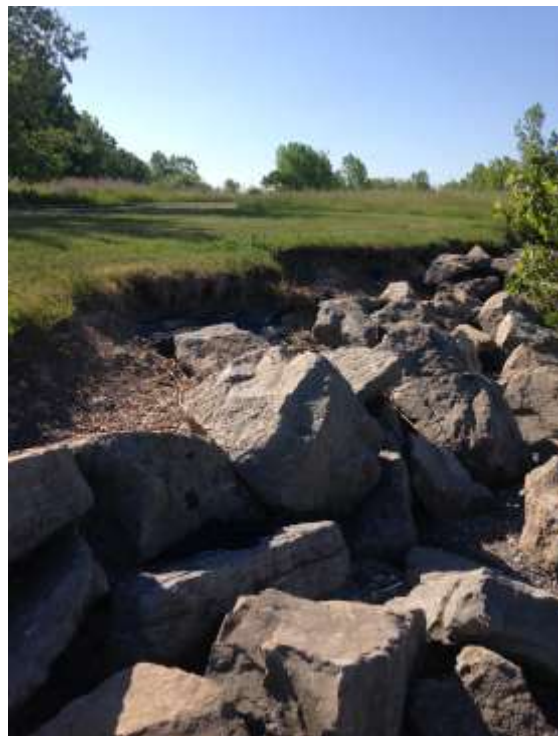
Exhibit:	Date:	Port-Greenbelt PRR
7	6/9/2016

Looking south along
eastern bank of Bell
Slip (see Figure 2).
Vertical banks are
visible above stone
revetment.

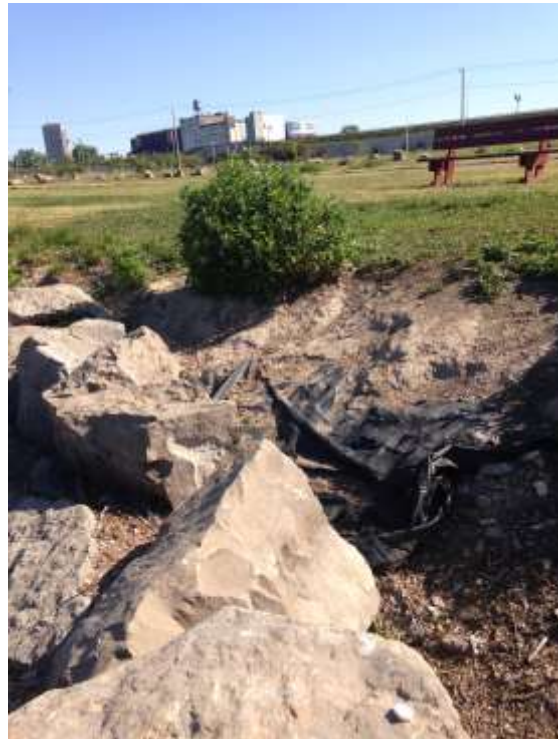
Exhibit:	Date:
8	6/9/2016

Looking north along eastern bank of Bell Slip (see Figure 2). Fabric and soil erosion visible above stones.

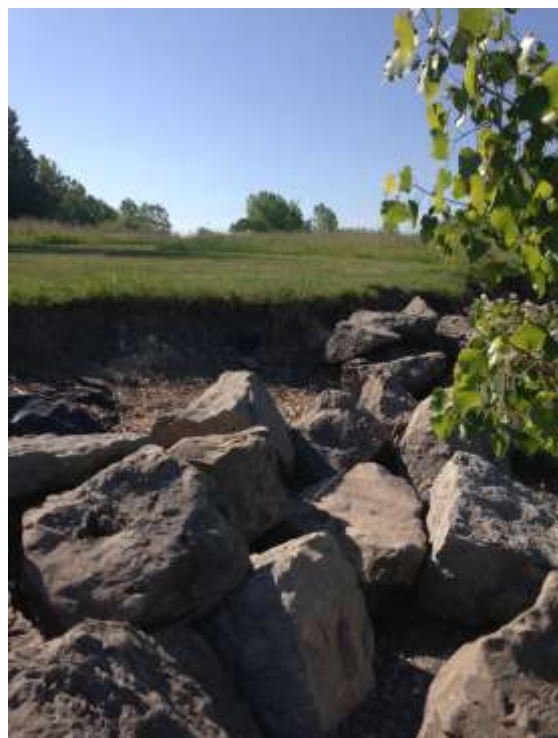
Exhibit:	Date:
9	6/9/2016

Looking south along eastern bank of Bell Slip (see Figure 2). Vertical banks are visible above stone revetment.

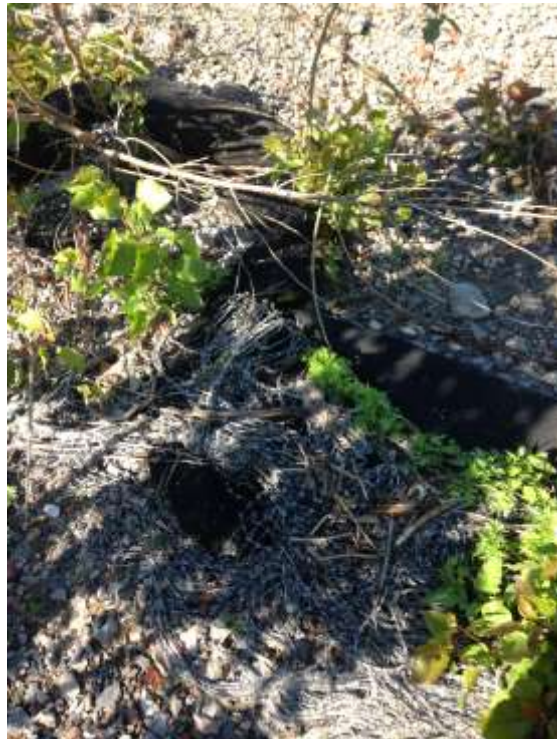
Exhibit:	Date:
10	6/9/2016

Netting and part of toe sock visible on eastern bank of Bell Slip

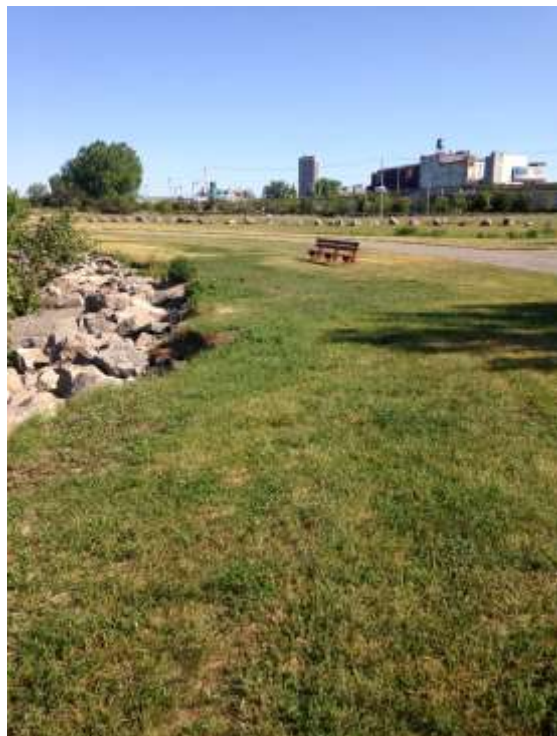
Exhibit:	Date:
11	6/9/2016

Looking north along path near eastern bank of Bell Slip. Darker grass and apparent depression near bench.

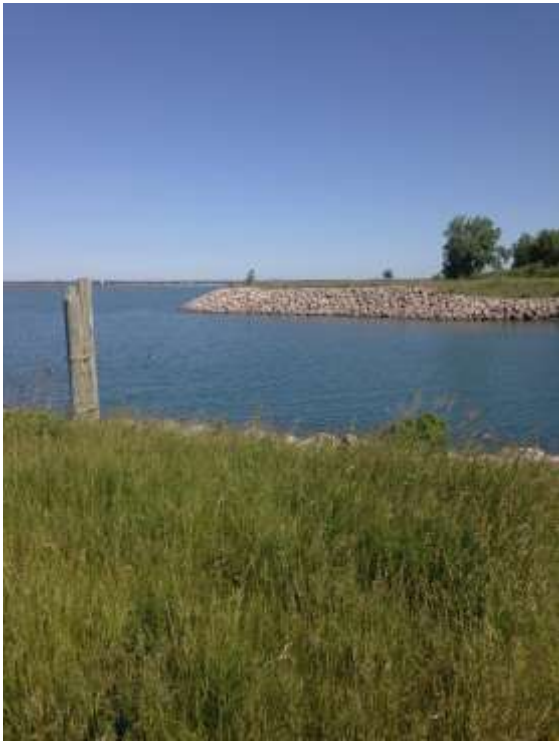
Exhibit:	Date:	Port-Greenbelt PRR
12	6/9/2016

Looking north at
entrance to Bell Slip
