PERIODIC REVIEW REPORT

PORT-GREENBELT
SHORELINE IMPROVEMENT PROJECT
CITY OF BUFFALO, ERIE COUNTY, NEW YORK

SITE NO. B-00149-9

LiRo ENGINEERS, INC.
690 Delaware Avenue
Buffalo, New York 14209

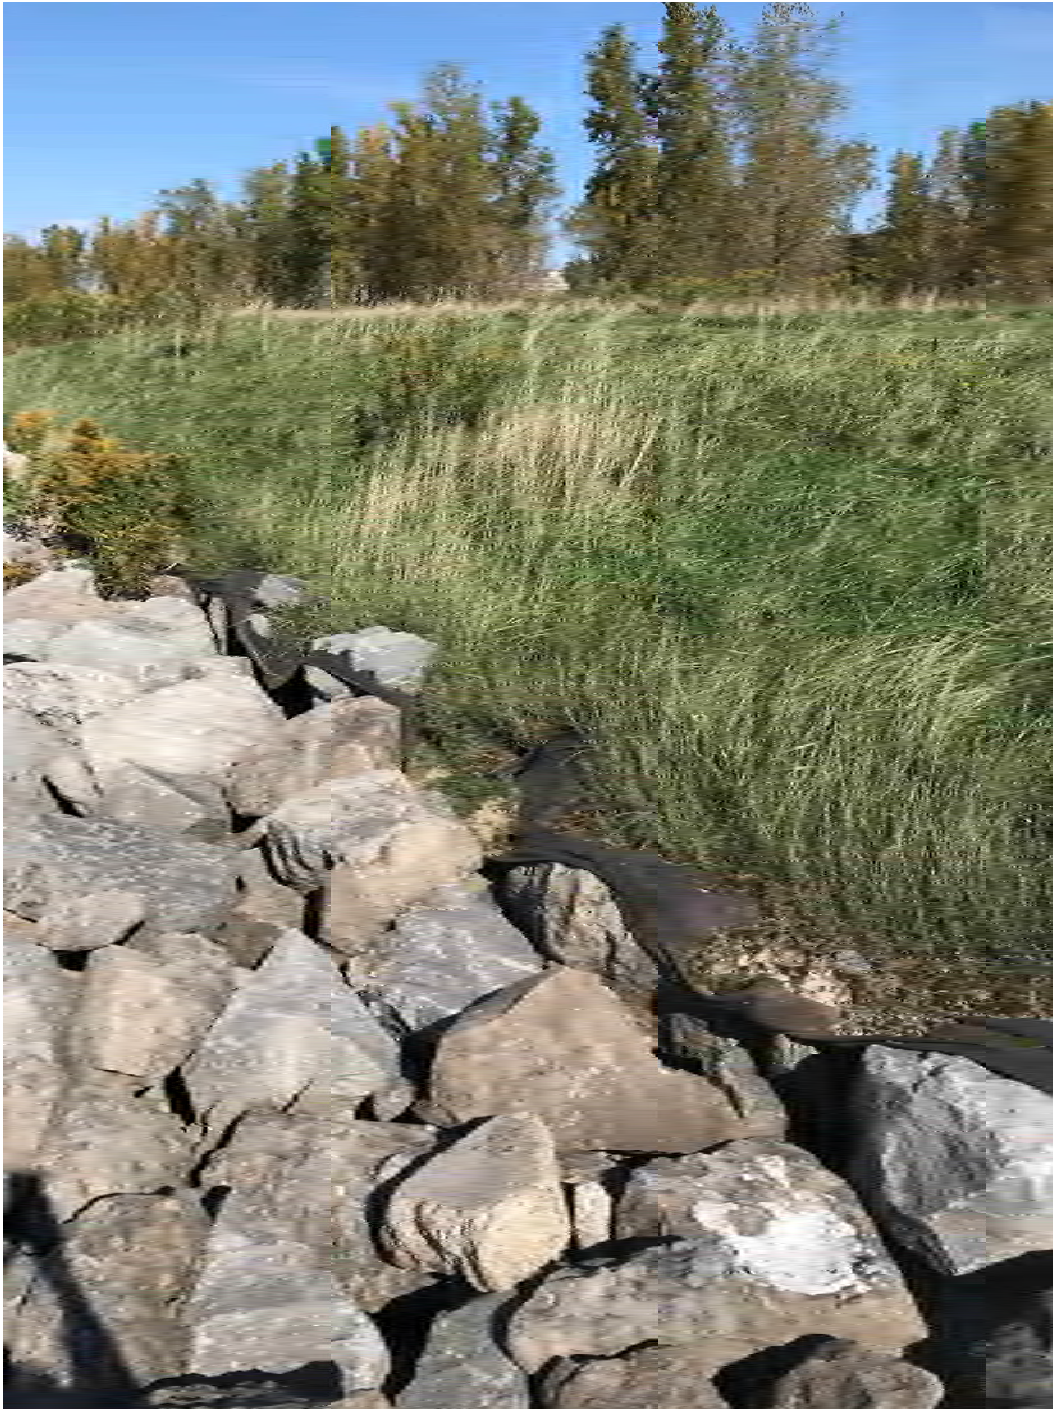
View of exposed geotextile between revetment and soil cover system.

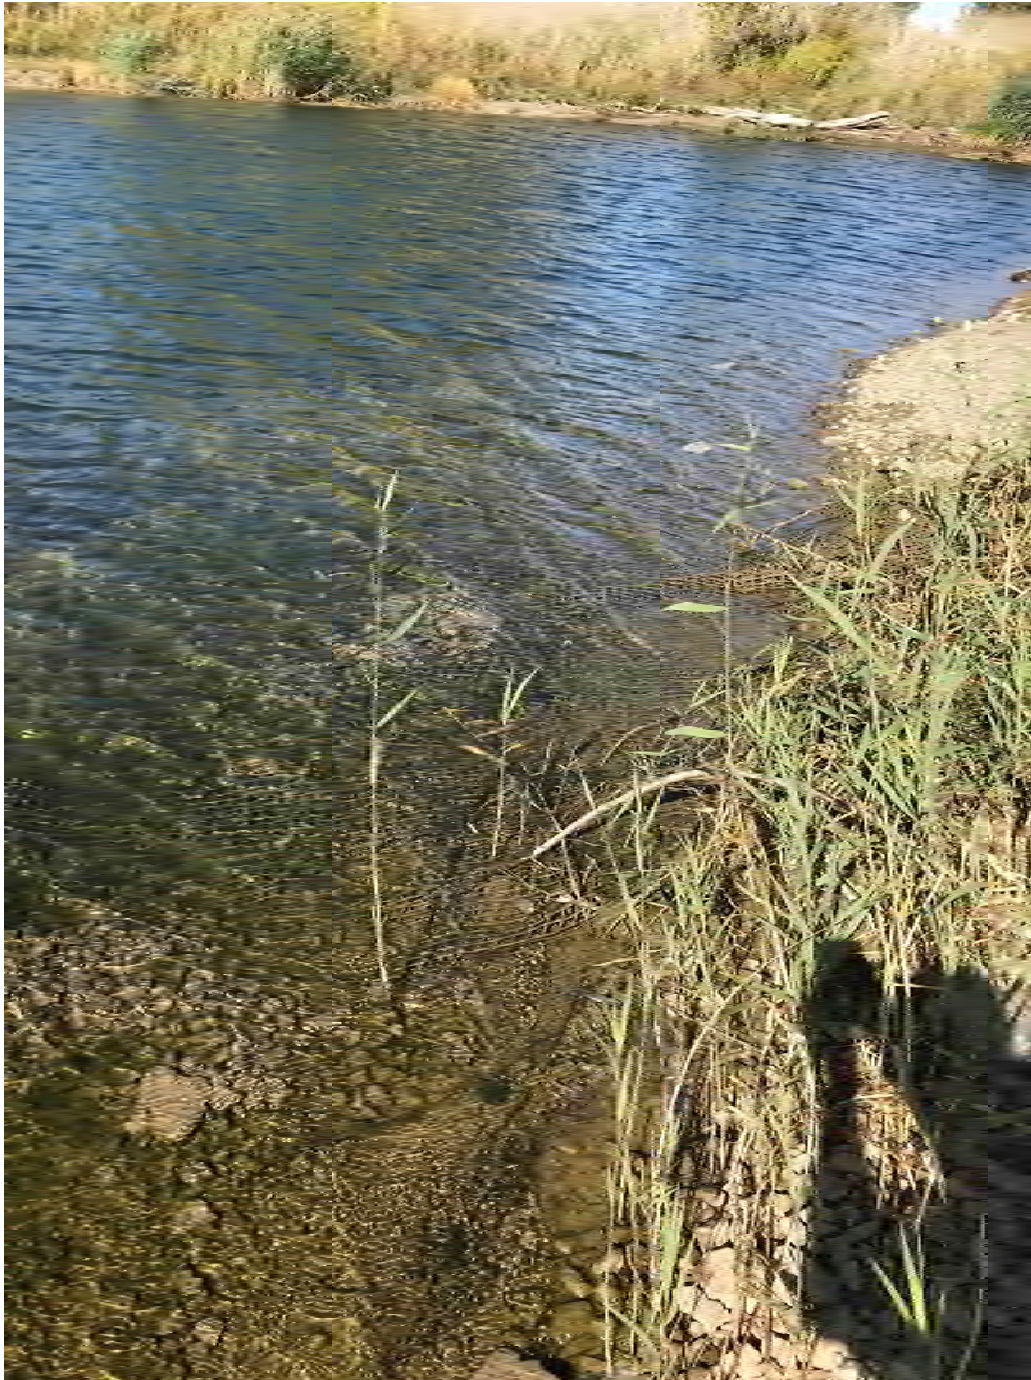
East side of Bell Slip, visible netting along shoreline.

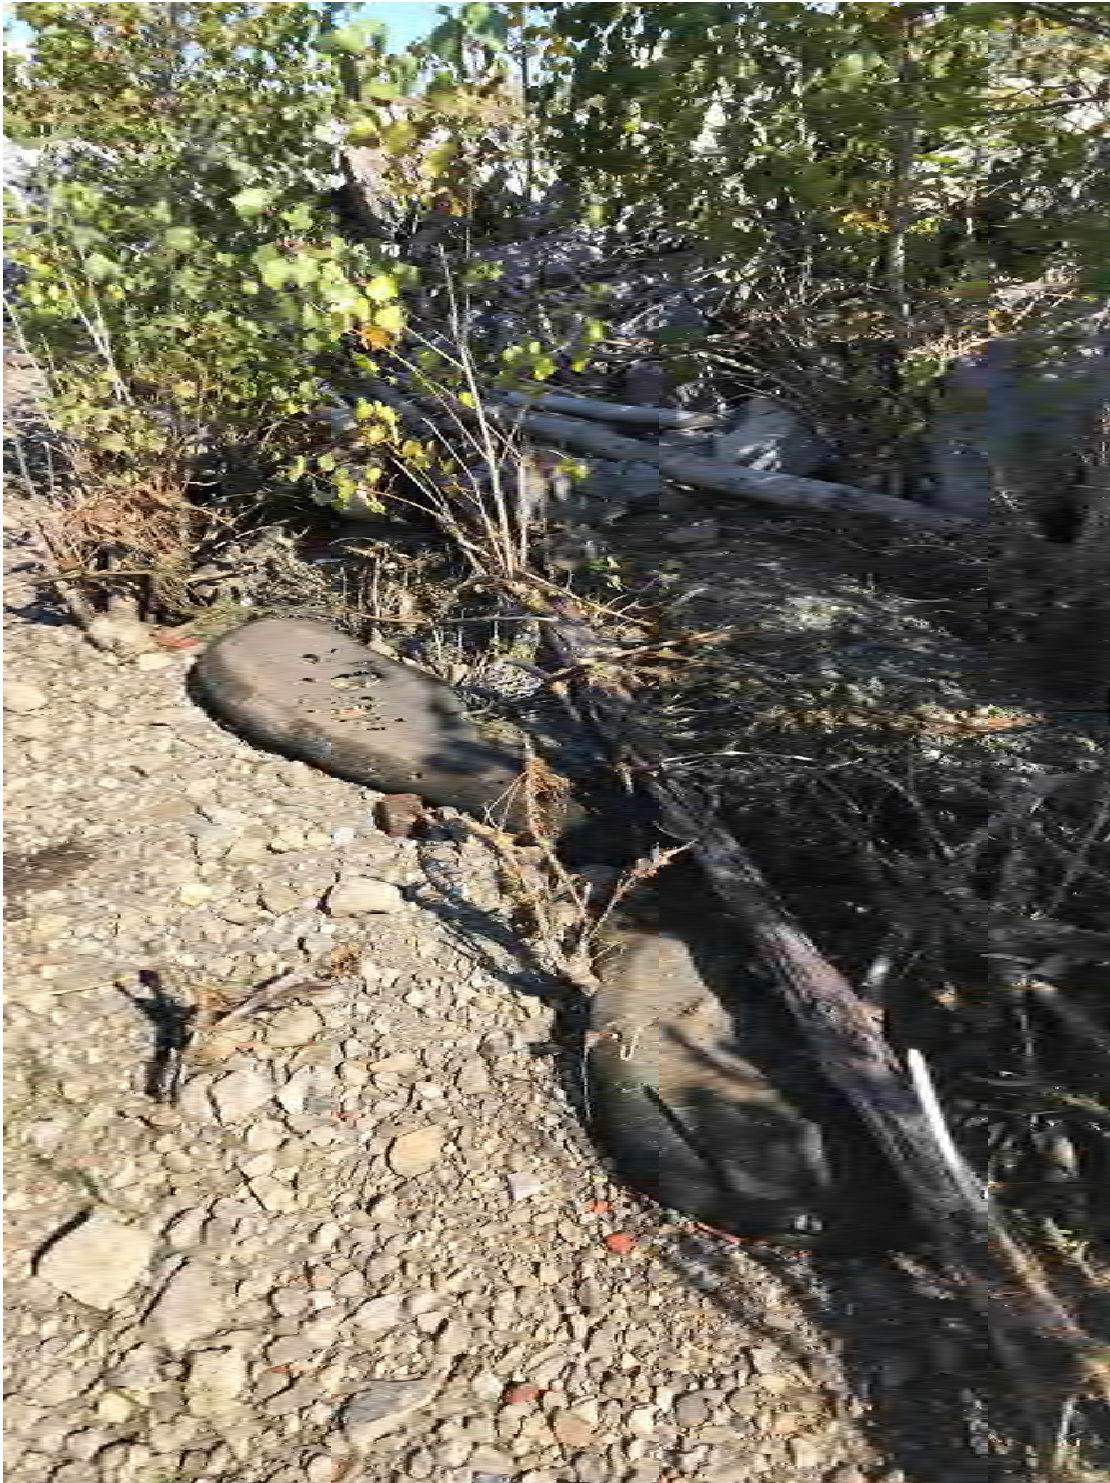
Exposed toe sock and netting along east shoreline of Bell Slip.

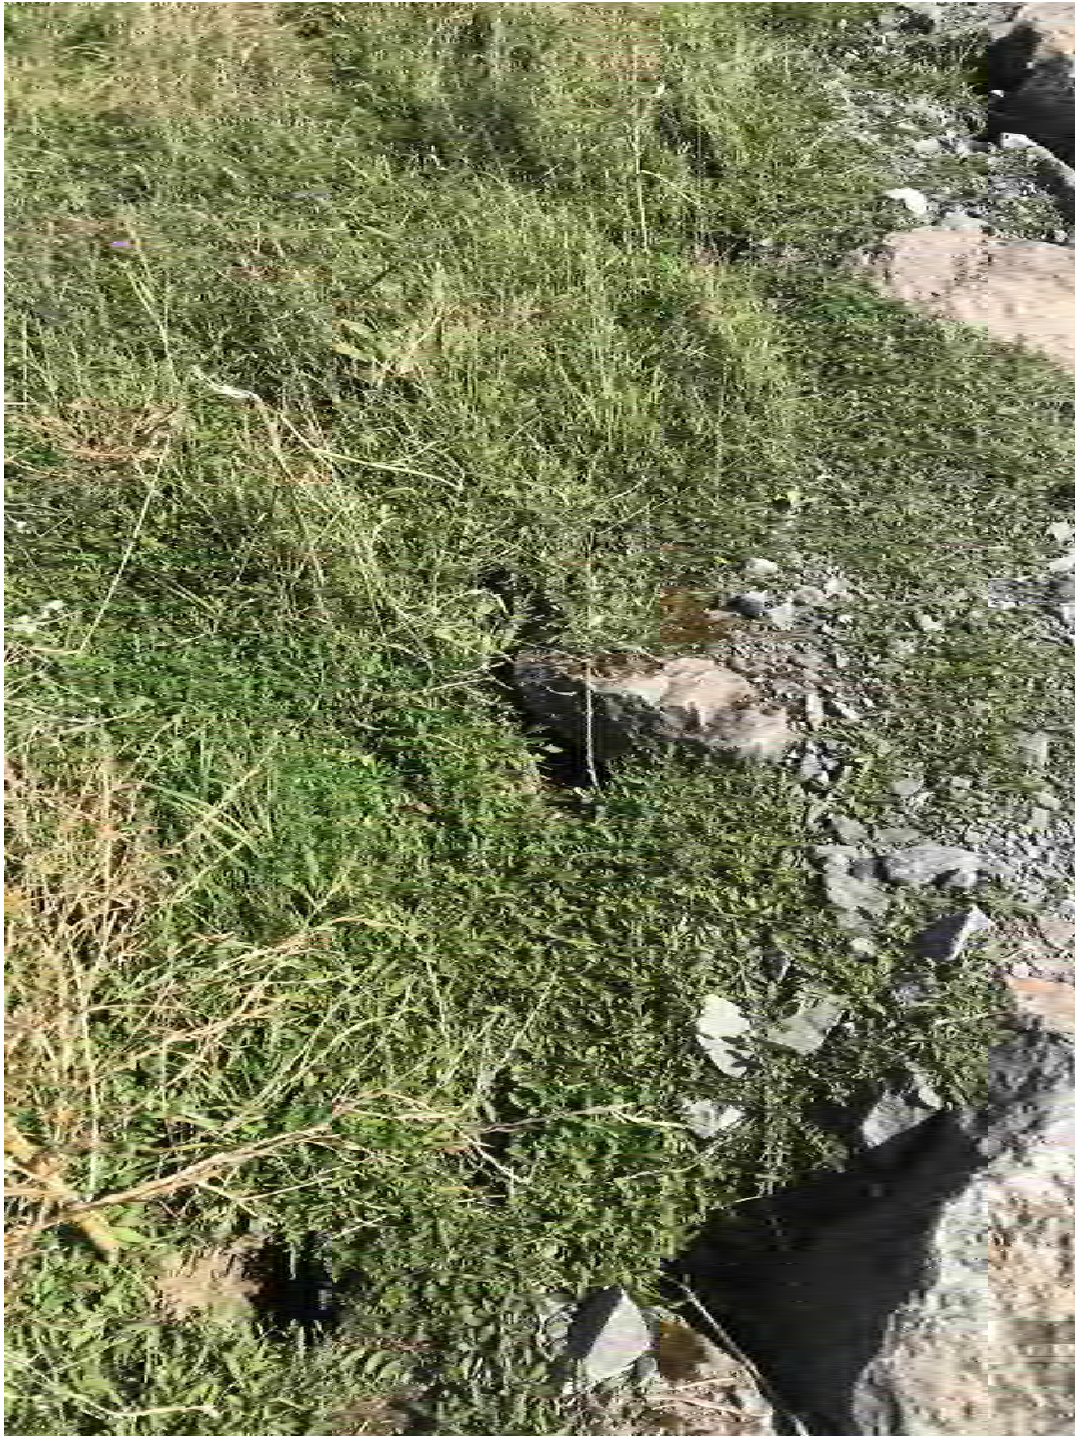
Borrow damage to cover system along soil/rip-rap interface along Bell Slip.

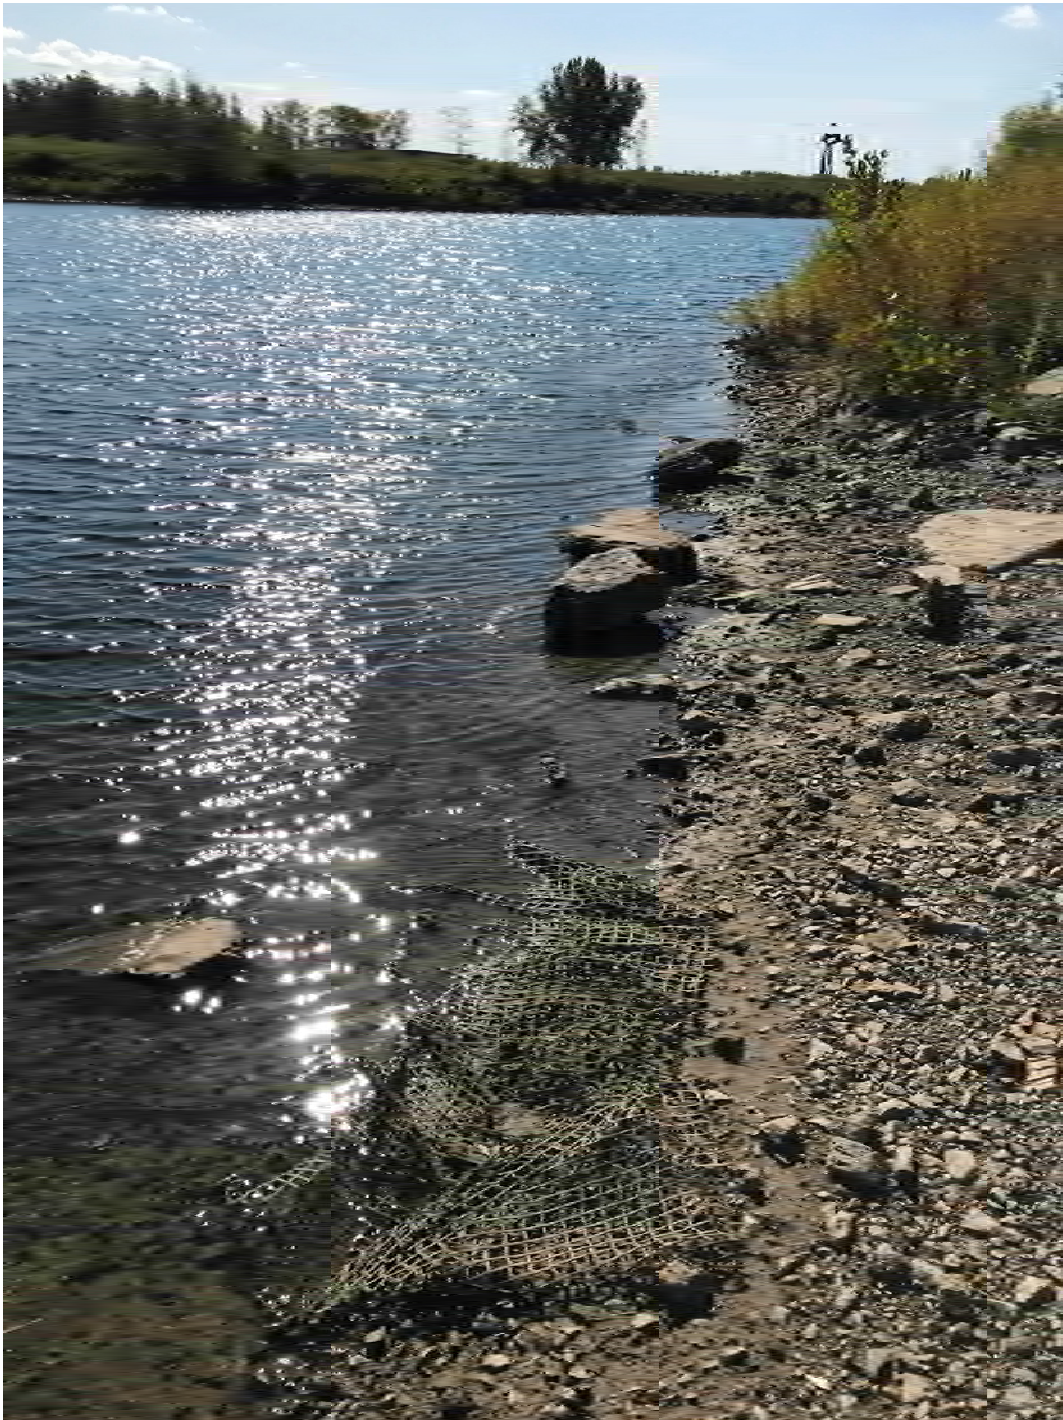
Exposed netting along shoreline, north side of Bell Slip.

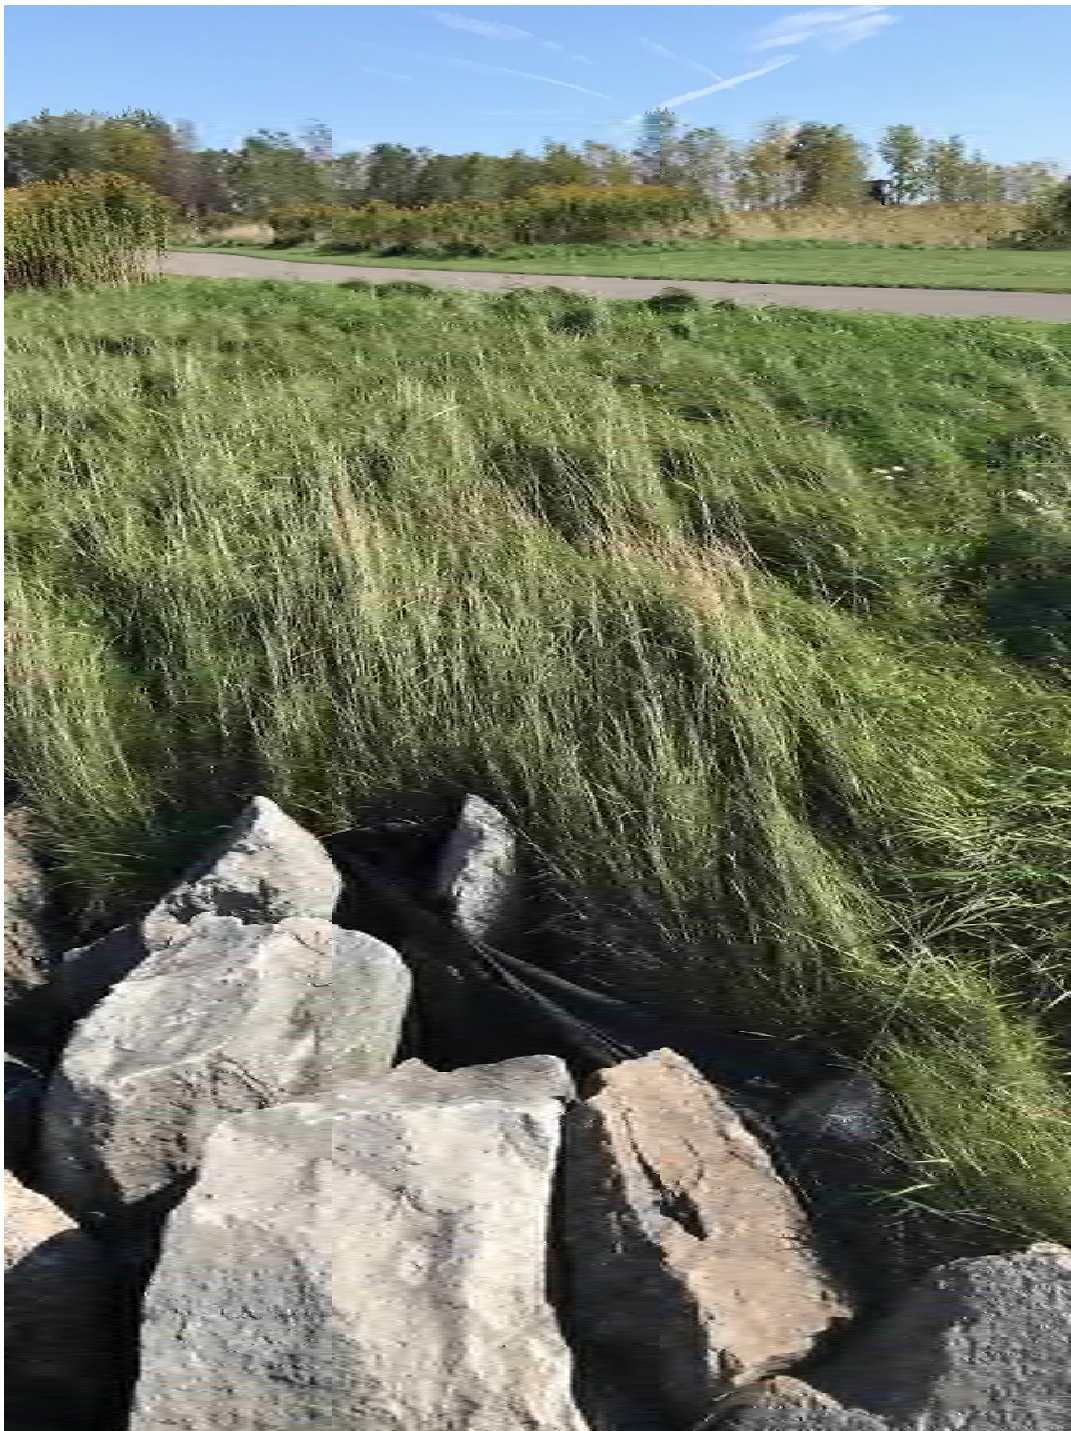
Area of exposed geotextile between revetment and soil cover system, south side of Bell Slip.

Eroded areas will be cut back as needed to provide a uniform edge. In areas where the filter fabric is intact but has been displaced, the fabric will be laid out flat to its original extents. In areas where the filter fabric is missing or deteriorated, new filter fabric will be placed. New filter fabric shall meet the specs of Mirafi 600X geotextile. A manufacturers cut sheet is provided in Appendix A.

Following repair/replacement of the filter fabric a Heavy Stone Fill will be placed to the extent of the erosion. Heavy Stone Fill will be placed on the shoreline slope to the limit of erosion. The fill placement will build up the revetment to match or slightly exceed the height of the slope at the limit of erosion. The stone placed along the slope break will take the force of the wave action and help prevent further erosion

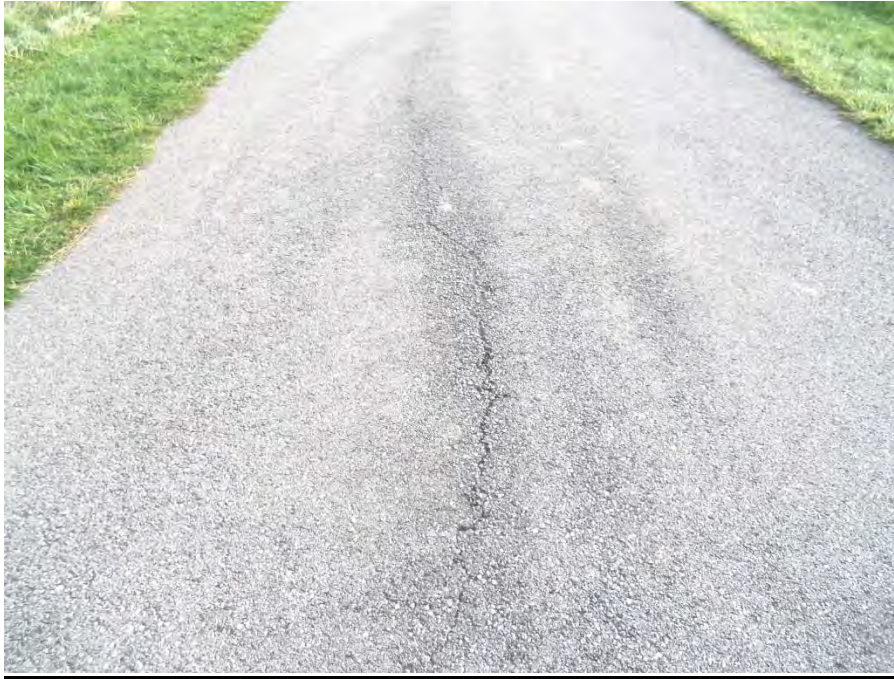
View of crack in asphalt in section of path along the south side of Bell Slip.

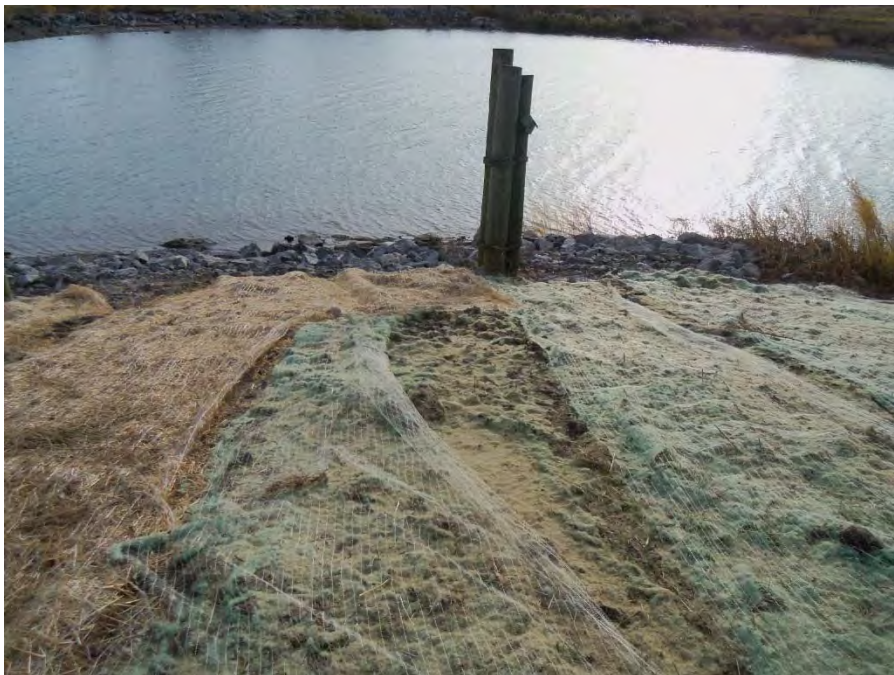
View of new netting installed in 2020 in a portion of the south side of Bell Slip.

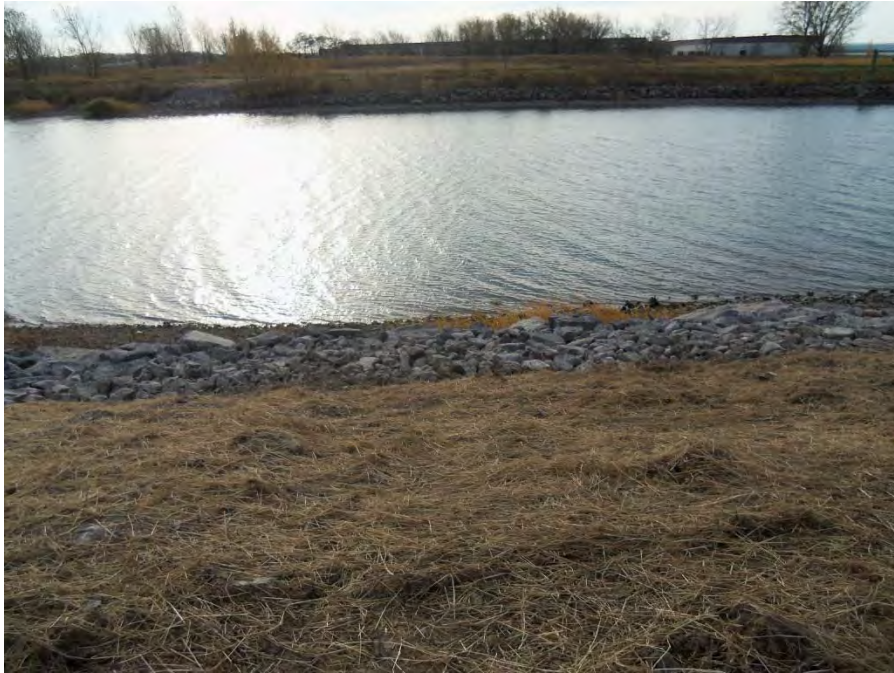
View of new revetment installed in 2020 in a portion of the south side of Bell Slip.

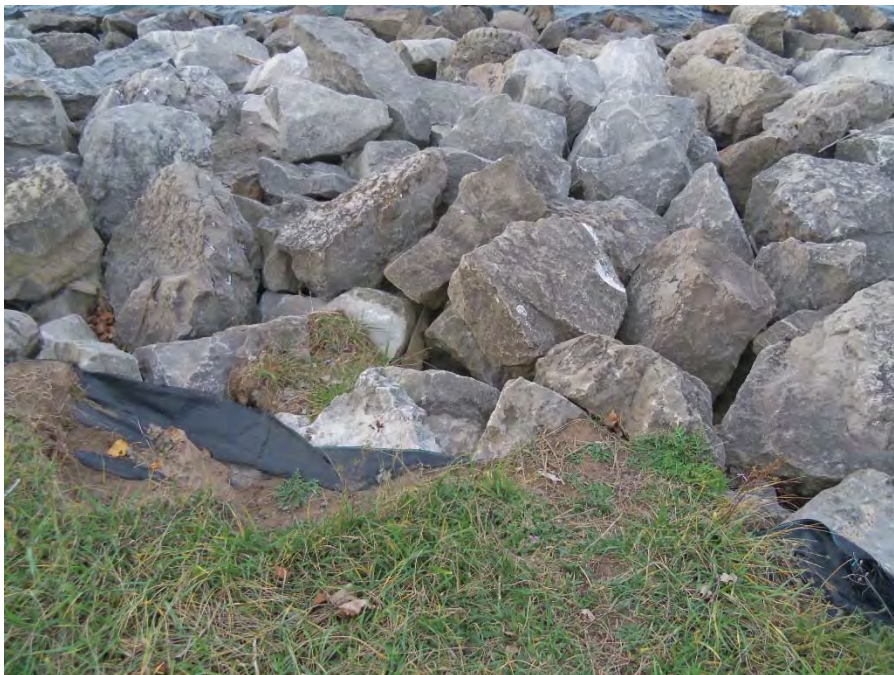
View of exposed geotextile located approximately midway between Bell Slip and north end of Greenbelt.

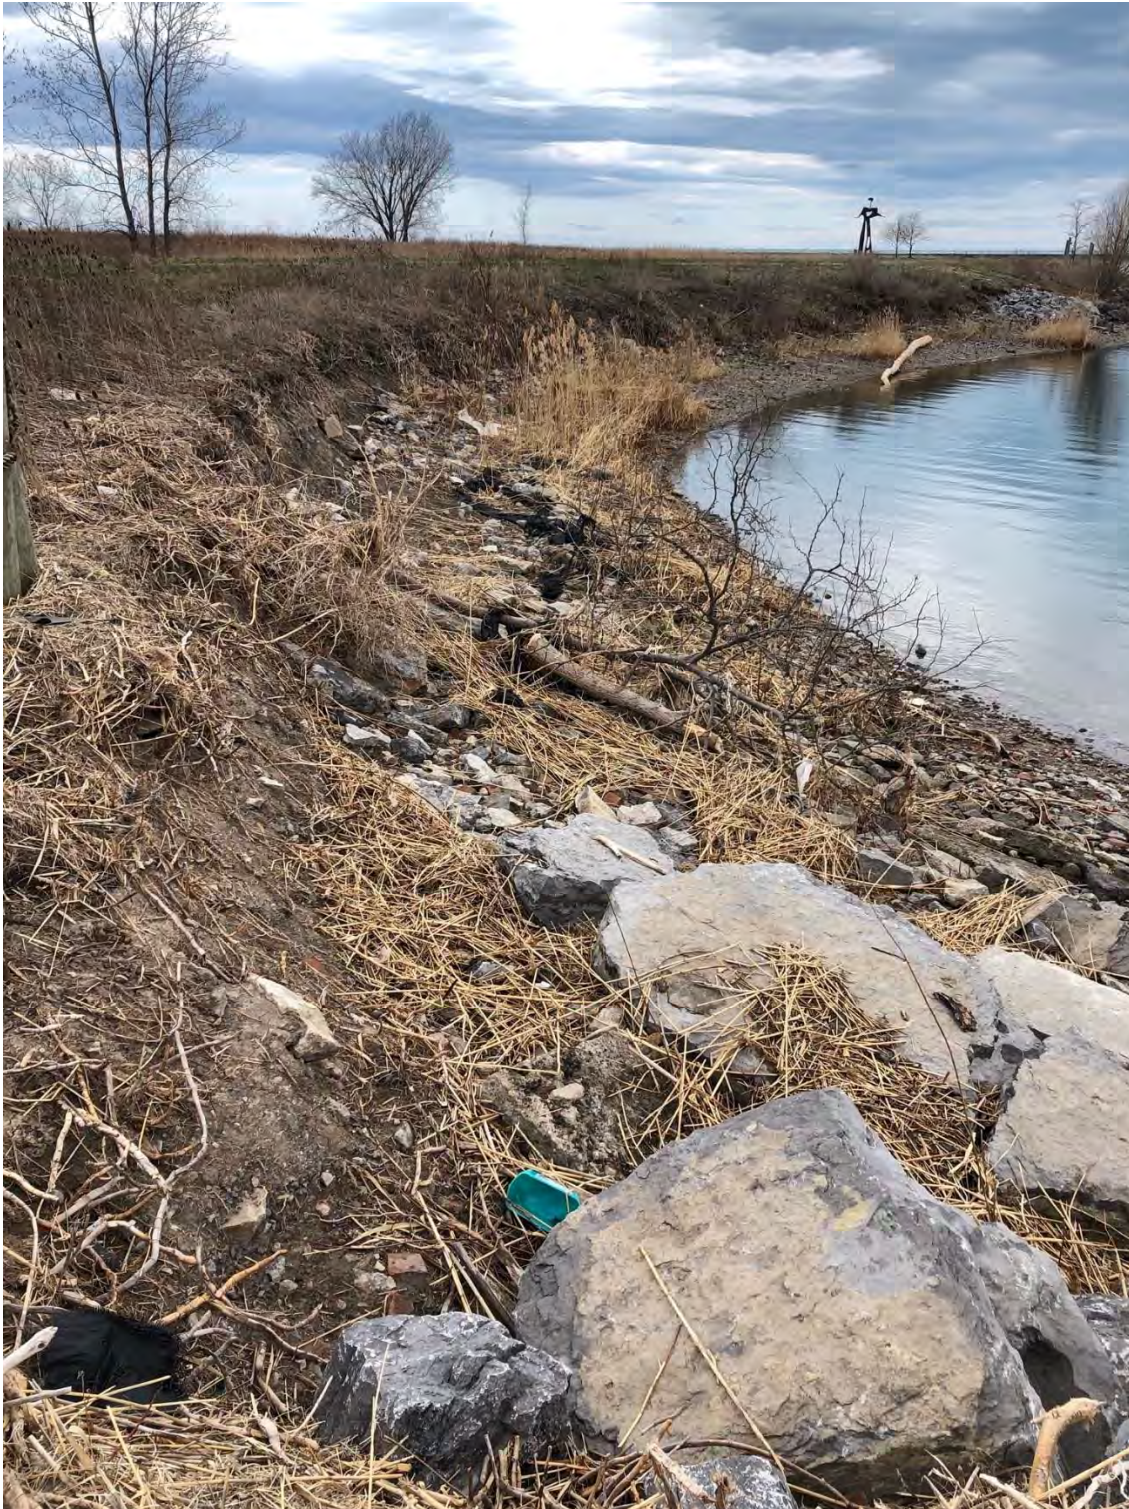
Generally, the slip looked to be in good condition with significant portions of the area covered with stones and vegetative cover. It was noted that most of the small trees/shrubs near the water's edge had been cut and removed by beavers. No animal burrows were found. There was also a small amount of debris (mostly driftwood) noted along the water's edge.

View of brush and trees cleared by beavers at Bell Slip.

Trees between the Port Greenbelt trail and the Bell Slip will be protected against beaver damage. This will be accomplished by wrapping individual trees or larger groups of trees with wire mesh fencing. Fencing will be placed around the trees with enough room to allow for tree growth over several years. Fencing will be inspected as part of the annual inspections and will be replaced if excessive corrosion is noted or additional room is needed for tree growth.

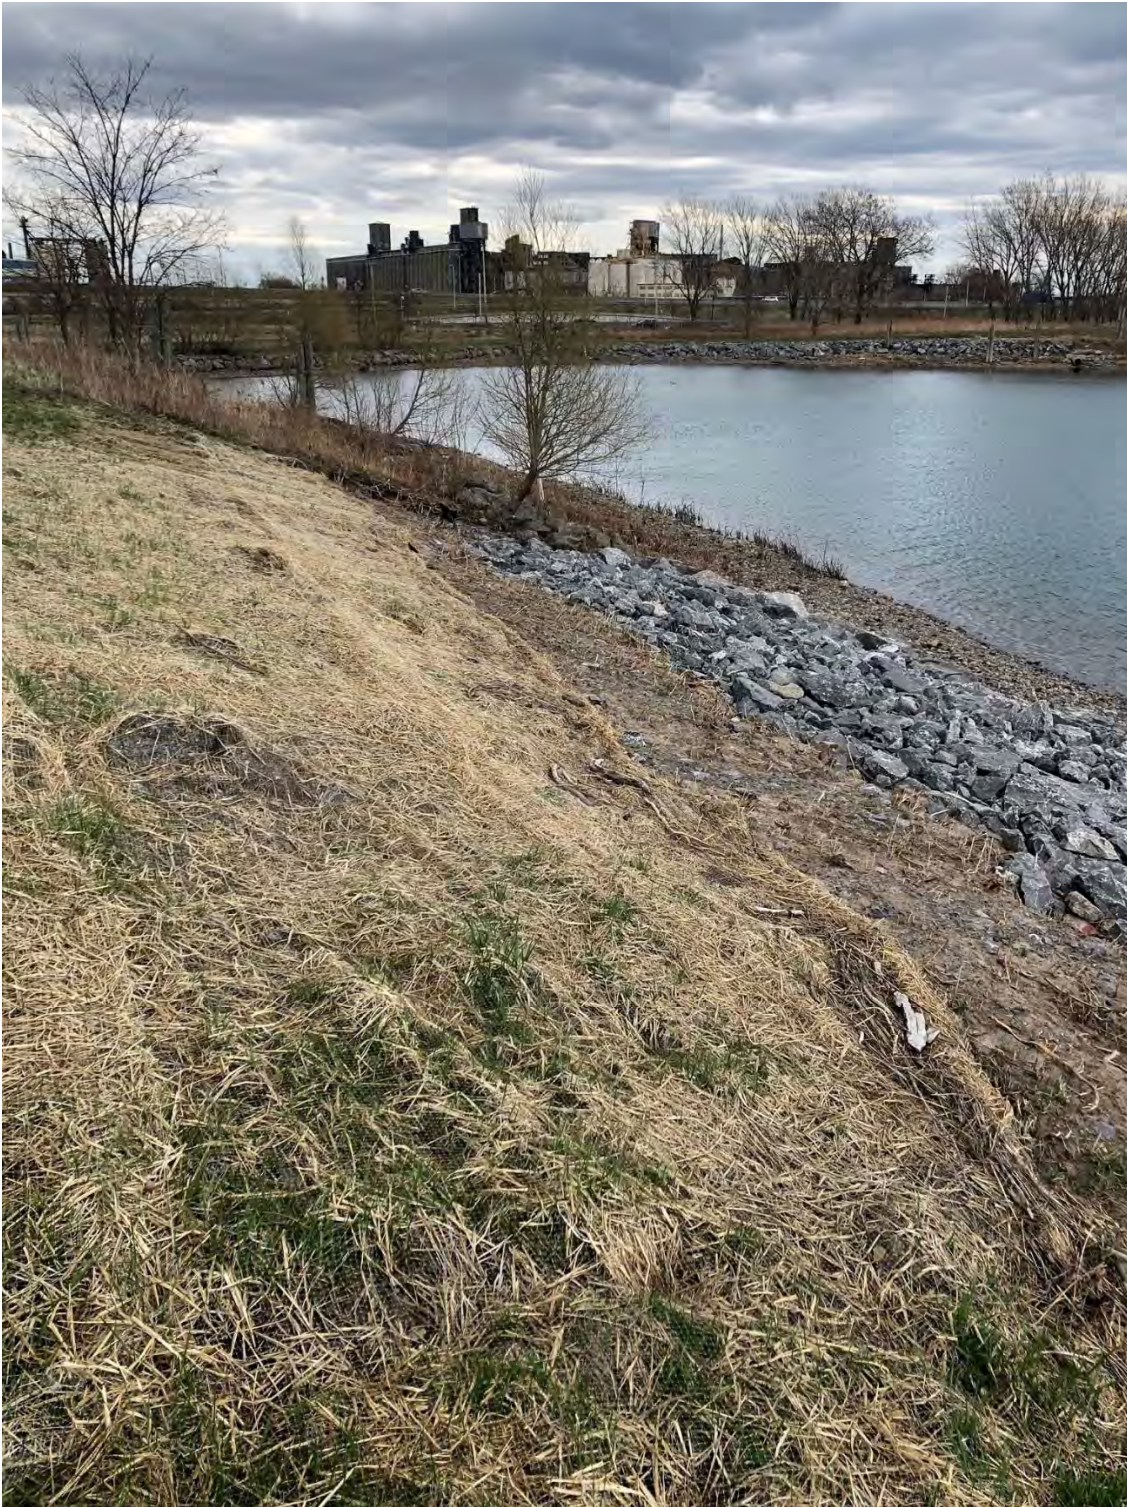
In October 2020, additional armor stone and medium stone was installed along the northern shoreline where shoreline erosion had been noted. A straw erosion blanket was also added in this area. Areas requiring topsoil and seeding will be addressed by the next Corrective Measures Work Plan.

View of erosion control blanket on northern bank slope at Bell Slip.

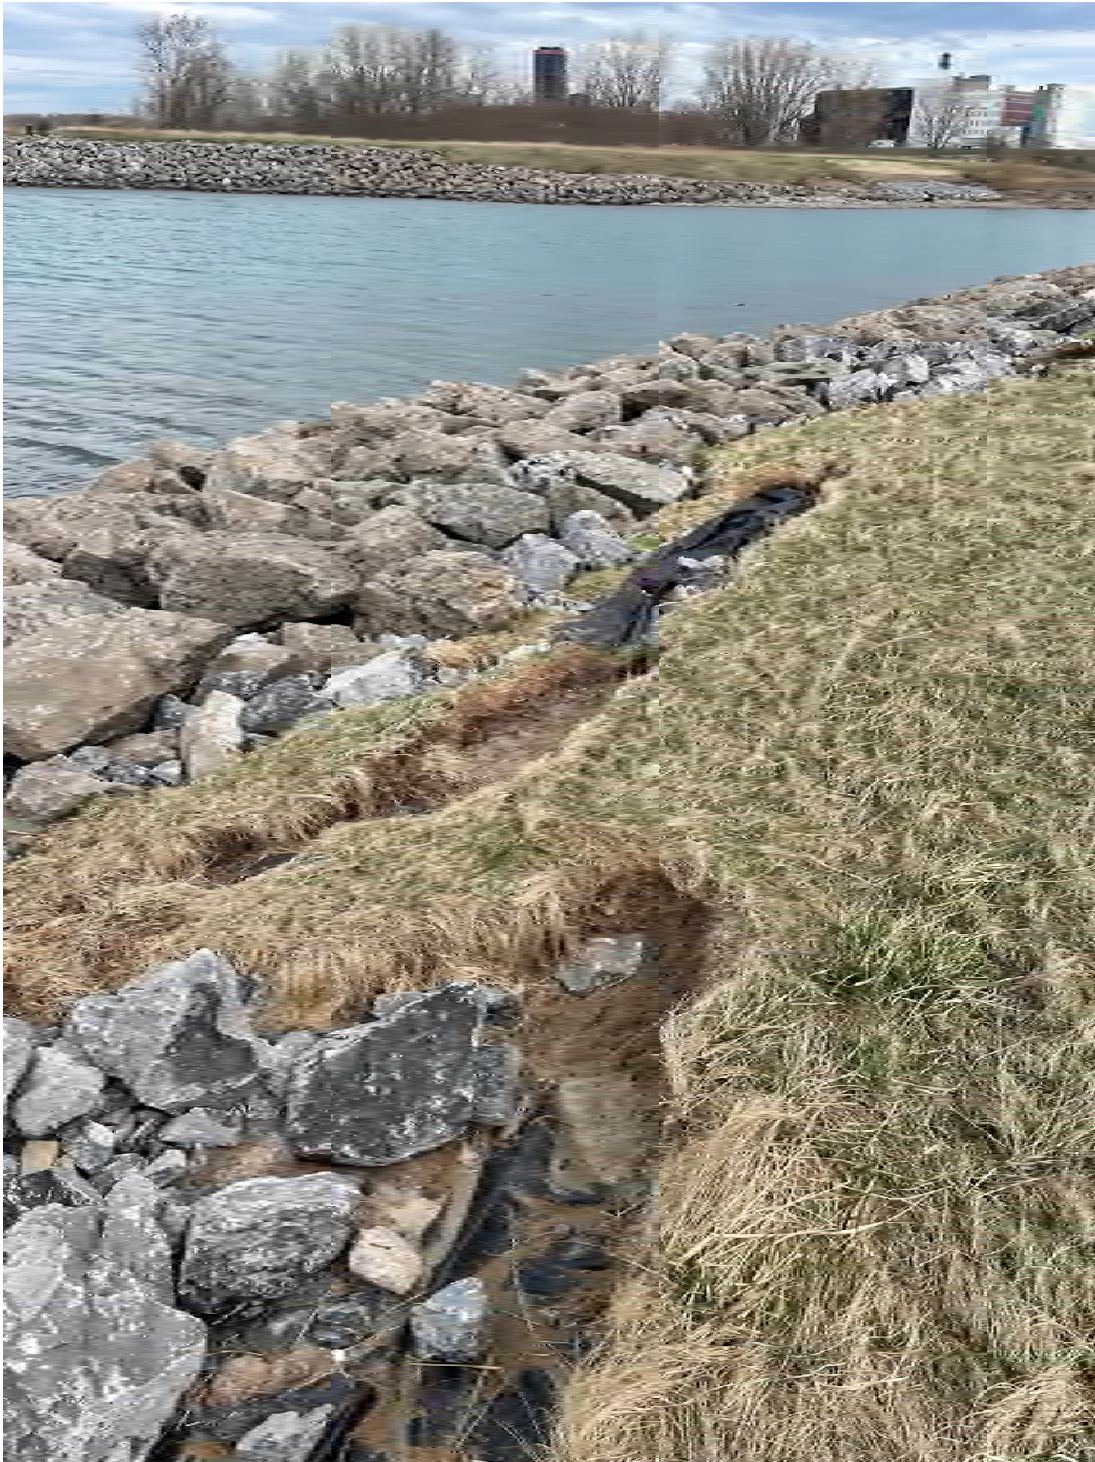
A few areas on the east side and south side of the Bell Slip showed signs of soil sloughing and erosion. It is thought that this gap is either due to erosion during periods of high lake levels where water overtopped the revetment.

View of bank erosion on South side of Bell Slip, view looking towards the east.

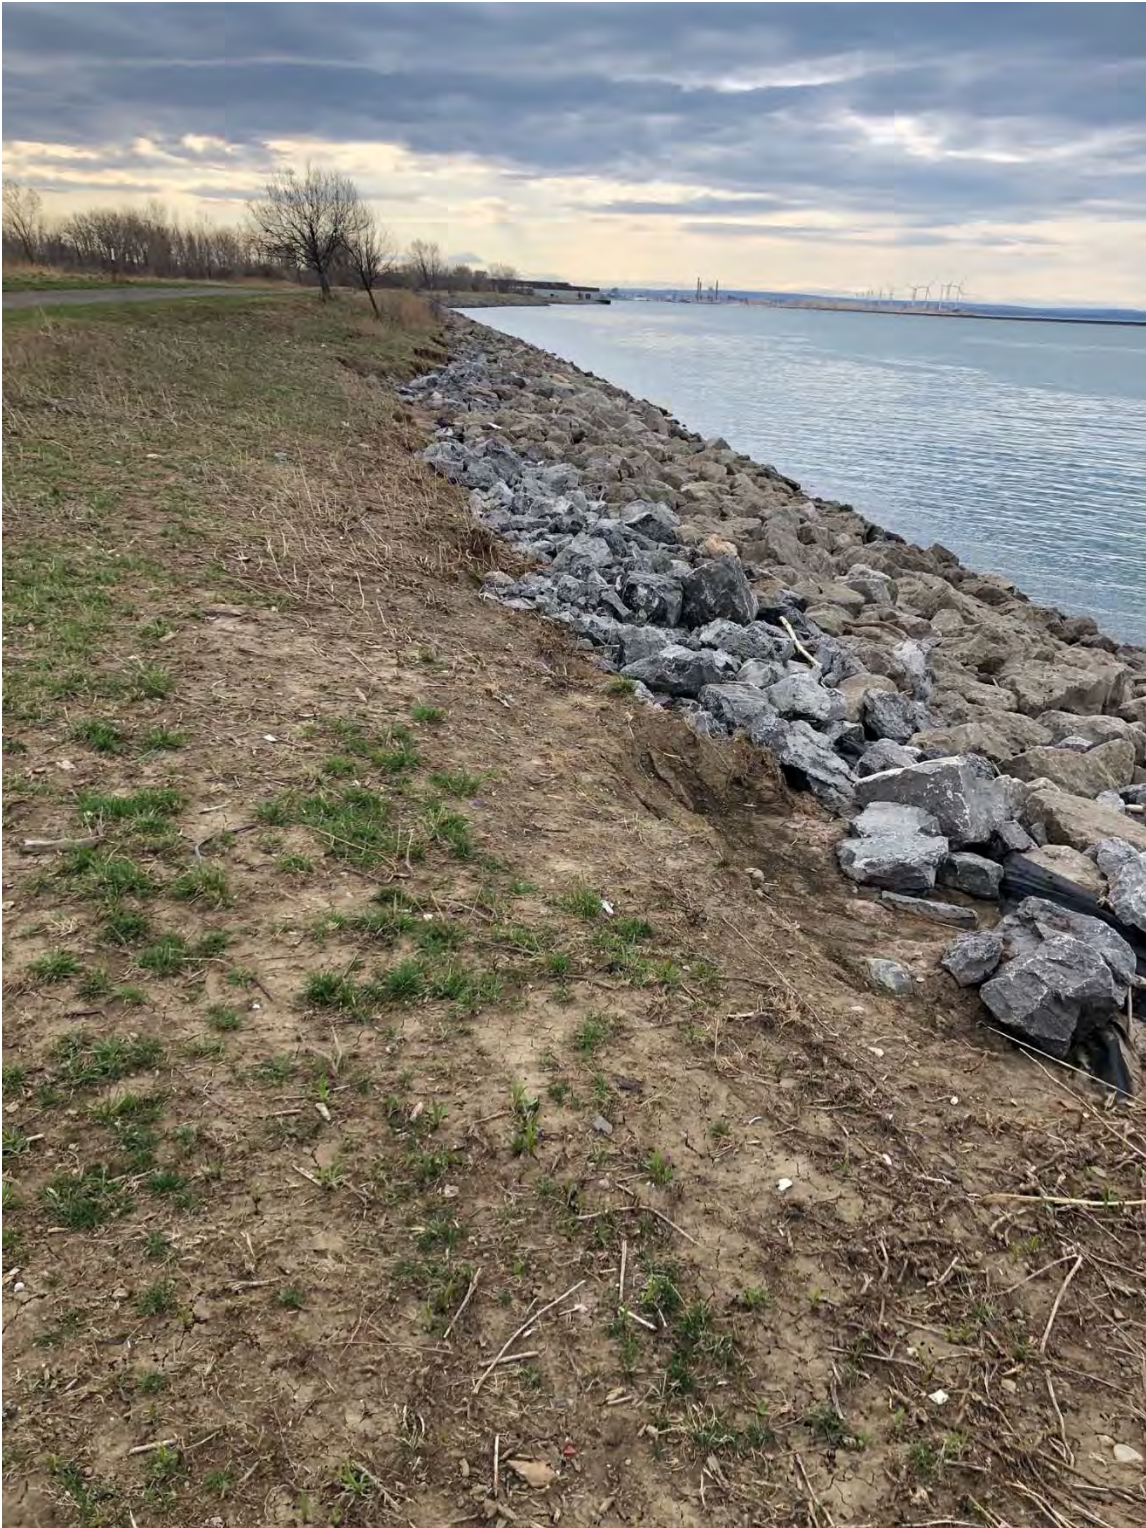
View of medium stone placed behind the armor stone.

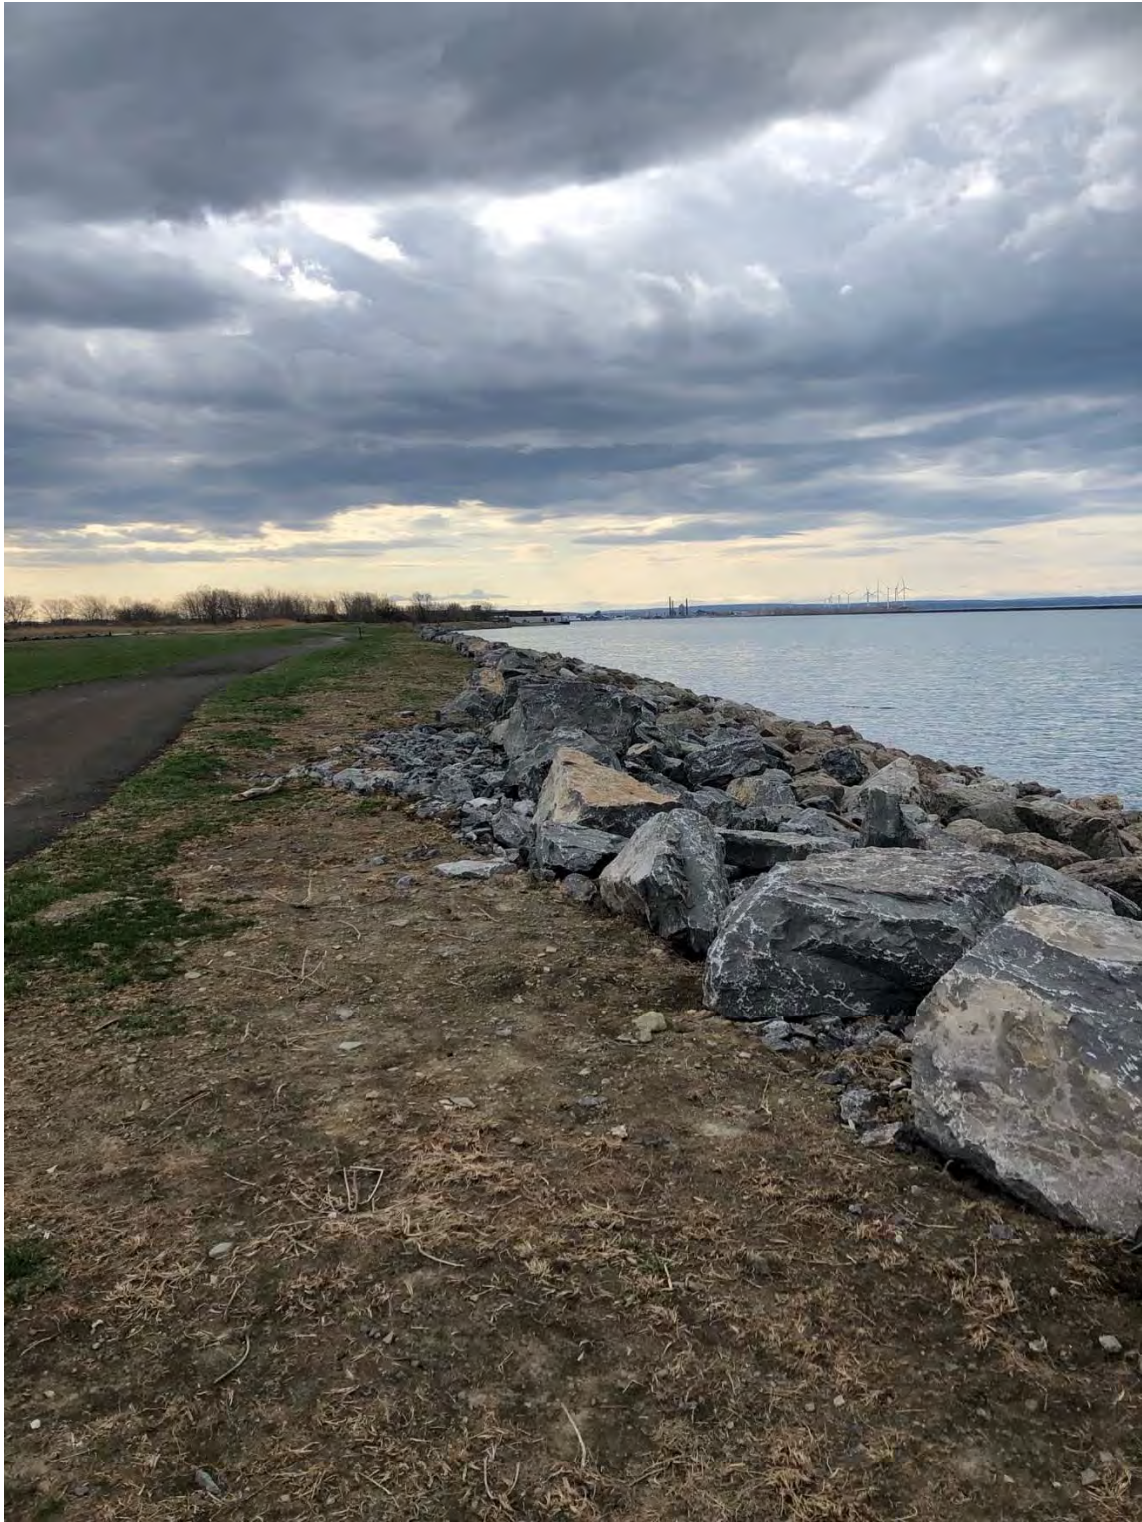
View of new armor stone placed at the top of the bank.

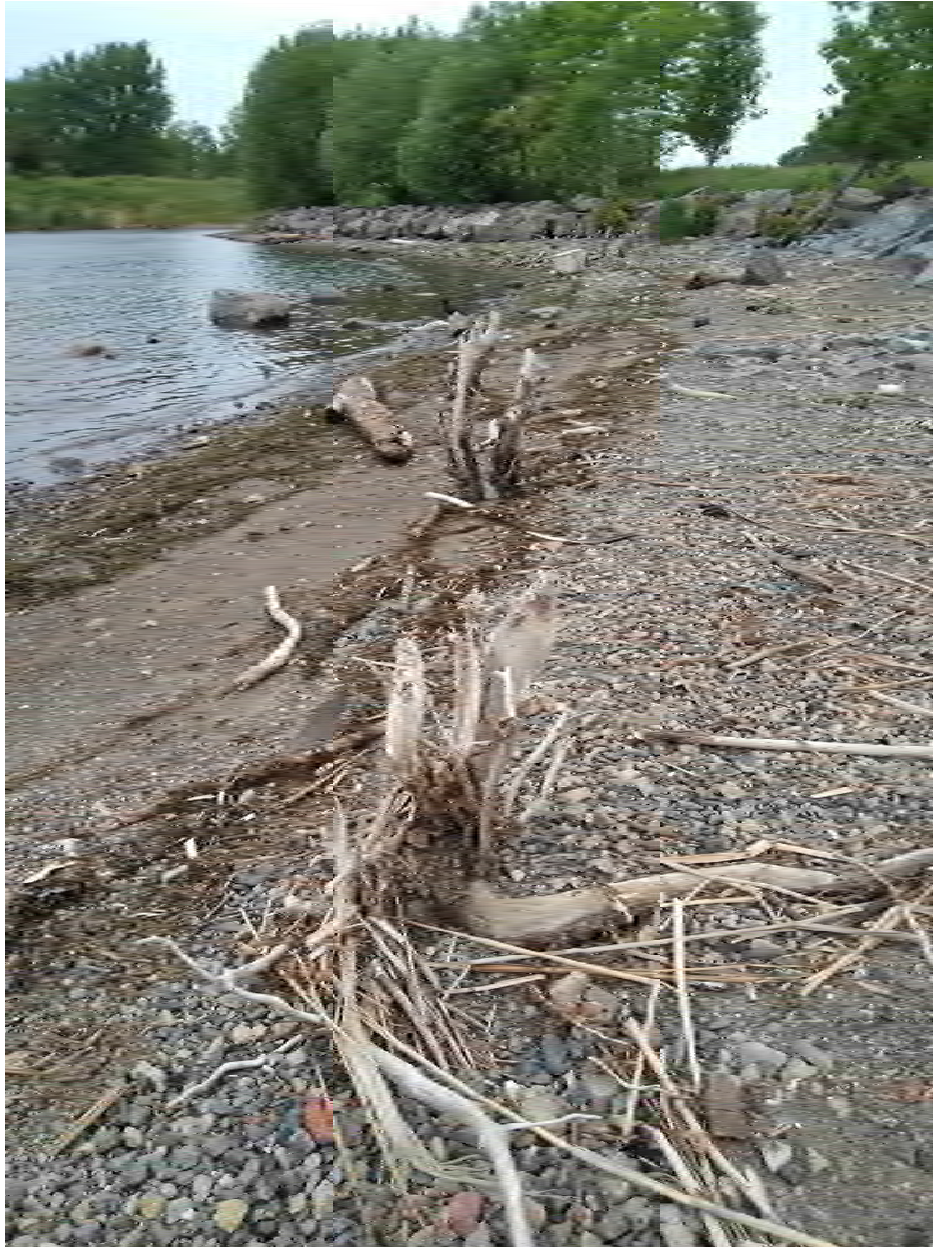
Photo No. 1 – Stumps left behind following tree removal by beavers. East side of Bell Slip.
