PERIODIC REVIEW REPORT

PORT-GREENBELT
SHORELINE IMPROVEMENT PROJECT
CITY OF BUFFALO, ERIE COUNTY, NEW YORK

SITE NO. B-00149-9

LiRo ENGINEERS, INC.
690 Delaware Avenue
Buffalo, New York 14209

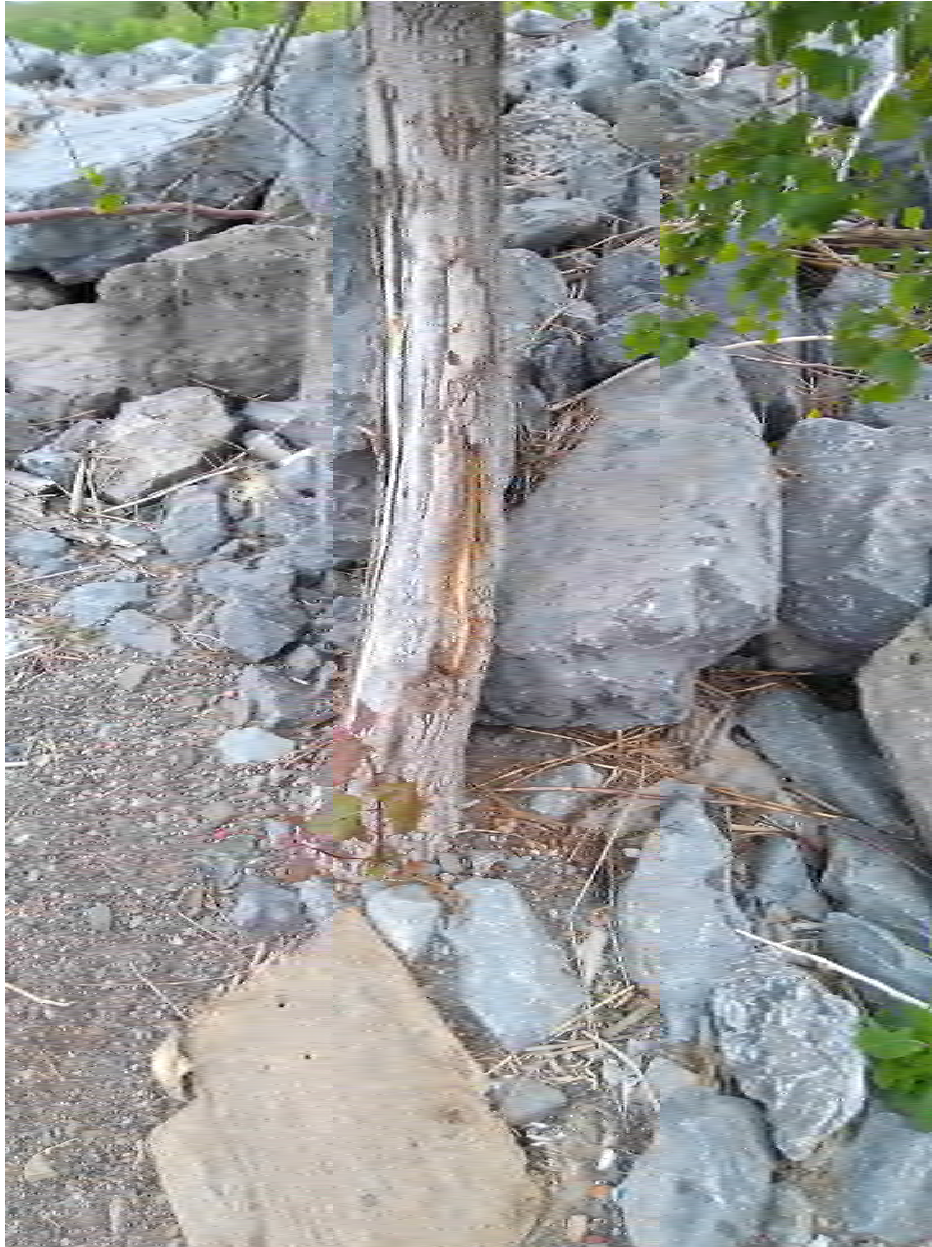
Photo No. 2 – Damage to tree trunk by beavers. East side of Bell Slip.

Trees between the Port Greenbelt trail and the Bell Slip will be protected against beaver damage. This will be accomplished by wrapping individual trees or larger groups of trees with wire mesh fencing. Fencing will be placed around the trees with enough room to allow for tree growth over several years. Fencing will be inspected as part of the annual inspections and will be replaced if excessive corrosion is noted or additional room is needed for tree growth.

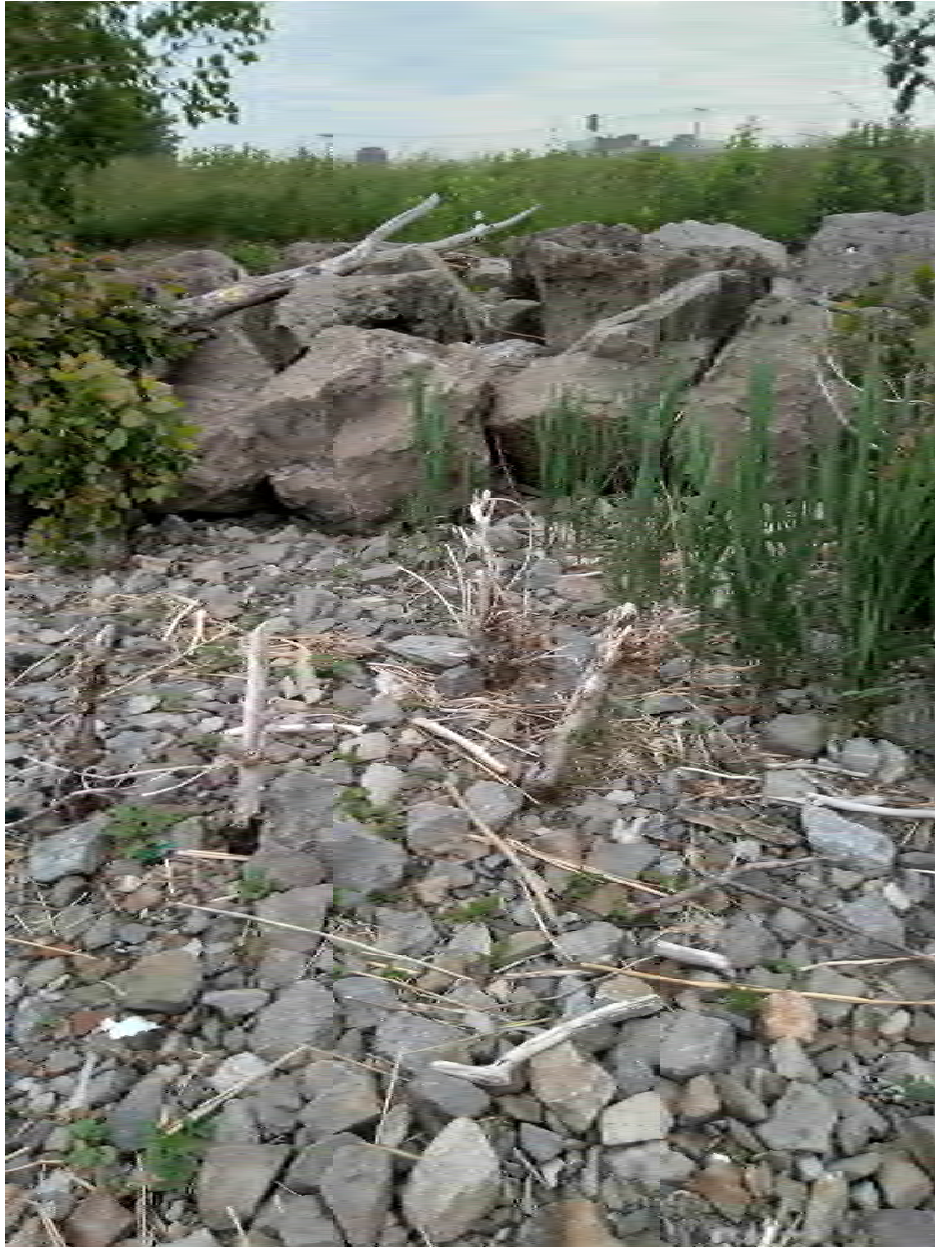
Photo No. 3 - Stumps left behind following tree removal by beavers. East side of Bell Slip.

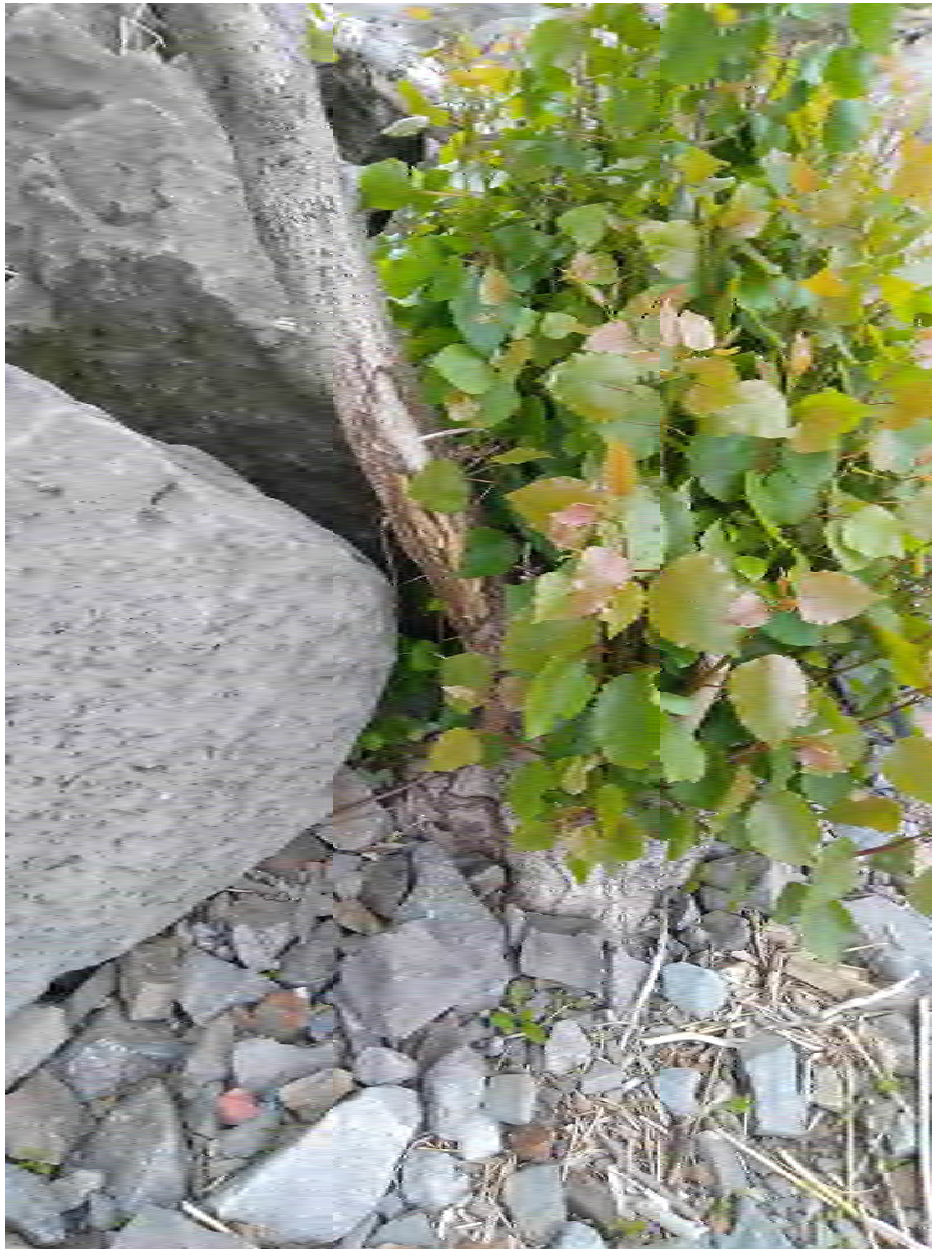
Photo No. 4 - Damage to tree trunk by beavers. East side of Bell Slip.

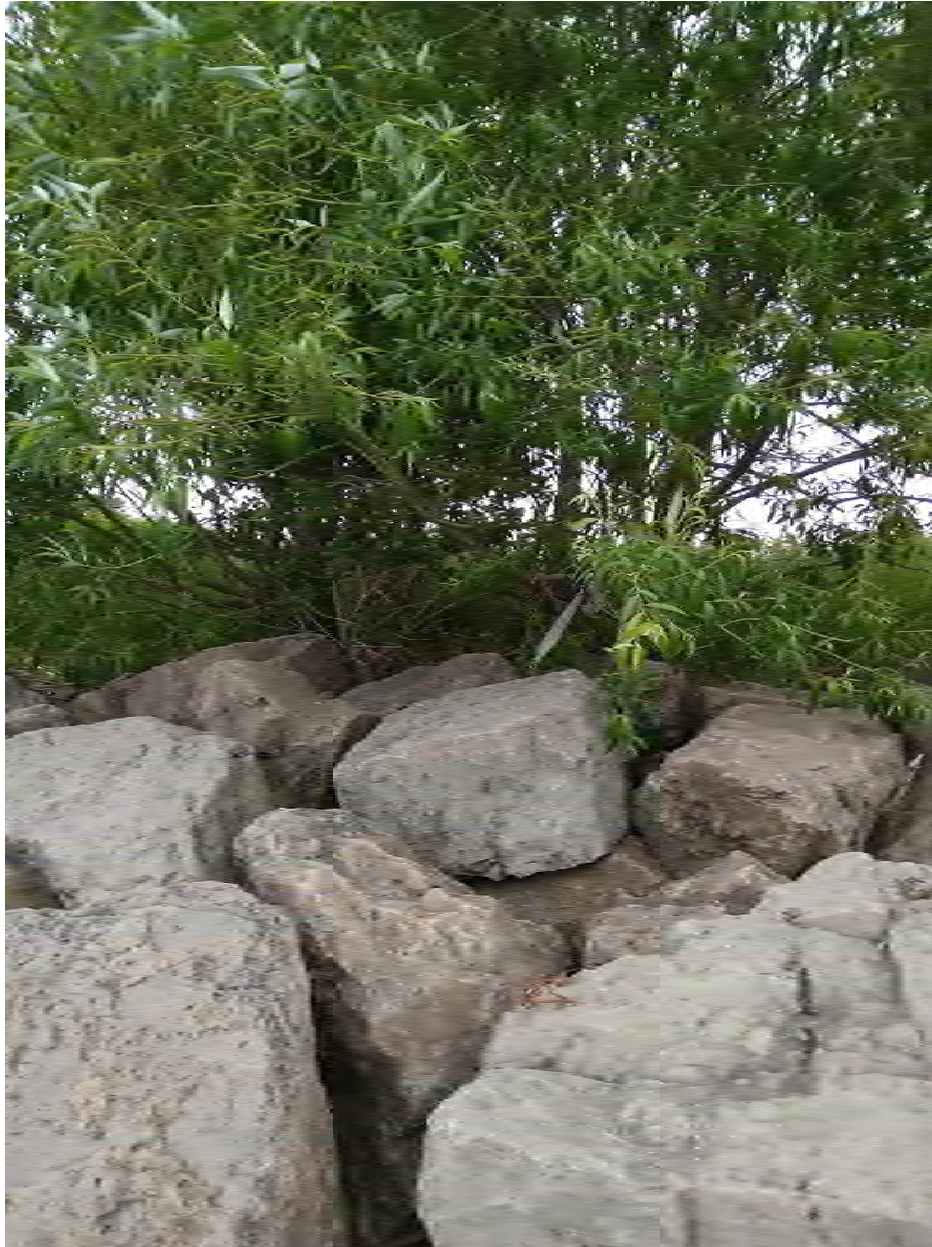
Photo No. 5 – Group of trees at top of armor stone, untouched by beavers. East side of Bell Slip.

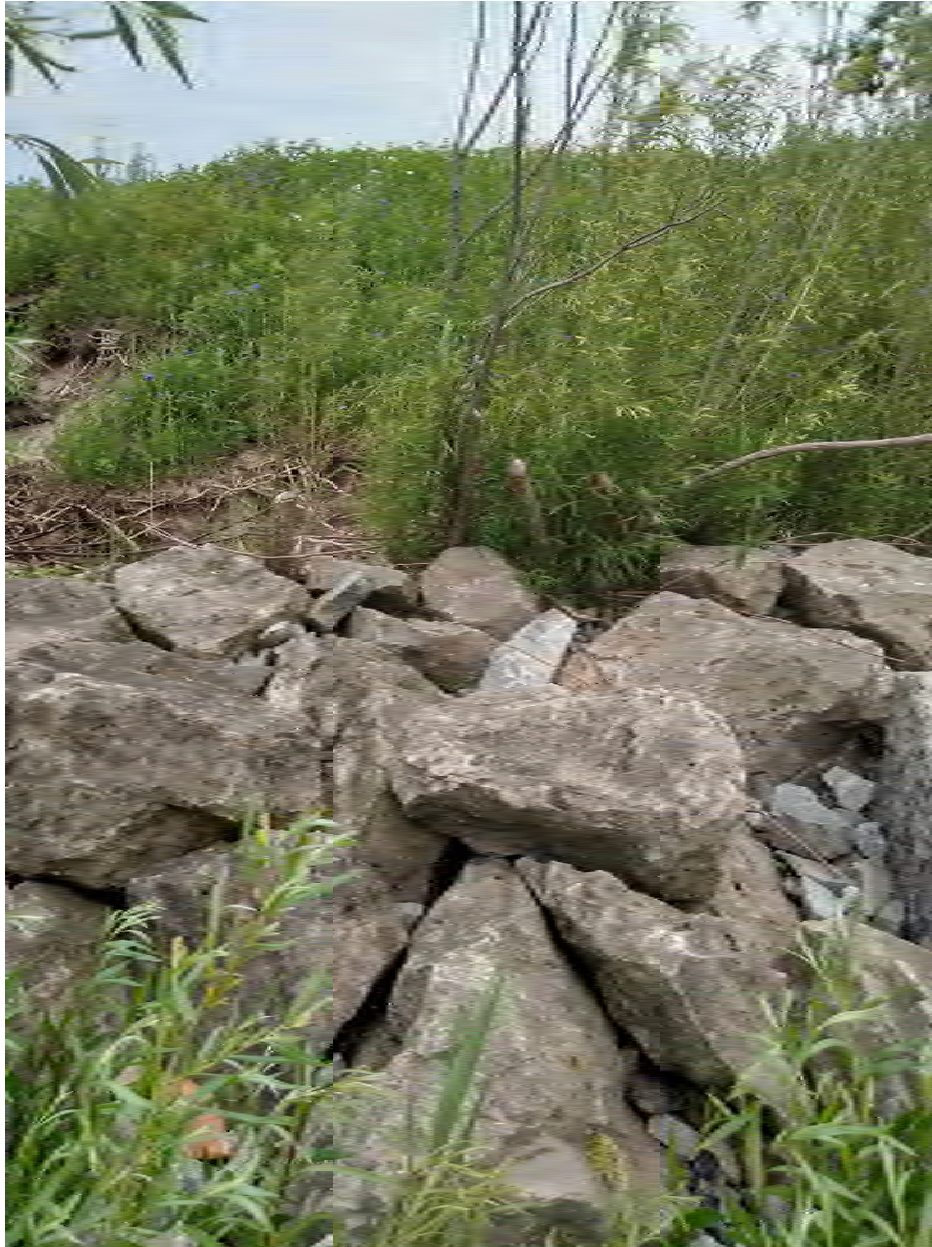
Photo No. 6 – Beaver damage to trees at top of armor stone. North side of Bell Slip.

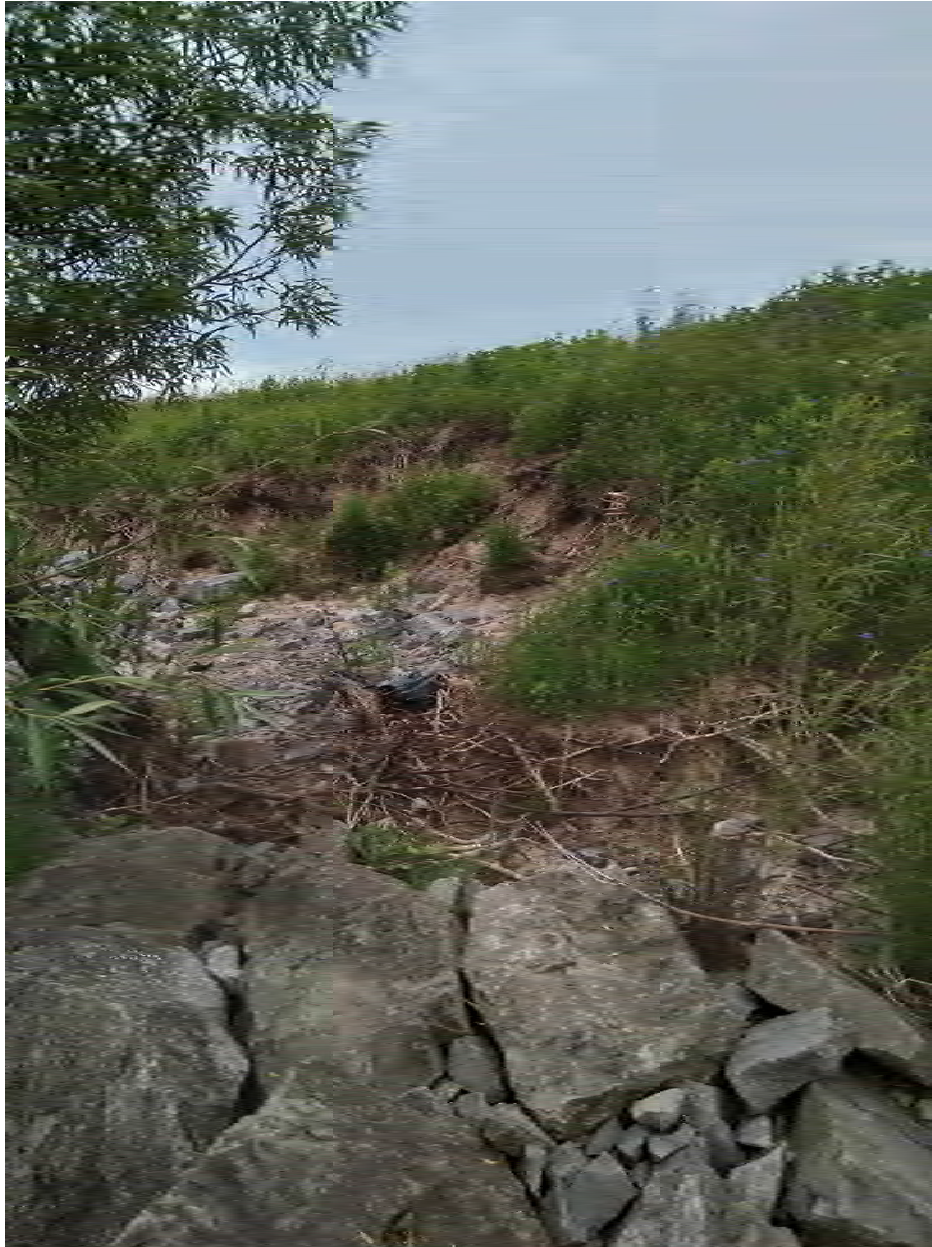
Photo No. 7 – Stump left behind following tree removal by beavers and damage to embankment. North side of Bell Slip.
