Site Management (SM) – Shoreline Erosion NFTA Outer Harbor Greenbelt, Buffalo Erie County, Site No.: B00149

LiRo Engineers, Inc. (LiRo) is providing this letter to document the repair of the shoreline erosion that was identified during the December 2023 Annual Inspection. The repair was completed in accordance with the August 30, 2024 Corrective Measures Work Plans (CMWP) along with the September 5, 2024 CMWP approval letter issued by the Department.

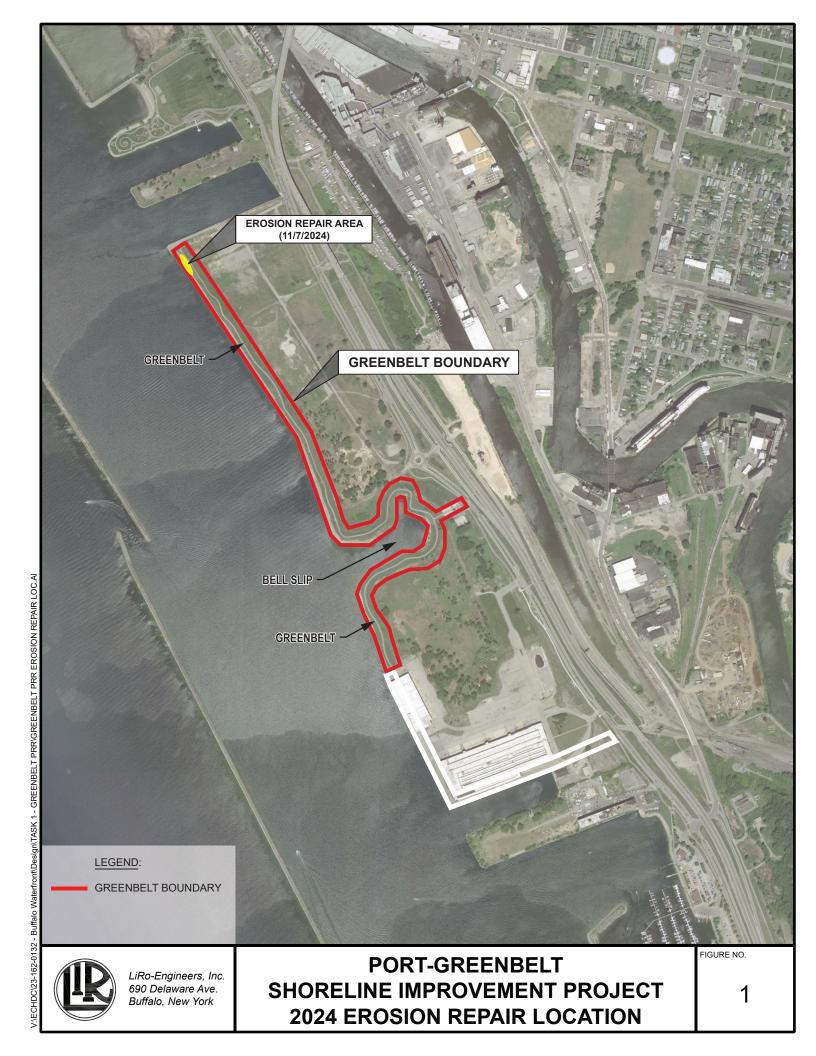
FIGURE 1 – 2024 EROSION REPAIR LOCATION

The erosion repair work was conducted on November 7, 2024 by Elbers Landscape Service (Elbers). The repair work was overseen by LiRo Geologist Jason Kryszak. The repair was conducted in the area as shown on attached Figure 1.

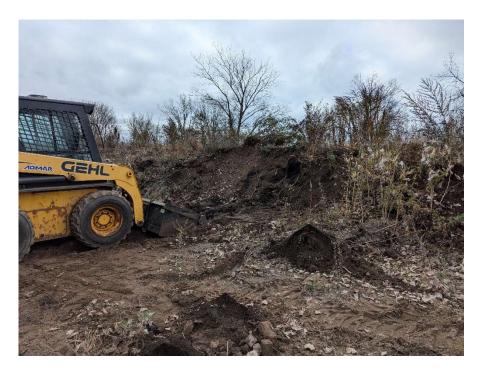
Photograph 1: Elbers collecting fill material from the Joseph Davis State Park stockpile

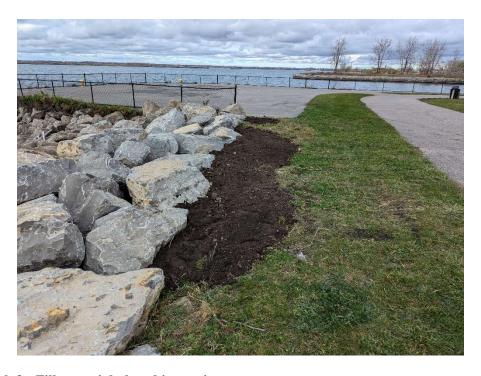
Photograph 2: Fill material placed in erosion area

- The filter fabric demarcation layer was inspected and found to be intact and in good condition.
 No new placement of filter fabric was required.
- Elbers placed approximately three cubic yards of approved fill material from the Joseph Davis State Park stockpile in the erosion area. The material was spread out and leveled to match the surrounding grade.
- Elbers then placed seed over the fill material

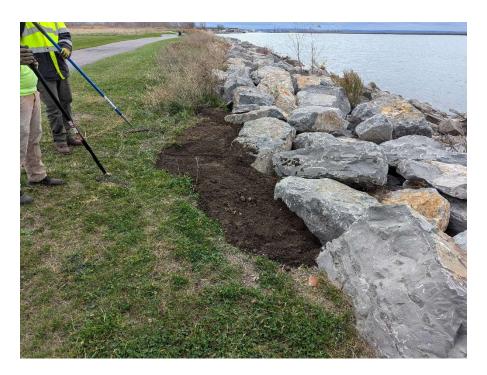
Photograph 3: Fill material spread out in the erosion area

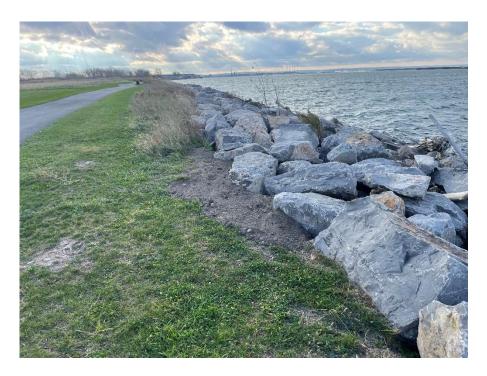
On November 8, 2024, I performed an inspection of the work and found the work was completed in accordance with the approved CMWP.

Photograph 4: Final inspection of the repaired area on November 8, 2024
