*Re: 2011 Annual Site Management Plan Surface Cover Report
Former Independent Leather Tannery Site (#B-00158)
City of Gloversville, Fulton County
C.T. Male Project No. 10.1125*

C.T. Male Associates, P.C. (C.T. Male) has completed a site visit to observe the site's surface cover at the Former Independent Leather Tannery Site in Gloversville, New York in accordance with NYSDEC approved Site Management Plan dated January 13, 2009. This letter serves as the 2011 Annual Report.

FIGURE 1
SURFACE COVER CONDITION OBSERVATIONS

INDEPENDENT LEATHER TANNERY
ANNUAL SITE MANAGEMENT PLAN MONITORING

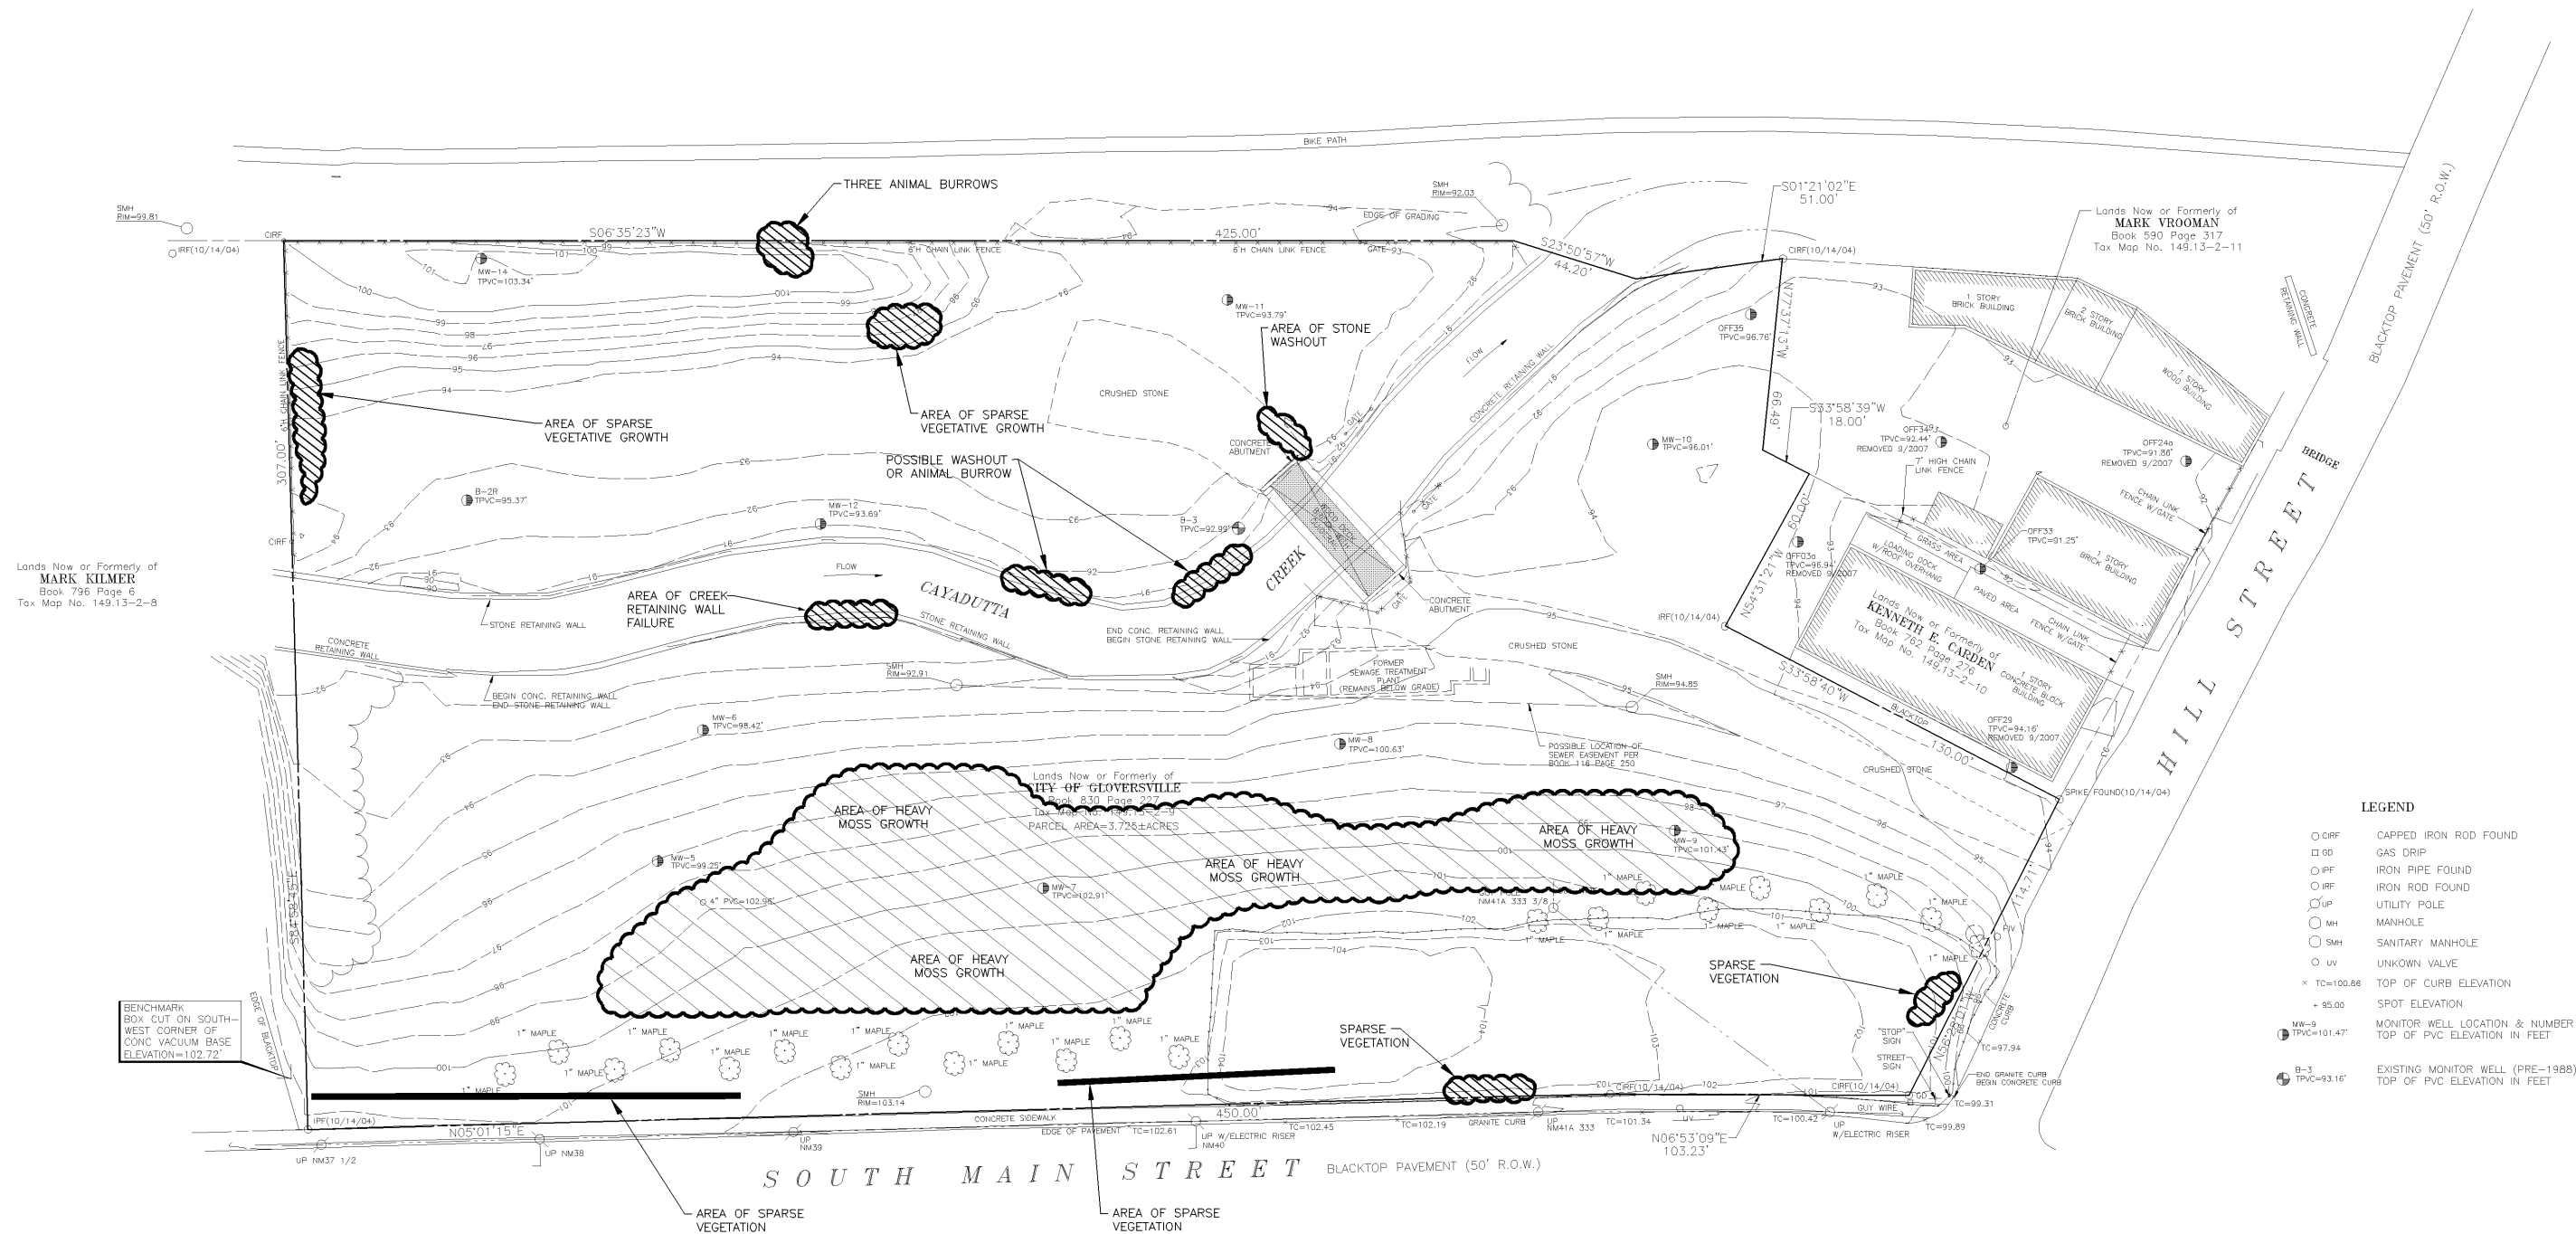
On October 19, 2011, the ±3.7 acre site was traversed on foot to observe the condition of the site's surface cover system (i.e., barrier to contact with existing soil). The surface vegetation was stable with a mixture of grass, weeds and moss. There were no unvegetated areas, erosion or other surface disturbances observed except for the following. Photos taken during the site visit are attached to this letter, and the areas discussed are shown on Figure 1.

- There was a relatively large area of heavy moss growth on the western side of the site, as shown on the attached Figure 1. The moss growth appears to be inhibiting the growth of grass, but the surface is still stable with no on-going erosion. This moss growth appears to be similar to what was observed in March and November 2010.

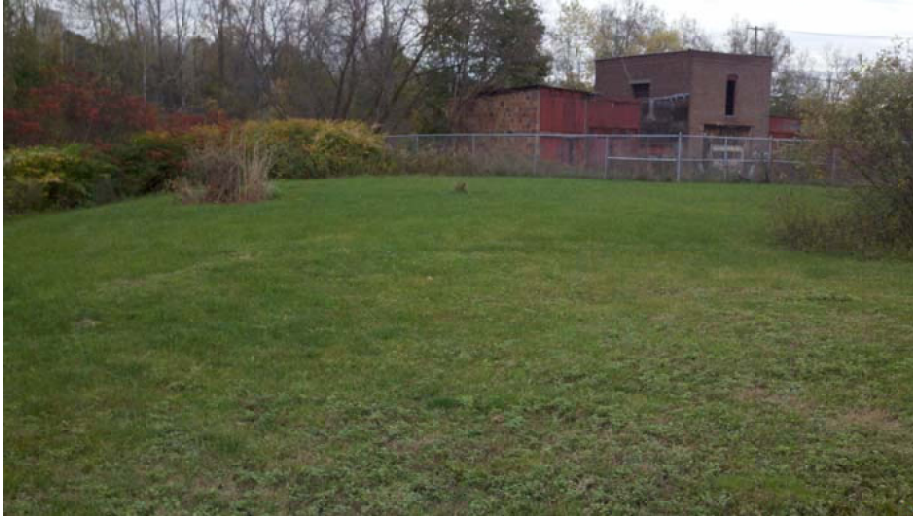
Picture #01.jpg

Picture #01:	Surface cover on the west side of the creek looking south.
Picture #02:	Surface cover (heavy moss) on the western side of the creek looking north across the site.
Picture #03:	Surface cover along South Main Street on the west side of the site.
Picture #04:	Sparse vegetation at the southwest extreme corner of the site.
Picture #05:	Sparse vegetative cover on the west side of the site adjacent to South Main Street.
Picture #06:	Stripped vegetation along the western property line (south end).
Picture #07:	Surface cover on the north end of the site.
Picture #08:	Surface cover in the middle portion of the site on the west side of the creek.
Picture #09:	Stripped vegetation along the western property line (south end).
Picture #10:	Surface cover middle portion of the site, west side, looking south.
Picture #11:	Creek traversing the site, middle section, looking south.
Picture #12:	Creek traversing the site, northern portion, looking north.

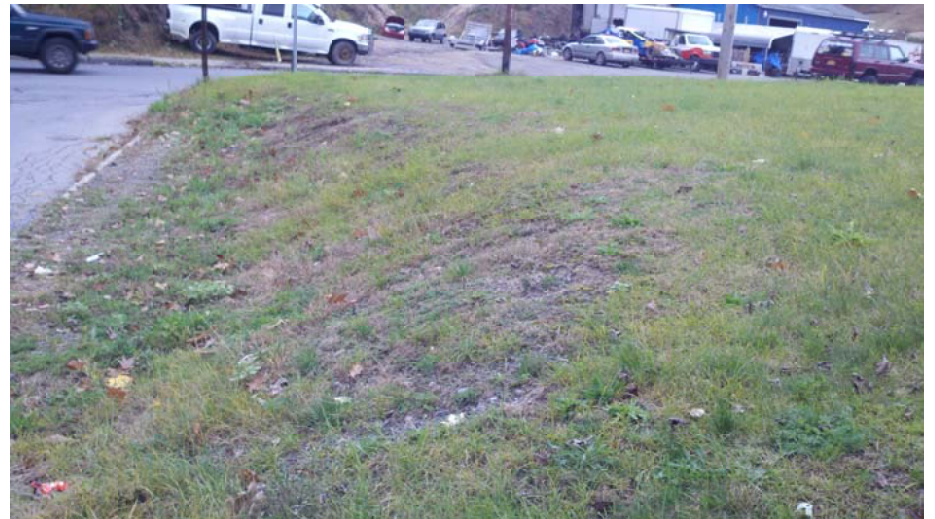
Picture #04.jpg

- The tire tracks/ruts on the west side of the site that were void of grass at the surface in November 2010 were again vegetated.
- There was a small area of sparse vegetation located in the extreme southwest corner of the site. This was apparent on the side slope along Hill Street. Although the vegetation was limited, there were no signs of on-going erosion.

The surface cover system continues to be well established at the project site. Based on the October 19, 2011 site visit, areas that could be improved and repaired were noted. This includes placing soil into the animal burrows, repairing the disturbance from the dirt bike, placing stone near the bridge's apron, and seeding areas of sparse vegetation in the Spring of 2012.

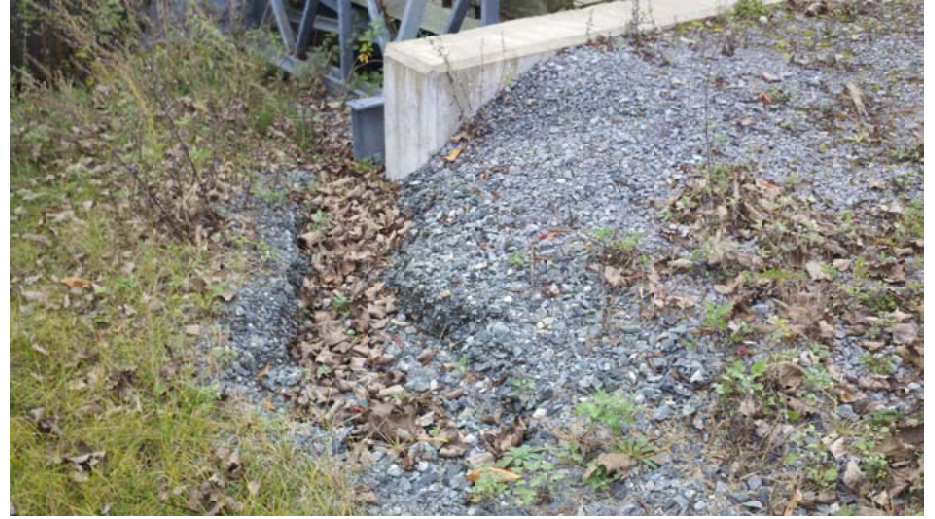
Picture #14.jpg

- There is evidence of stone washout on the east side of the bridge over the creek at its foundation. This location is the same location that has washed out previously and was repaired.

Picture #13:	Creek traversing the site, southern portion, looking south.
Picture #14:	Stone washout at the east side of the site at the bridge's apron.
Picture #15:	Surface cover on the east side of the side, south end.
Picture #16:	Surface cover (stone) on the east side of the site, looking north.
Picture #17:	Failed portion of the creek retaining wall.
Picture #18:	Sparse vegetation on the east side of the site.
Picture #19:	Animal burrow along eastern property line.
Picture #20:	Animal burrow along eastern property line.
Picture #21:	Sparse vegetation on the east side of the site along the northern property line.
Picture #22:	Possible washout along the creek retaining wall on the east side of the site.
