Re: 2014 Annual Site Management Plan Surface Cover Report
Former Independent Leather Tannery Site (#B-00158)
City of Gloversville, Fulton County
C.T. Male Project No. 10.1125

Figure 1
Surface Cover Condition Observations

Attachment No. 1
Site Visit Pictures

2014 PHOTO LOG

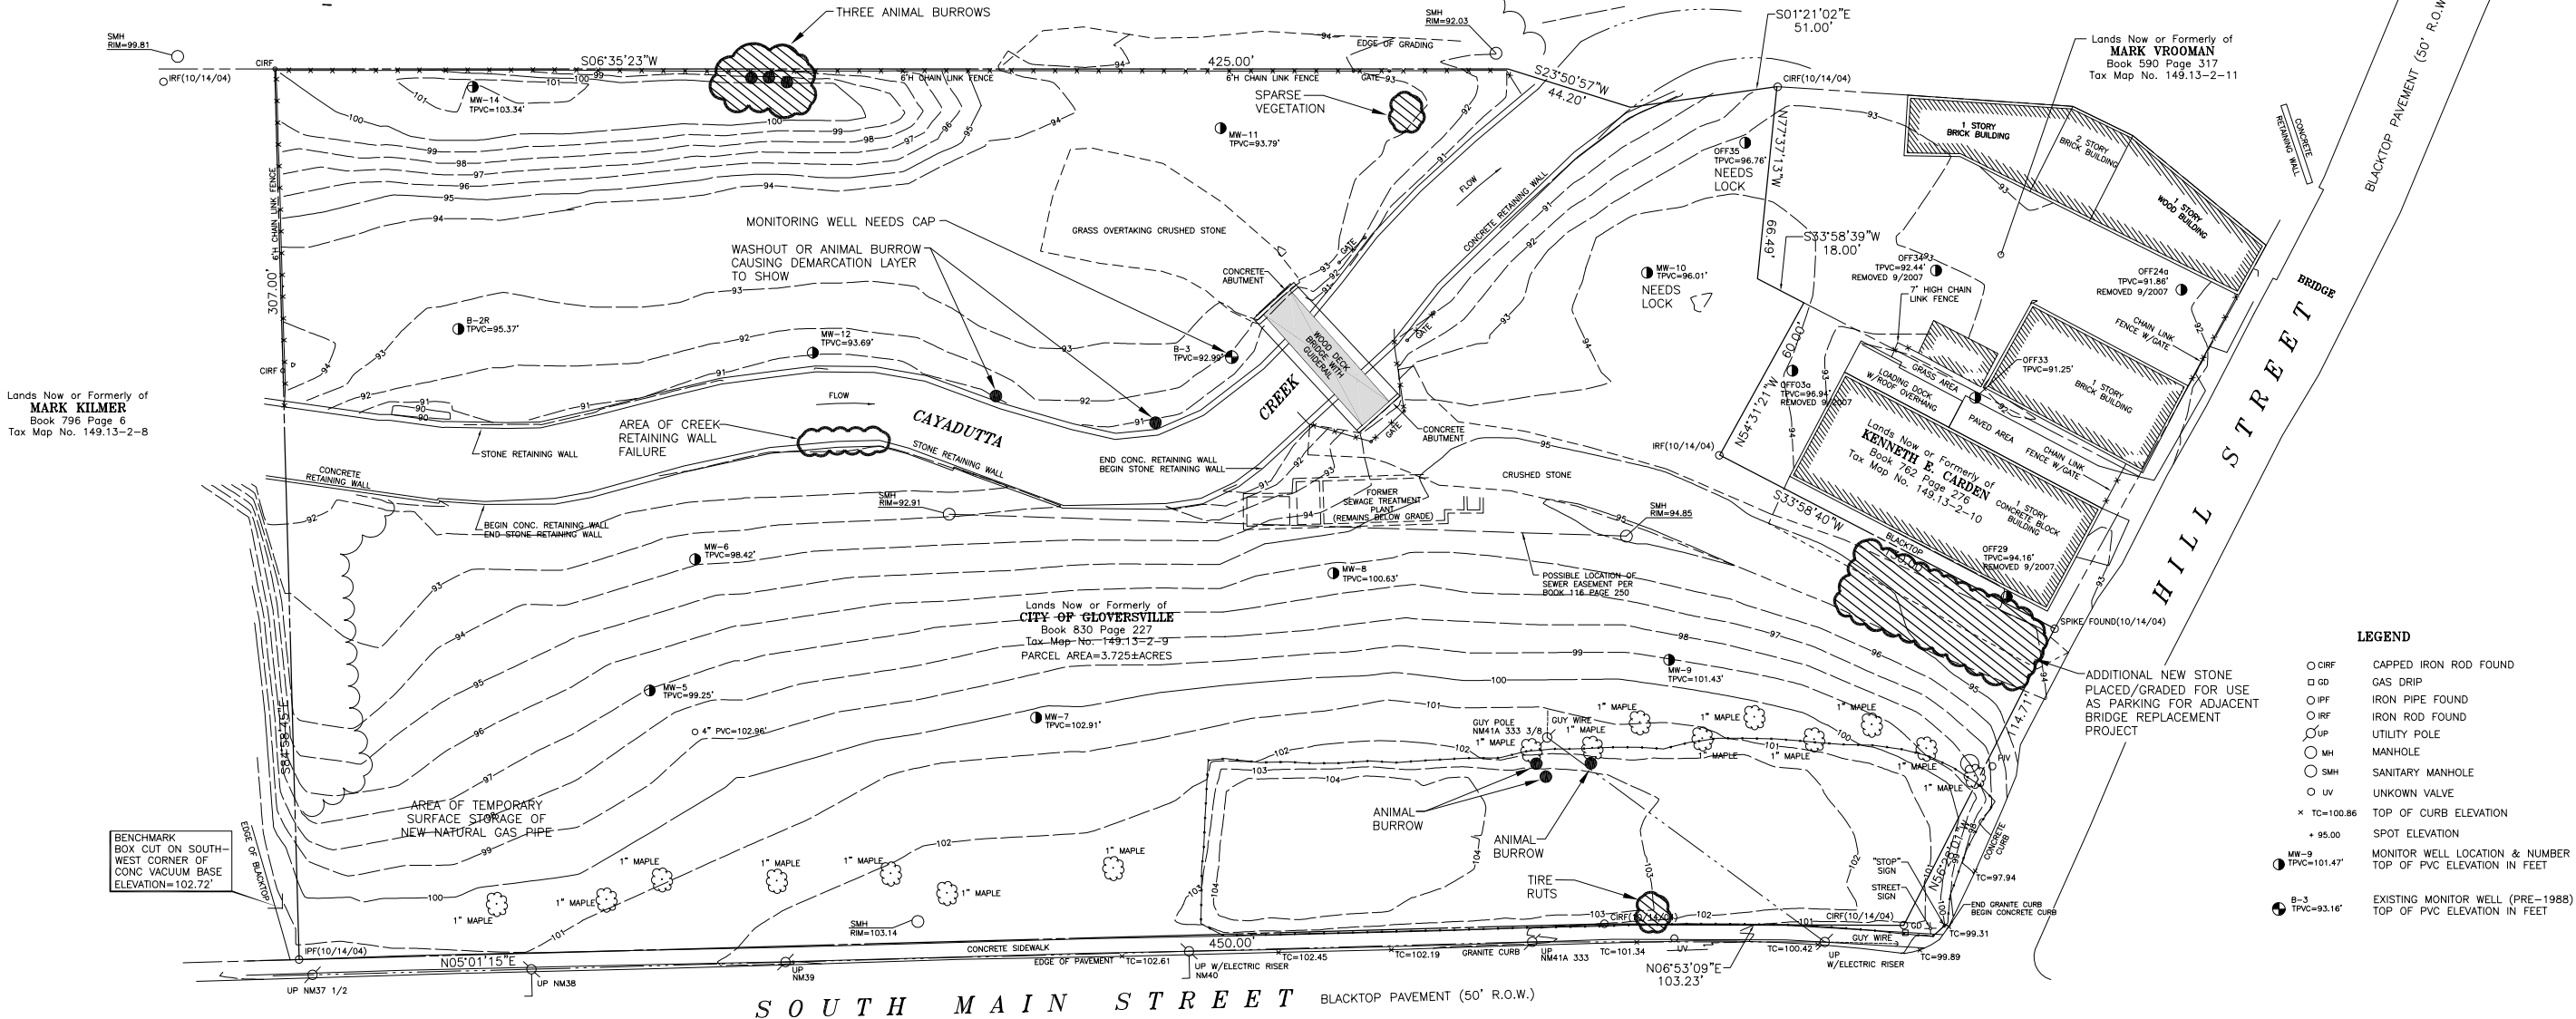
On November 26, 2014, the ±3.7 acre site was traversed on foot to observe the condition of the site's surface cover system (i.e., barrier to contact with existing soil). A minimal amount of snow was accumulating on the ground surface at the time of the site walk, but did not limit the surface observations. The surface vegetation was stable with a mixture of grass and weeds. There were no unvegetated areas, erosion or other surface disturbances observed except for the following. Photos taken during the site visit are attached to this letter, and the areas discussed are shown on Figure 1.

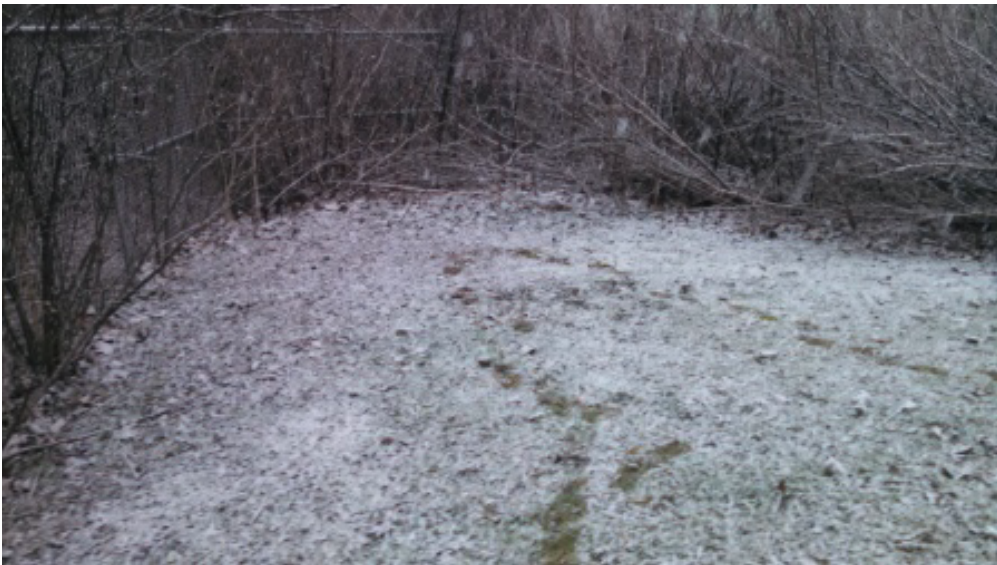
IMG_20141126_114314_087.jpg
11/26/2014

Picture #087:	East side of the site where sparse vegetation exists.
Picture #144:	East side of the site looking north.
Picture #632:	East side of the site where a former washout area existed.
Picture #957:	Animal burrow along eastern property line.
Picture #300:	Looking west across the site at the creek wall failure.
Picture #794:	Looking southwest across the site.
Picture #008:	Creek retaining wall repaired in 2010.
Picture #133:	Creek retaining wall repaired in 2012 which has failed (looking south).
Picture #847:	Creek retaining wall repaired in 2012 which has failed (looking north).
Picture #426:	Washout or animal burrow along creek wall (east side of the site).
Picture #830:	2 nd area of washout or animal burrow along creek wall (east side of the site).
Picture #497:	Monitoring well B-3 missing a cap.
Picture #100:	Top view of creek wall failure on west side of the site.
Picture #371:	Northwest portion of the site showing typical monitoring well, surface cover and temporary gas line piping storage.

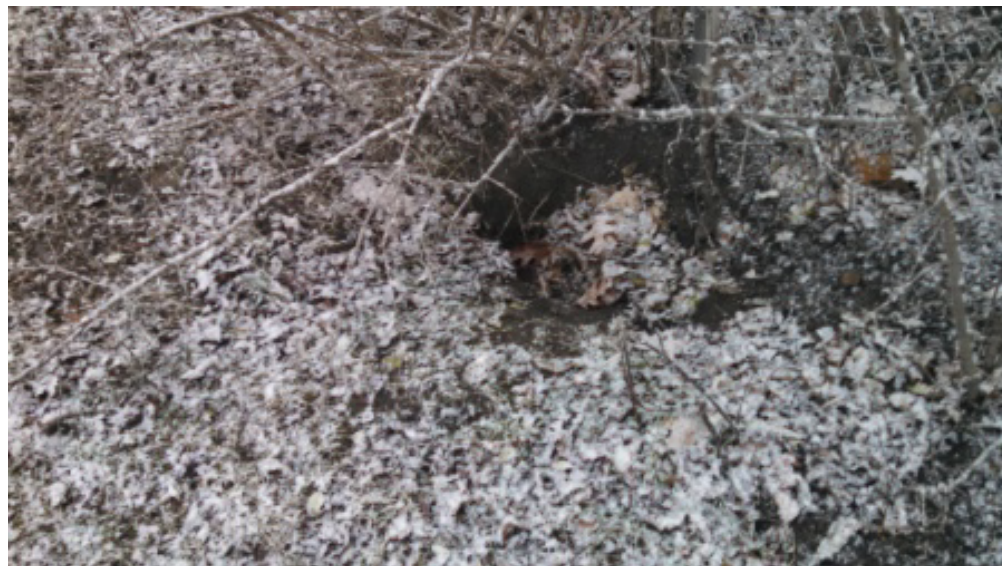
IMG_20141126_114421_957.jpg
11/26/2014

- Three (3) animal burrows were noted on site along the eastern property line along the bike path at the very edge of the surface cover system limits, one more than observed during last year's site visit. The burrows are in similar location as identified during March and November 2010, October 2011, October 2012 and December 2013.

The surface cover system continues to be well established at the project site. Based on the November 26, 2014 site visit, areas that could be improved and repaired were identified. This includes placing gravel in the animal burrows (soil placement has not worked), filling in vehicle caused ruts, and repairing the portion of the creek retaining wall that has collapsed.

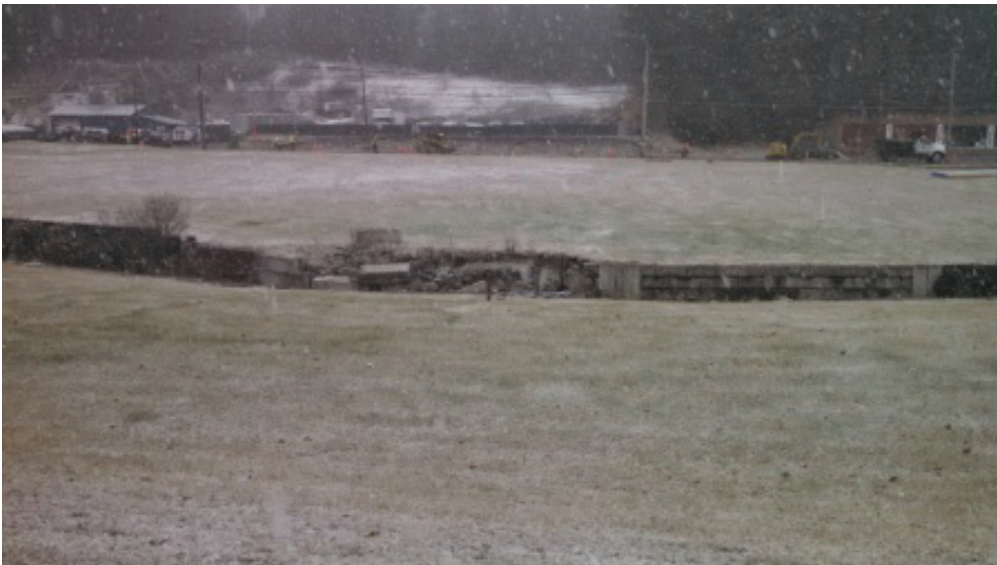
IMG_20141126_114503_300.jpg
11/26/2014

- Two (2) ruts in the surface cover were noted in the southwest corner of the site along the sidewalk and likely caused by a vehicle.
- A section of the creek retaining wall (west side), which was repaired in September 2012 and again failed in 2013 remains unrepaired. The rectangular concrete blocks used for the repair are caved partially into the creek. The length of wall failure is estimated to be on the order of 40 linear feet. The cause of the wall failure is undetermined, but assumed to be natural water flow undermining the foundation blocks. The exposed

soil created by the wall failure is minimal, if any, and did not appear to be entering the creek at the time of the site visit. The elevation of the exposed soil is near the middle of the remaining wall and above the typical average water level in the creek.

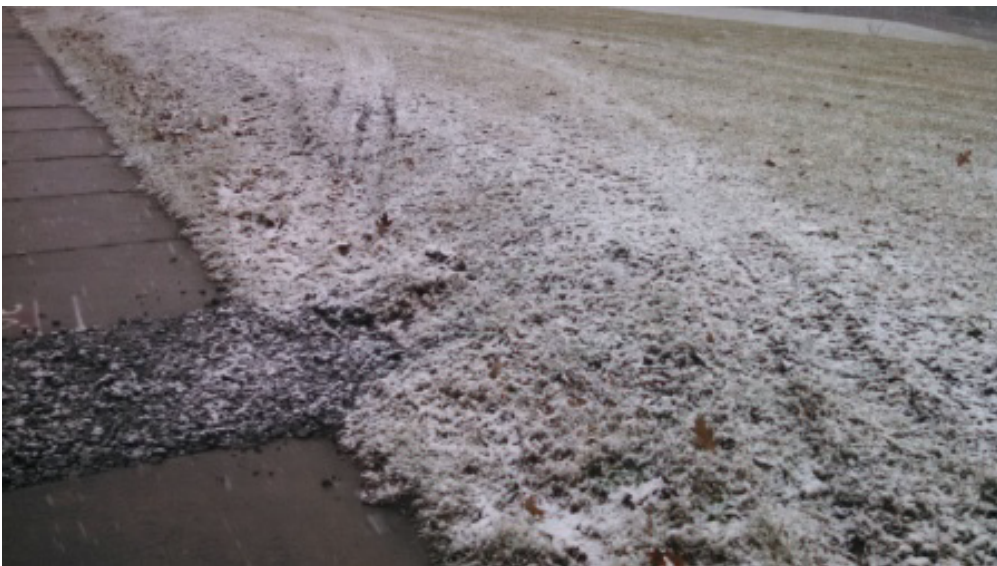
IMG_20141126_115520_761.jpg
11/26/2014

Picture #761:	Vehicle ruts along western property line near the south end.
Picture #254:	Animal burrow at the base of the maple tree on west side of site.
Picture #030:	Monitoring well MW-10 missing a lock.
Picture #400:	Monitoring well OFF35 missing a lock.
Picture #947:	Area of additional gravel placement/grading.

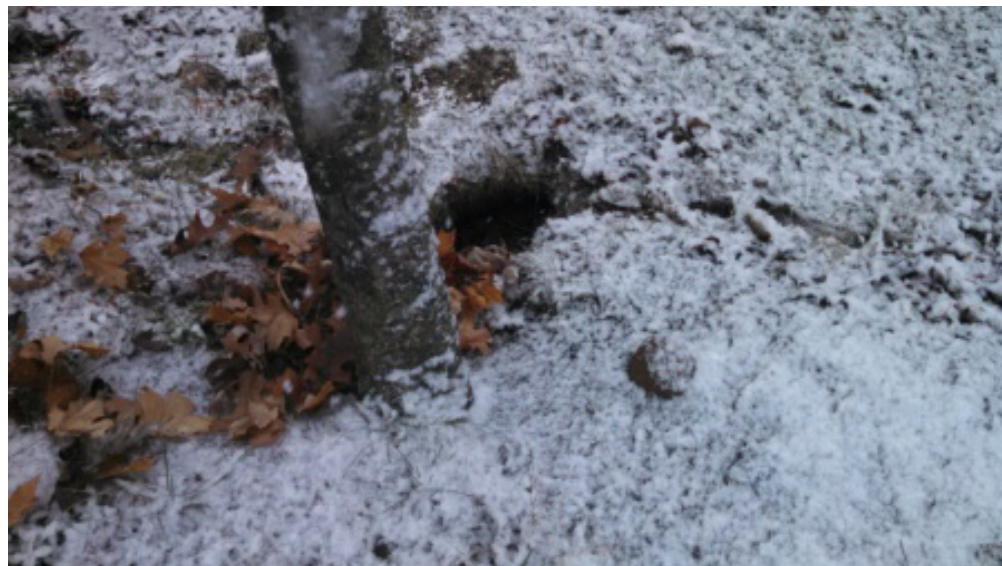
IMG_20141126_115739_254.jpg
11/26/2014

- Three (3) animal burrows were noted near the base of two (2) separate maple trees on the west side of the creek utility pole NM41A 333. These burrows existed on-site during last two annual site visits, but are no larger than last year.
