Subject: BCP Site #B00164: BUDC – Hanna Furnace Sub-Parcel 3
Site Management 2024 Periodic Review Report and IC/EC Certification

Periodic Review Report

Hanna Furnace Subparcel 3

April 2024

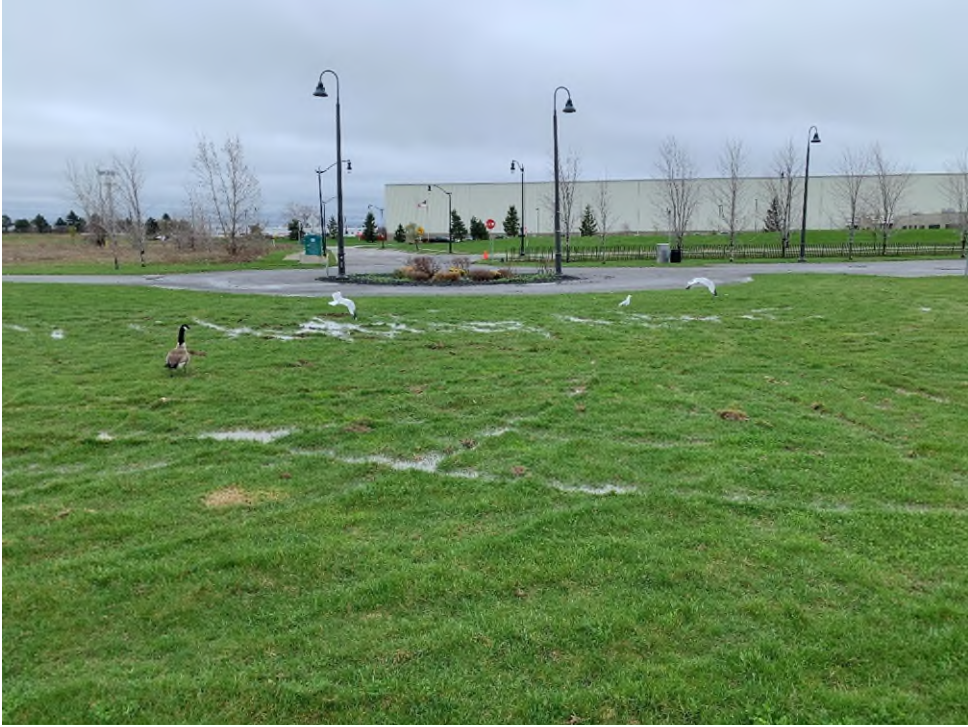
- Minor rutting was observed in soil adjacent to the south parking area (see Photographs 10, 15, and 17) as a result of unauthorized vehicular traffic and/or site maintenance. It is recommended that areas be filled and re-seeded with NYSDEC-approved materials as part of general site maintenance to prevent long-term deterioration of the cover systems.

<p>Photograph: 17</p> <p>Description: Soil cover, asphalt with tire tracks</p> <p>Direction of photo: South</p> <p>Photograph taken by: L. Goetz</p> <p>Date: 4/12/24</p>

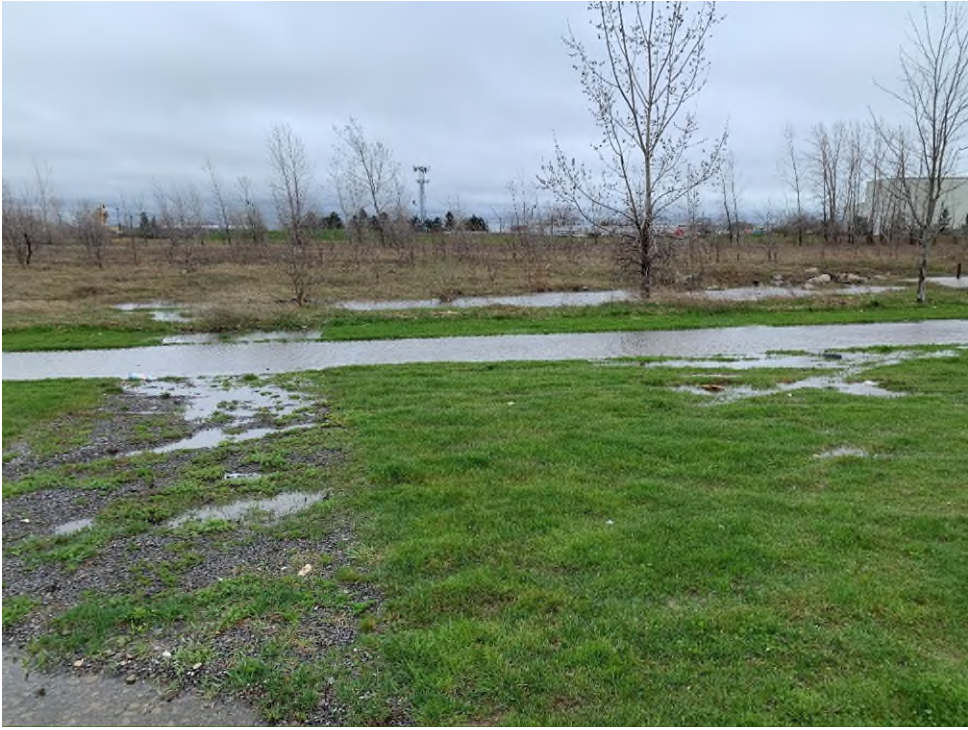
- Some minor ponding due to the recent rainfall was noted in gravel pathways installed in the northern portion of the site and in soil along the southern and northern site boundaries (see Photographs 18 and 28). Future observations or inspections under dry conditions should be noted to assess the degree of surface water accumulation.

<p>Photograph: 18</p> <p>Description: Soil cover, vegetation, and asphalt with minor ponding</p> <p>Direction of photo: South</p> <p>Photograph taken by: L. Goetz</p> <p>Date: 4/12/24</p>

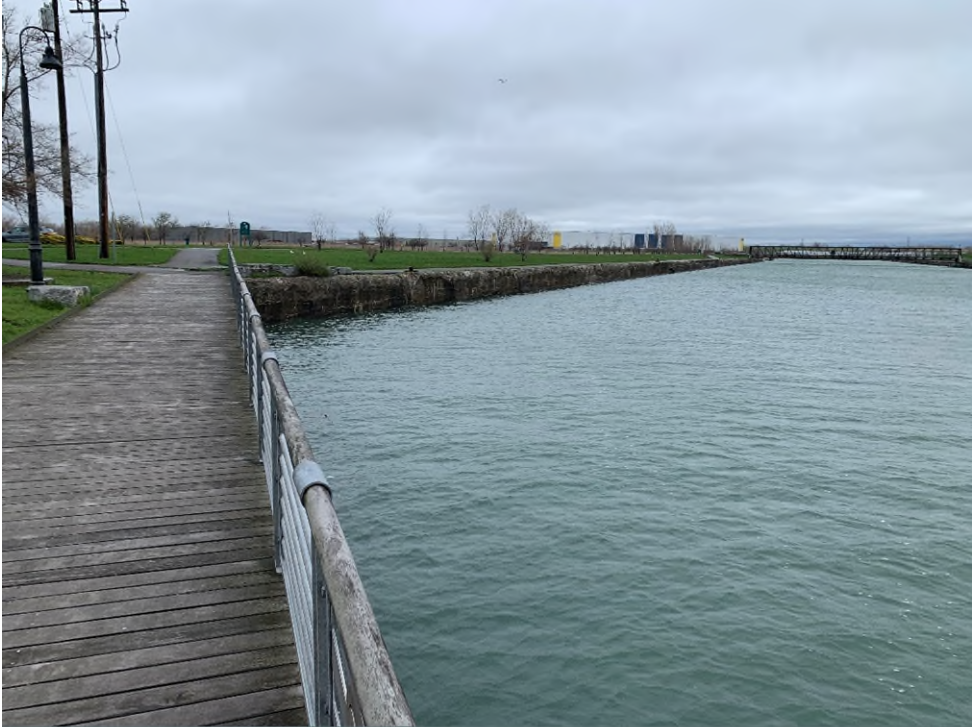
- Evidence of historical deterioration and pitting along the top of the canal wall was observed on the north side of the canal due to the age of the wall. No indications of canal wall settling, cracking, or deflection were observed during visual inspections (see Photographs 29 and 30). Additional attention should be applied to this area during future annual inspections to track any excessive deterioration.

<p>Photograph: 29</p> <p>Description: Canal wall</p> <p>Direction of photo: Northeast</p> <p>Photograph taken by: L. Goetz</p> <p>Date: 4/12/24</p>

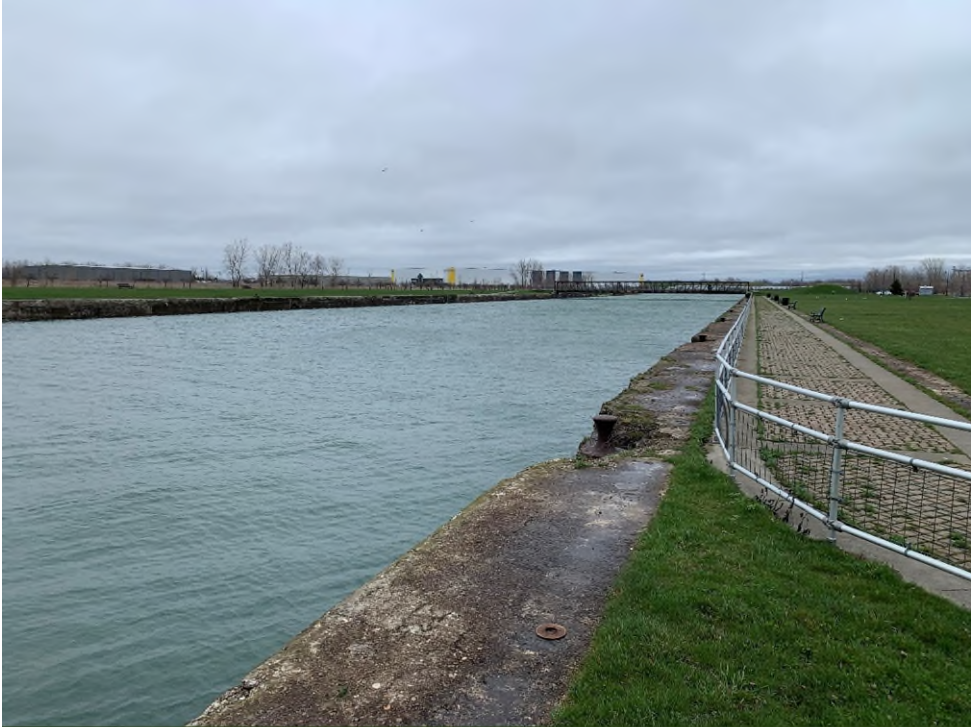
<p>Photograph: 31</p> <p>Description: Canal wall</p> <p>Direction of photo: East</p> <p>Photograph taken by: L. Goetz</p> <p>Date: 4/12/24</p>
