2026 Periodic Review Report

(Reporting Period: March 28, 2025 to March 28, 2026)

Location:
Hanna Furnace Subparcel 3
Buffalo, New York
BCP Site #B00164

LaBella Project No. 2262002

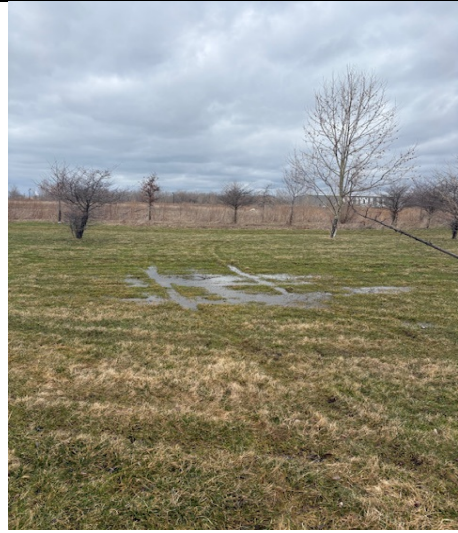
10. North side looking north at field, some seasonal pooling and mild rutting

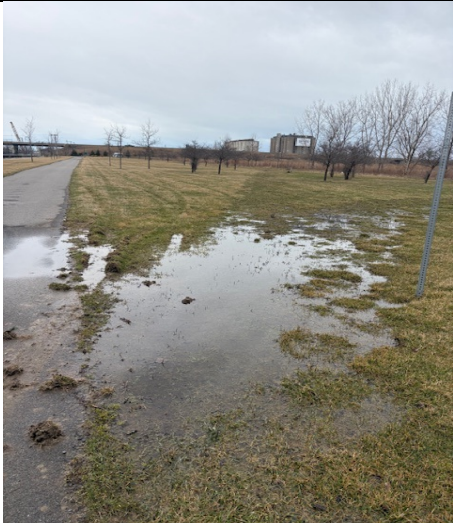
11. North side looking west at field and asphalt path, some seasonal pooling and mild rutting

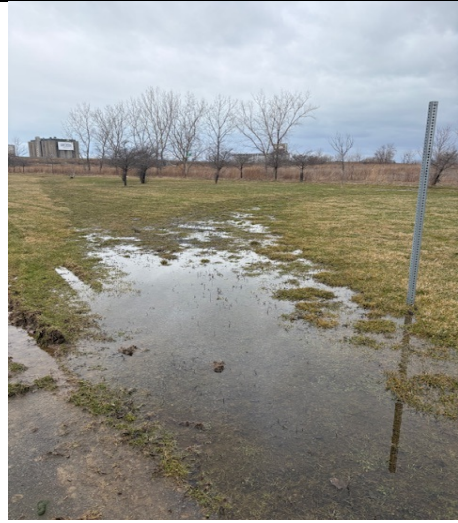
12. North side looking northwest at field, some seasonal pooling and mild rutting

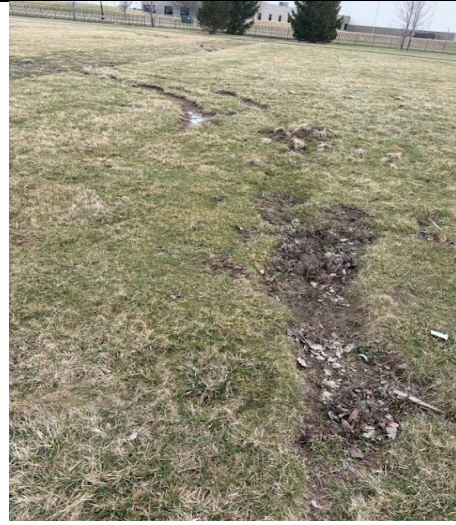
- Minor to significant rutting was observed in numerous locations across the site. Significant rutting was observed on the south side of the site. Rutting appears to be from unauthorized vehicular traffic entering the site at the south parking area. It is strongly recommended that areas be filled and reseeded with NYSDEC approved materials as part of future site maintenance to prevent the long-term deterioration of the Site cover systems.

17. South side looking south at rutting in field

Overall, the remedial program is viewed to be effective in achieving the remedial objectives for the site. No changes to the SMP or the frequency of PRR submissions are recommended at this time. Vehicle rutting observed across the site should be properly repaired to maintain the effectiveness of the cover system.

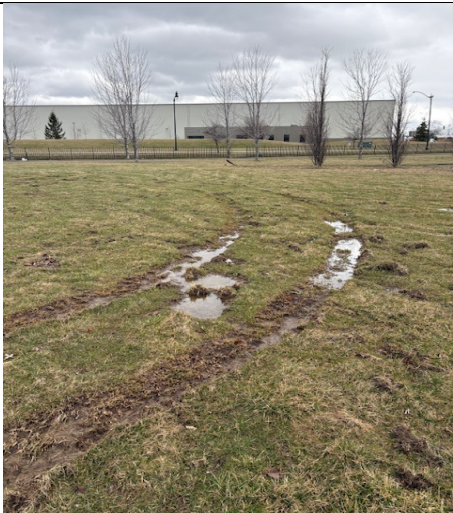
18. South side looking south at rutting

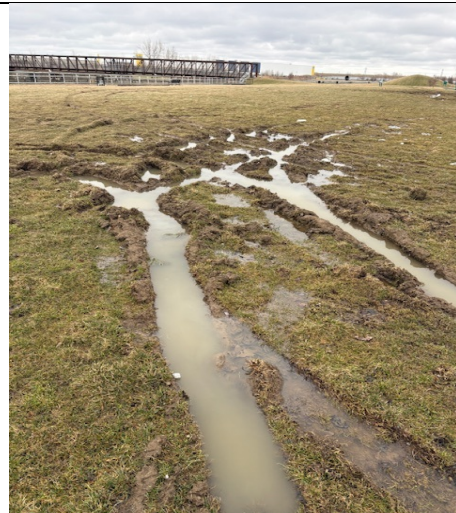
19. South side looking northeast at rutting

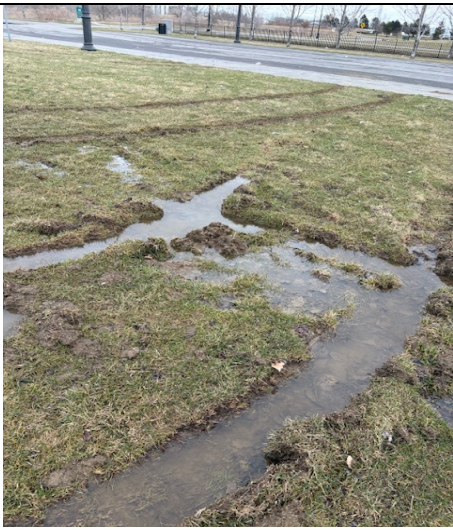
20. South side looking south at rutting

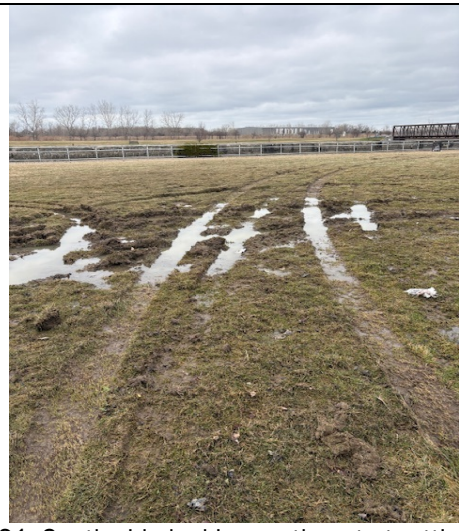
21. South side looking northeast at rutting

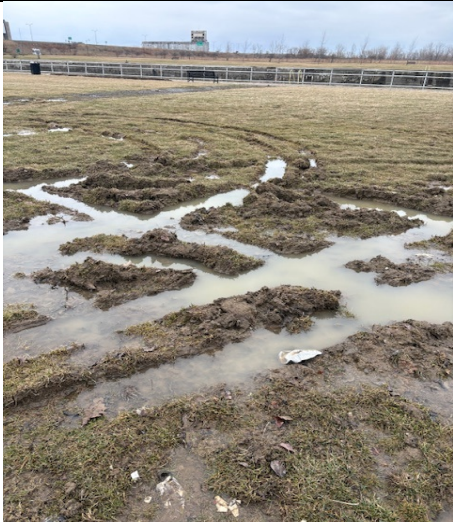
22. South side looking northwest at rutting

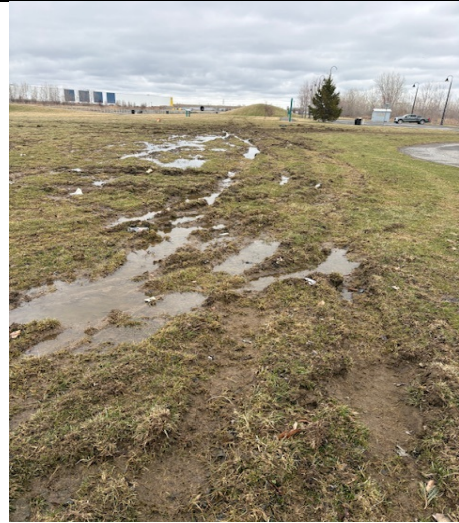
23. South side looking east at rutting

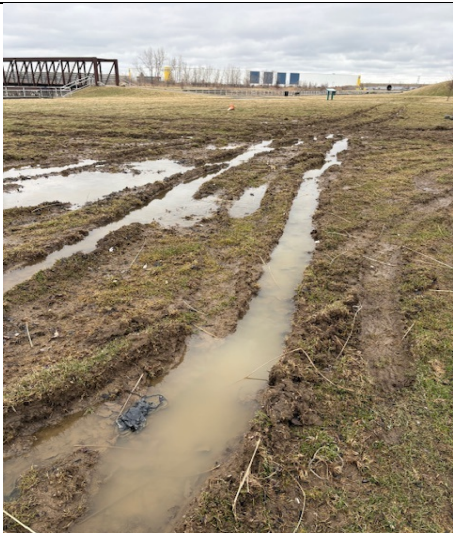
24. South side looking northeast at rutting

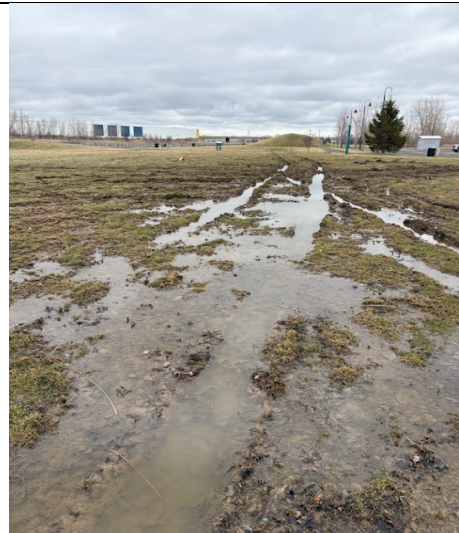
25. South side looking east at rutting

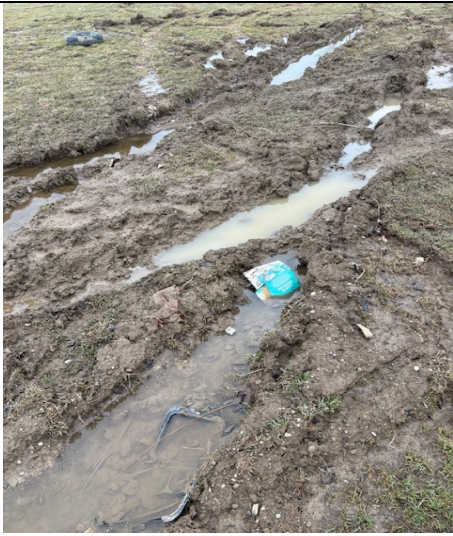
26. South side looking at significant rutting

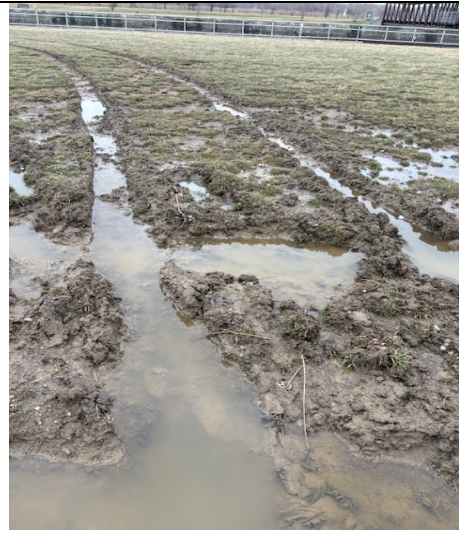
27. South side looking north at rutting

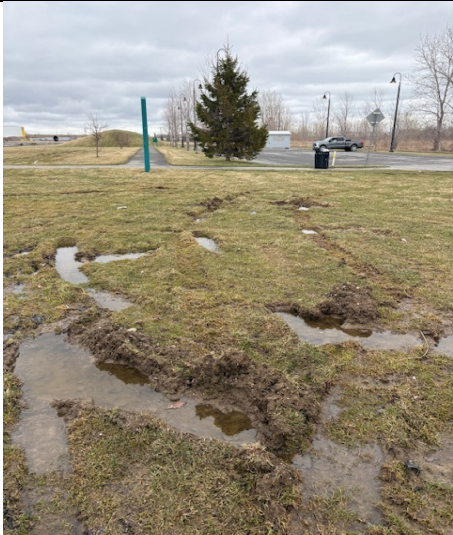
28. South side looking east at rutting

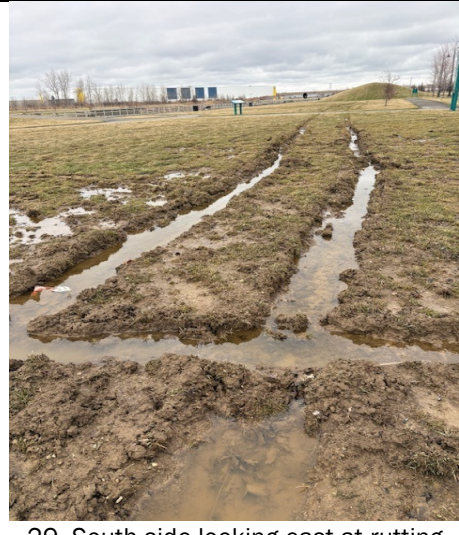
29. South side looking east at rutting

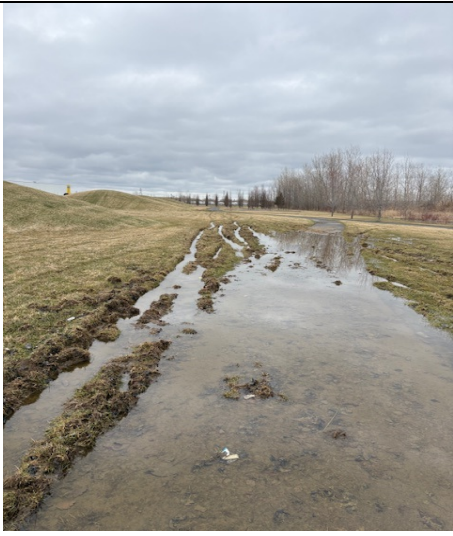
32. South side looking east at rutting

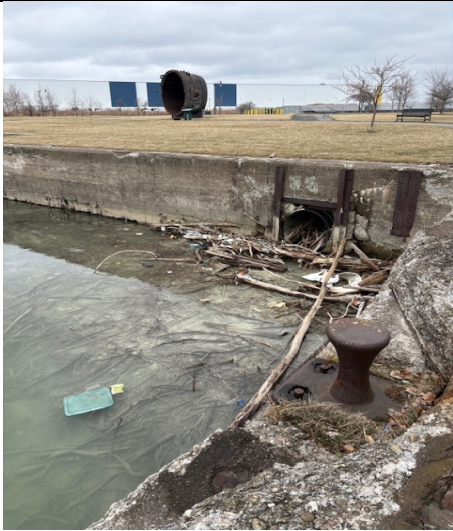
34. South side looking east at end of canal, canal wall in good condition

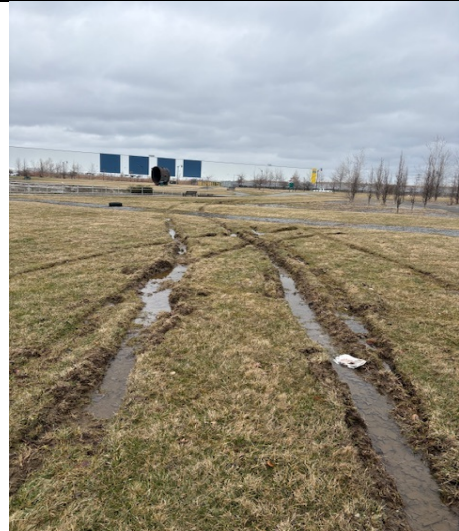
35. South side looking northeast at end of canal rutting
