Gus Franczyk Park
Buffalo, New York

Construction Closeout Report

August 2001

Franczyk Park Drainage Improvement Project Construction Closeout Report

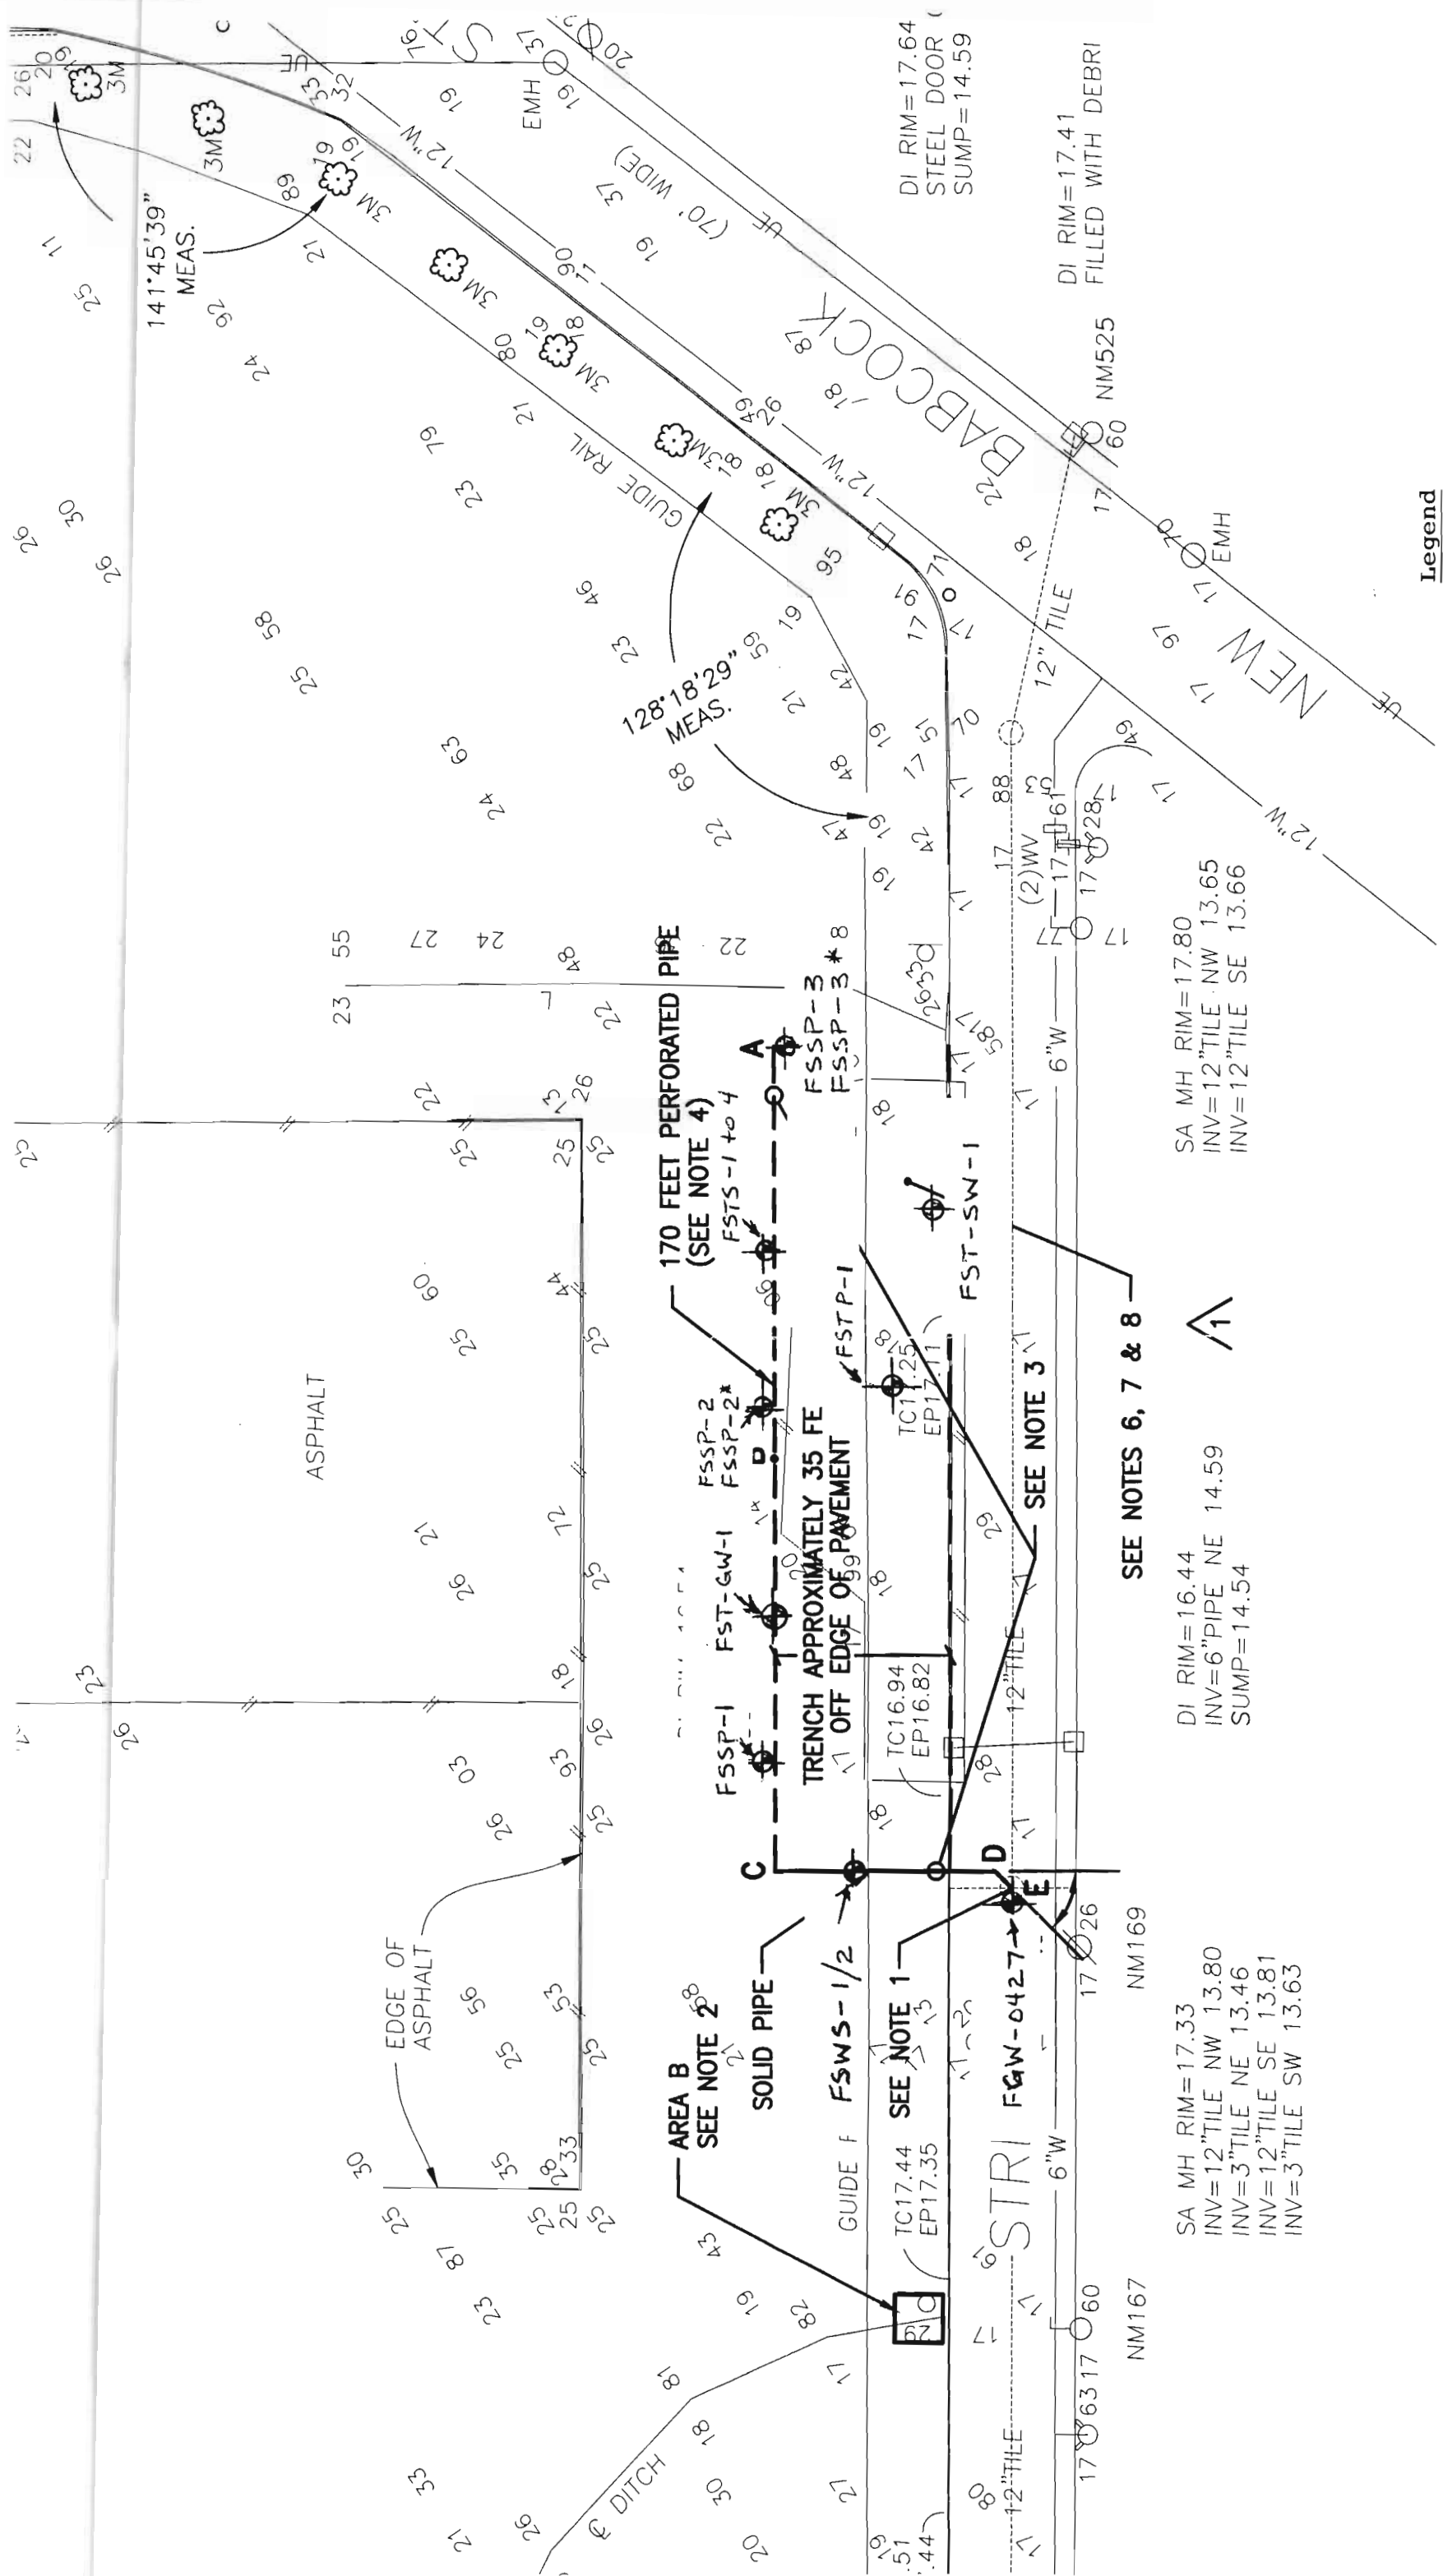
Figure 4.1

The following section briefly summarizes the analytical testing performed as part of this project. Figures 4.1 and 4.2 provide sample locations on Fleming Street and Lewis Street respectively.

Four samples were collected during the excavation of the Fleming Street trench. These four samples were taken from one location and reflect the soil profile there. Table 4.1 provides the results and indicates high arsenic levels in all four samples ranging from 106 mg/kg to 22,400 mg/kg. The highest value appears associated with a thin yellow layer of material. High total lead levels were found in two of the samples, with the highest being associated with a red/purple silty brick flour (21,100 mg/kg). These soils were thought to be indicative of high contaminant levels and were used as indicator soils for further sampling on this project.

Three soil samples were taken of the trench and seep area prior to completing backfilling. Table 4.2 presents these results and confirms high lead and arsenic levels in red/purple fill initially identified during the trench sampling. Two samples were split and sent to separate labs, the comparative results sample to sample (FSSP-2 with FSSP-2*, and FSSP-3 with FSSP-3*) were not very good. However, all four samples had high total lead and arsenic concentrations. The reddish/purple soils were not found in large defined source areas but appear thinly spread across the site in isolated pockets and layers. The thin yellow arsenic laden layer was discontinuous and could not be traced for any distance in the trench. Other black ash and cinder soils also appear to contain elevated lead and arsenic levels. Below approximately 4 ft, one finds a silty clay that still contains somewhat elevated concentrations of lead and arsenic.

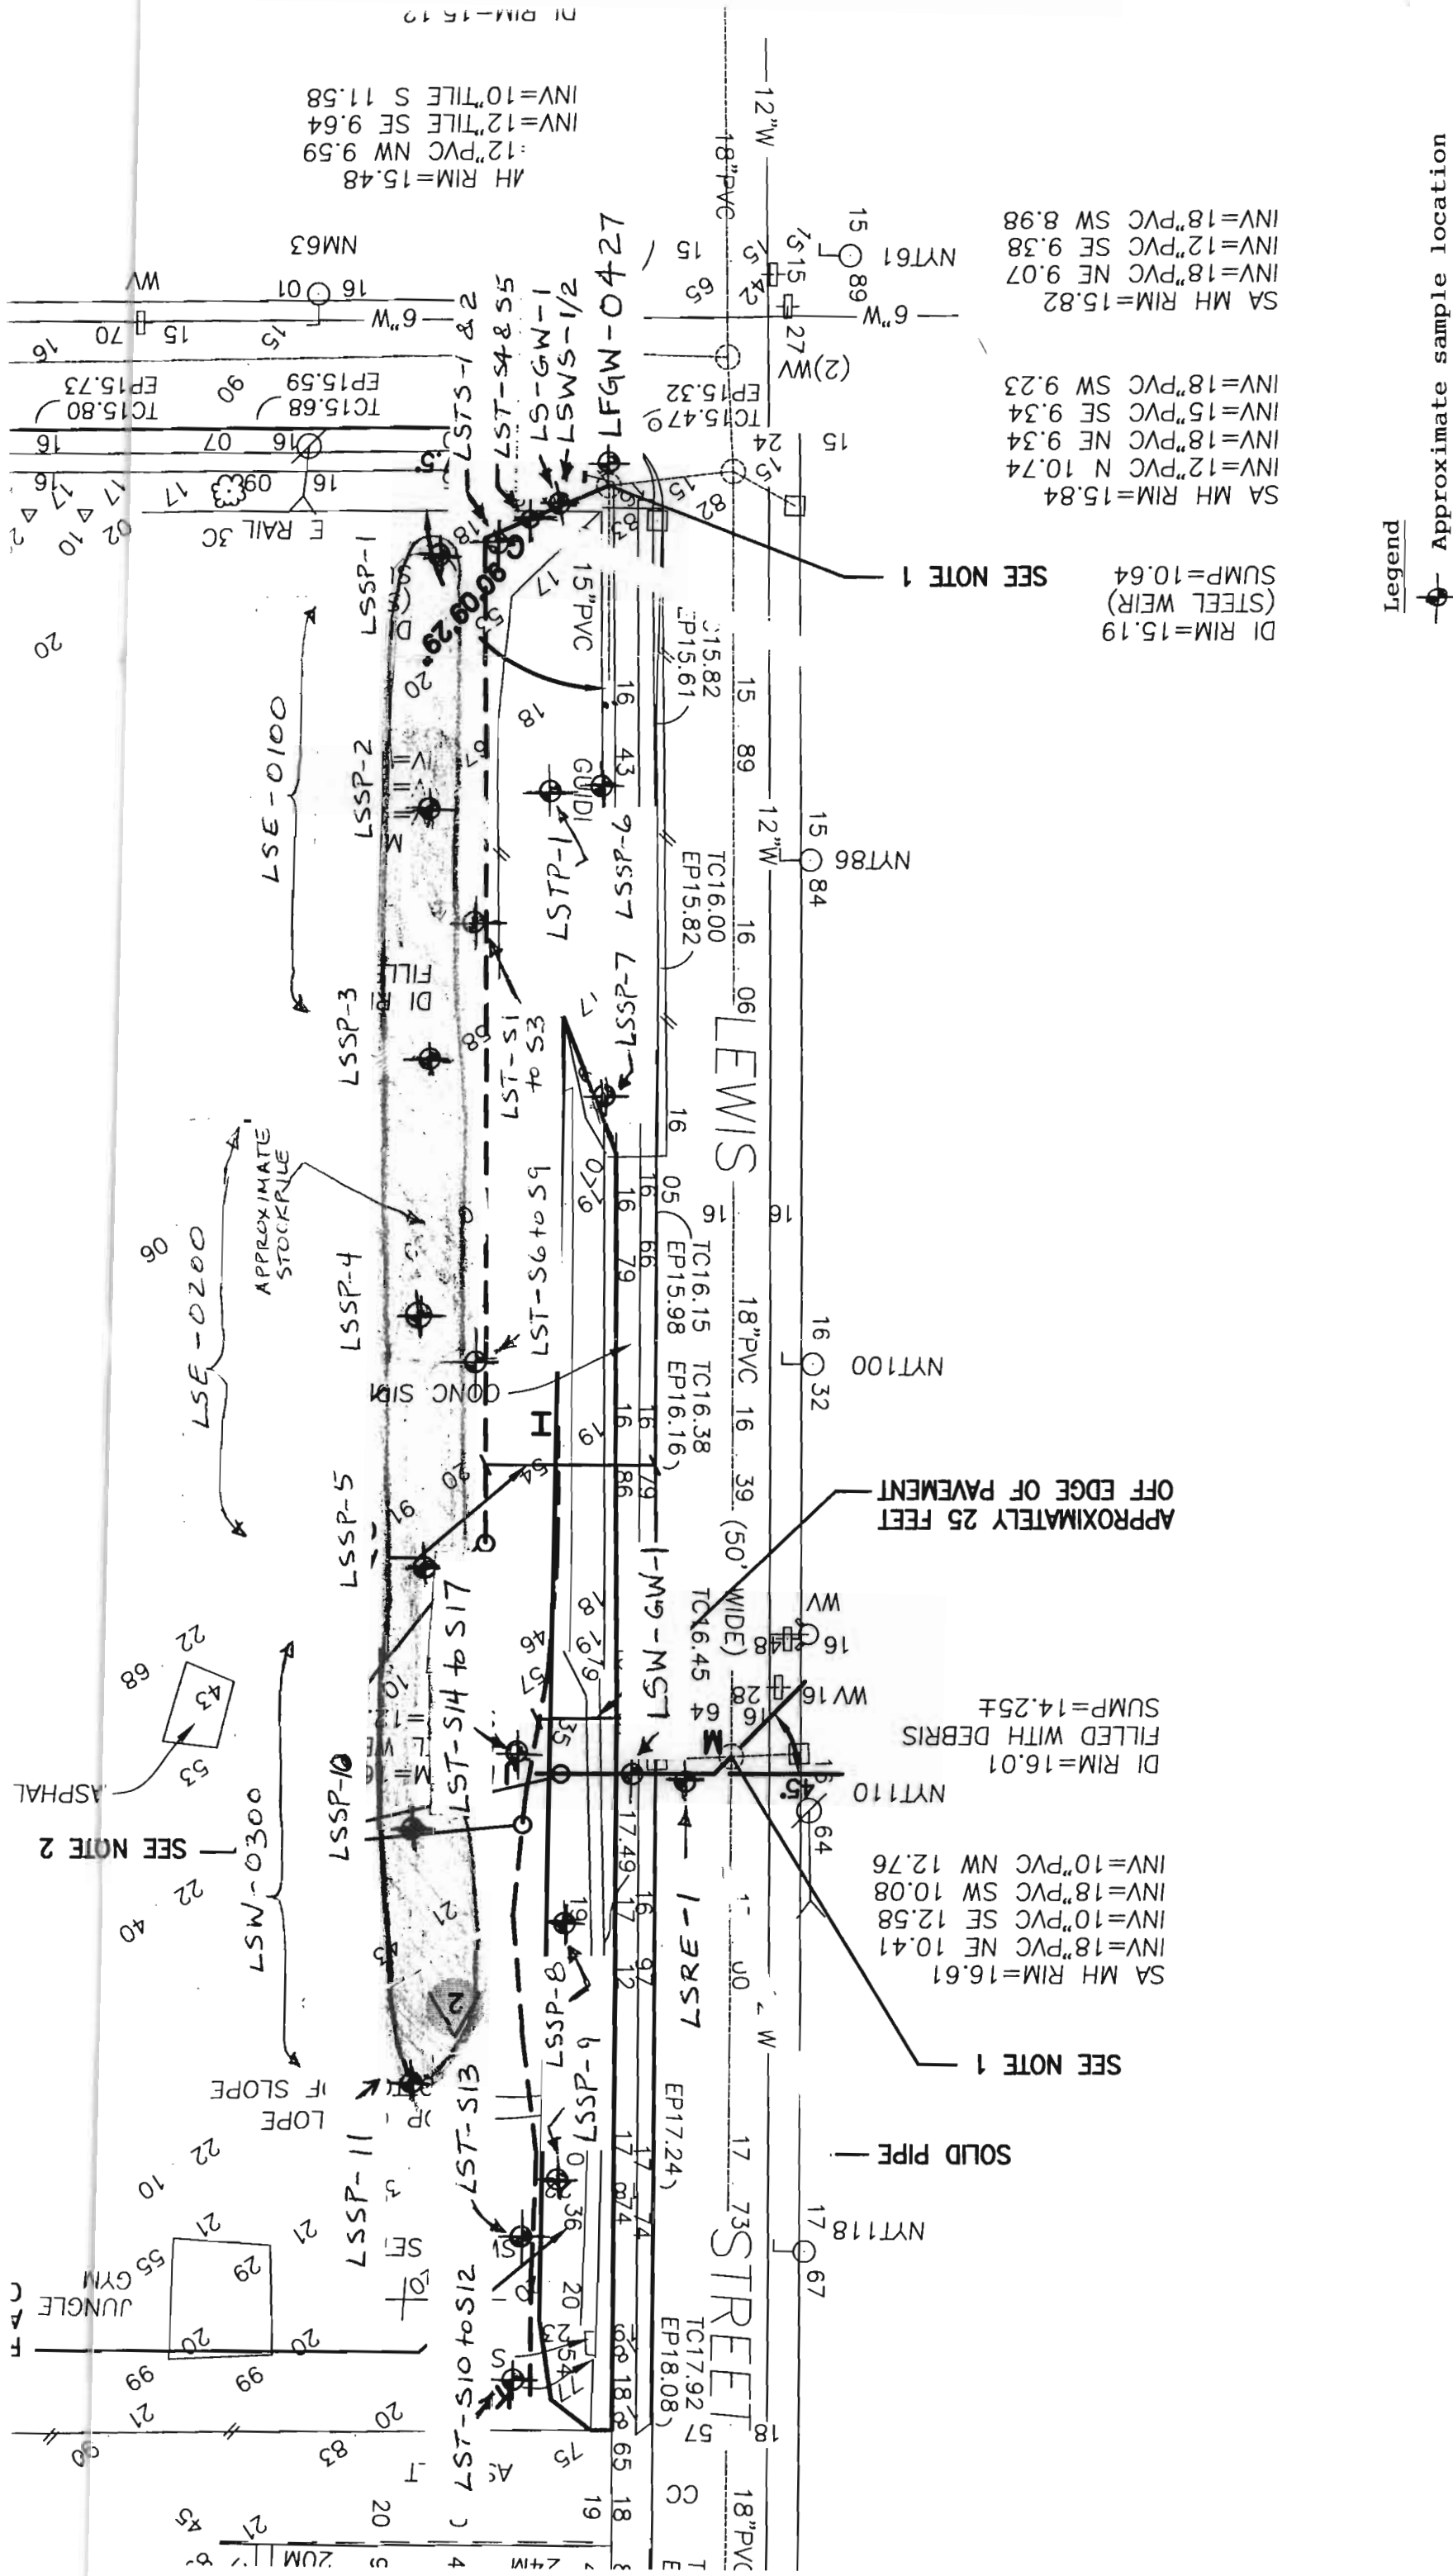
Figure 4.2
Lewis St. Sampling Locations

Nineteen (19) samples were collected during the excavation of the east and west Lewis Street drainage trenches. Table 4.1 summarizes information about these samples. The three highest total lead concentrations in these samples appeared to be associated with gray to black ash and cinder fill (9,680 mg/kg to 26,600 mg/kg), while the highest arsenic levels appeared associated with a yellow fine brick/silt fill (569 mg/kg) and reddish purple fine sandy silt (449 mg/kg). The results in the table appear to indicate that contaminant levels vary significantly with location and depth. The apparent natural silty clay soils at depth (3 ft and below) appear

to have generally lower (residual) arsenic and lead levels. In the Lewis Street work area, the black ash and cinders appear indicative of high total lead containing materials, while the reddish purple fine sandy silt (similar to that observed along Fleming Street) contain both lead and arsenic. Some yellow fine sandy silt (again similar to the thin layer observed on the Fleming Street trench) also contains high arsenic levels.

Eleven (11) surface soil samples were collected prior to backfilling the site with topsoil. In addition, one sample (LSRE-1) was taken (of reddish purple material found between the cobblestones beneath the existing asphalt pavement) during the road cut for the sewer tie-in. Table 4.4 presents the analytical results and indicates relatively high total lead levels in most of these areas. Elevated arsenic levels were also observed in most of the samples. These remaining materials appear to be ash/cinders and demolition debris fill. These areas were subsequently covered with 3 to 12 inches of offsite topsoil.
