**Department of
Environmental
Conservation**

DAILY INSPECTION REPORT

Site Code #: B-00-184	Date: 07/27/2018	Report #: AT-1
------------------------------	-------------------------	-----------------------

Site Name: Fosters Refrigeration
Location: City of Hudson, Columbia Co.
DEC Proj. Mgr.: Jeff Trad
Contractor: Precision Environmental
Contractor Proj. Mgr.: Steve Phelps

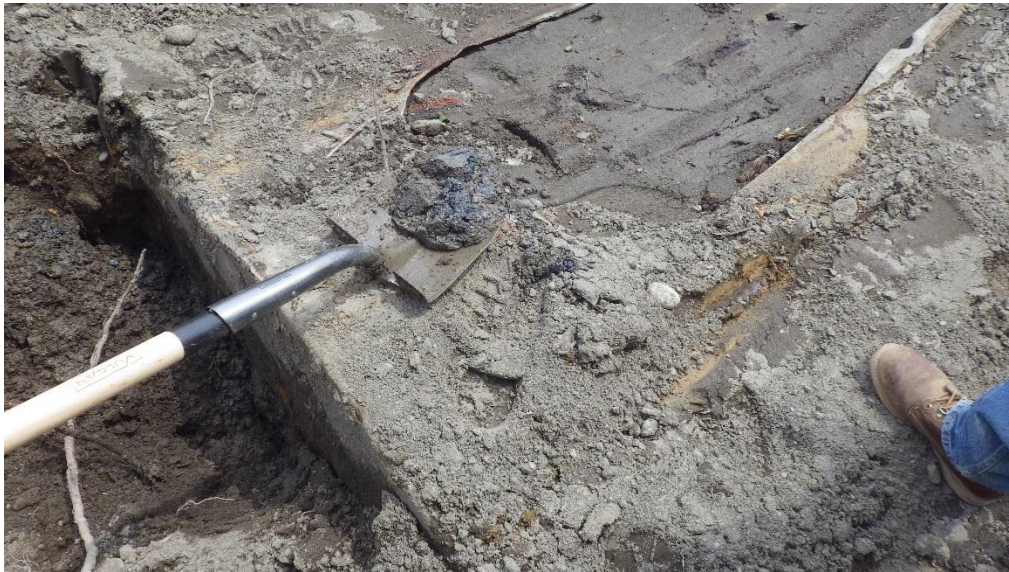
Contaminated soil with oil from UST tank

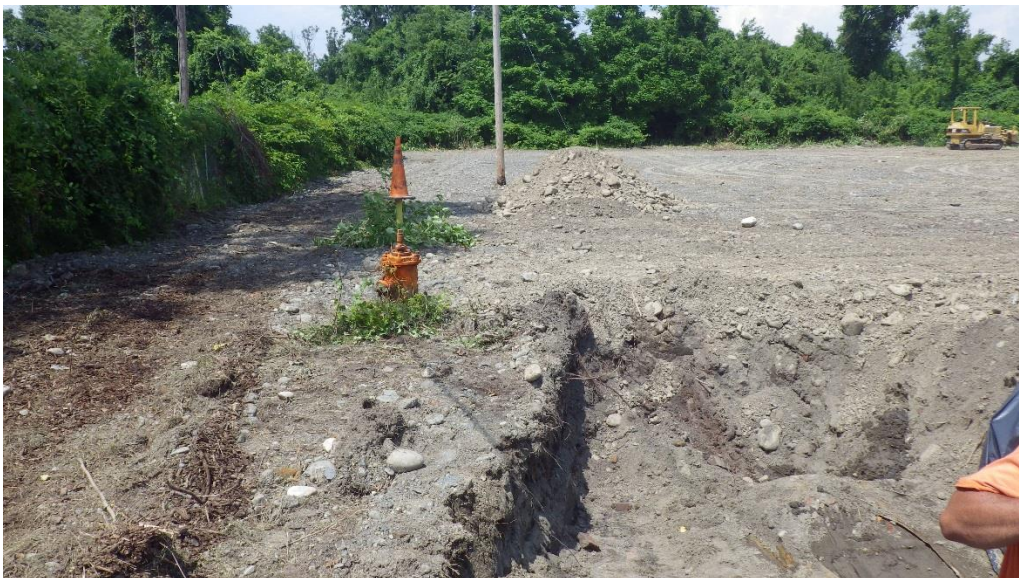
Active Gas line and Water line next to the UST tanks

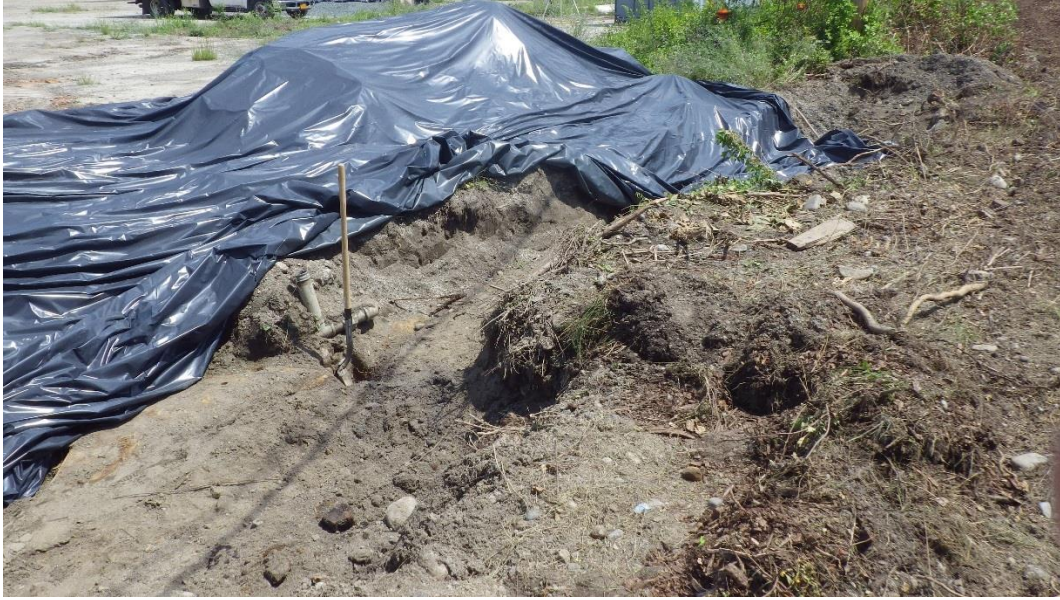
2nd UST tank identified next to the 1st one
