***Remedial Investigation Report***  
**Former Boiler House Property**  
**NYSDEC Site No. B00197**  
**US Route 4 and Best Avenue**  
**Town of Stillwater**  
**Saratoga County, New York**

**December 2008**

***Chazen Project No. 30201.14***

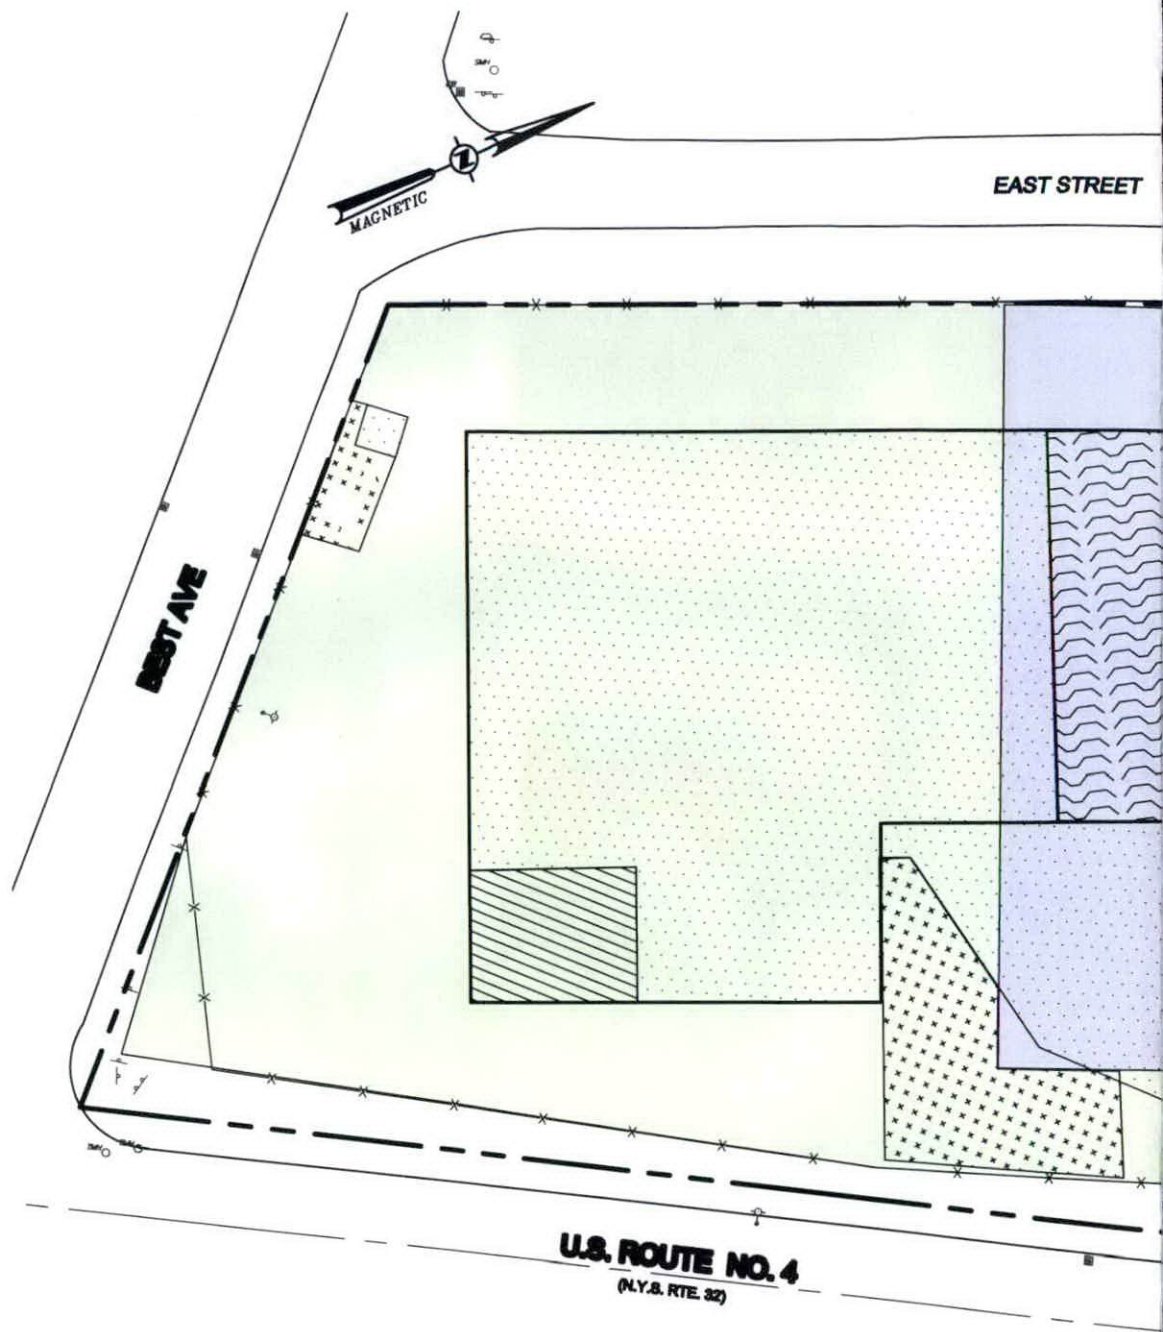
Figure 15  
Summary of Excavations and Backfill Materials

- In October, November, and December 2006, TCC observed the removal of 3,825 tons of petroleum- and PCB-contaminated soil and coal ash waste as well as the backfilling, grading, and seeding of the site as an IRM.

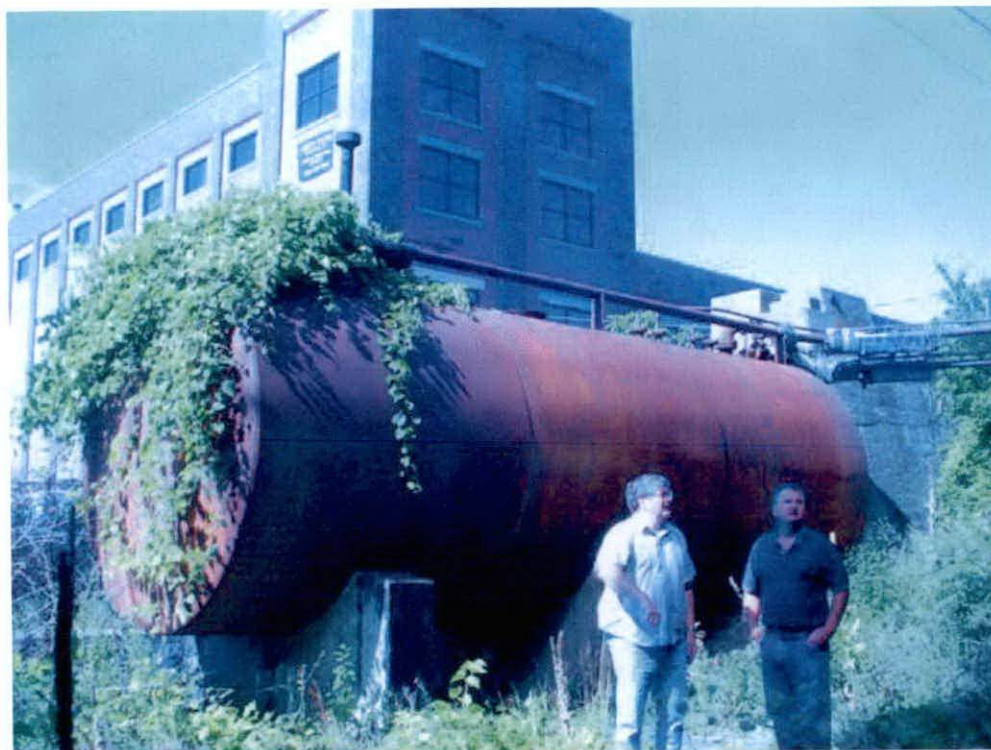
Photo 4

- Drums and other smaller containers were observed inside and outside of the boiler house. Two drums appeared to contain used motor oil and were in poor condition. No information pertaining to the historic use, storage, or disposal practices of petroleum and/or chemicals was identified in available records.

2002 photograph of the 16,000-gal AST on the south side of the boiler house

- In June 2004, Optech Environmental Services completed the product removal and tank cleaning of the on-site 16,000-gallon fuel oil AST as an IRM.
- On July 14, 2004, Optech Environmental Services completed the product inventory and disposal of drums and other small containers found throughout the building as an IRM.

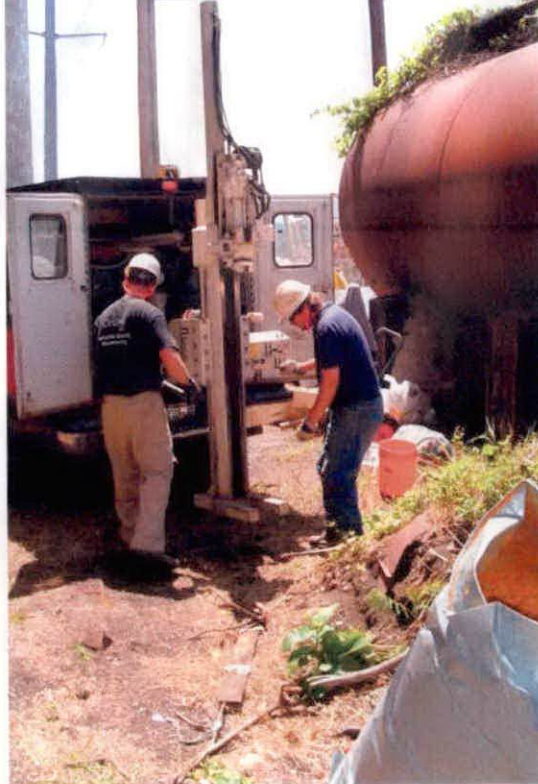
**Photo 5**

2004 photograph of the subsurface soil investigation near the 16,000-gal. AST on the south side of the boiler house.

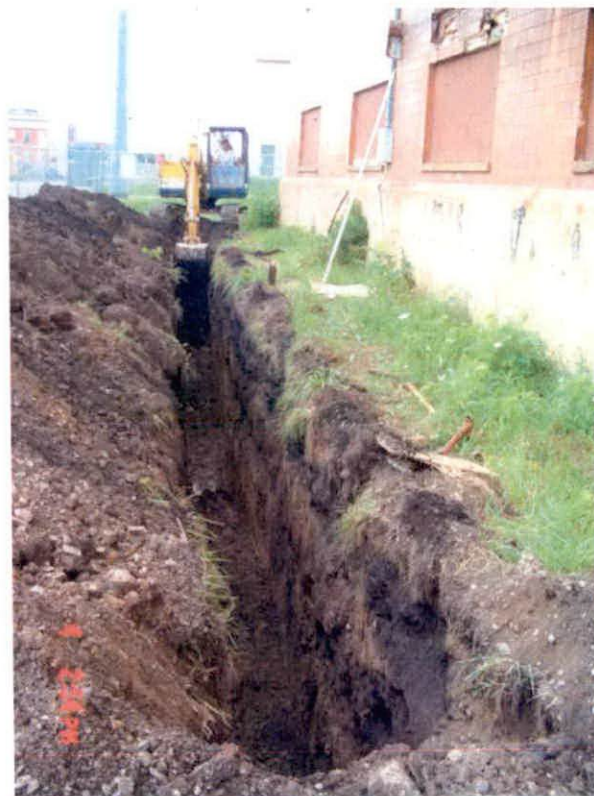
**Photo 6**

A three-inch steel pipe was encountered at approximately three feet below the ground surface in TP-7 along the eastern side of the site building. Petroleum was noted within and beneath this pipe and petroleum odors were noted. The NYSDEC was contacted and this petroleum release was assigned to the existing site spill record (NYSDEC Spill No. 0445021).

2004 photograph of the test pit investigation. This test pit is parallel to the east side of the boiler house.

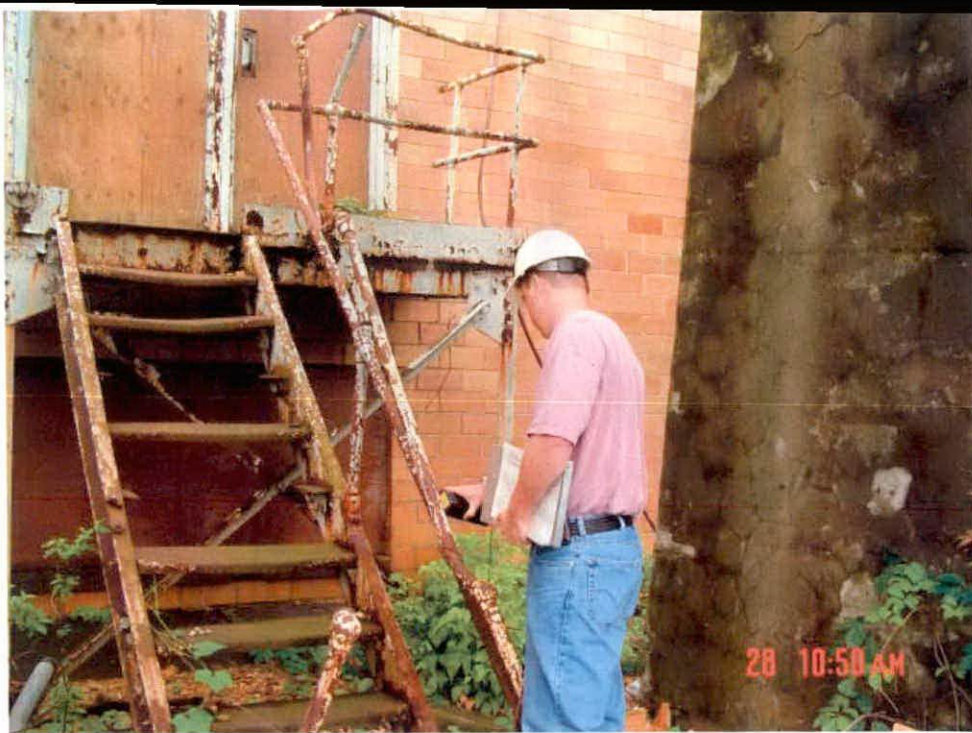
Photo 7

- Painted surfaces, including the southern smoke stack, appeared to be in poor condition. Chipping and peeling paint was observed. Based on the age of the boiler house, painted and coated surfaces were suspected to have contained lead and/or asbestos. No documentation pertaining to the use or presence of lead-based paint (LBP) or asbestos-containing materials (ACMs) on the site was identified.

Lead-based paint survey completed in 2004.
