***Remedial Investigation Report***  
**Former Boiler House Property**  
**NYSDEC Site No. B00197**  
**US Route 4 and Best Avenue**  
**Town of Stillwater**  
**Saratoga County, New York**

**VOLUME 1 of 7**

**February 2009**

***Chazen Project No. 30201.14***

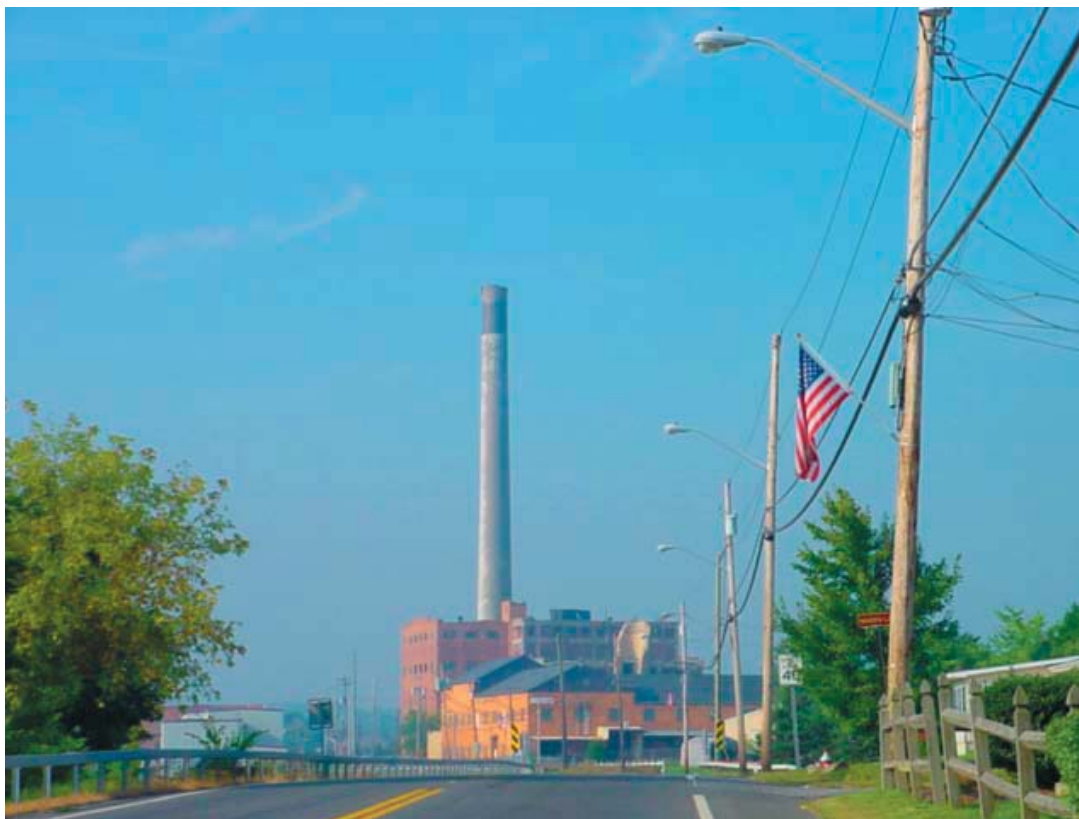
**Photo 2**  
A 2002 photograph of the boiler house and Polyset Company facing south  
along U.S. Route 4.

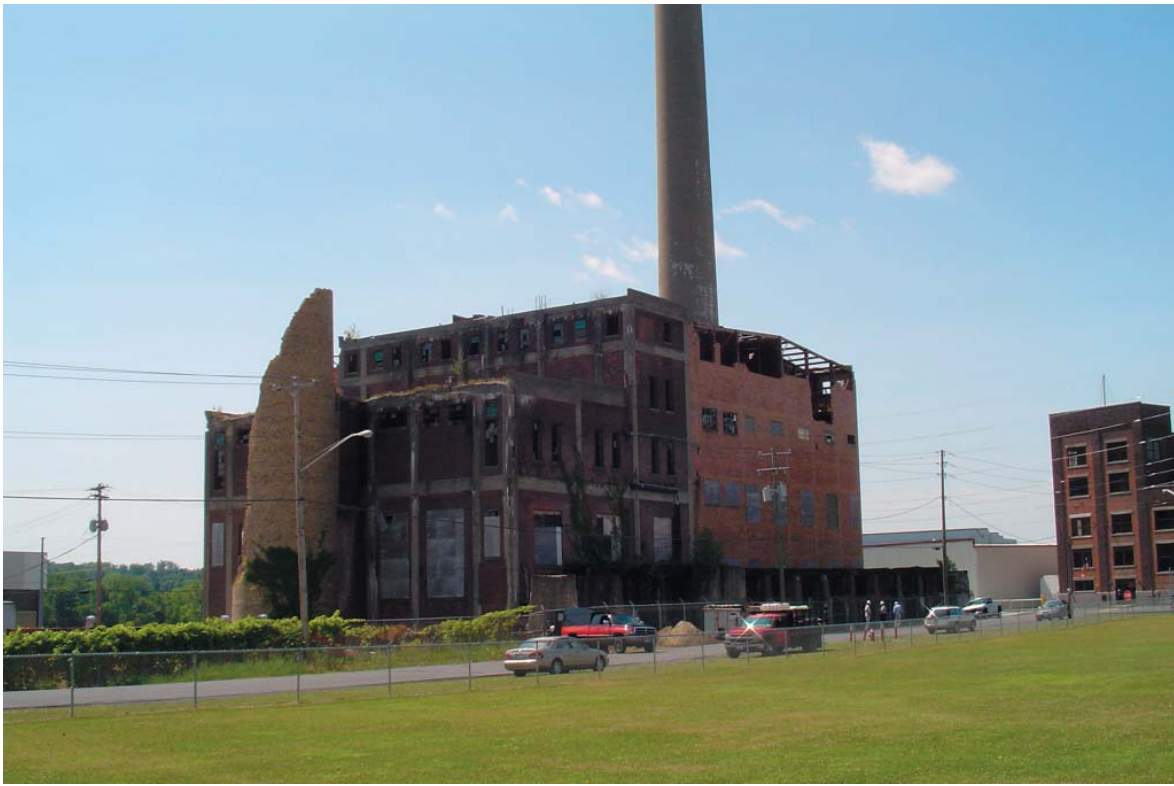
**Photo 3**

2004 photograph of the boiler house facing southeast from Riverside Park.

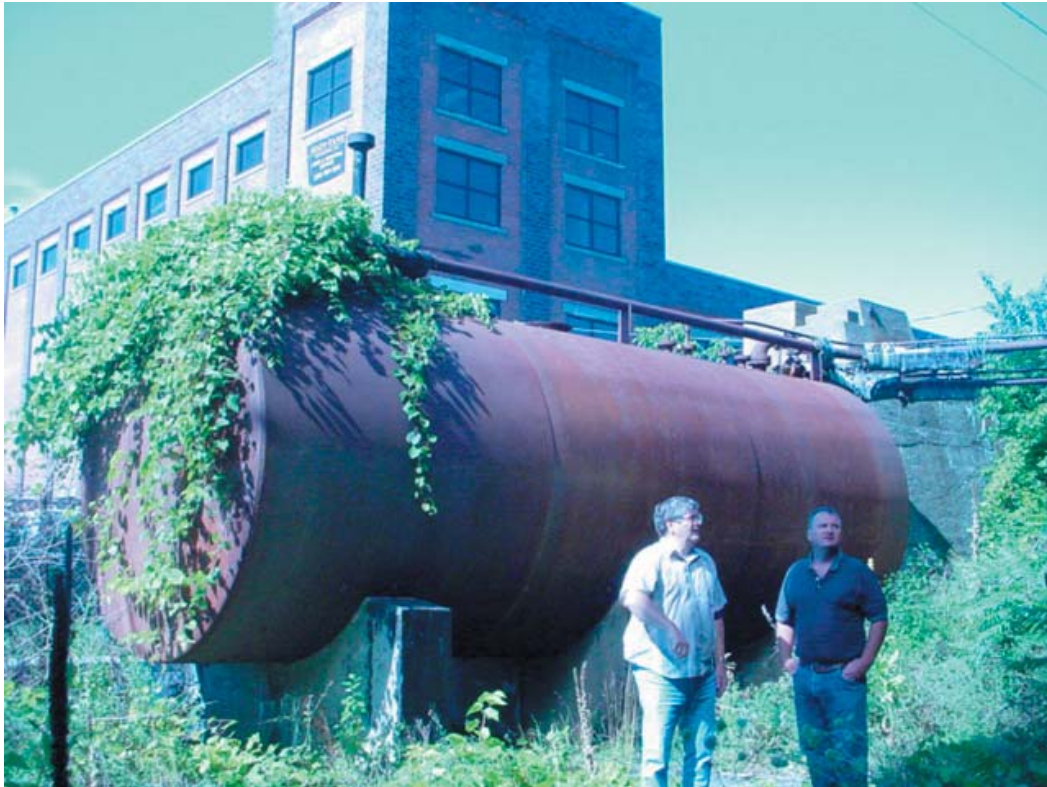
**Photo 4**

2002 photograph of the 16,000-gal AST on the south side of the boiler house

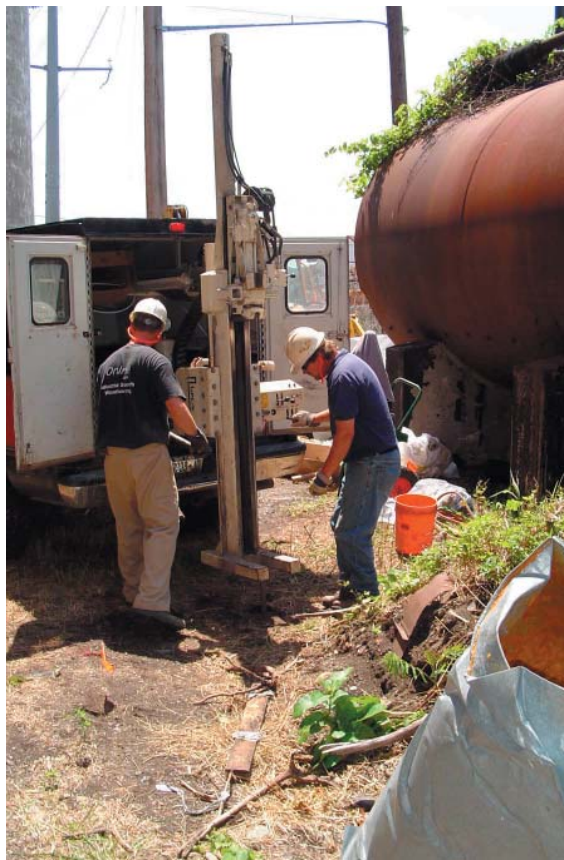
**Photo 5**

2004 photograph of the subsurface soil investigation near the 16,000-gal. AST on the south side of the boiler house.

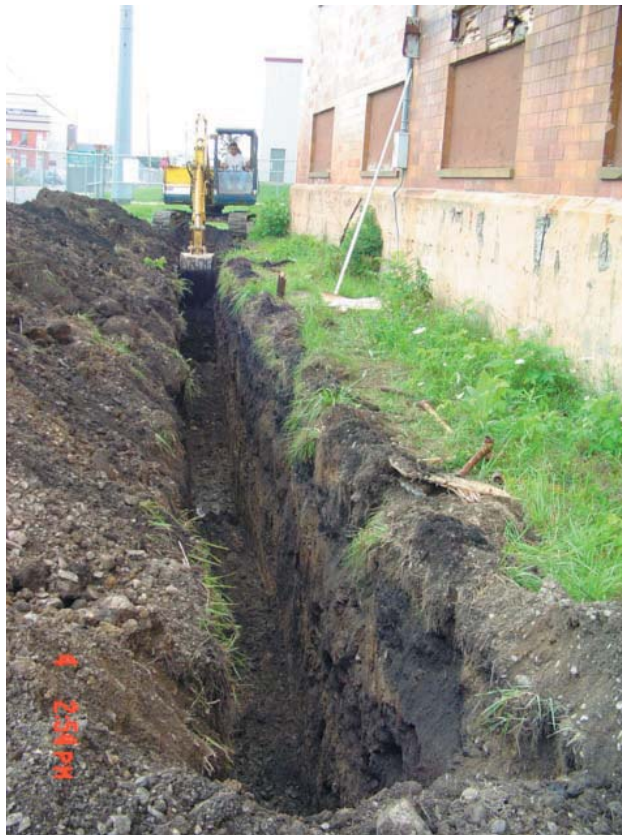
**Photo 6**

A three-inch steel pipe was encountered at approximately three feet below the ground surface in TP-7 along the eastern side of the site building. Petroleum was noted within and beneath this pipe and petroleum odors were noted. The NYSDEC was contacted and this petroleum release was assigned to the existing site spill record (NYSDEC Spill No. 0445021).

2004 photograph of the test pit investigation. This test pit is parallel to the east side of the boiler house.

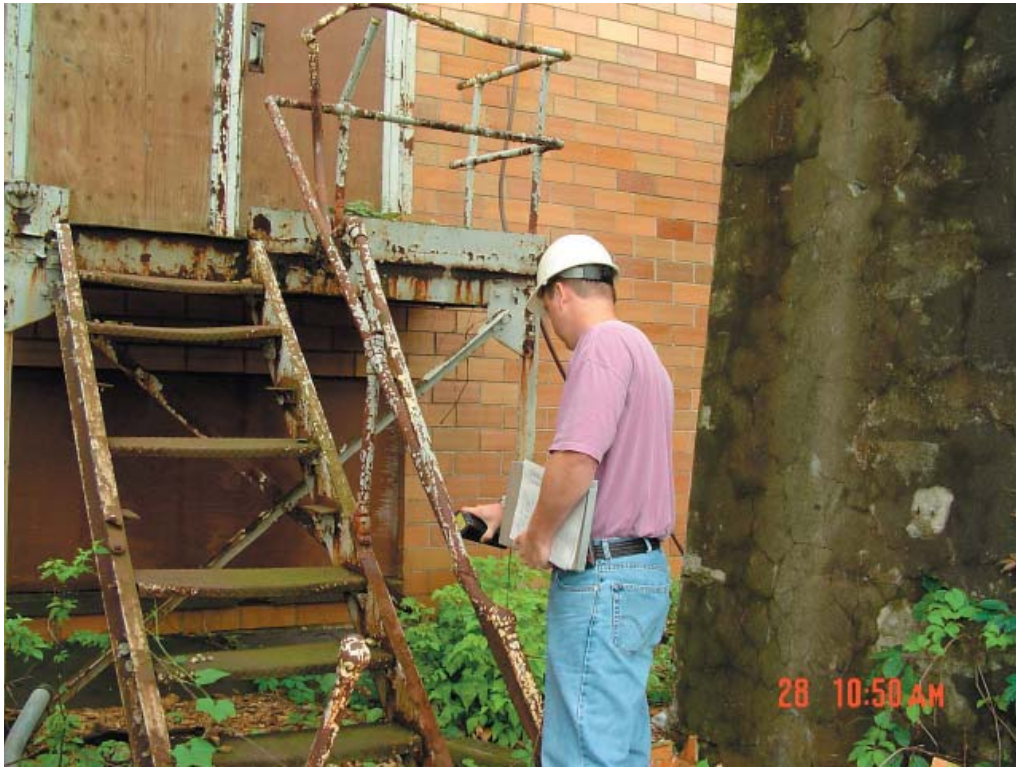
**Photo 7**

Lead-based paint survey completed in 2004.
