From: Jason Stewart <jasons@act.earth>
Sent: Wednesday, February 10, 2021 5:24 PM
To: Dressler, Sarken E (DEC)
Cc: chelseaf@act.earth; Paul Stewart; Berninger, Steven G (HEALTH); Engelhardt, Chris A. (DEC)
Subject: Re: 486 Sunrise Highway BCP Site no. C130220 PFAS SRI
Attachments: soil borings (4).pdf

From: Jason Stewart <jasons@act.earth>
Sent: Wednesday, February 10, 2021 1:11 PM
To: Dressler, Sarken E (DEC) <Sarken.Dressler@dec.ny.gov>
Cc: chelseaf@act.earth; Paul Stewart <pauls@act.earth>
Subject: 486 Sunrise Highway BCP Site no. C130220 PFAS SRI

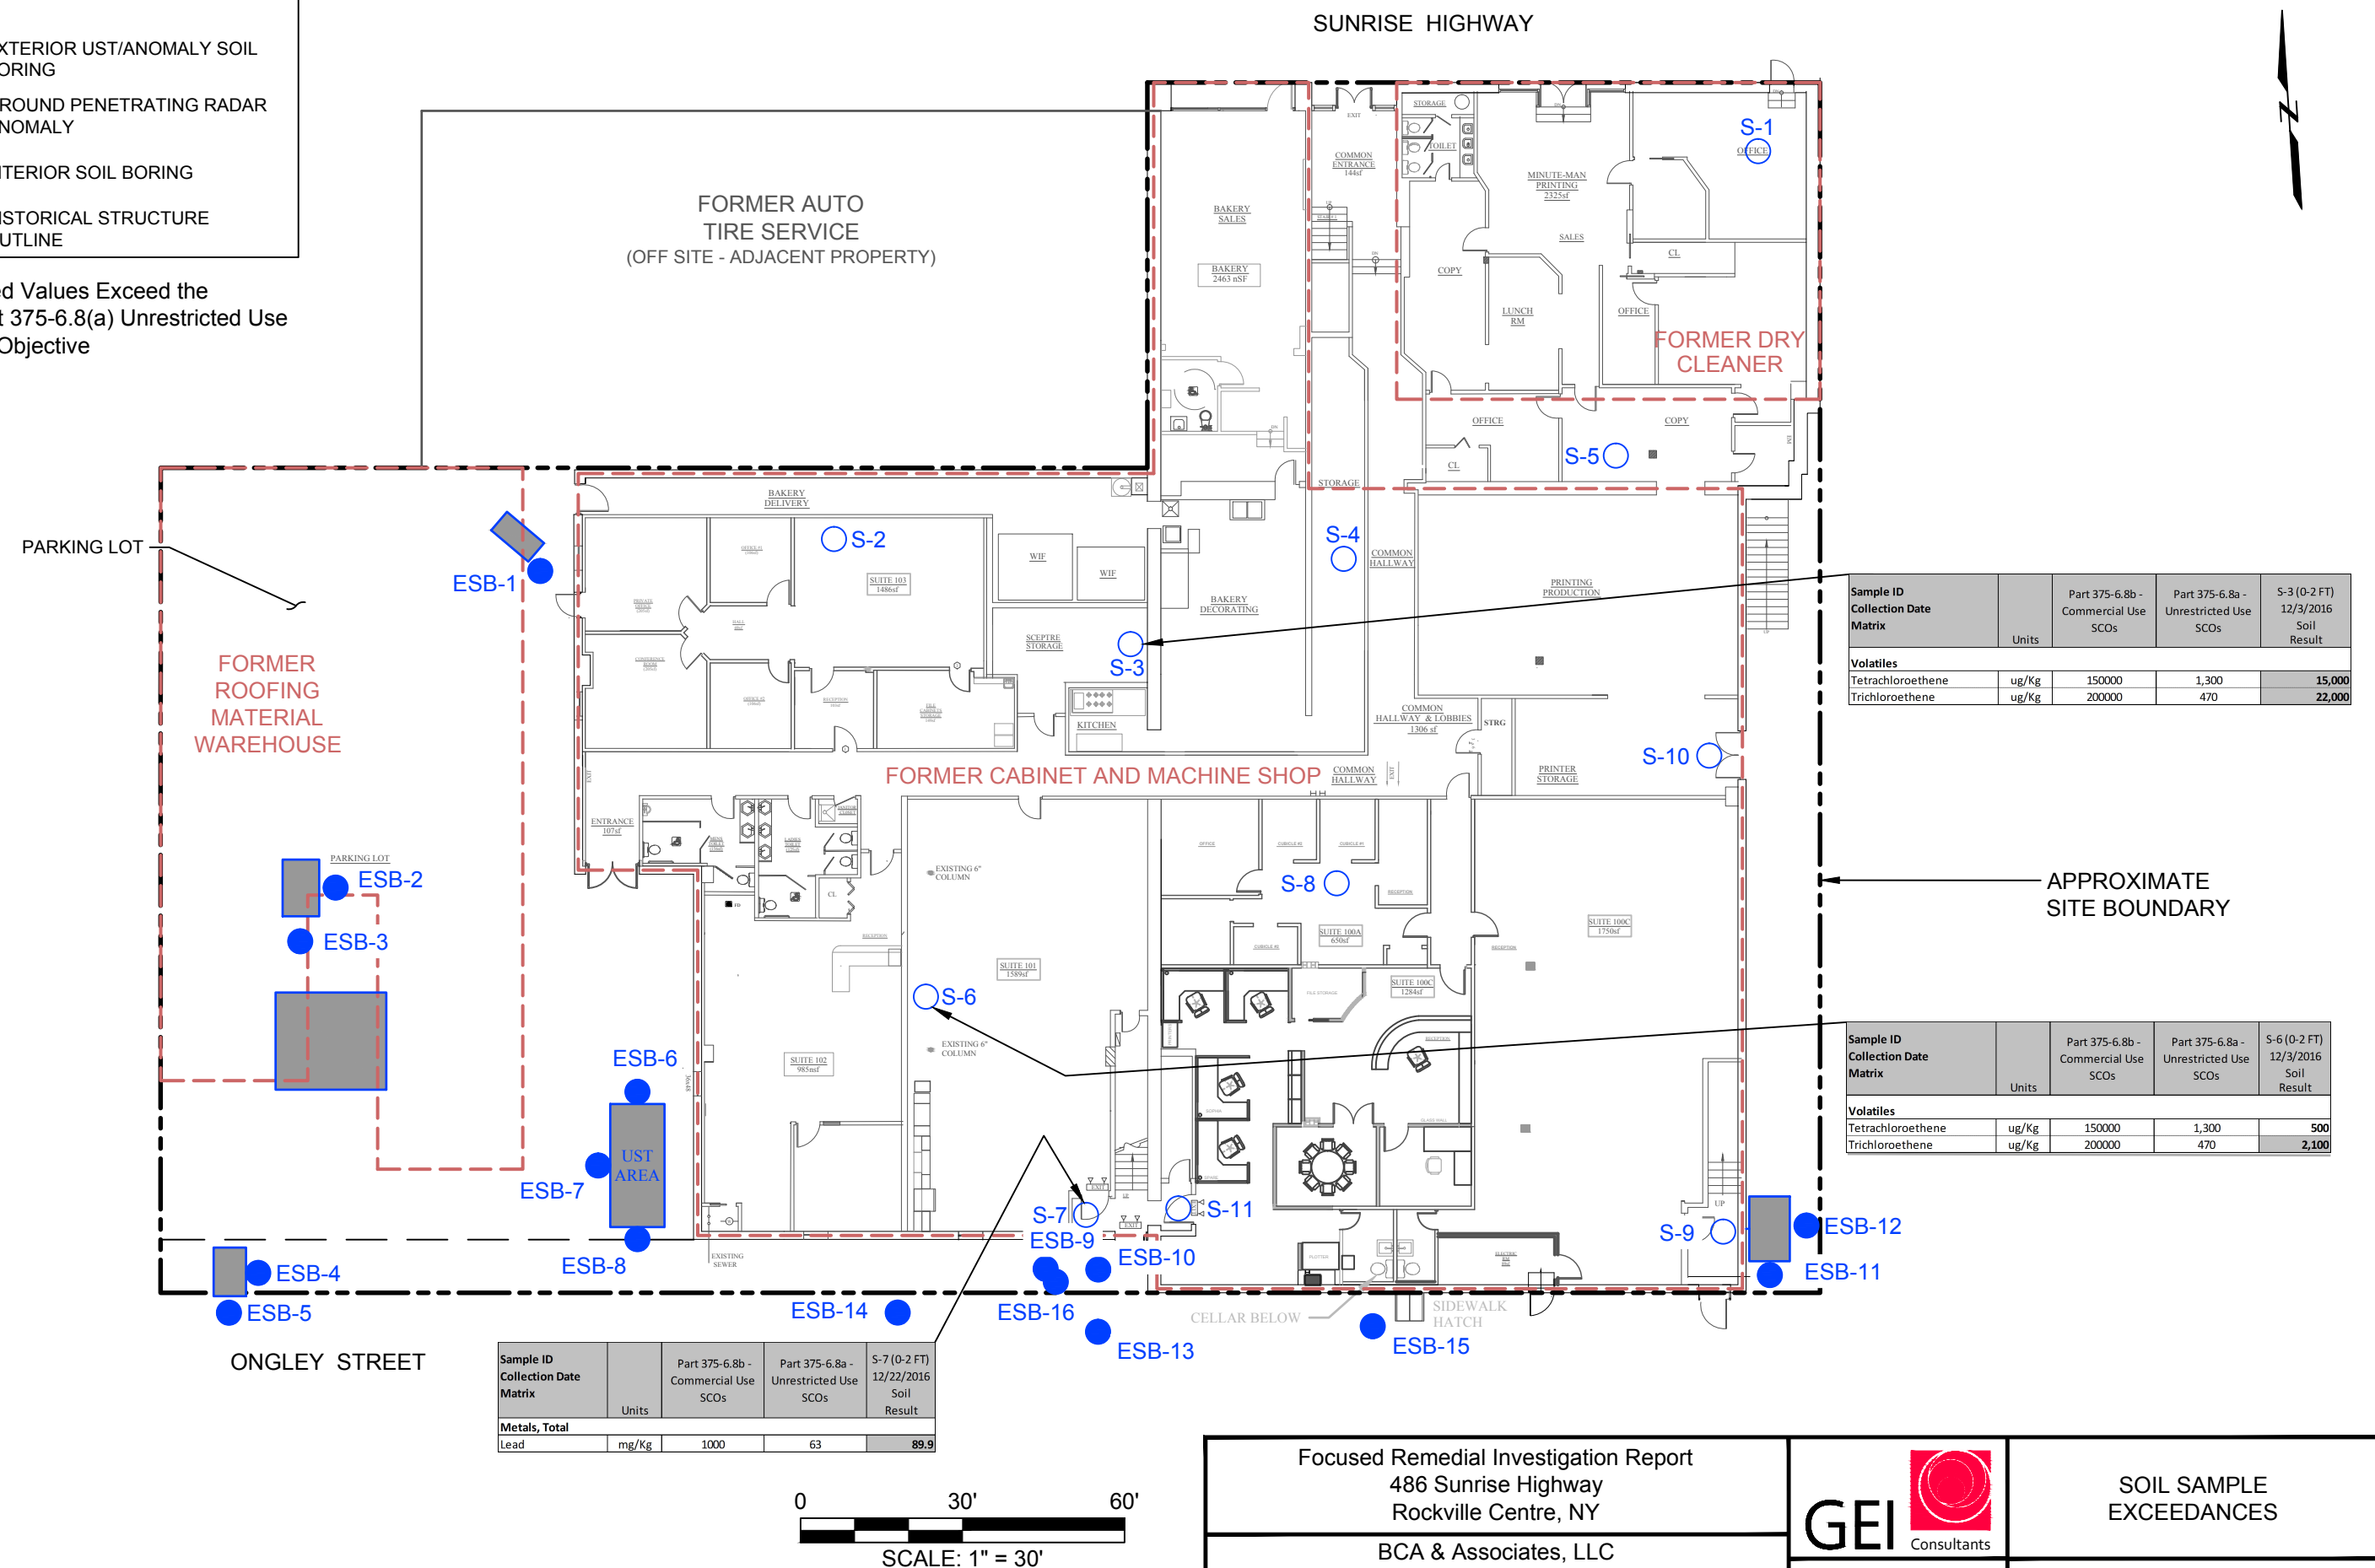
NOTE: Shaded Values Exceed the
NYSDEC Part 375-6.8(a) Unrestricted Use
Soil Cleanup Objective

In summary, during the remedial investigation, GEI only found soil exceedances in the former cabinet and machine shop (see attached figure). No soil exceedances were found in the soil borings around the former drycleaner. No exceedances for chlorinated VOCs in groundwater were found onsite. In our PFAS investigation, all monitoring wells sampled for PFAS except for PW-2S had concentrations of PFOA and PFOS between 5.4 to 38.9 ppt. This is seen as background at the property because it is seen both upgradient and downgradient to the site. However, PW-2S had a concentration of 116 ppt of PFOS. PW-2S is hydraulically downgradient to the location with TCE and PCE exceedances for soil, which is also the location of the highest soil vapor concentrations for TCE and PCE.

We are proposing to install a soil boring and permanent monitoring well around the former temporary well TW-2 and soil boring S-3 to determine if the soil at the location with PCE and TCE exceedances is contributing to the higher levels of PFOS seen at PW-2S. We will sample for PFAS at 0-2' below the concrete slab and at the groundwater interface. In addition, we will sample for VOC in 2' increments to vertically delineate the VOC concentrations at that location. We will also resurvey the monitoring wells to determine an accurate groundwater flow diagram for the site.
