### PREFERRED ENVIRONMENTAL SERVICES

Re: Limited Phase II Site Assessment
B.H. Aircraft Company Inc. Facility
441 Eastern Parkway, Farmingdale, New York
(SCTM NO. 100-46-01-20)

#### LIMITED PHASE II SITE INVESTIGATION - AUGUST 2002

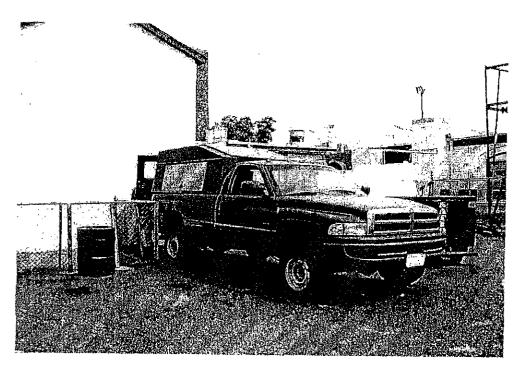
Photograph No. 3 - Sampling of groundwater directly downgradient of the former Plating Building.

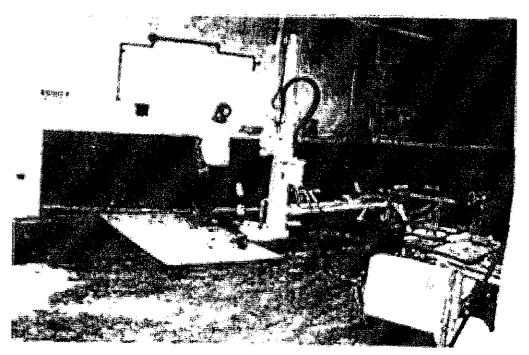
Photograph No. 4 - Sampling of soils directly adjoining the former vapor degreaser area in main building.

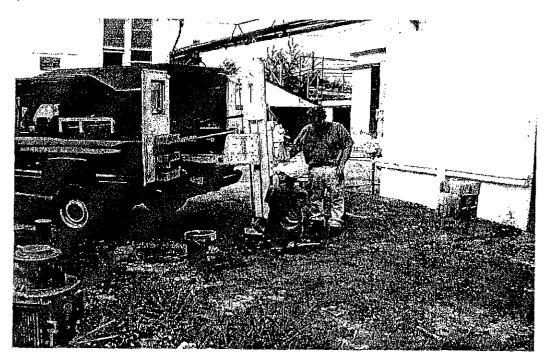
Photograph No. 6 - Sampling of groundwater directly downgradient of the former wash room and boiler room.

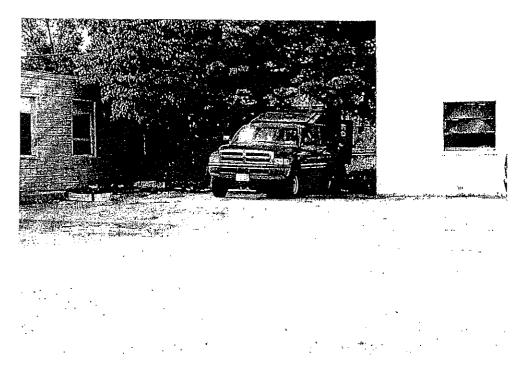
Photograph No. 7 - Sampling of soils directly underlying the footprint of the former zyglo sludge tank.

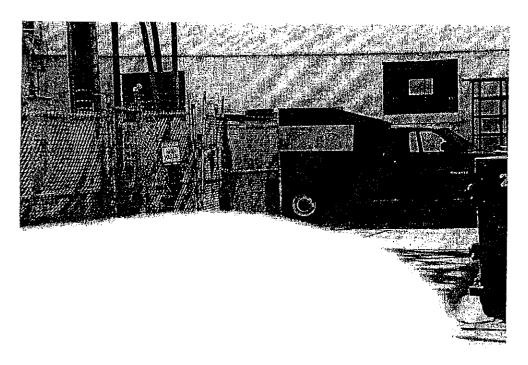
Photograph No. 9 - Sampling of groundwater downgradient of the transformer area.

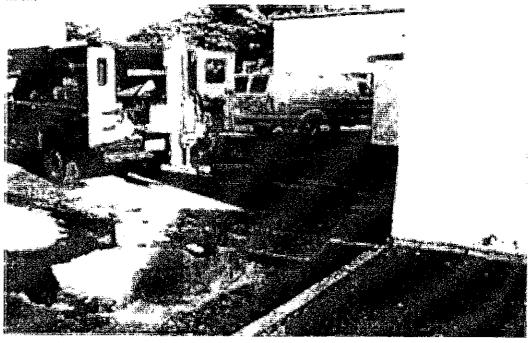
Photograph No. 10 - Sampling of soils in the footprint of the former gasoline tank.
