EVALUATION OF SPECIFIC BUILDING CONCERNS
REGARDING SOIL VAPOR TRANSPORT
LOCATED AT 327 & 329 MAIN STREET
HUNTINGTON, NEW YORK

ON-SITE VISITS CONDUCTED NOVEMBER 14, 2011

SUBJECT: Report Regarding Forensic Evaluation
Mitigation of Pathways of VOC's from Carillon Cleaners
into an Adjoining Restaurant
Location: 327 & 329 Main Street
Huntington, New York

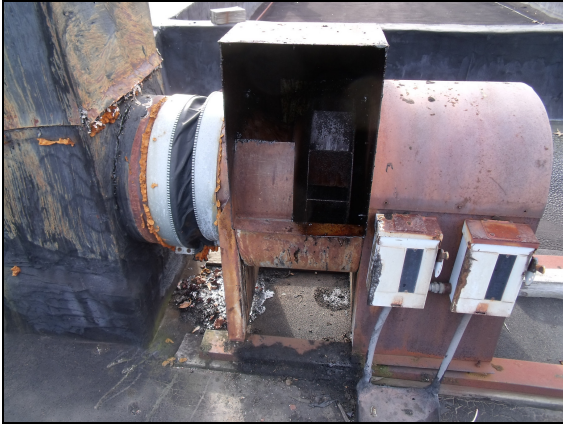
2.1.1 Restaurant Establishment Observations: By observation, there is a rooftop heating and cooling unit with no indication of outside air introduction. There is an atmospherically vented, gas hot water heater located in the basement. There is also a kitchen exhaust hood and a wall mounted exhaust fan (see Photos, Appendix A). It is very unclear as to whether there is any planned make-up air supplied for the exhausts. There is a rather clogged hood on the roof in the vicinity of the exhaust that may have been, or could still be, intended for make-up air intake from the roof (see Photo #3, Appendix A). Evaluation of the suspect make-up air hoods function is beyond our scope.

Photo #1: Restaurant hood exhaust fan.

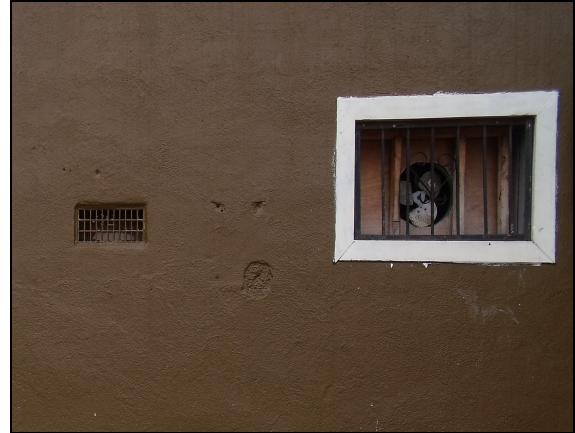
Photo #2: Restaurant wall exhaust fan.

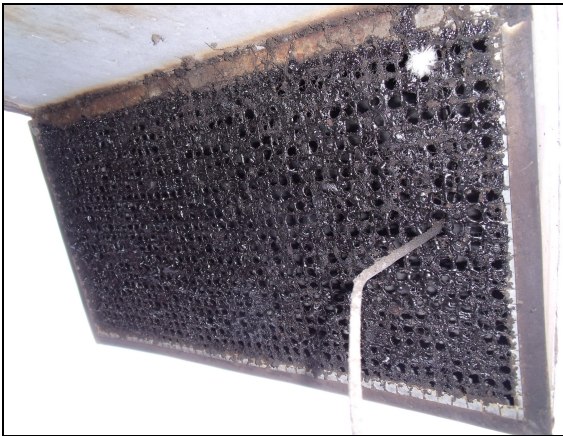
Photo #3: Restaurant rooftop air intake???

If the restaurant has a make-up air system for the kitchen exhaust hood, it should be placed back in service as the negative suction is borderline for violation of typical NFPA guidelines for negative pressures related to kitchens with gas-fired equipment. Additionally, there is an atmospherically vented, hot water heater located in the basement that could be down-drafted by negative building pressures at various times during the year. This approach to provide proper make-up air provisions makes sense; however, equipment will need to be maintained to prevent clogging (see Photo #3, Appendix A). Design of such a system, or review of a design, is not part of our scope.

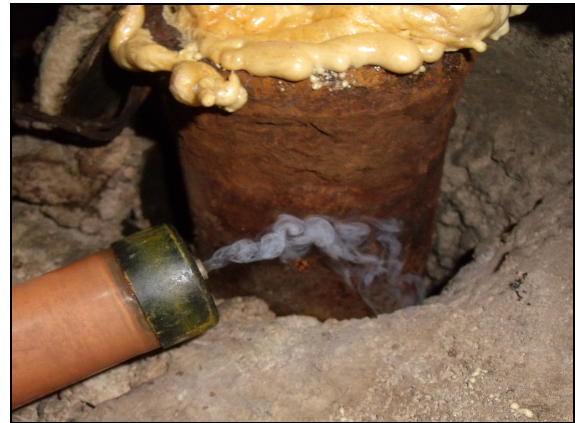
Finding: Under exhaust fan operating conditions, the negative pressures were confirmed (with chemical smoke) to move air from the dry cleaning establishment

into the restaurant via air leakage sites in the parting wall (see Photo #4, Appendix A & Sketch, Appendix B).

Photo #4: Air flow into restaurant from dry cleaner basement.

Access to the block wall separating the facility is not readily accomplished; however, the concept of improved air sealing also makes sense. As a minimum, appropriate fire stop materials can be utilized where holes or penetrations can be identified, such as the penetration in the wall in Photos #4 and #9 in Appendix A. Design of such a system, or review of a design, is not part of our scope.

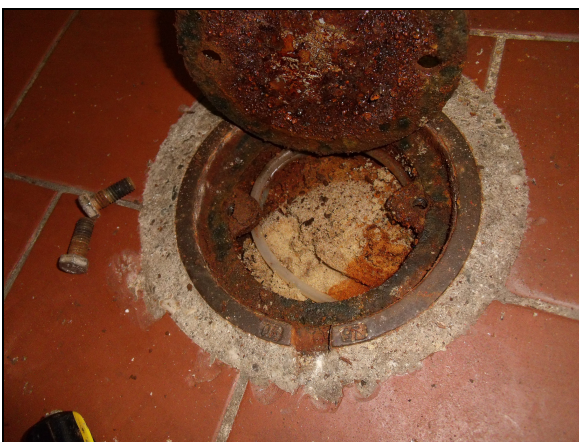
In both of the above noted restaurant exhaust negative pressure fan conditions (-10 and -20 pascals), the current soil vapor extraction system (which is located under the dry cleaning establishment and the basement floor of the restaurant), was observed at the vapor test ports in the basement, to create sufficient suction under the floors, to move room air down into the sub-slab soil even though the restaurant exhaust fans and dry cleaning exhaust fans create negative pressures in the rooms above (Test Port Photo #5, Appendix A).

Finding: The soil vapor extraction system's basement floor suction is not over-powered by the observed negative building pressures created by the restaurant exhaust fans.

Photo #5: Restaurant basement floor test port.

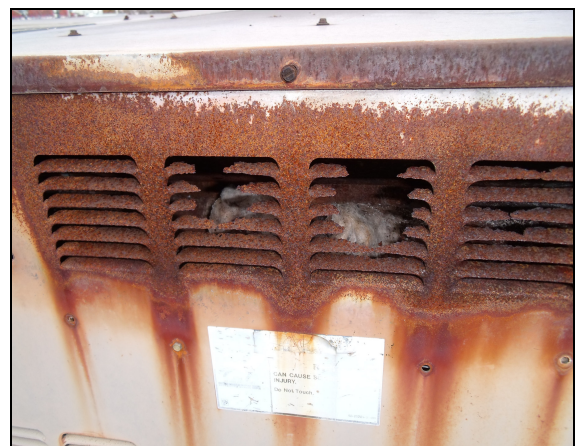
Make-up air is currently provided passively via the abandoned, evaporative, cooling units and via reverse air flow through any exhaust fans when they are not operating, whenever the building is pulled negative via the exhaust fan operation for the dry cleaning establishment (see Photo #6, Appendix A).

Photo #6: Restaurant rooftop heating unit.

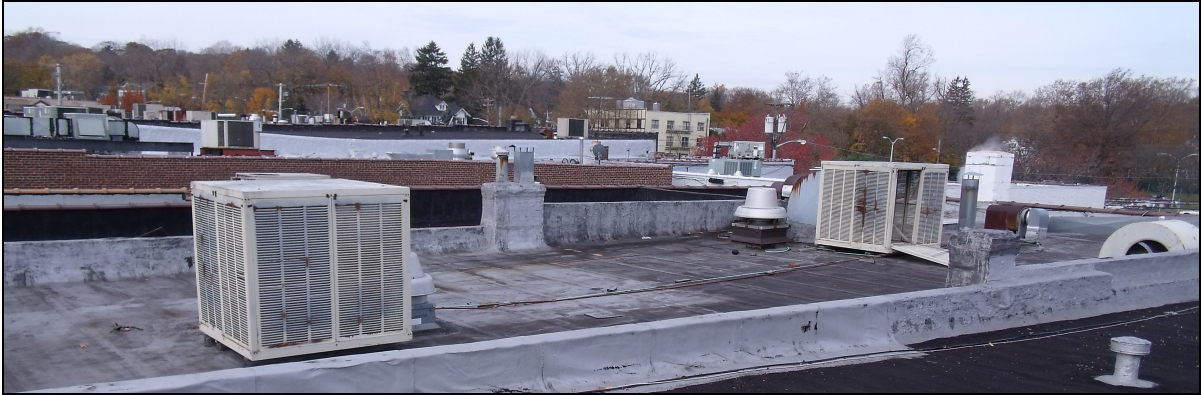
Photo #7: Dry cleaner rooftop equipment.

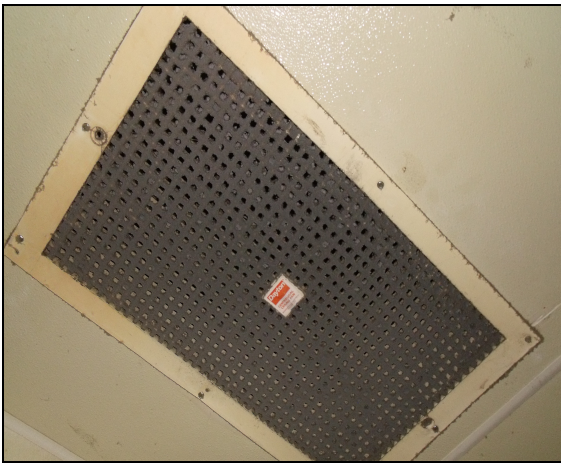
Photo #8: Dry cleaner machine room exhaust.

It is our understanding that the dry cleaning machine isolation area door cannot be kept closed due to overheating and that PCE within the room is associated with the machine operation. Discussions with a representative of the owner included the concept of modifying one of the larger existing exhaust fans located above the containment room, such that it extracts more air and heat from the containment room and at a much higher rate than it is currently exhausted at. This approach makes sense; however, all exhaust fans will need to be maintained to prevent clogging (see Photos #8 and #10). Proper design of such a system, or review of a design, is not part of our scope.

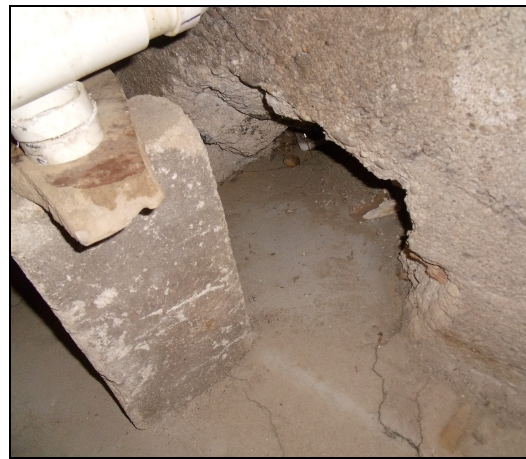
2.1.4 Sub-Slab Pressure Field Extension Observations Under Dry Cleaning Establishment: When testing was conducted with all of the above noted exhaust fan operational conditions for the dry cleaning establishment, the current soil vapor extraction system (which is located under the dry cleaning establishment and restaurant) was observed at both of the test ports. Results indicated that the sub-slab suction was sufficient suction under the floors to move room air down into the sub-slab soil even though the restaurant exhaust fans and dry cleaning exhaust fans create negative pressures in the rooms above. Air movement at a partially filled construction hole in the side wall near the vapor extraction was also confirmed to be in the desired direction, down into the sub-slab (see Photo #9).

Photo #9: Construction hole basement of dry cleaner.

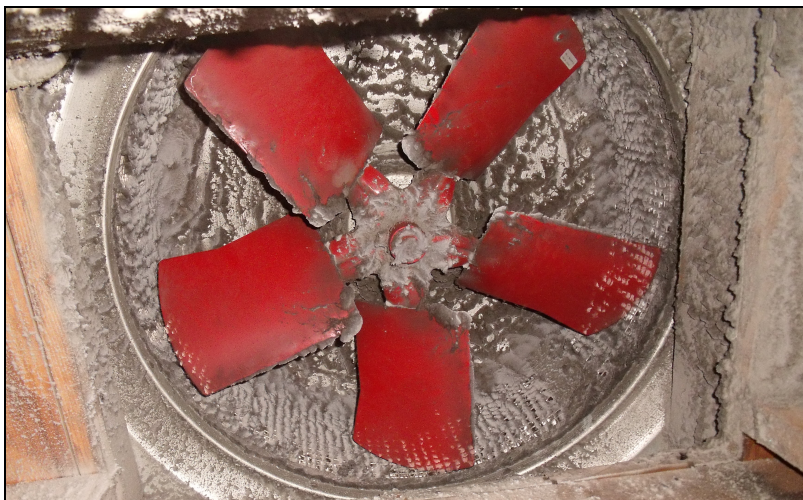
Photo #10: Dry cleaner general exhaust (1 of 4).

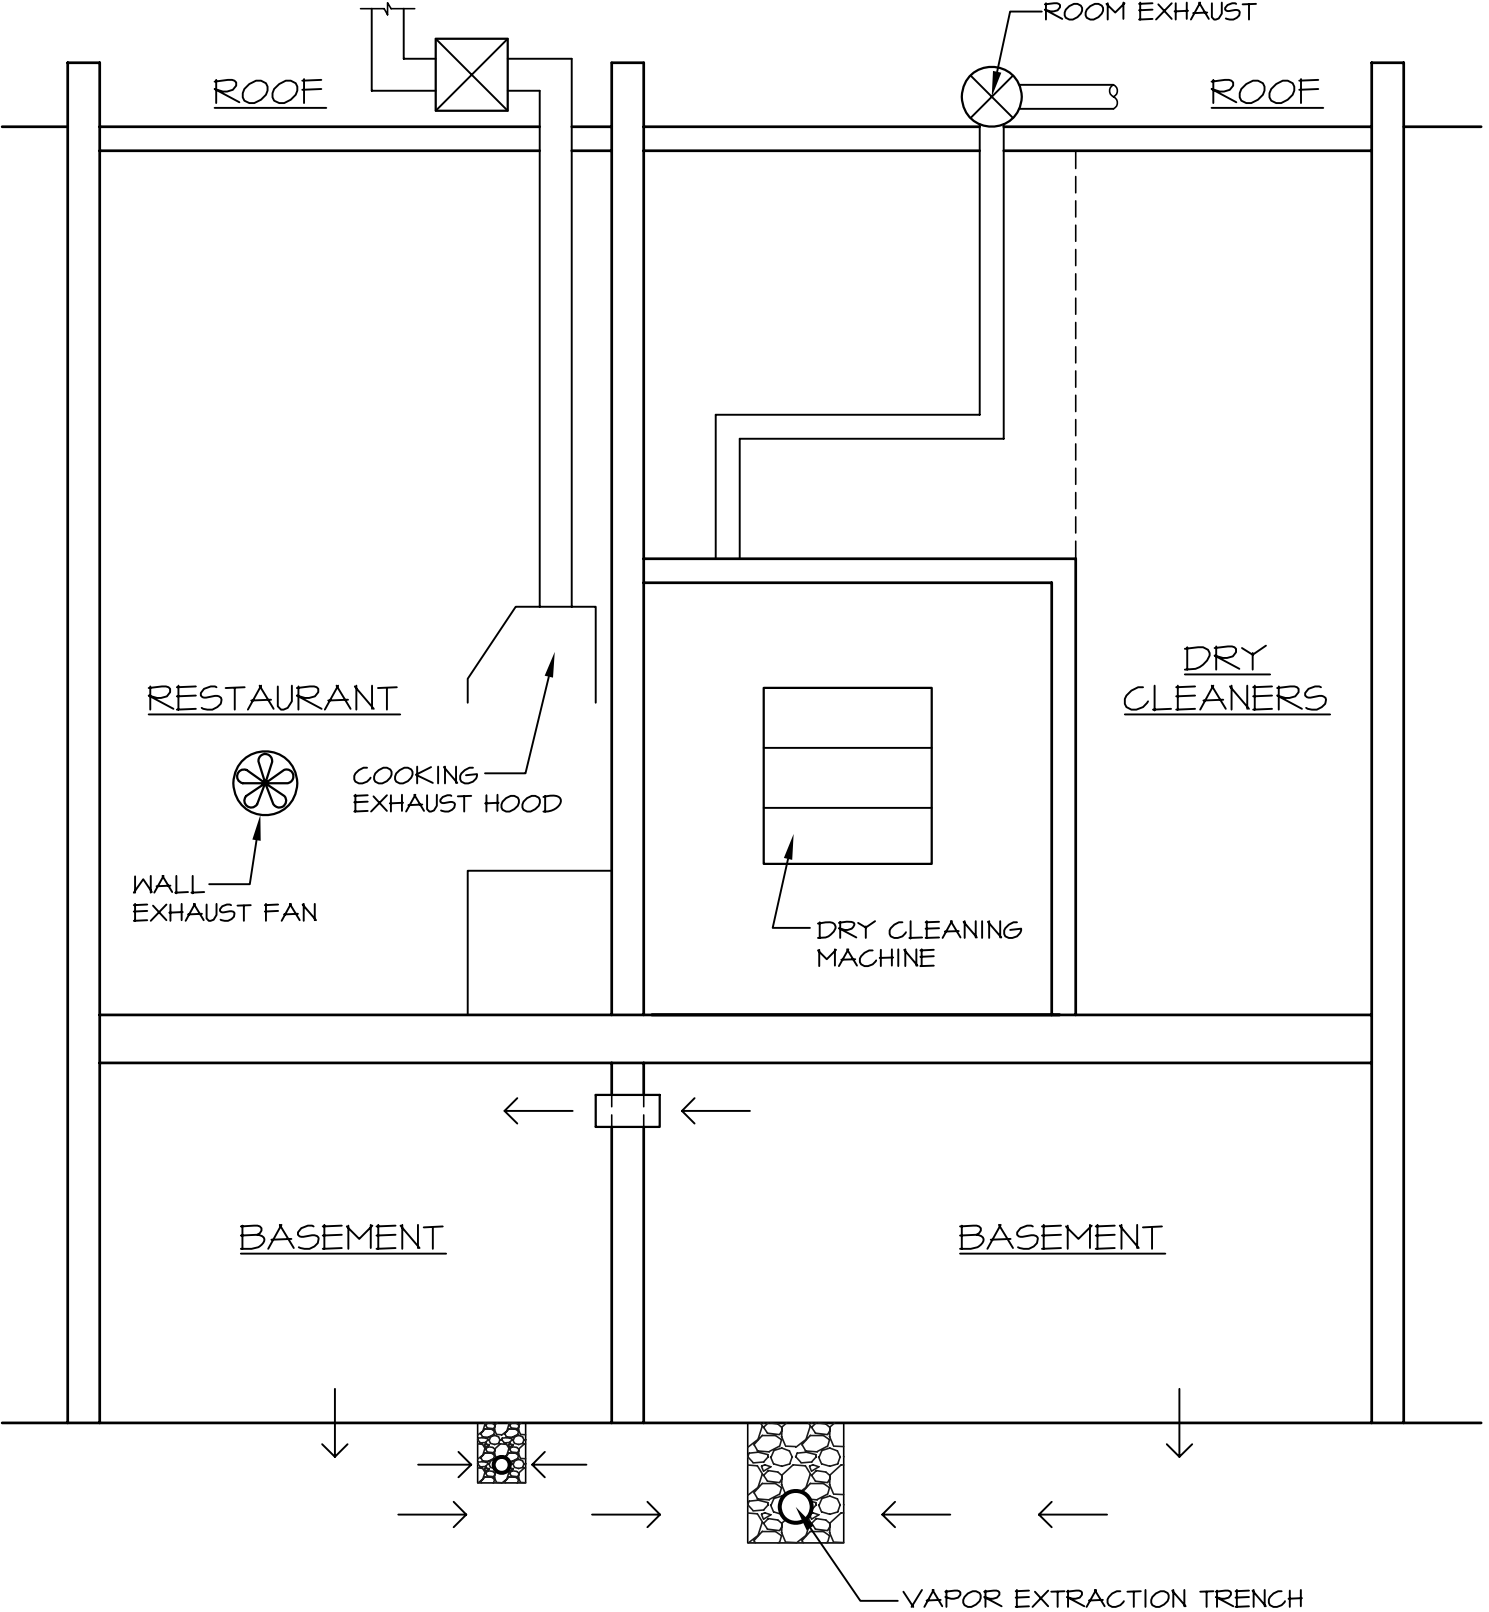
SKETCH OF CROSS SECTION FROM STREET VIEW

Finding #1: High restaurant negative pressures: In the as-found condition, when the restaurant kitchen hood exhaust and wall prop fan exhaust are operated (separately or together) they create sufficient negative pressures in the restaurant to pull air directly from the dry cleaning shop (first floor and basement) through parting wall penetrations into the restaurant. The dry cleaning machine and associated isolation room are directly on the other side of the wall adjacent to the restaurant (see Cross-Sections Sketch, Appendix B).
