# **ANNUAL SITE MANAGEMENT REPORT**

## **Parkview Commons Site**

**436 East 161<sup>st</sup> Street  
Borough of Bronx, New York**

**Brownfield Cleanup Program: C203014**

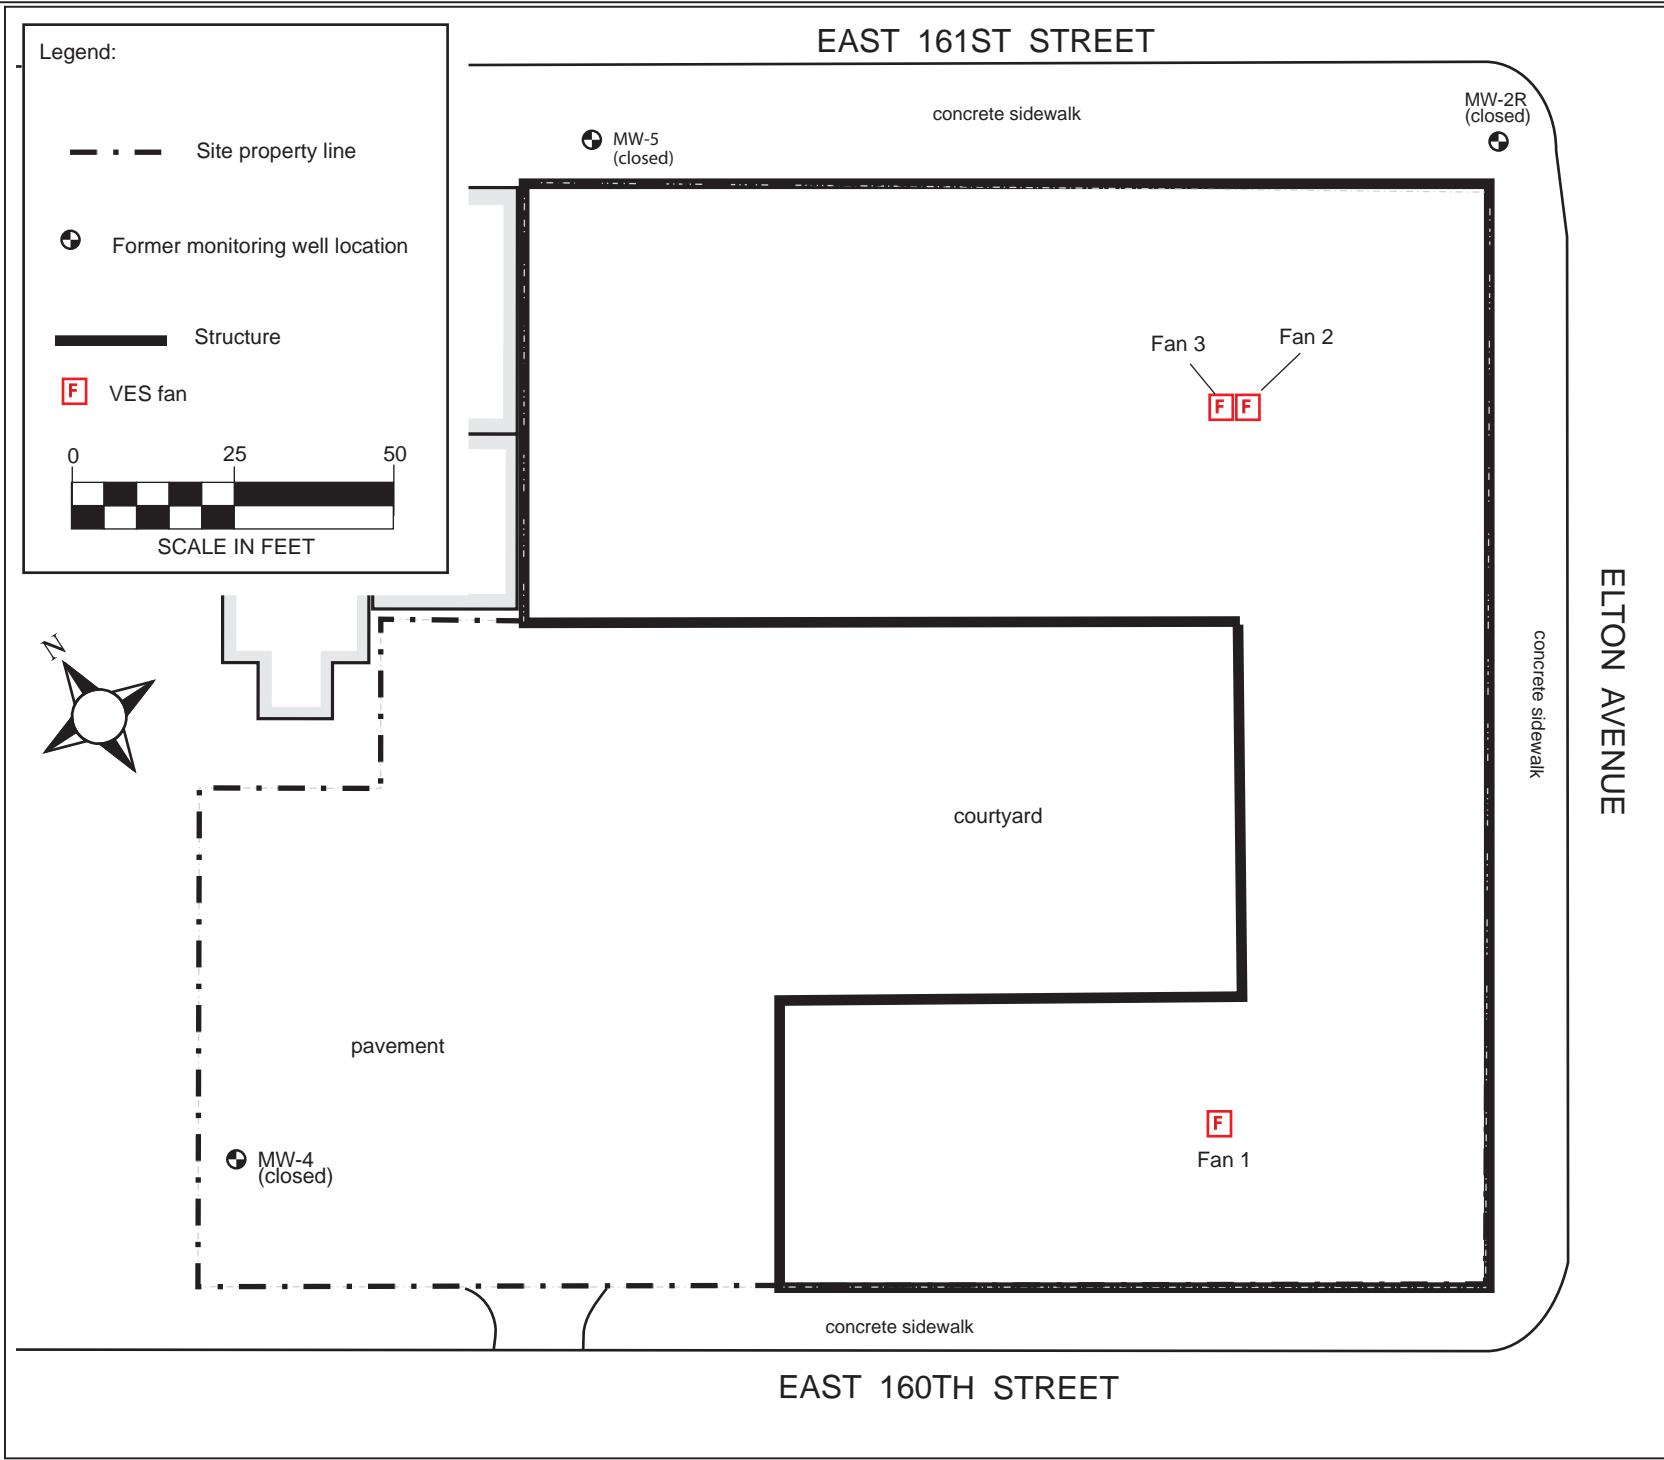
**Figure 2:  
Selected Site  
Features Map**

- Installation of a barrier layer consisting of certified clean soil and pavement. A demarcation layer, consisting of black, porous filter fabric, was installed under the imported soil. The asphalt barrier was installed on the southwest portion of the Site (Figure 2, Appendix A).

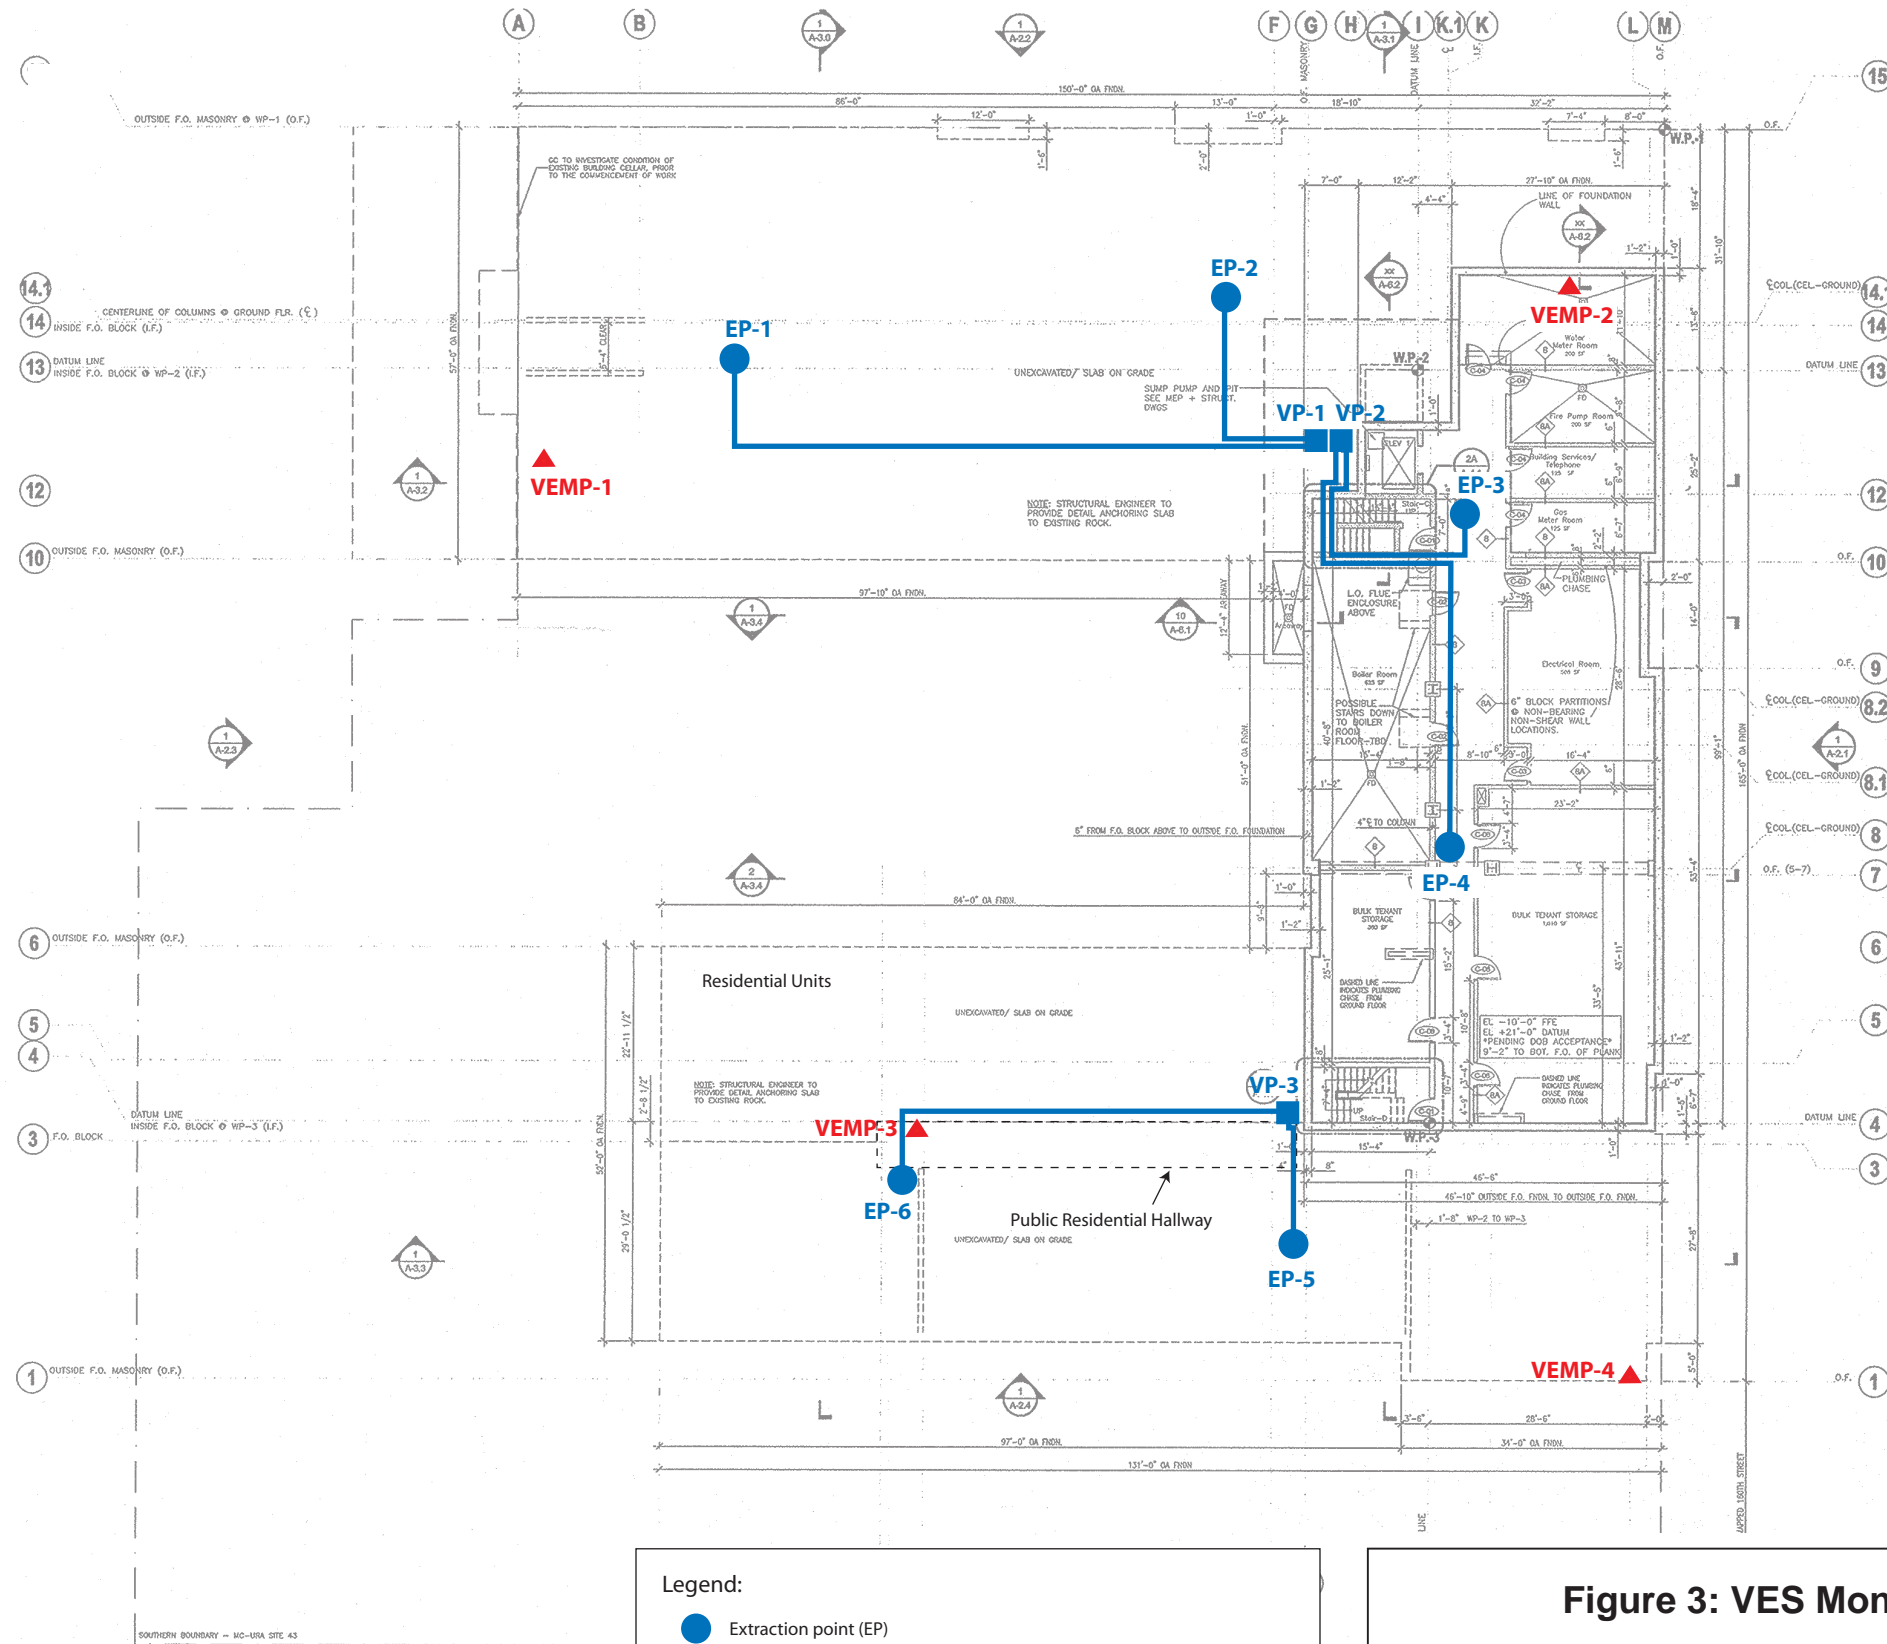
**Figure 3: VES Monitoring Point Locations**

The VES equipment, piping, and fans were visually inspected and no deficiencies were noted. The location of the vapor extraction monitoring points (VEMPs) are provided in Figure 3, Appendix A. All fans were operational at the time of the inspection. The vacuum readings at the four monitoring points were as follows:

- VEMP – 1: -0.016 in w.c.
- VEMP – 2: -0.013 in w.c.
- VEMP – 3: -0.144 in w.c.
- VEMP – 4: -0.025 in w.c.s

The vacuum readings of the U-manometers located at VP-1, VP-2, and VP-3, were recorded as 0.5, 1.0, and 0.5 in w.c.; these data and the VEMPs indicate that the VES is working properly at the Site. The barrier layer was observed to be free from significant damage at the time of the inspection.
