## **ANNUAL SITE MANAGEMENT REPORT (PERIODIC REVIEW REPORT)**

### **Parkview Commons Site**

**871 Elton Avenue**  
*(formerly known as 436 East 161<sup>st</sup> Street)*

**February 2018**

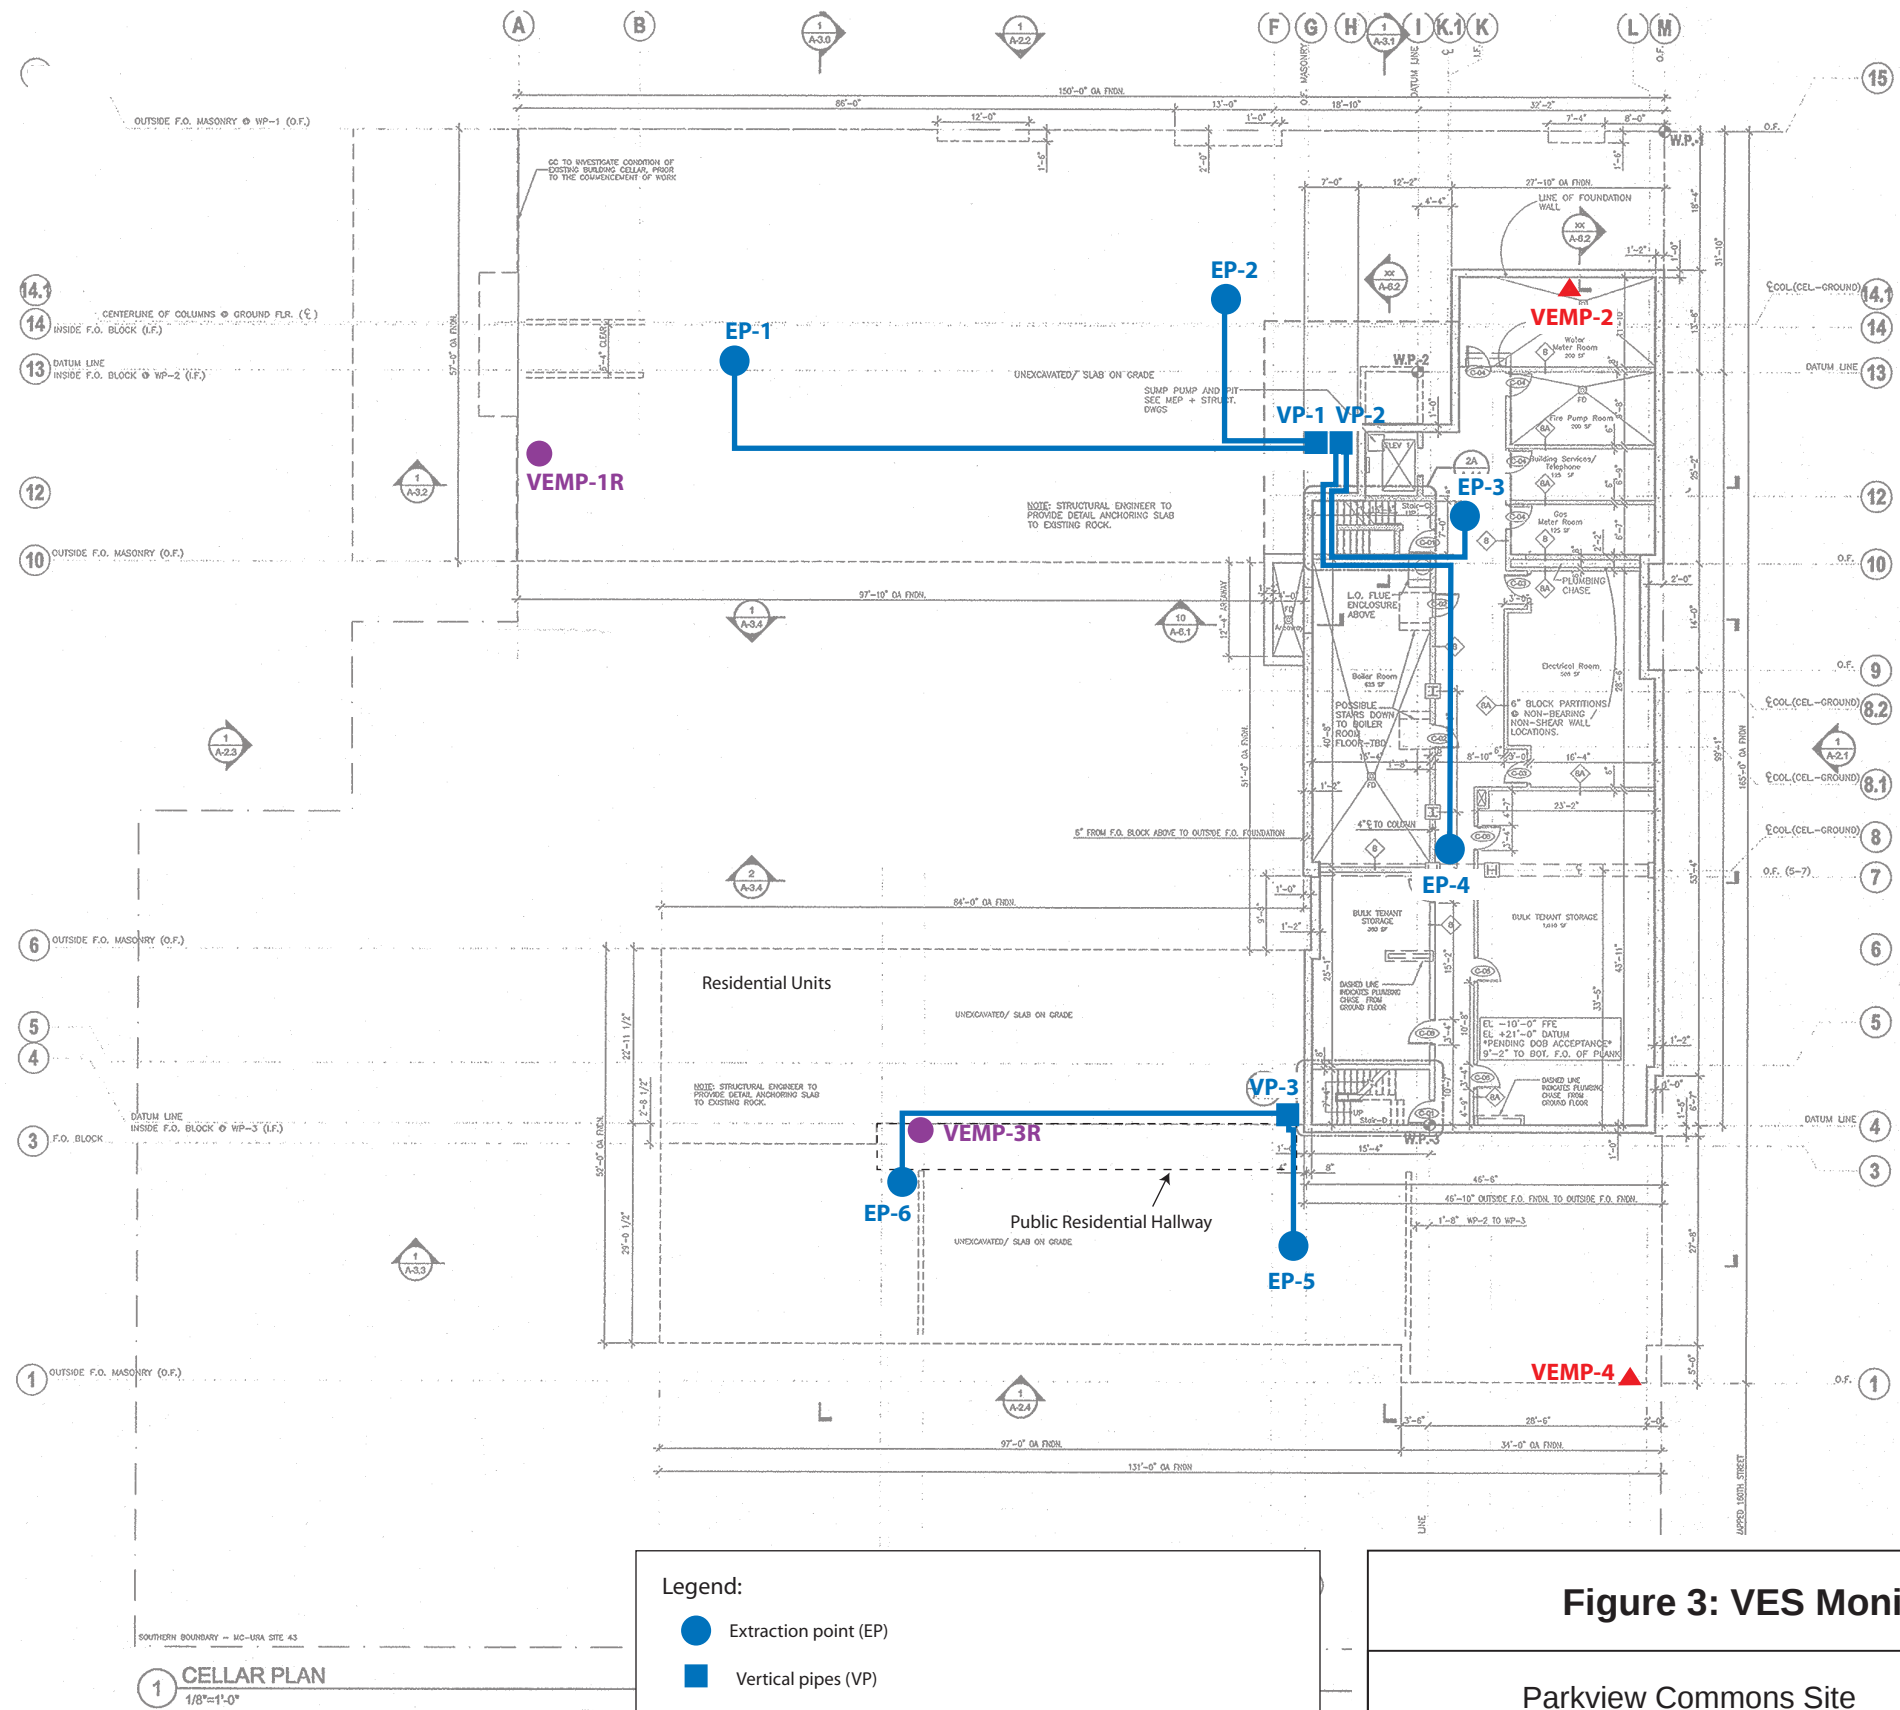
Figure 3: VES Monitoring Point Locations

All fans were operational during the site inspection. Table A (below) reports vacuum measurements collected at vapor extraction monitoring points (VEMPs) during the inspection. Figure 3 in Appendix A depicts the location of the VEMPs.

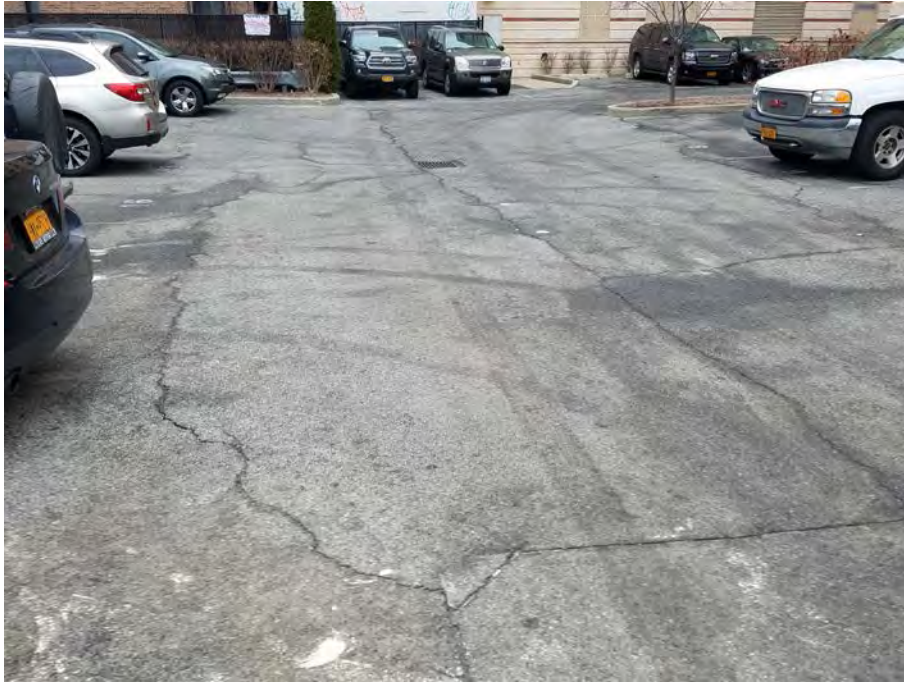
The barrier layer was observed to be free from significant damage during the annual site inspection. Site inspection photographs are presented in Appendix D.

1. Paved parking barrier layer, western portion of Site

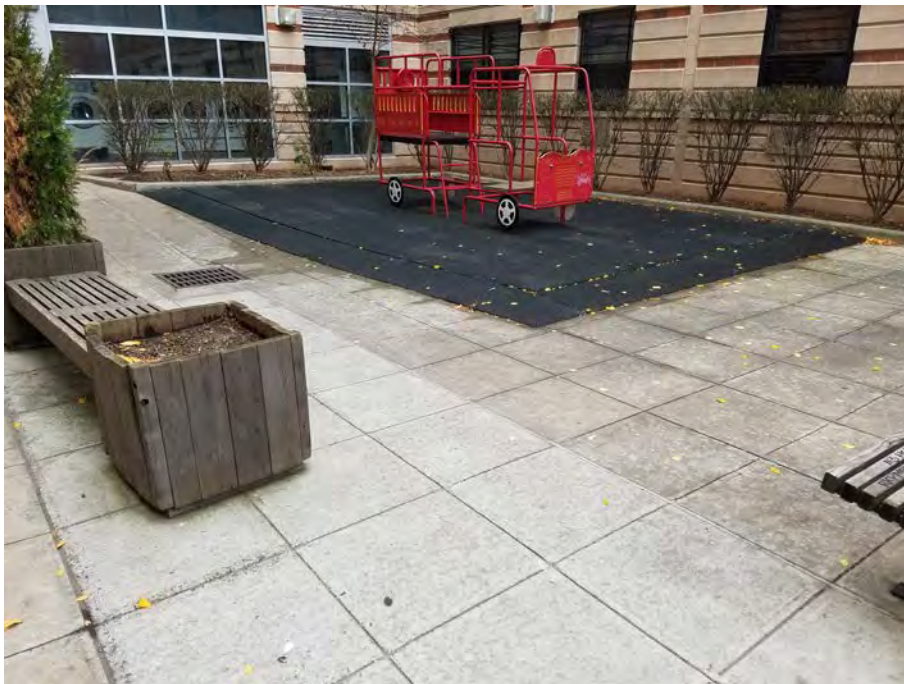
2. Courtyard barrier layer, central portion of Site

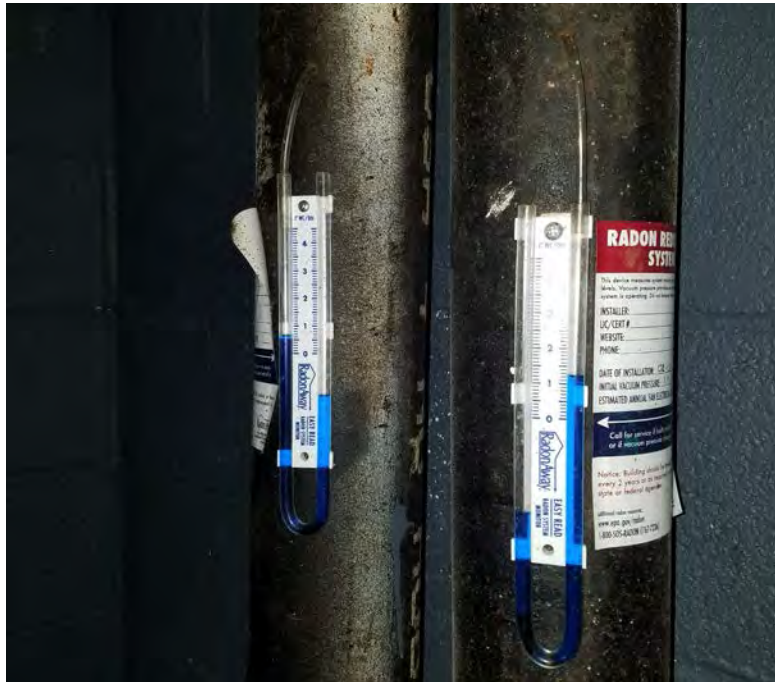
Vacuum readings of the U-manometers located at VP-1, VP-2 and VP-3 were recorded as 0.6 in w.c., 1.2 in w.c. and 2.0 in w.c., respectively. Data from the U-manometers and the VEMPs indicates that the VES is working properly.

3. U-manometer s corresponding to VP-1 (left) and VP-2 (right), both displaying negative pressure readings

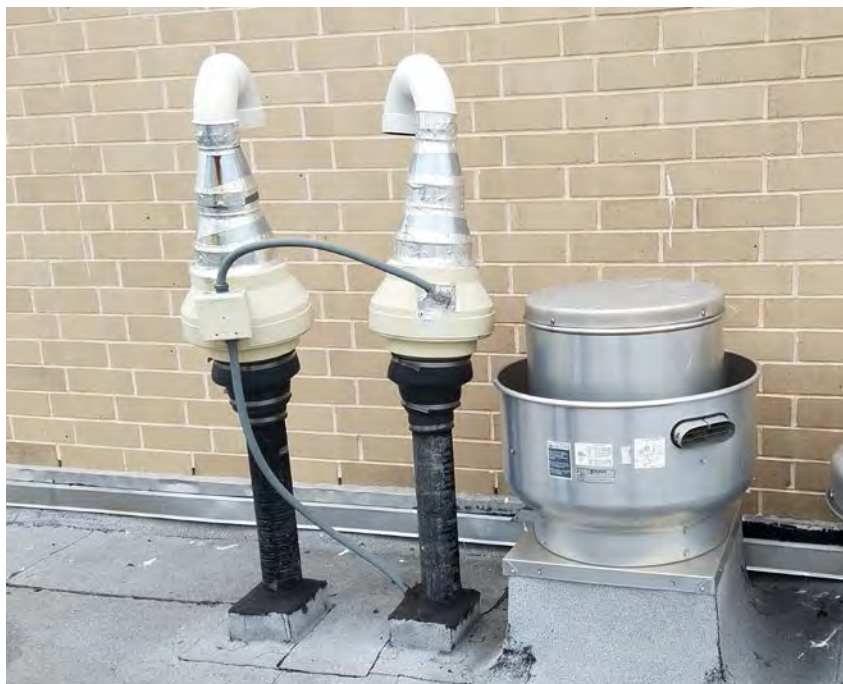
4. VES fan connected to VP-1 and VP-2, located on roof

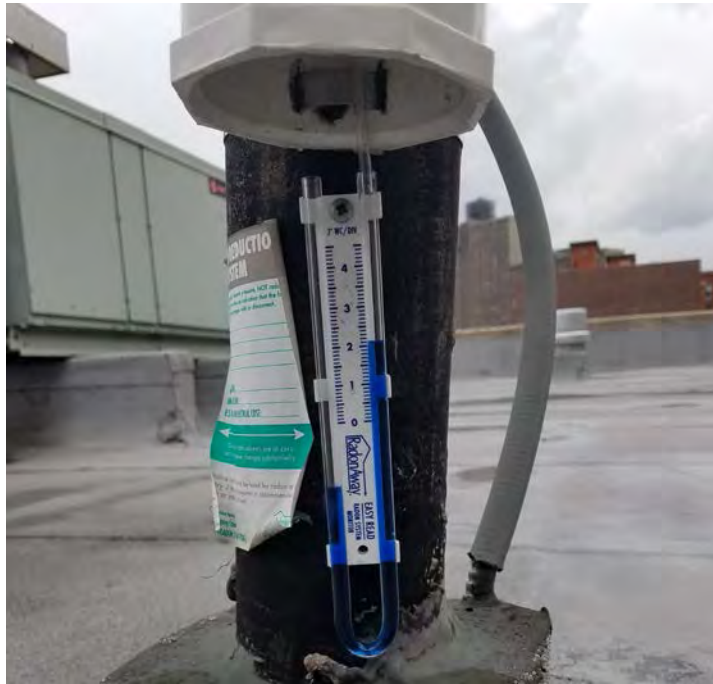
5. U-manometer corresponding to VP-3, displaying a negative pressure reading

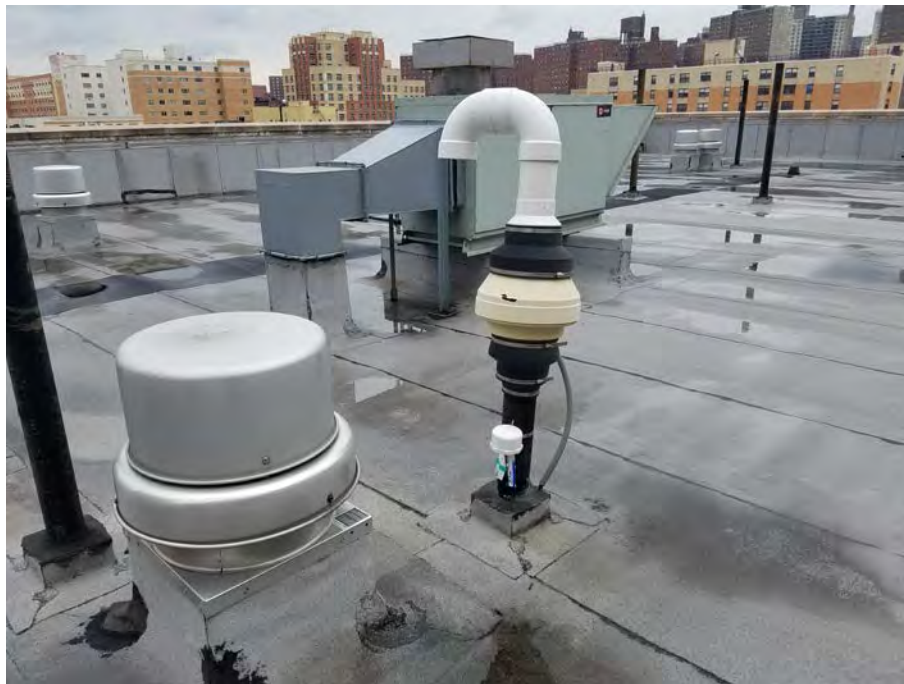
6. VES fan connected to VP-3, located on roof

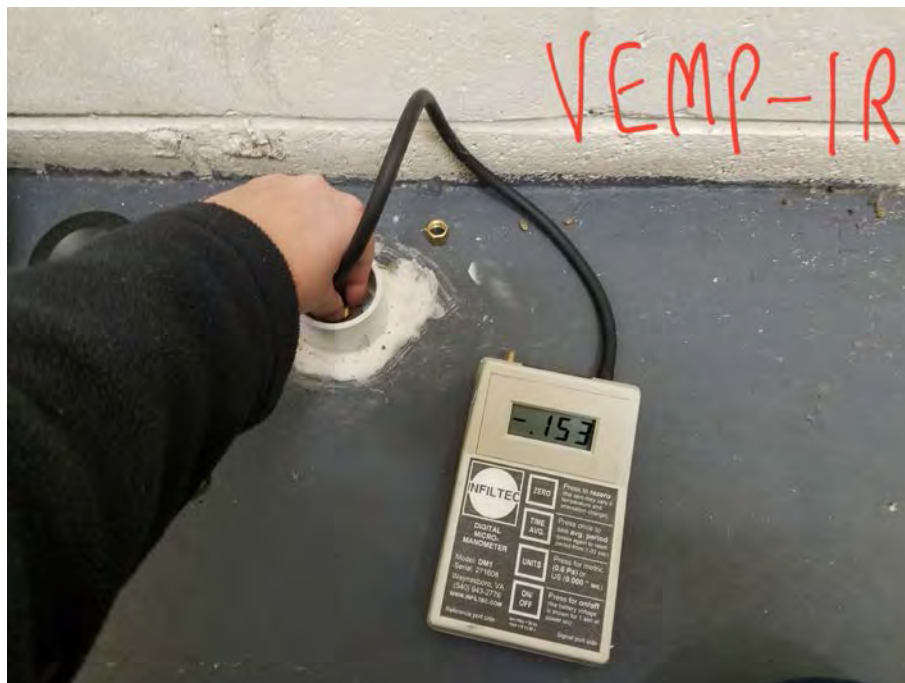
| Monitoring Points (Location in Building) | Vacuum measurement: December 12, 2017 |
|---|---|
| VEMP-1R (northwest) | -0.153 |

7. Negative pressure reading at VEMP-1R (northwestern portion of building)

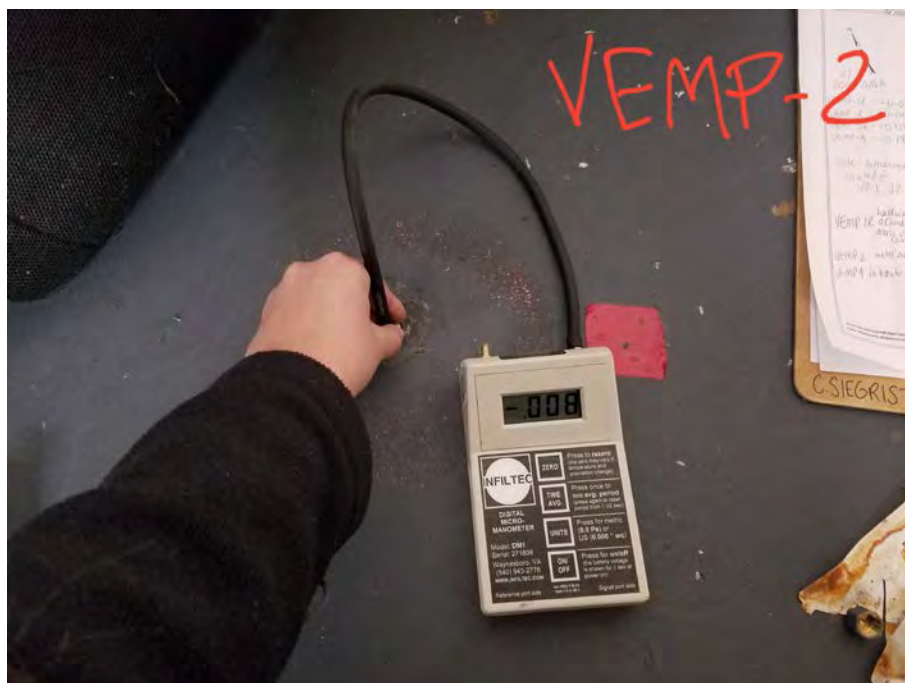
| Monitoring Points (Location in Building) | Vacuum measurement: December 12, 2017 |
|---|---|
| VEMP-2 (northeast) | -0.008 |

8. Negative pressure reading at VEMP-2 (northeastern portion of building)

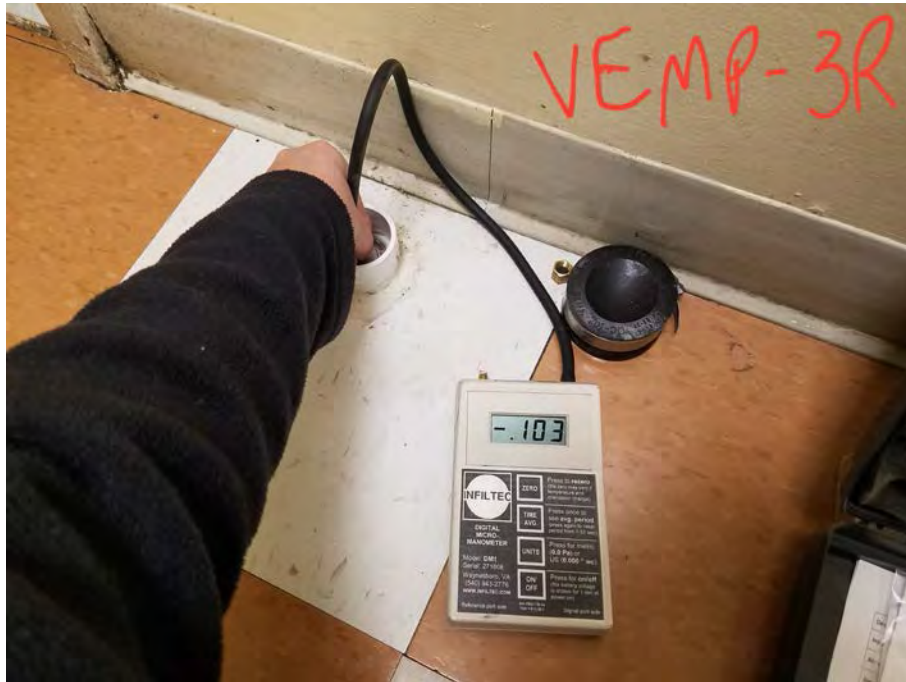
| Monitoring Points (Location in Building) | Vacuum measurement: December 12, 2017 |
|---|---|
| VEMP-3R (southwest) | -0.103 |

9. Negative pressure reading at VEMP-3R (southwestern portion of building)

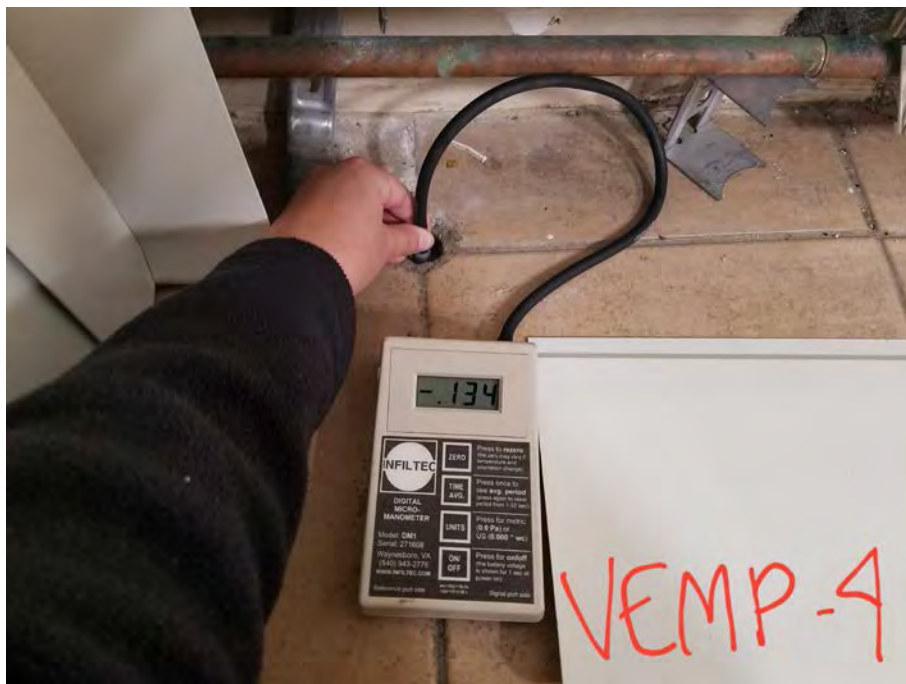
| Monitoring Points (Location in Building) | Vacuum measurement: December 12, 2017 |
|---|---|
| VEMP-4 (southeast) | -0.134 |

10. Negative pressure reading at VEMP-4 (southeastern portion of building)
