PERIODIC REVIEW REPORT

Parkview Commons Site

871 Elton Avenue
(formerly known as 436 East 161st Street)
Borough of Bronx, New York

February 1, 2019

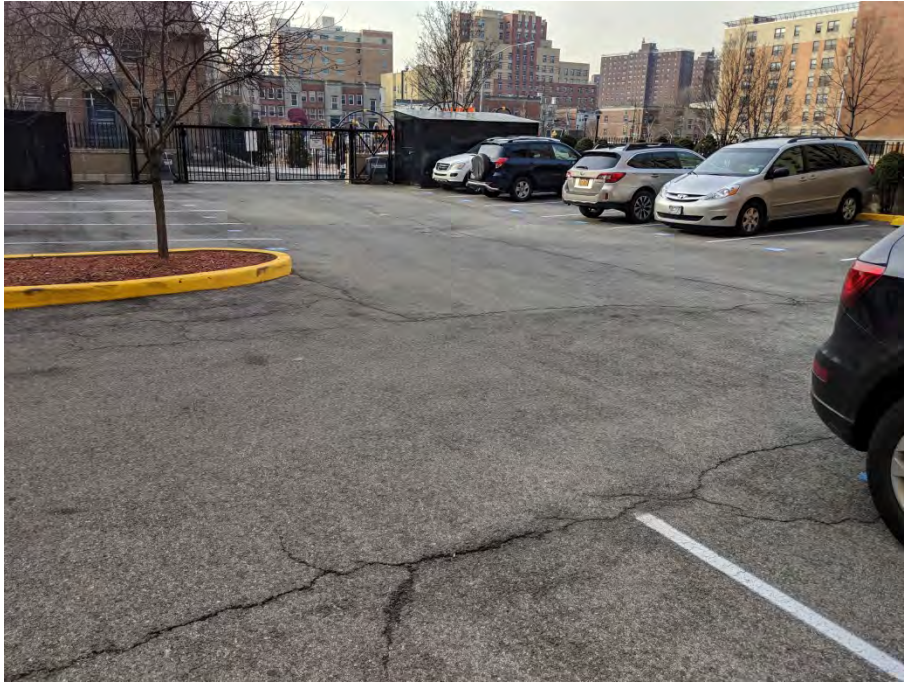
The barrier layer was observed to be free from significant damage during the annual site inspection. Site inspection photographs are presented in Appendix D.

1. Paved parking barrier layer, western portion of Site

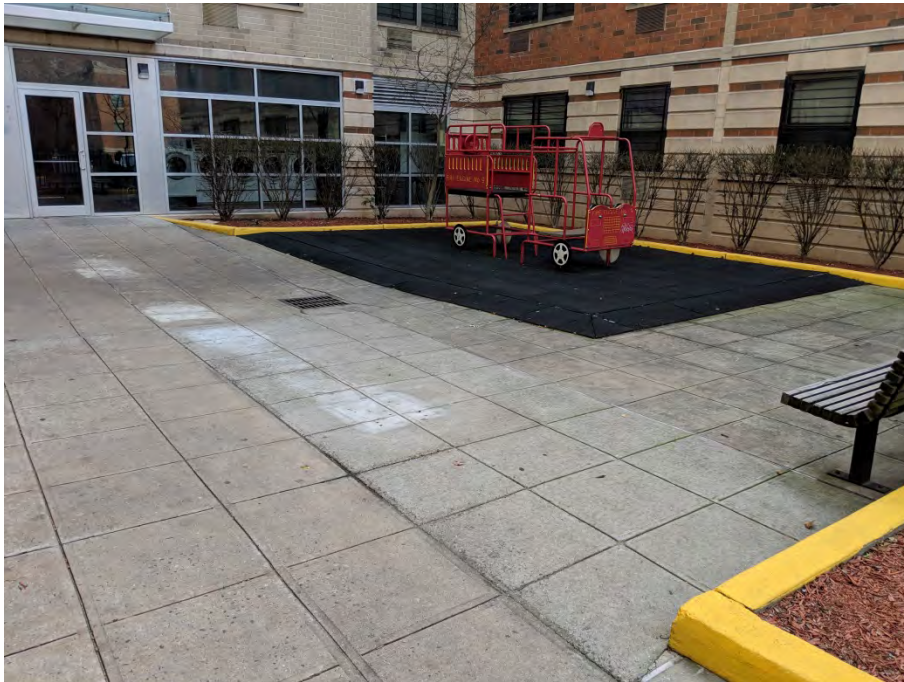
2. Courtyard barrier layer, central portion of Site

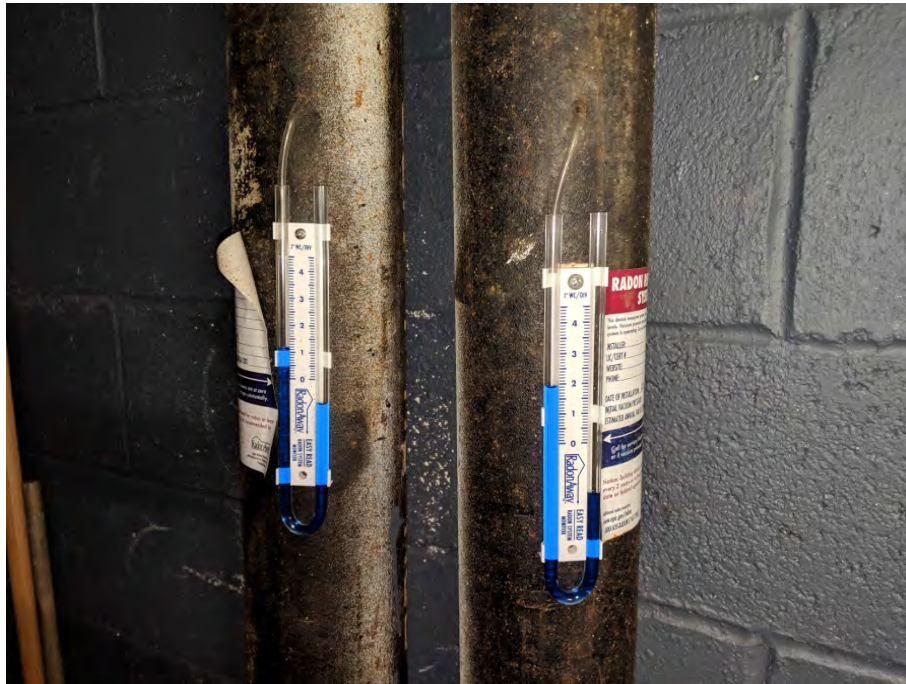
Vacuum readings of the U-manometers located at VP-1, VP-2 and VP-3 were recorded as -1.1 in w.c., -1.9 in w.c. and -1.3 in w.c., respectively. Data from the U-manometers and the VEMPs indicates that the VES is working properly.

3. U-manometers corresponding to VP-1 (left) and VP-2 (right), both displaying negative pressure readings

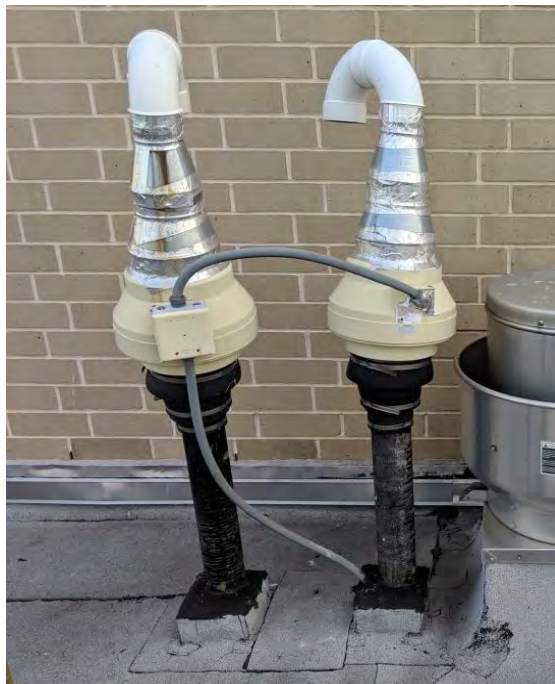
All fans were observed to be operational during the site inspection.

4. VES fans connected to VP-1 and VP-2, located on roof

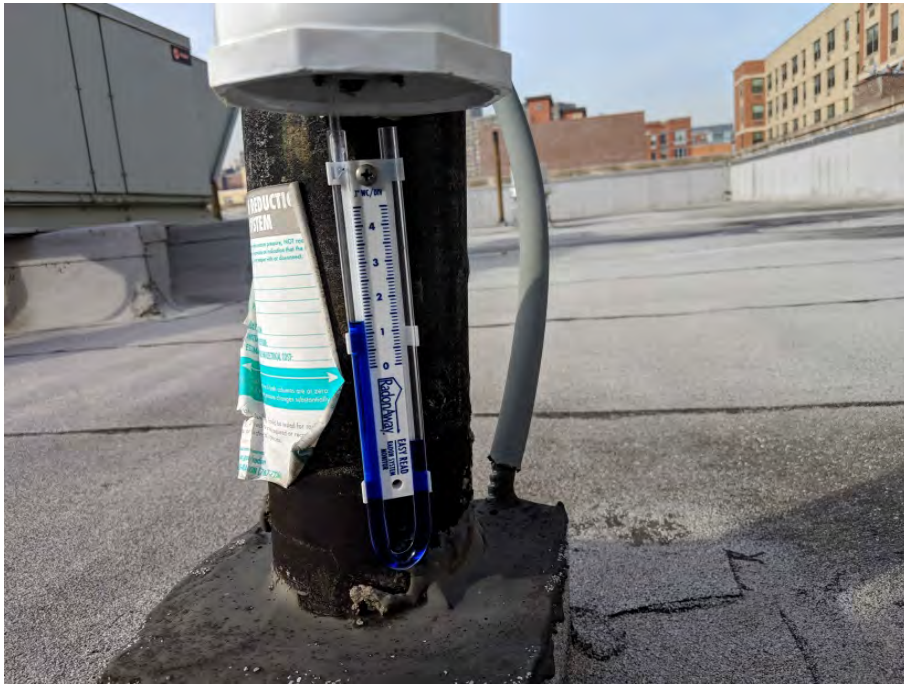
5. U-manometer corresponding to VP-3, displaying a negative pressure reading

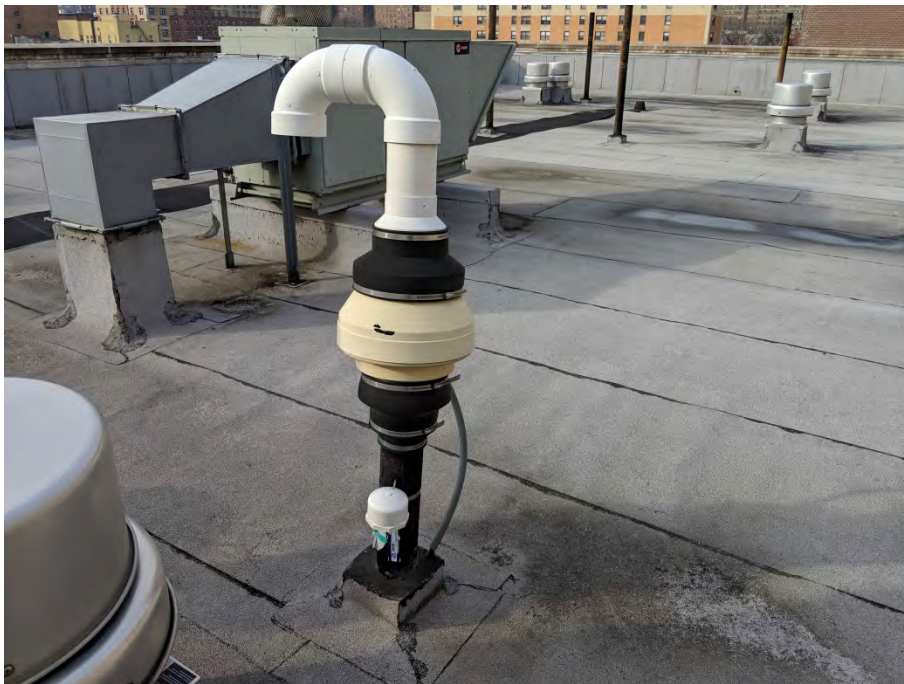
6. VES fan connected to VP-3, located on roof

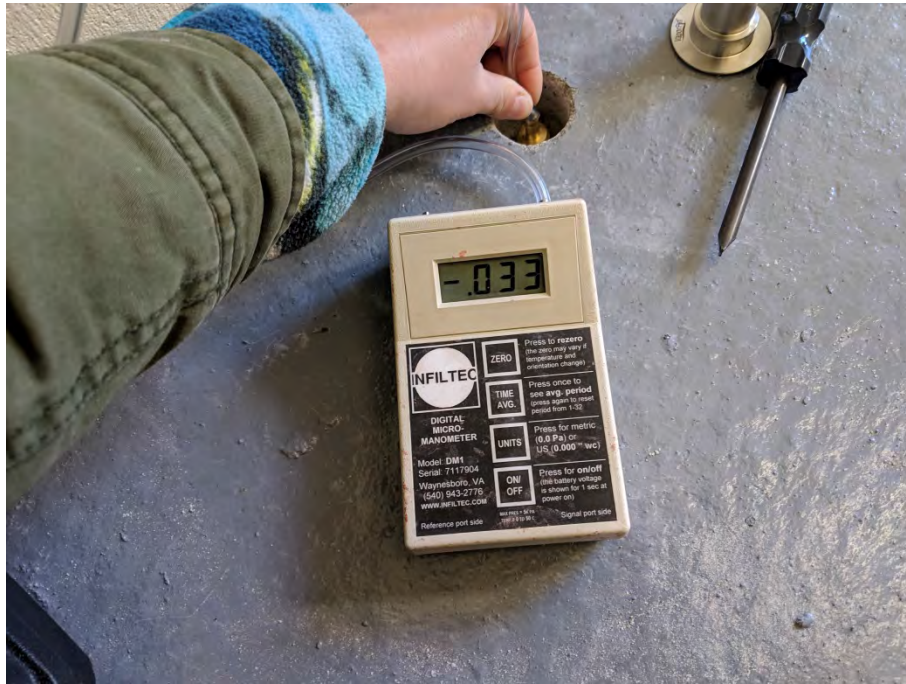
During the December 20, 2018 inspection, the seal on an abandoned monitoring point (VEMP-1) was observed to be in poor condition and appeared to influence the digital manometer readings at VEMP-1R. VEMP-1R was replaced and VEMP-1 was re-sealed on January 30, 2019 by personnel from Core Down Drilling under the direction of WCD. VEMP-3R was also replaced at this time at the request of the building manager (VEMP-3R was situated in such a way that it

| Monitoring Points | Location in Building | Vacuum Measurement |
|---|---|---|
| VEMP-1R | Northwest | -0.033 |

7. Negative pressure reading at VEMP-1R (northwestern portion of building)

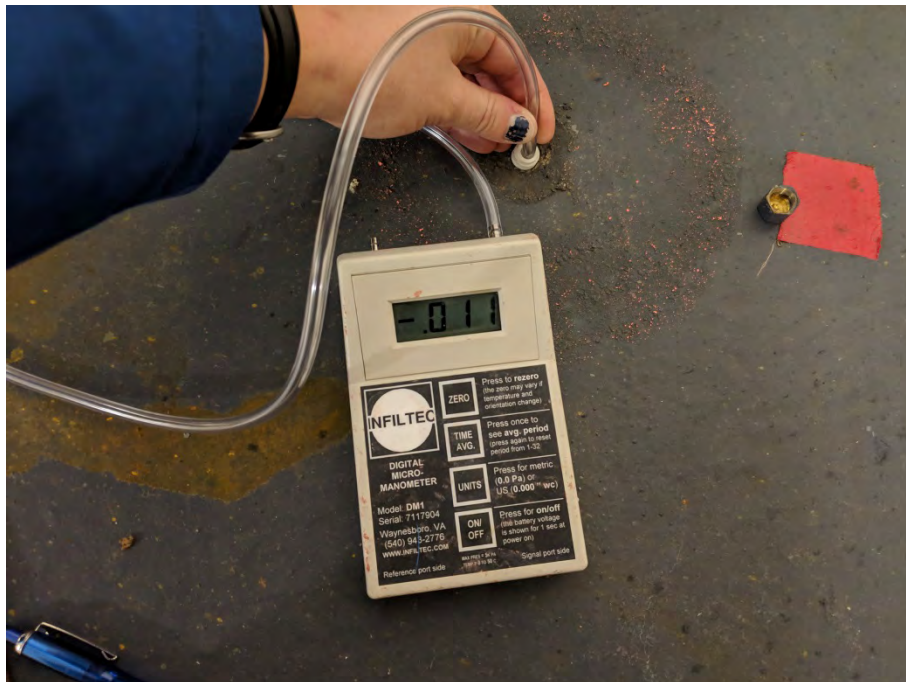
| Monitoring Points | Location in Building | Vacuum Measurement |
|---|---|---|
| VEMP-2 | Northeast | -0.011 |

8. Negative pressure reading at VEMP-2 (northeastern portion of building)

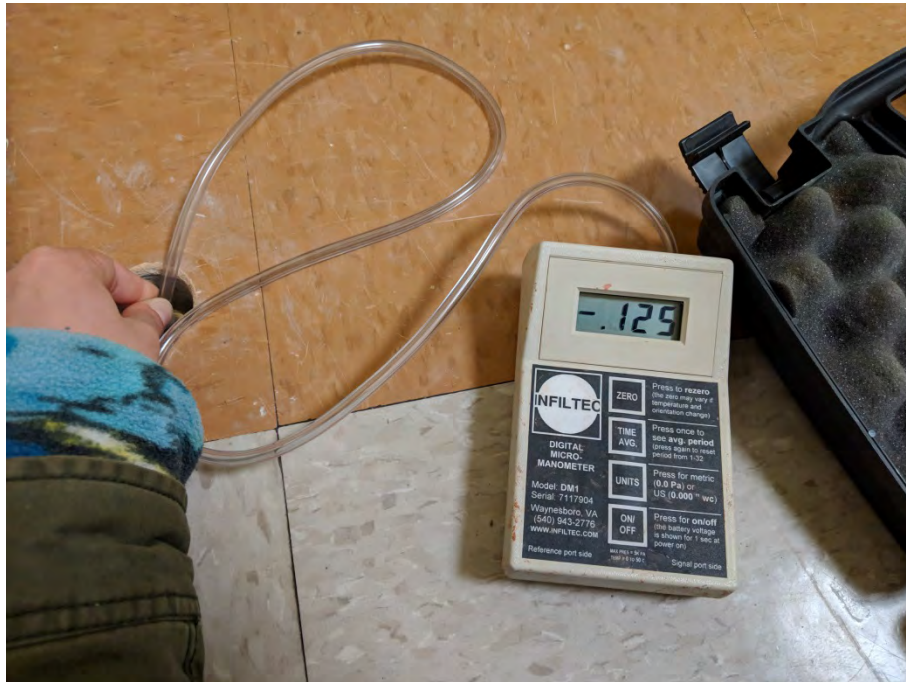
| Monitoring Points | Location in Building | Vacuum Measurement |
|---|---|---|
| VEMP-3R | Southwest | -0.1025 |

9. Negative pressure reading at VEMP-3R (southwestern portion of building)

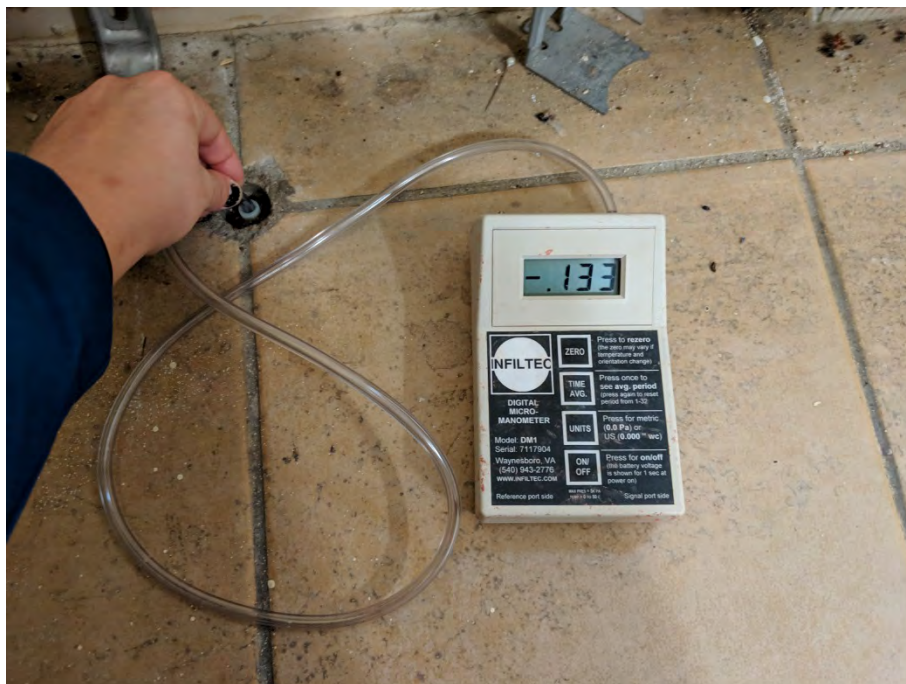
| Monitoring Points | Location in Building | Vacuum Measurement |
|---|---|---|
| VEMP-4 | Southeast | -0.133 |

10. Negative pressure reading at VEMP-4 (southeastern portion of building)
