**ANNUAL SITE MANAGEMENT REPORT
FROM AUGUST 2012 TO JULY 2013
MOTT HAVEN CAMPUS-X790
730 CONCOURSE VILLAGE WEST
BRONX, NEW YORK
BCP AGREEMENT # C-203030**

Date of Issue: September 10, 2013

Cardno ATC Project No. 015.19125.1675

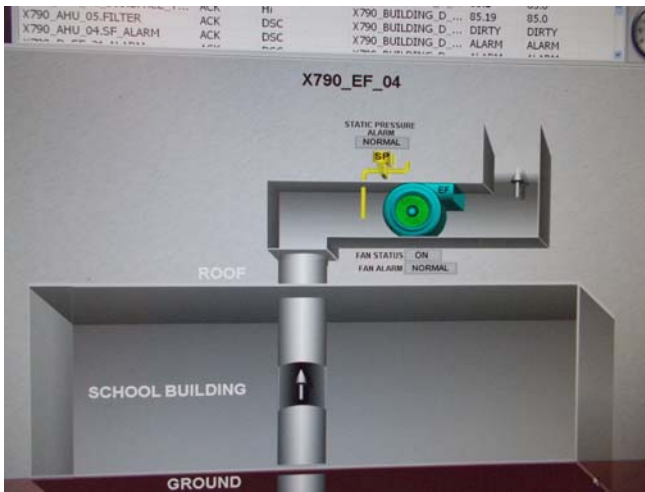
Photo 1: View of BMS on typical SSDS fan unit (EF-4).

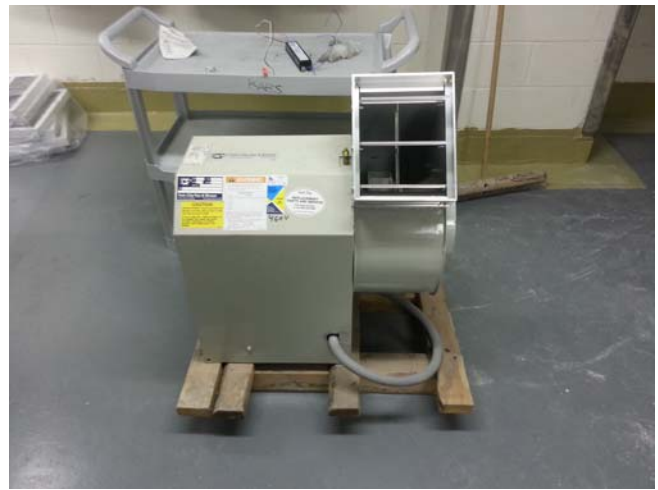
Photo 2: View of spare SSDS fan unit (EF-7) in Room B80.

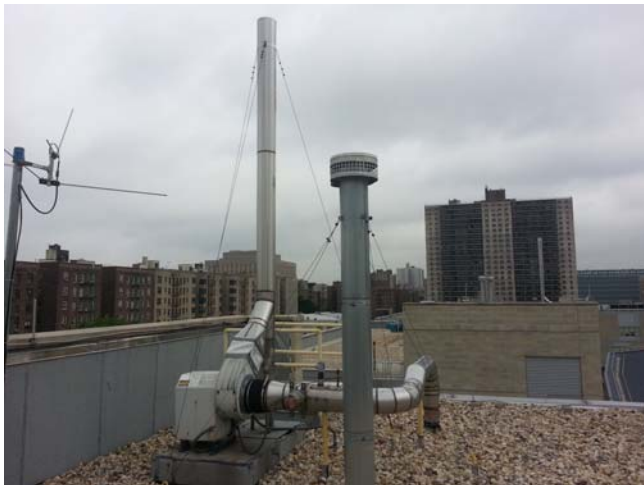
Photo 3: View of typical SSDS roof fan unit (EF-4).

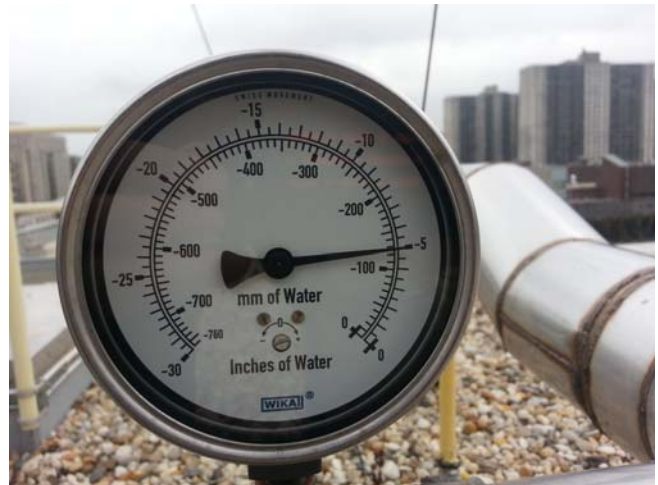
Photo 4: View of typical vacuum gauge associated with SSDS fan units (EF-4).

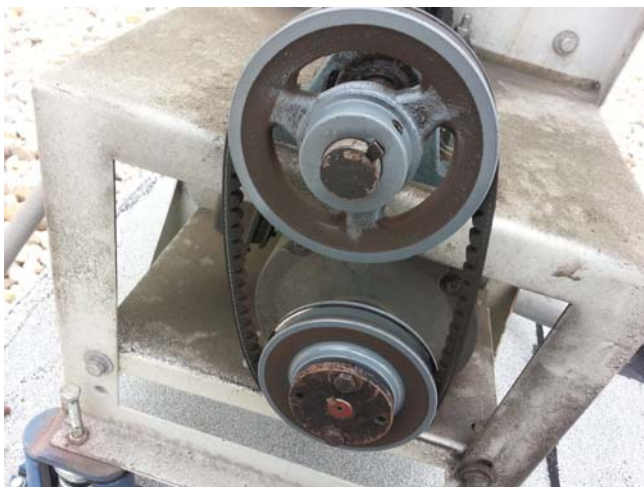
Photo 5: View of typical SSDS fan belt (EF-5).

1. Continue documenting all operation and maintenance activities on ECs;
2. Conduct preventative maintenance and document accordingly; and
3. Continue to replace any worn fan belts.

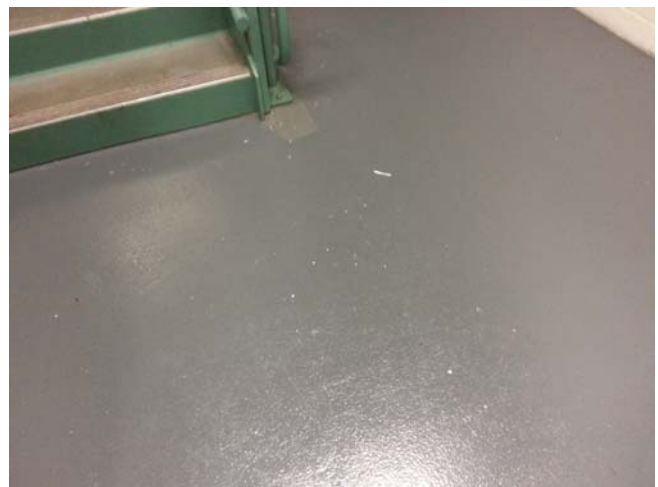
Photo 6: View of typical bare floor in Stairwell H.

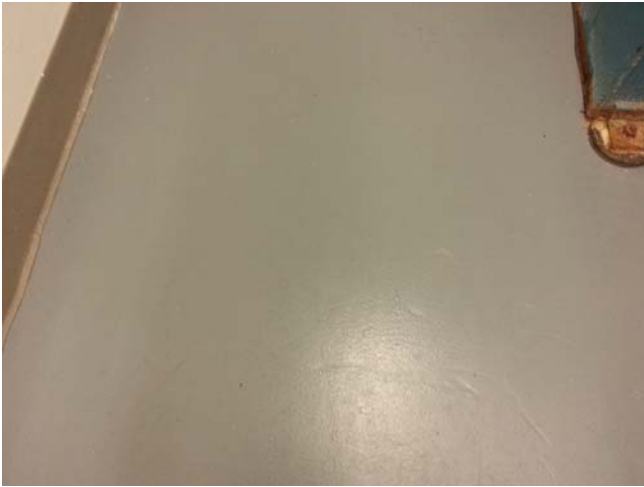
Photo 7: View of typical bare concrete floor in Room C59.

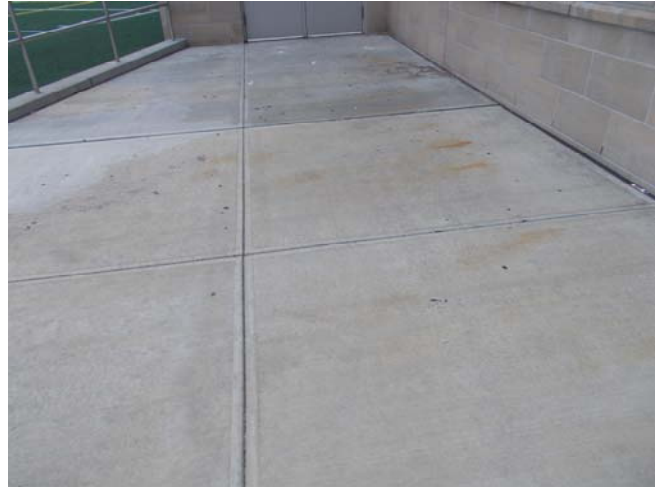
Photo 8: View of typical sidewalk pavers.

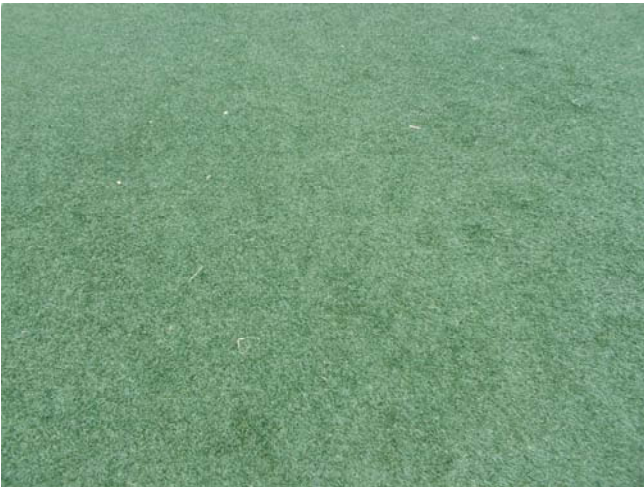
Photo 9: View of artificial turf on football field.

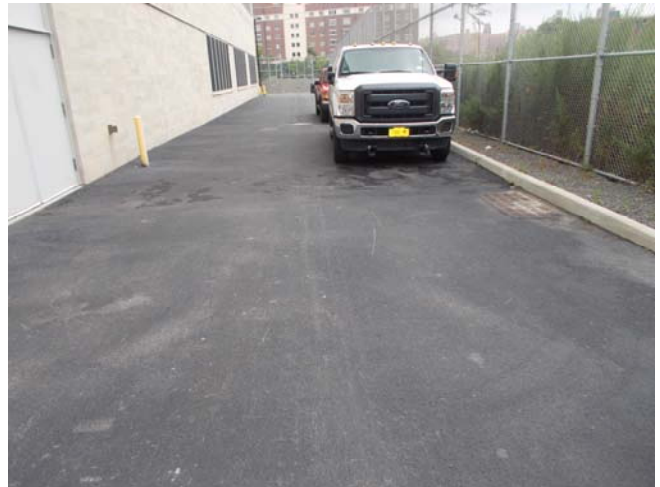
Photo 10: View of typical asphalt cover.
