**ANNUAL SITE MANAGEMENT REPORT  
FROM AUGUST 2013 TO JULY 2014  
MOTT HAVEN CAMPUS-X790  
730 CONCOURSE VILLAGE WEST  
BRONX, NEW YORK  
BCP AGREEMENT # C-203030**

Date of Issue: August 28, 2014  
REVISED: October 28, 2014

Cardno ATC Project No. 015.19125.1883

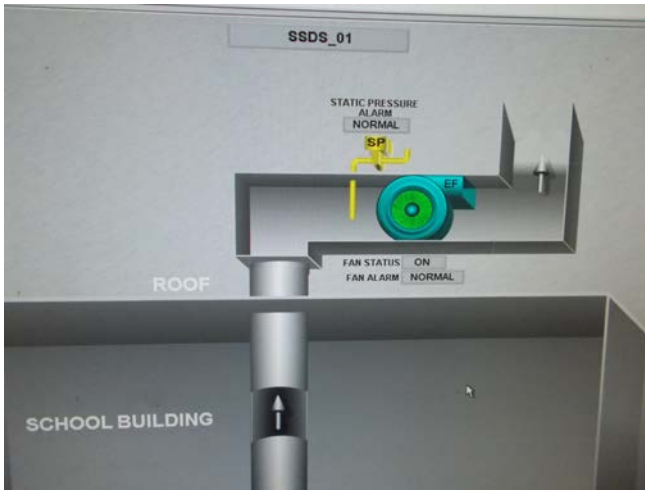
Photo 1: View of BMS on typical SSDS fan unit (EF-1).

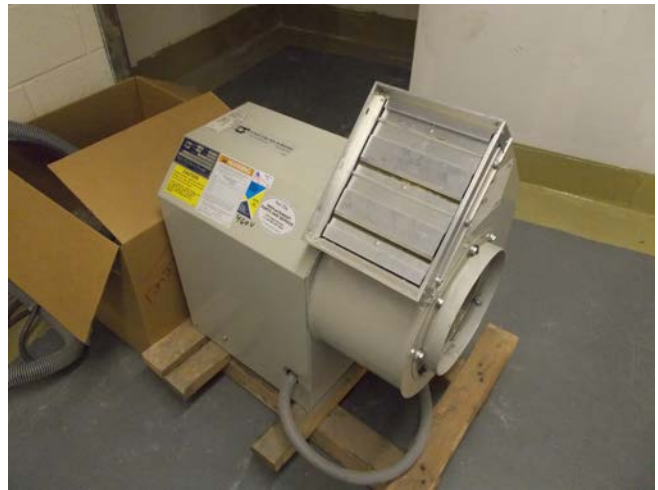
Photo 2: View of spare SSDS fan unit (EF-7) in Room B80.

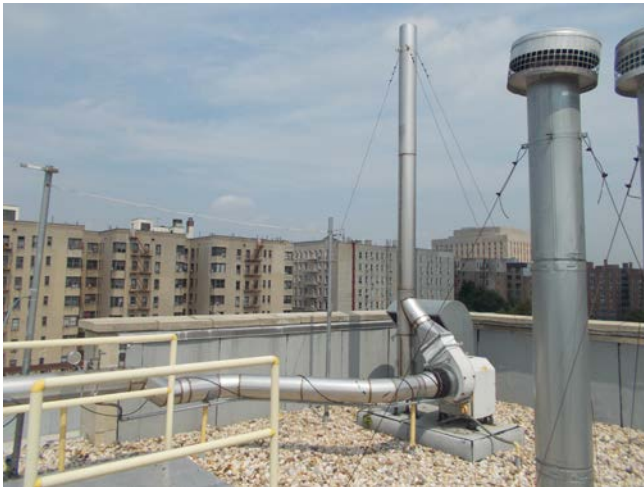
Photo 3: View of typical SSDS roof fan unit (EF-2).

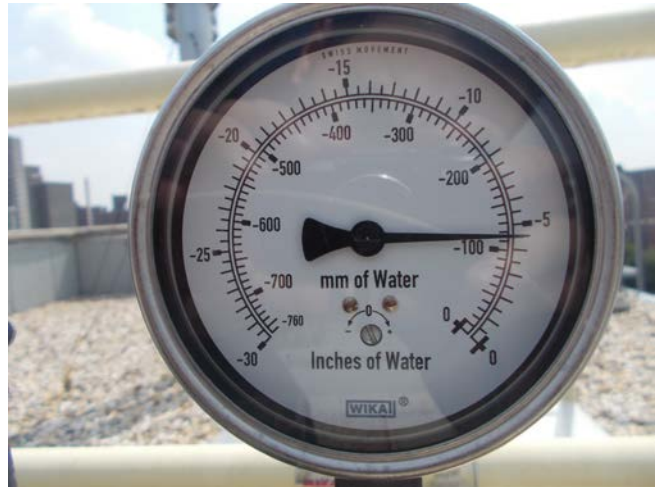
Photo 4: View of typical vacuum gauge associated with SSDS fan units (EF-2).

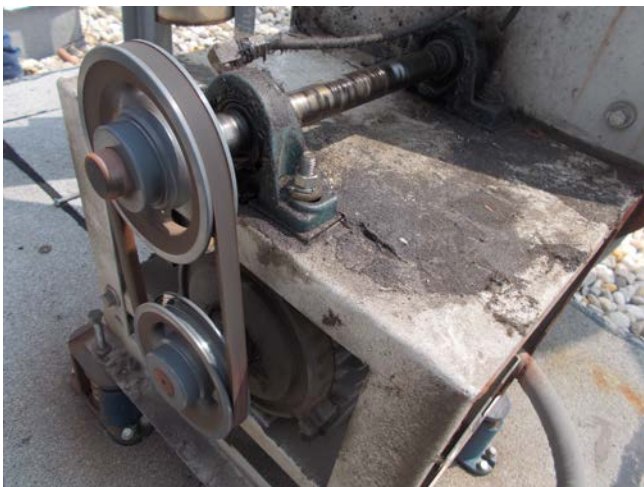
Photo 5: View of typical SSDS fan belt and assembly (EF-4).

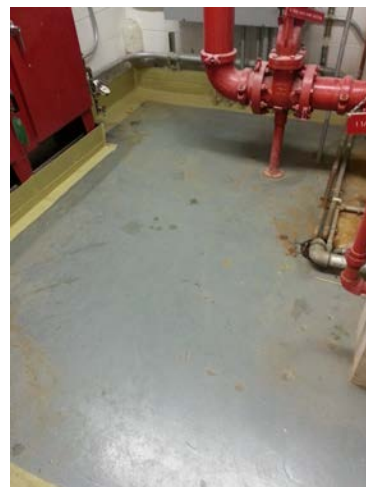
Photo 6: View of typical bare floor in the Fire Pump Room (Room C20D).

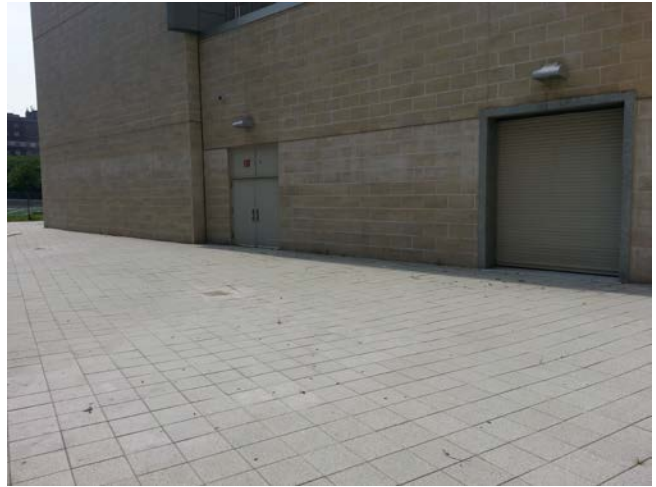
Photo 8: View of typical sidewalk pavers.

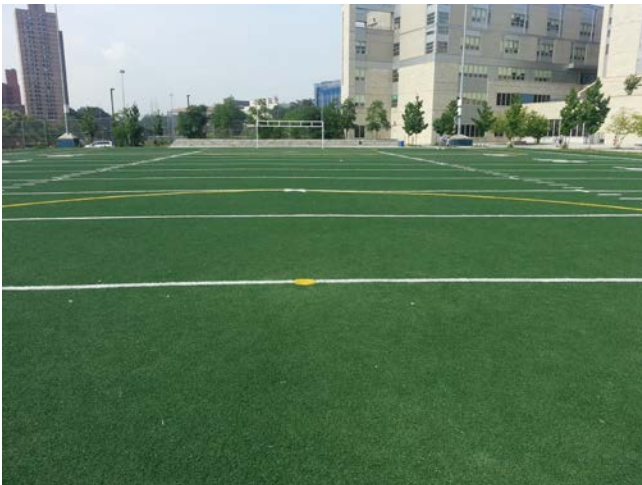
Photo 9: View of artificial turf on football field.

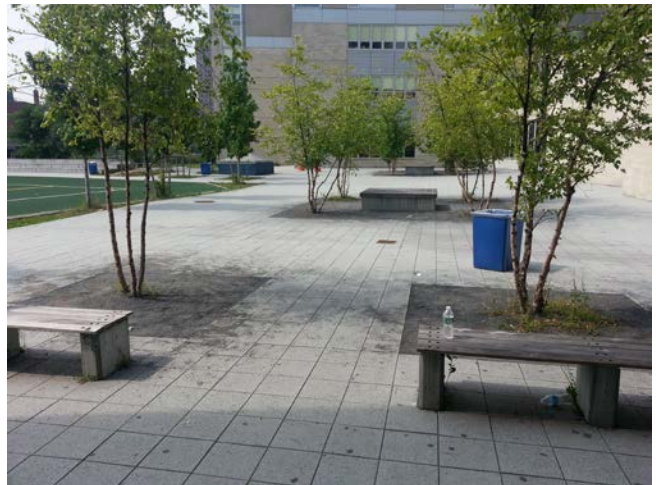
Photo 10: View of various site covers.

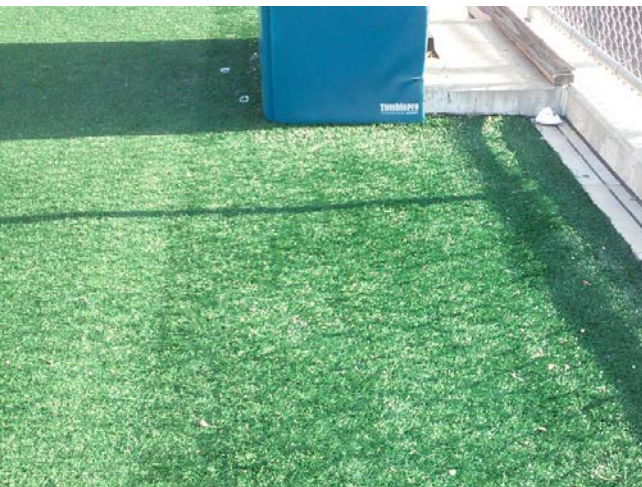
- Vibration damping cloth is slightly worn on SSDS fan unit EF-6;
- The BMS is fully commissioned;
- A spare fan unit labeled EF-7 is available at the school and is located in Room B80;
- Minor depression (4' x 2' x 4") at the east end of the artificial turf by the 40 yard line;
- Slight soil erosion (4.5' x 2' x 2") adjacent to the auditorium building by the 45 yard line; and
- Surficial cracks around the manhole on East Access Drive by the 35 yard line.

Photo 11: View of repairs made to the minor depression (4'x 2'x 4'') at the east end of the artificial turf.

Repairs to the minor depression and soil erosion were completed by a representative from Temco on October 20, 2014. Please see site photographs in Attachment 5. A work order has been submitted and repairs are underway for the minor surficial cracking around the manhole on East Access Drive. Please see attached correspondence for the work order in Attachment 8. The custodian was advised to notify ATC once the minor surficial cracking around the manhole has been addressed.

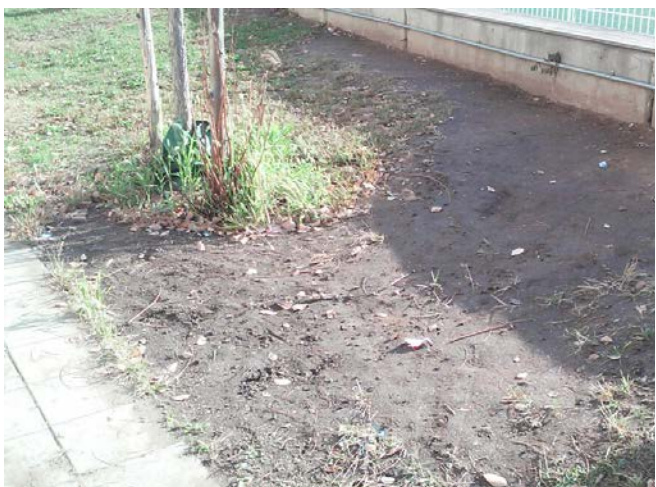
Photo 12: View repairs made to the soil erosion (4.5' x 2' x 2'') adjacent to the auditorium building.
