**ANNUAL SITE MANAGEMENT REPORT  
FROM AUGUST 2014 TO JULY 2015  
MOTT HAVEN CAMPUS-X790  
730 CONCOURSE VILLAGE WEST  
BRONX, NEW YORK  
BCP AGREEMENT # C-203030**

Date of Issue: September 14, 2015

**REVISED: December 11, 2015**

Cardno ATC Project No. Z214YI0181

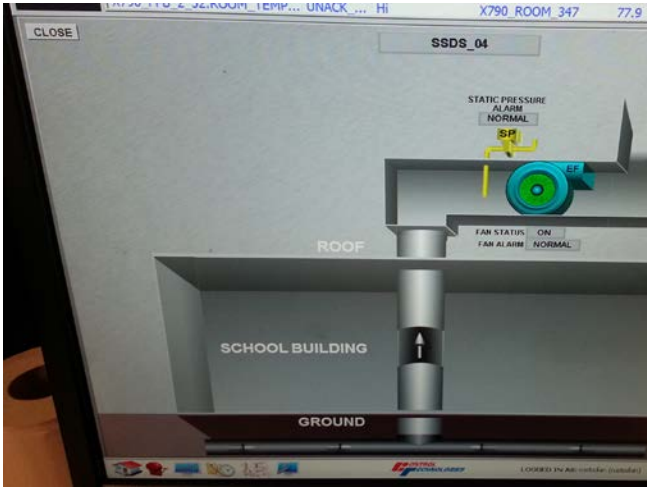
Photo 1: View of functional BMS on typical SSDS fan unit (EF-4).

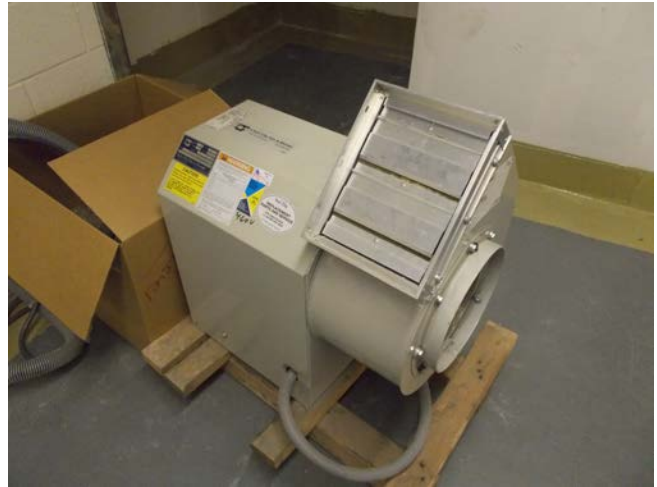
- All SSDS fans are operational;
- A spare fan unit labeled EF-7 is available at the school and is located in Room B80; and
- Repairs of the surficial cracks around the manhole on East Access Drive by the 35 yard line were completed by a representative from Temco on November 11, 2014.

Photo 2: View of spare SSDS fan unit (EF-7) in Room B80.

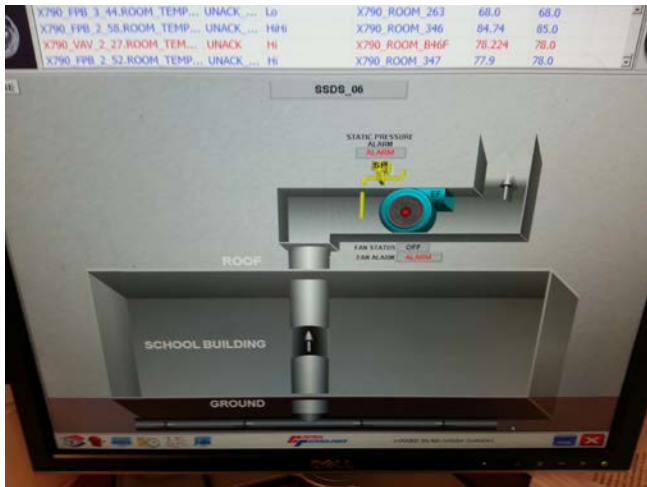
During the annual inspection, the BMS was connected to all SSDS fans except for EF-6. The BMS was falsely indicating an alarm for EF-6 after ATC confirmed that the fan was operational and running. ATC advised the custodian that the BMS should be repaired immediately. In addition to the monthly inspections, ATC further advised the custodial staff to perform visual daily checks of all SSDS fan units until the BMS was repaired.

Photo 3: View of BMS incorrectly indicating an alarm on fan unit SSDS-6.

ATC received notice from the school's building manager on September 11, 2015 that the BMS had been repaired remotely by CTI and was connected and showing correct status of all SSDS fans. As such ATC conducted a follow-up inspection on September 14, 2015.

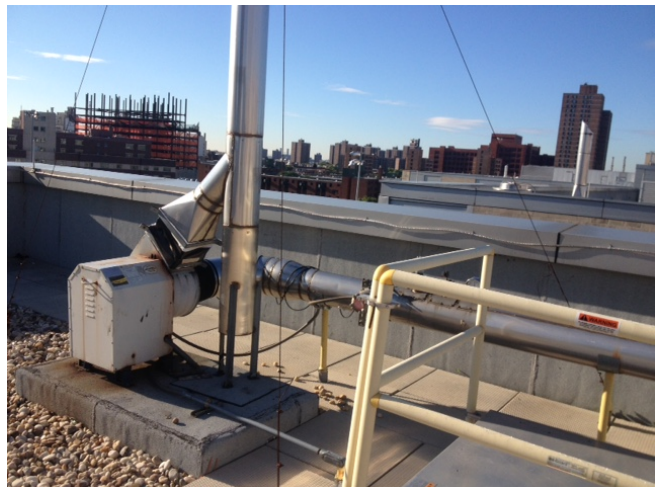
2. All pillow block bearings on SSDS fans were greased during the February 26, 2015 monthly inspection.
3. On March 14, 2015, SSDS fan unit EF-6 in Building B went down due to a defected fuse. Repairs were made by a Temco electrician on March 16, 2015 and the fan was returned to service.
4. Services to replace the fuse SSDS fan unit EF-6 in Building B were made in April, June and July 2015 by Temco representatives.

Photo 4: View of typical SSDS roof fan unit (EF-6).

1. Repair/replace the vacuum gauge on SSDS fan unit EF-6 on Building B.
2. Continue documenting all operation and maintenance activities on ECs;
3. Continue to conduct monthly and routine/preventative maintenance inspections and record observations in the Monthly and Routine and Preventative Maintenance logs; and
4. Continue to replace any worn fan belts and conduct preventative maintenance on the SSDS fan units as needed.

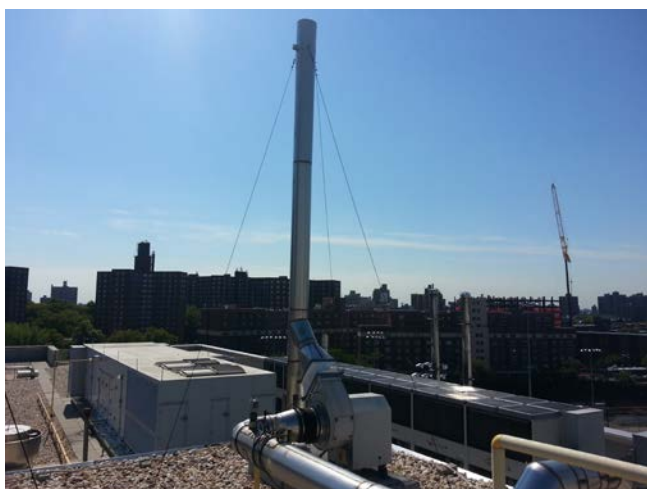
Photo 5: View of typical SSDS roof fan unit (EF-1).

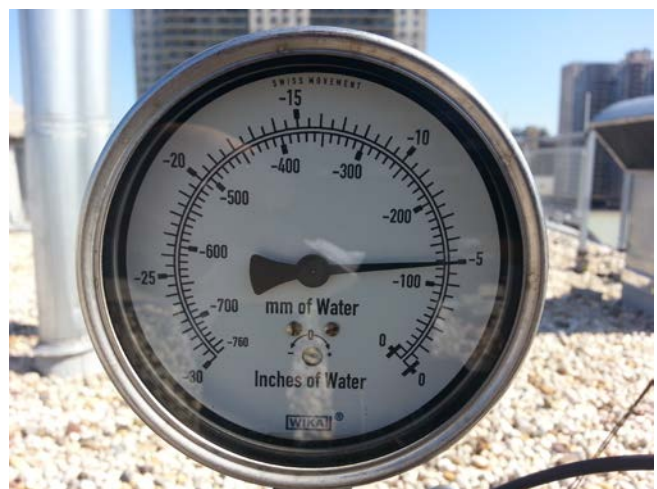
Photo 6: View of typical vacuum gauge associated with SSDS fan units (EF-1).

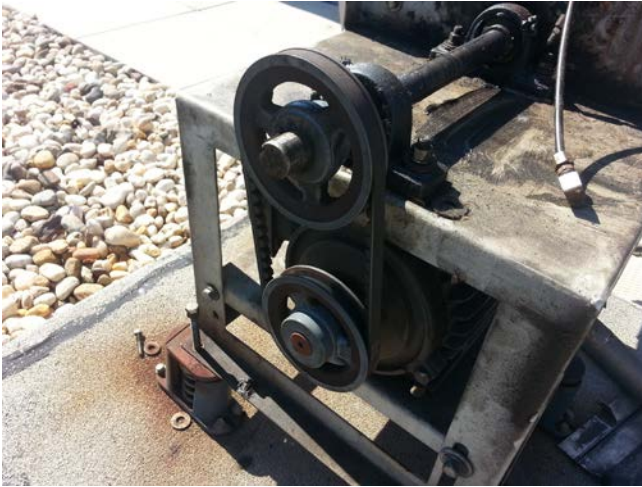
Photo 7: View of typical SSDS fan belt and assembly (EF-6).

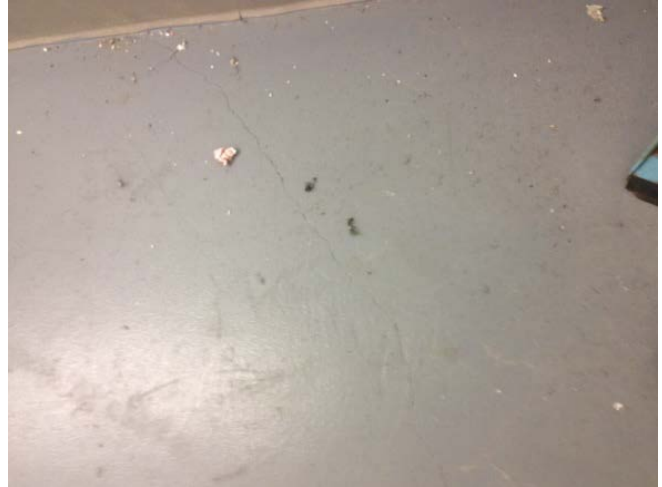
ATC inspected the accessible areas of the basement floors. ATC did not observe any visible concrete cracks penetrating into the basement floor during the site inspections. Furthermore, ATC did not observe any floor joints in the basement floor. As such, smoke testing consistent with Section 3.2.2 of the SMP was not conducted. ATC's observation of the basement concrete floors was limited due to architectural finishes such as ceramic floor tiles, vinyl floor tiles, wood flooring and miscellaneous equipment and furniture. ATC also inspected the DOT maintenance corridor and did not observe any visible cracks.

Photo 8: View of typical bare floor in Room C59.

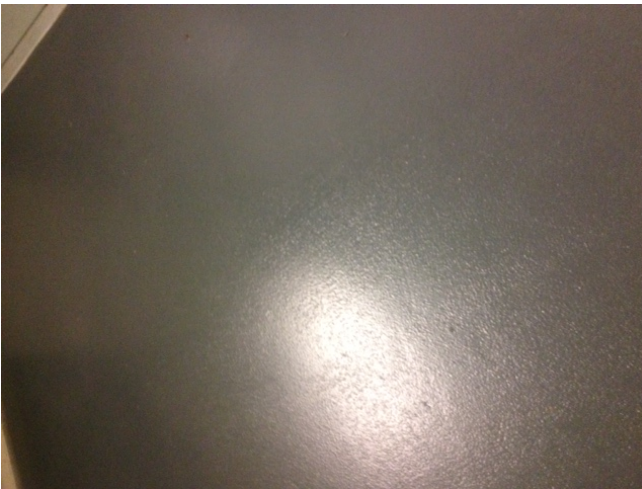
Photo 9: View of typical bare concrete floor in Stairwell H.

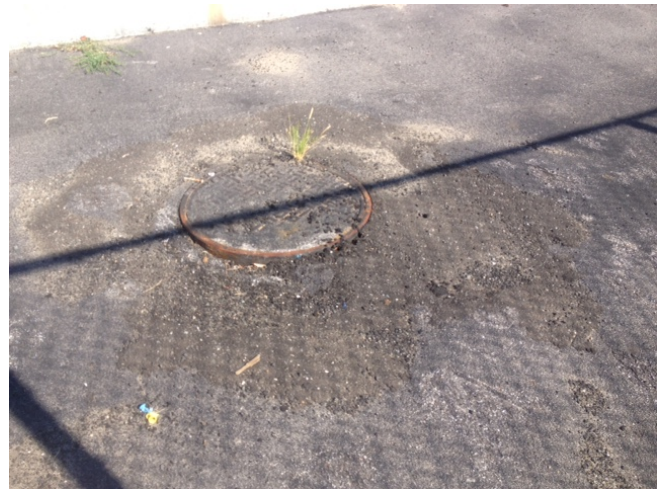
ATC inspected the composite cover system around the perimeter of the Mott Haven Campus including the paved and unpaved areas. There was no evidence of pavement removal. No structures have been constructed on the unpaved areas. ATC also observed minor surficial cracks around the manhole on East Access Drive by the 35 yard line. The soil erosion and minor depression observed during last year's report were repaired on October 20, 2014 by a representative from Temco. Repair of the surficial cracks around the manhole on East Access Drive by the 35 yard line was completed by a representative from Temco on November 11, 2014.

Photo 10: View of repairs made to the manhole by the East Access Drive.

1. Minor cracks around the manhole cover on the East Access Drive were repaired on November 11, 2014 by a Temco Service Industries, Inc. (Temco) representative.

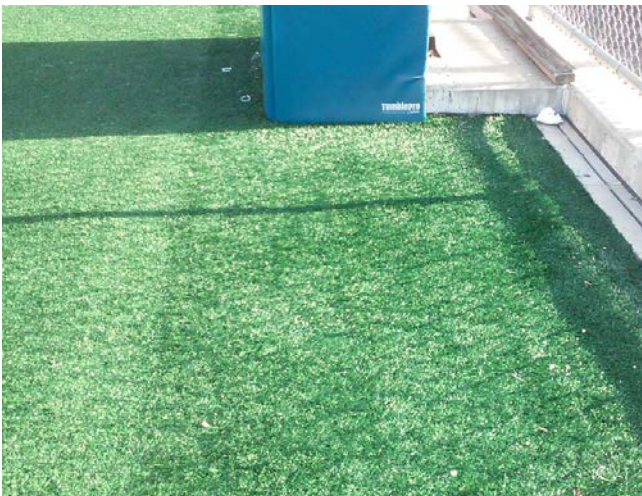
ATC did not observe any other visible cracks in the exterior paved areas or sidewalks during the annual inspection. ATC also inspected the artificial turf and observed no apparent holes, cracks or deterioration. ATC concludes that the composite cover system is intact and provides a barrier to direct contact with underlying soils.

Photo 11: View of artificial turf on football field.

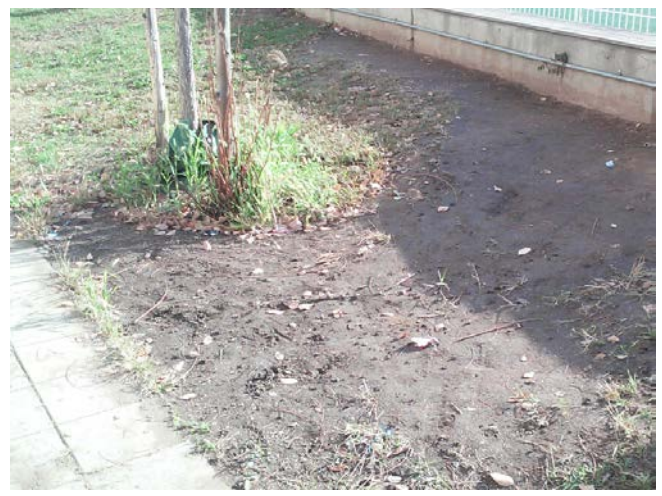
Photo 12: View of repairs made to the minor depression (4'x 2'x 4") at the east end of the artificial turf.

3. The Soil erosion and minor depression observed were repaired on October 20, 2014 by a representative from Temco;
4. Minor cracks around the manhole cover on the East Access Drive were repaired on November 11, 2014 by a Temco representative.

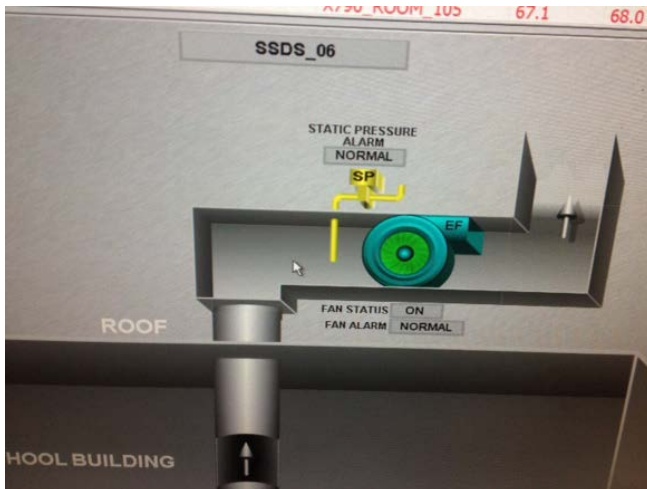
- ATC conducted a follow-up inspection at X790 to confirm repairs on the BMS.
- ATC met with custodian Mr. Robert Rivero Jr.
- ATC noted that the BMS had been repaired for SSDS-6 and that all fan units were demonstrating “Normal, ON” settings on the BMS.
- ATC conducted a visual inspection of all the SSDS fan units and noticed that they were operating as designed.

Photo 1: View of functional BMS on typical SSDS fan unit (EF-6).

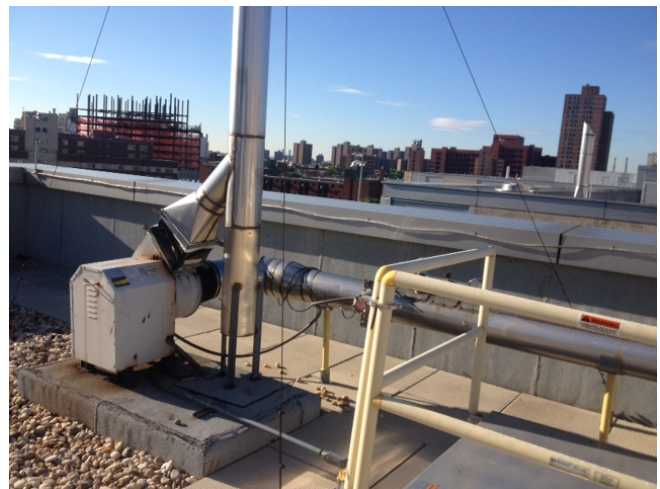
Photo 2: View of typical SSDS roof fan unit (EF-6).

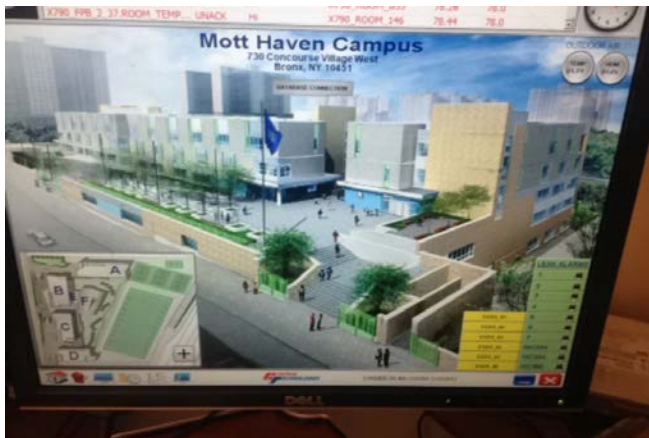
- ATC met with custodian Mr. Robert Rivero Jr.
- Mr. Rivero informed ATC that Control Technologies, Inc. had been performing remote maintenance on the BMS on 10/6/15.
- ATC conducted a follow-up inspection to confirm maintenance repairs on the BMS.
- ATC noted that the BMS was functioning properly for all fan units.
- ATC conducted a visual inspection of all the SSDS fan units and noticed that they were operating as designed.

Photo 1: View of functional BMS at P.S. X790.

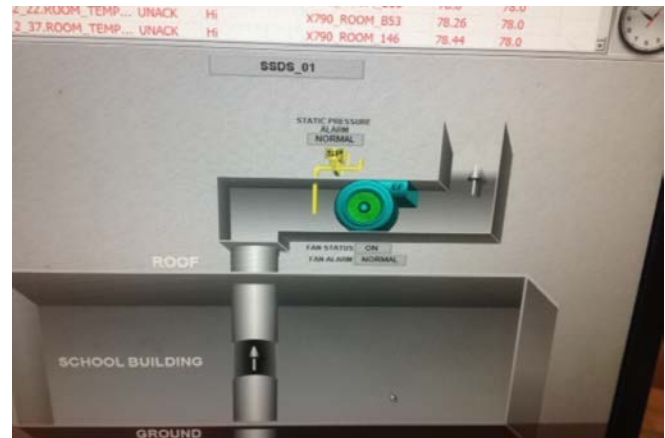
Photo 2: View of typical BMS showing normal status on SSDS fan unit SSDS-1.
