**ANNUAL SITE MANAGEMENT REPORT
FROM AUGUST 2017 TO SEPTEMBER 2018
MOTT HAVEN CAMPUS-X790
730 CONCOURSE VILLAGE WEST
BRONX, NEW YORK
BCP AGREEMENT # C-203030**

Date of Issue: October 24, 2018

ATC Project No. Z214YI1126

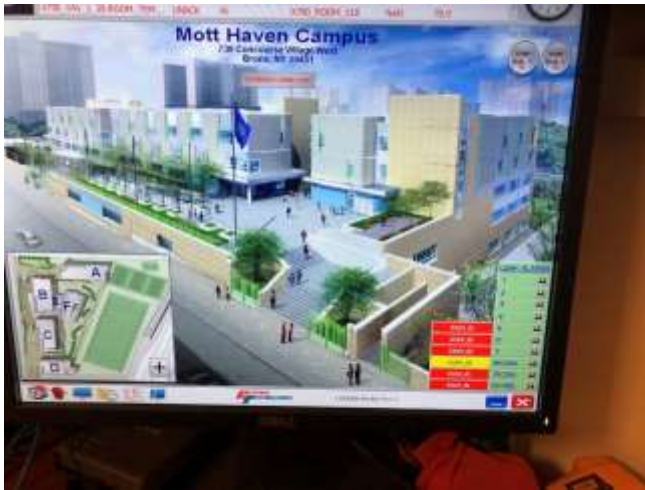
1. The BMS is not connected to the SSDS, even though the fan units were observed to be operational;
2. The flex joint cloths on SSDS fan units EF-4 and EF-6 were observed to be damaged;

Photo 1: View of BMS, reportedly not operating correctly.

1. Correct the BMS to monitor all units, complete the supplement daily checklist for each fan unit until the BMS had been repaired;
2. Replace the damaged flex joint cloths on SSDS fan units EF-4 and EF-6; DOE Work Order - WO#00678445

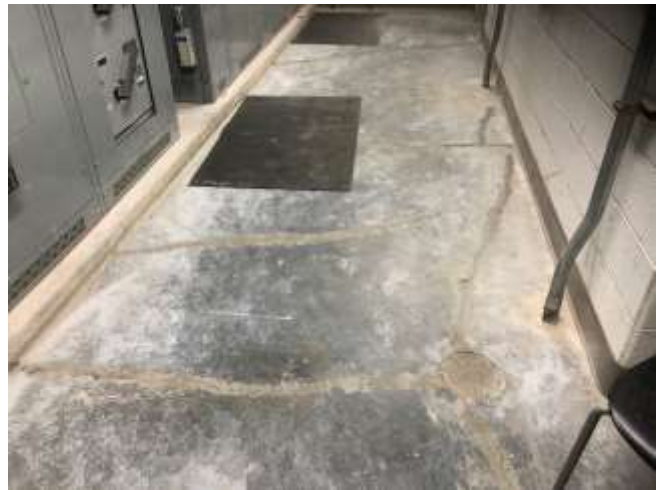
During the vapor barrier inspection of the lowest floor, ATC observed that the hairline cracks in Rooms C19, C20, C20B, C29F, C44, C48, C59, C80J, C84 and C86 reported in the previous year had been patched with cement by custodial staff. Any other significant cracks observed during these monthly inspections will require patching with cement or grout.

Photo 2: View of patched hairline cracks in Room C20.

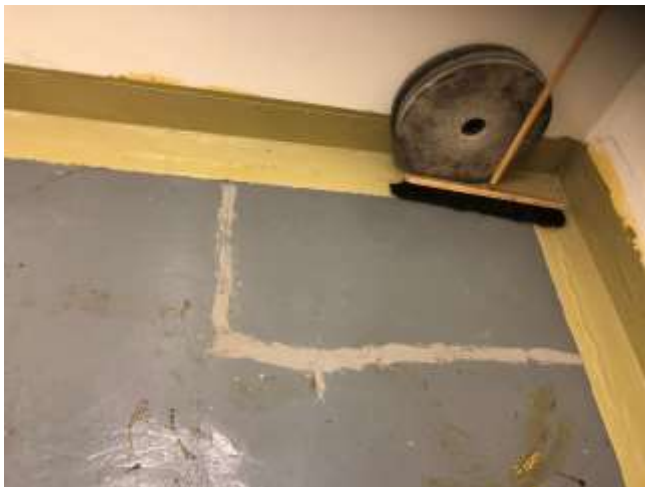
Photo 3: View of patched hairline cracks in Room C86.

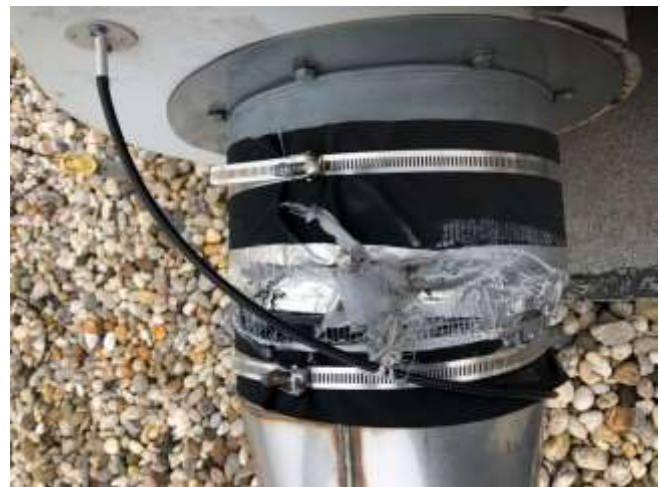
During the inspection of the SSDS fan units located on the roof, all SSDS fans were observed to be operational, however, the flex joint cloths on SSDS fan units EF-4 and EF-6 were damaged and require replacement, and the belt on EF-6 was observed to be loose.

Photo 6: View of damaged flex joint cloth associated with SSDS fan unit EF-4.

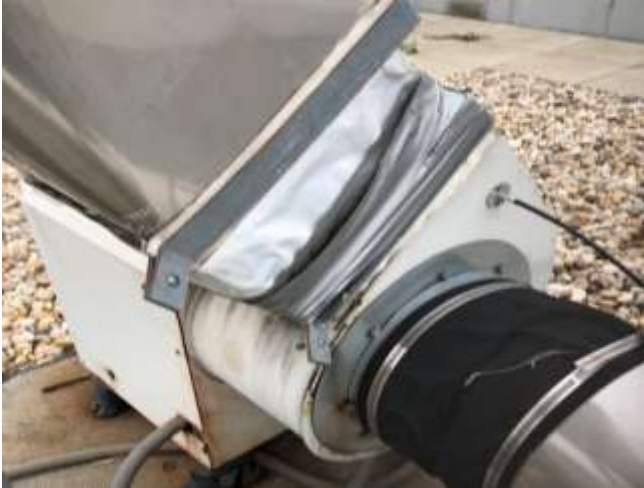
Photo 7: View of damaged flex joint cloth associated with SSDS fan unit EF-6.

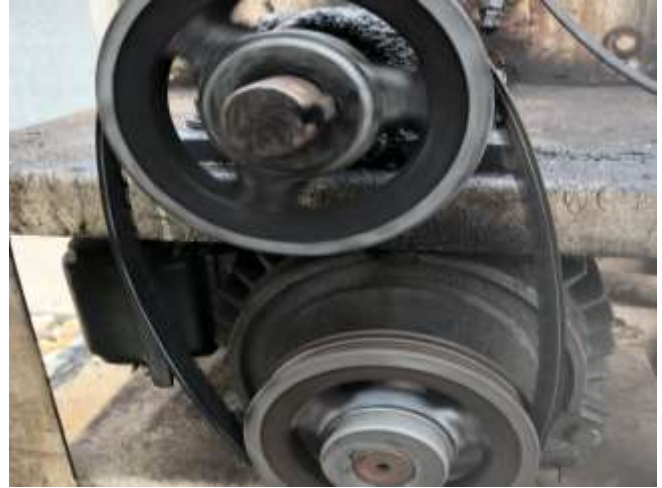
Photo 8: Loose belt observed on SSDS fan unit EF-6.

Following the annual inspection, custodial staff informed ATC that the belt on SSDS EF-6 had been replaced on September 28, 2018 and that the fan gauge on that fan was now operating correctly.

8. Conduct daily SSDS fan checks and document in the SSDS Fan Daily Checklist until the BMS is restored; and
9. Continue to replace any worn fan belts and conduct preventative maintenance on the SSDS fan units as needed.

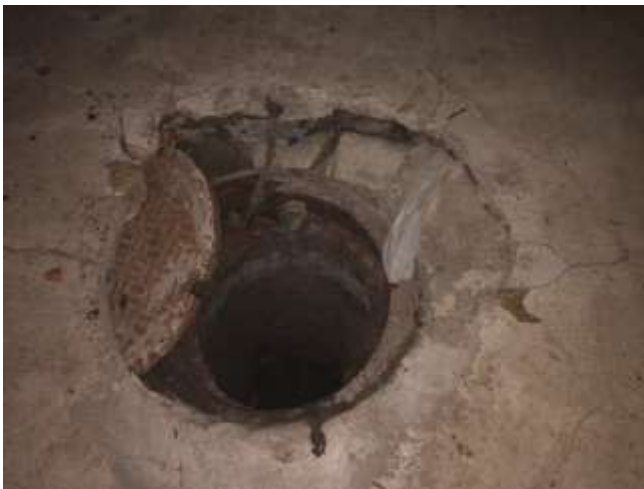
- North Manhole – cracking and lifting of concrete, approximately 8' x 8' area;
 - South Manhole – cracking and lifting of concrete, approximately 6' x 6' area;

Photo 9: Damaged concrete around north manhole on concrete cap area below P.S. 151X.

3. Repair damaged concrete cover system around manholes and Column H281 below building 156 per the Site Management Plan (SMP). DOE Work Order - WO#00599184.

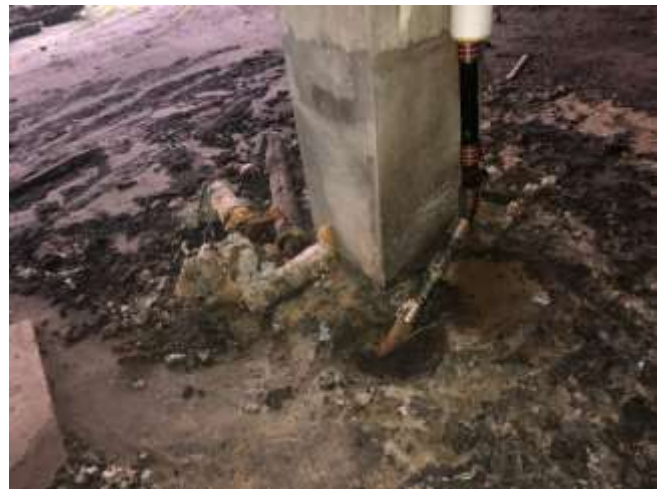
- Near Column H281 – cracking of concrete, approximately 3' x 3' areas;
- Cracking and deterioration of the asphalt pavement around the manhole near the emergency fire lane exit gate; and

Photo 10: Damaged concrete around column on concrete cap area below P.S. 151X.

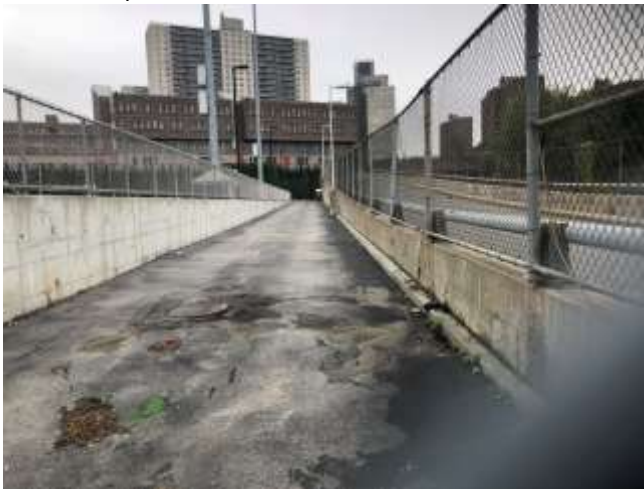
5. Cracking and deterioration of asphalt pavement around the manhole was observed near the emergency fire lane exit gate;
6. Slight soil erosion due to vehicular traffic was observed along the grass covered areas East of Tower D. Custodial staff reported that the soil has been ordered and is awaiting delivery;

Photo 11: View of damage on the asphalt pavement at the fire lane exit gate.

4. Repair excavated areas of the asphalt pavement south and southeast of Tower D per SMP requirements; DOE Work Order - WO#00010820-00226.
5. Repair damaged asphalt pavement around the manhole observed near the emergency fire lane exit gate. DOE Work Order -WO#007125725;

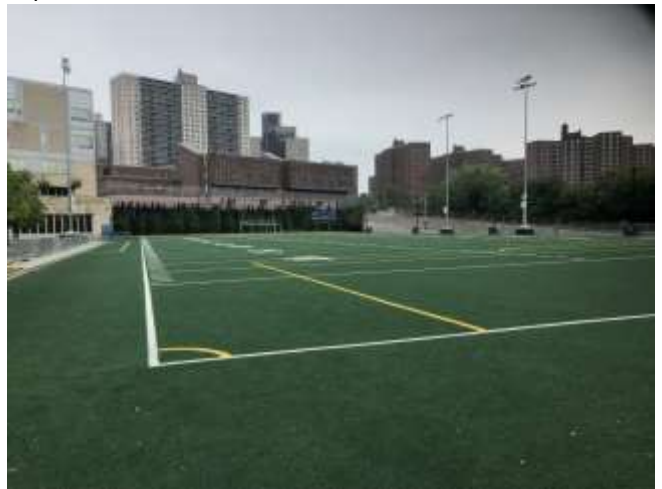
Photo 12: View of artificial turf on football field.

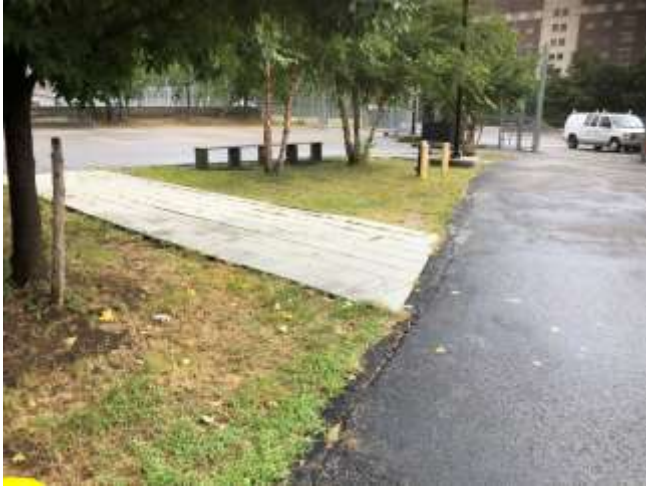
- Slight soil erosion due to vehicular traffic along the grass covered areas East of Tower D.

Photo 13: Landscaped areas south of Tower D with mild soil erosion.

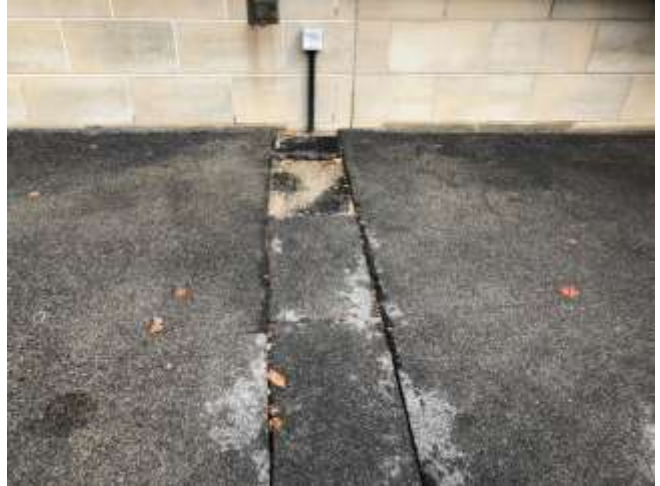
Photo 14: Area of damaged asphalt pavement south of Tower D reportedly due to a rerouted conduit line.

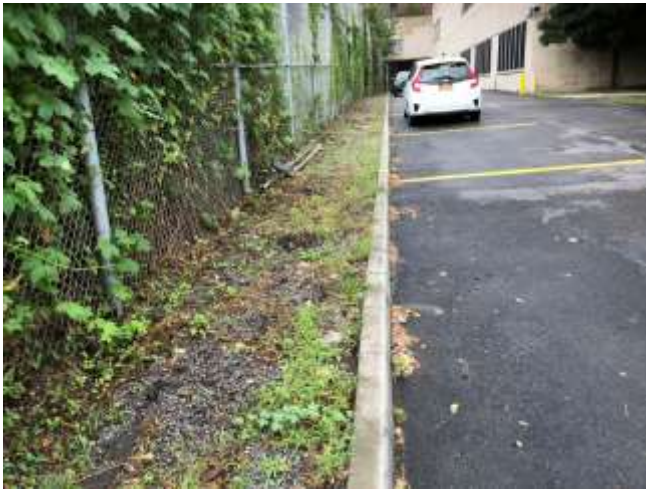
Photo 15: Area of damaged asphalt pavement south of Tower D reportedly due to a rerouted conduit line.

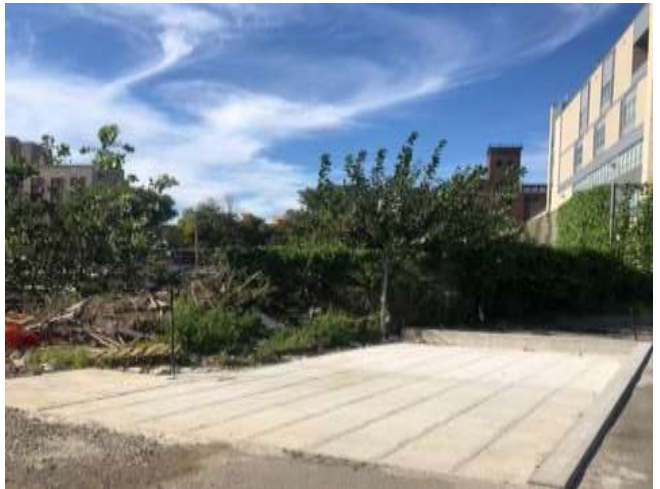
Photo 16: Shallow excavation southeast of Tower D to install a concrete pad for the proposed trash compactor.
