**ANNUAL SITE MANAGEMENT REPORT  
FROM JULY 2017 TO JUNE 2019  
MOTT HAVEN CAMPUS-X790  
730 CONCOURSE VILLAGE WEST  
BRONX, NEW YORK  
BCP AGREEMENT # C-203030**

Date of Issue: July 30, 2019  
REVISED: August 30, 2019

ATC Project No. Z214YI1126

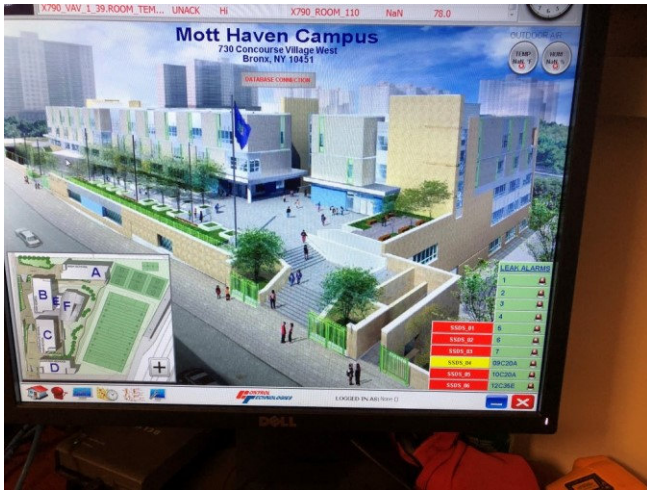
1. The BMS is not connected to the SSDS, even though the fan units were observed to be operational;
2. The flex joint cloths on SSDS fan units EF-4 and EF-6 were observed to be moderately damaged. Temporary repairs had been performed on the flex joints pending permanent replacement of the joint cloths;

Photo 1: View of BMS, reportedly not operating correctly.

1. Correct the BMS to monitor all units, complete the supplement daily checklist for each fan unit until the BMS had been repaired; DOE Work Order – WO#00682616

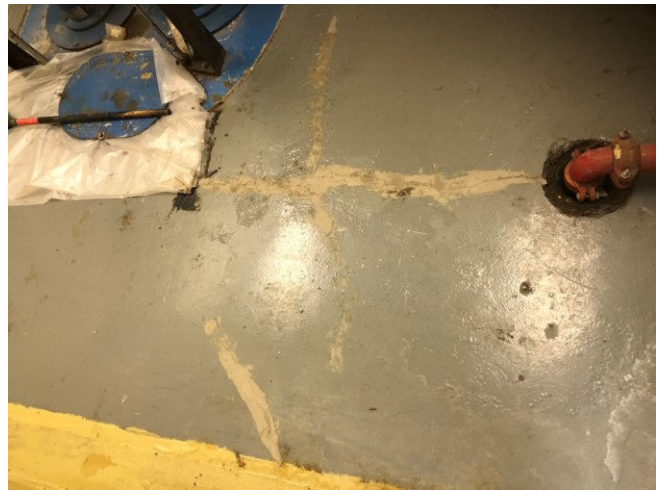
Photo 2: View of patched hairline cracks in Room C86.

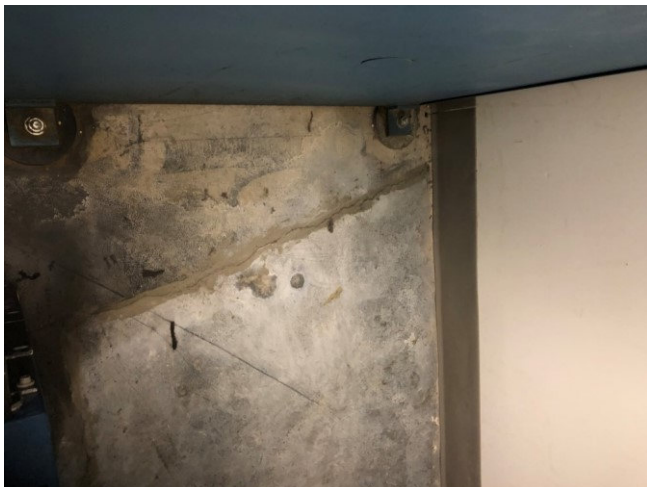
Photo 3: View of patched hairline cracks in Room C80J.

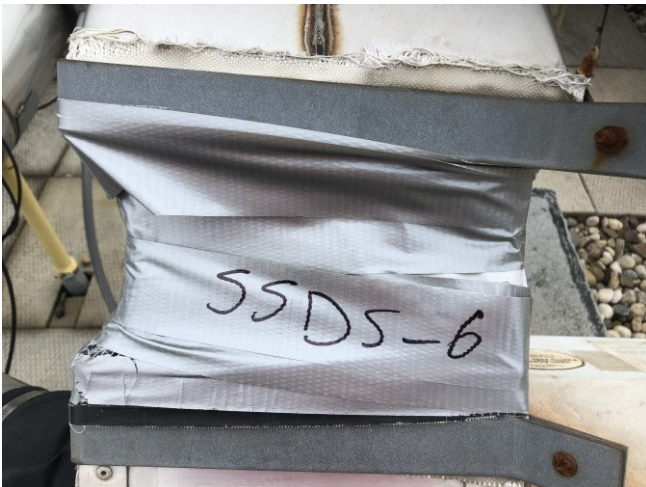
Photo 9: View of damaged flex joint cloth associated with SSDS fan unit EF-6, temporary repairs made.

2. Replace the damaged flex joint cloths on SSDS fan units EF-4 and EF-6; DOE Work Order - WO#00678445
3. Repair damaged concrete cover system around manholes and Column H281 below building 156 per the Site Management Plan (SMP). DOE Work Order - WO# 00722317.

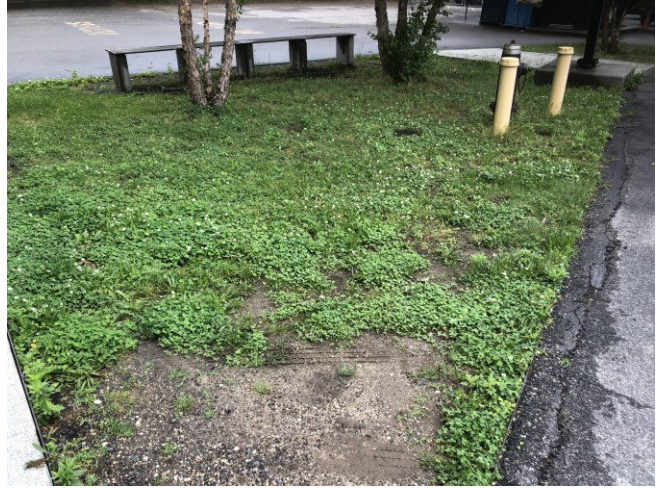
- Slight soil erosion due to vehicular traffic was observed along the grass covered areas East of Tower D. The custodial staff reported that the soil had been replaced and the grass reseeded in March 2019.

Photo 14: Area of landscaping previously observed with eroded soil, reseeded.

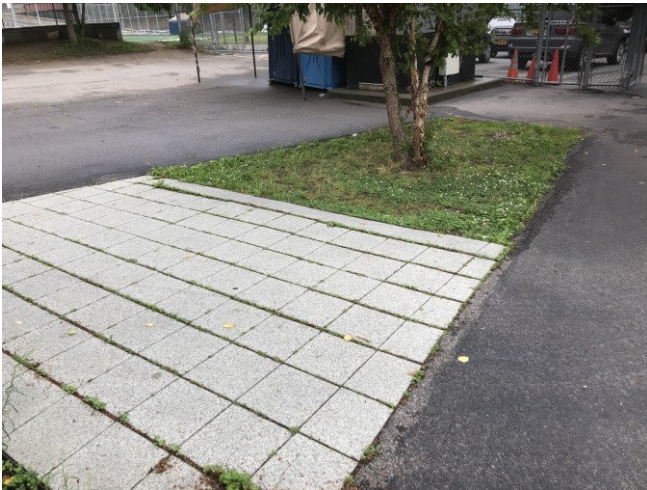
Photo 15: Area of landscaping previously observed with eroded soil, reseeded.

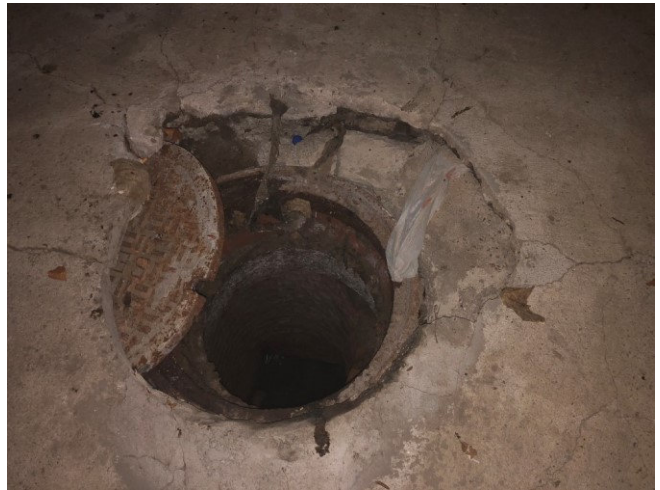
- North Manhole – cracking and lifting of concrete, approximately 8' x 8' area
  - South Manhole – cracking and lifting of concrete, approximately 6' x 6' area

Photo 16: Damaged concrete around north manhole on concrete cap area below P.S. 151X.

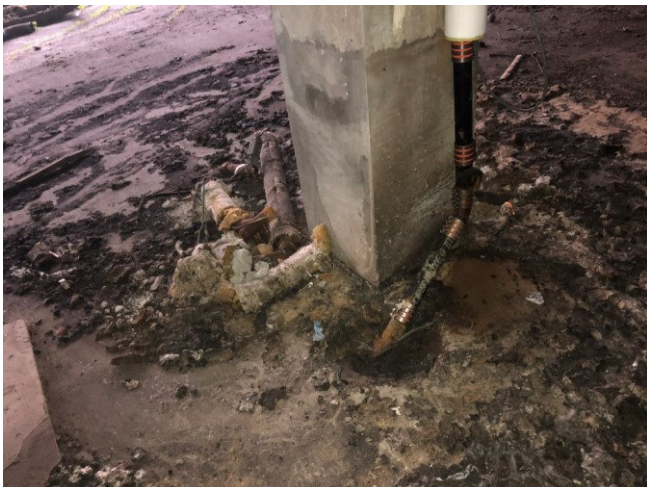
- Near Column H281 – cracking of concrete, approximately 3' x 3' area
- Moderate cracking and moderate deterioration of asphalt pavement around the manhole was observed near the emergency fire lane exit gate;

Photo 17: Damaged concrete around column on concrete cap area below P.S. 151X.

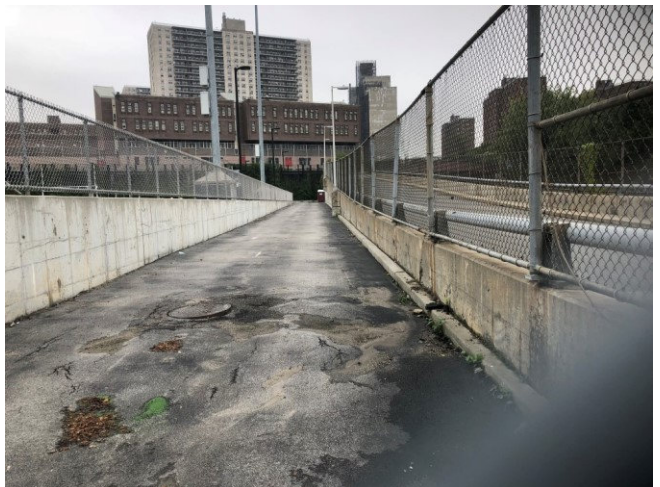
5. Moderate cracking and deterioration of asphalt pavement around the manhole was observed near the emergency fire lane exit gate;
6. The ICs and ECs are in place, remain effective;

Photo 18: View of damage on the asphalt pavement at the fire lane exit gate.

4. Repair damaged asphalt pavement around the manhole observed near the emergency fire lane exit gate. DOE Work Order -WO#007125725;
5. Continue documenting all operation and maintenance activities on ECs;

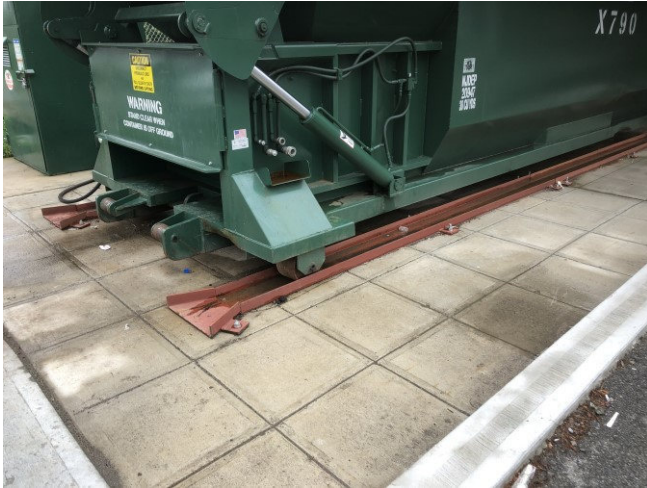
Photo 19: Repairs completed for compactor concrete pad.

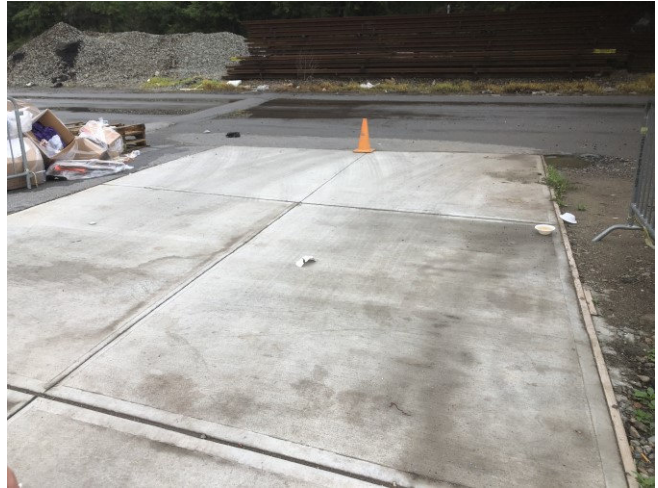
Photo 20: Repairs completed for compactor concrete pad.

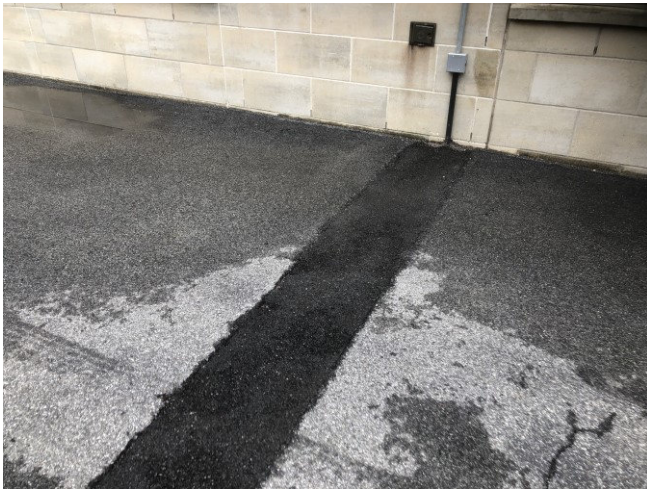
Photo 21: Repairs on asphalt pavement south of Tower D.

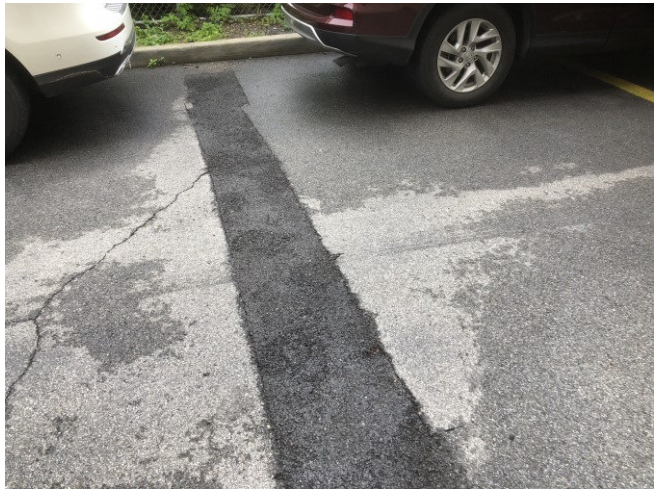
Photo 22: Repairs on asphalt pavement south of Tower D.
