2477 Third Avenue Property
BRONX, NEW YORK

Periodic Review Report
March 2022 to March 2023

NYSDEC Site Number: C203047

JANUARY 2024

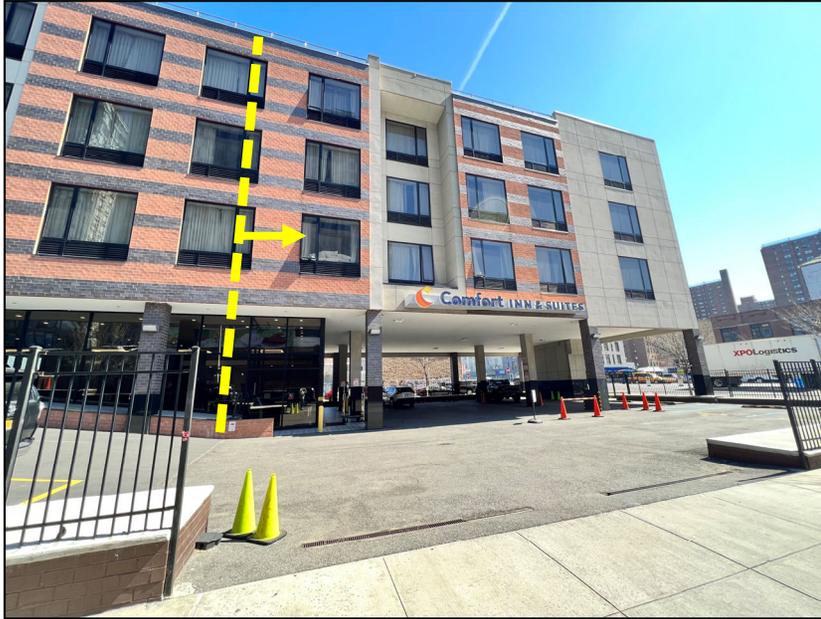
Photograph 1. BCP portion of the Hotel (the Site), looking north.

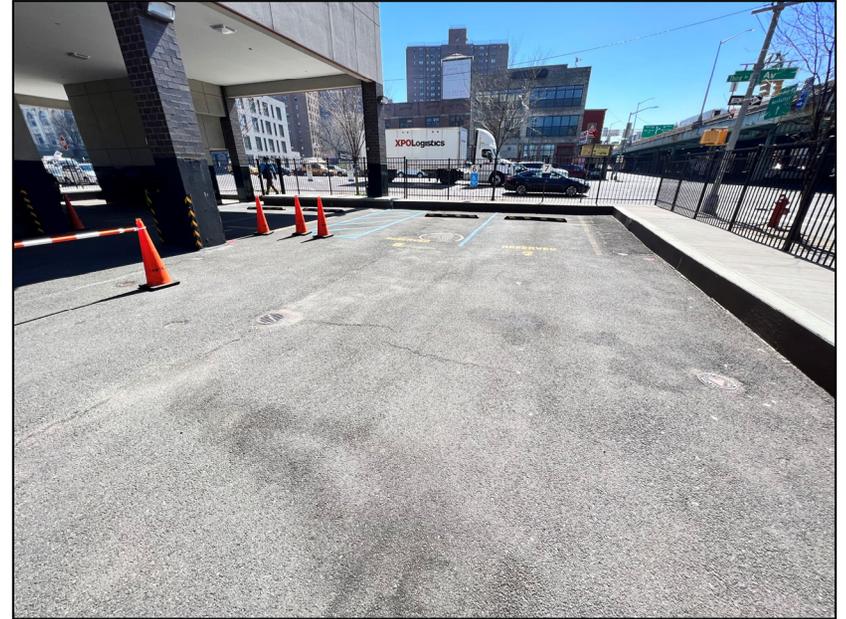
Photograph 2. Location of monitoring wells and injection wells on the southeastern portion of the Site (post-remedial monitoring area).

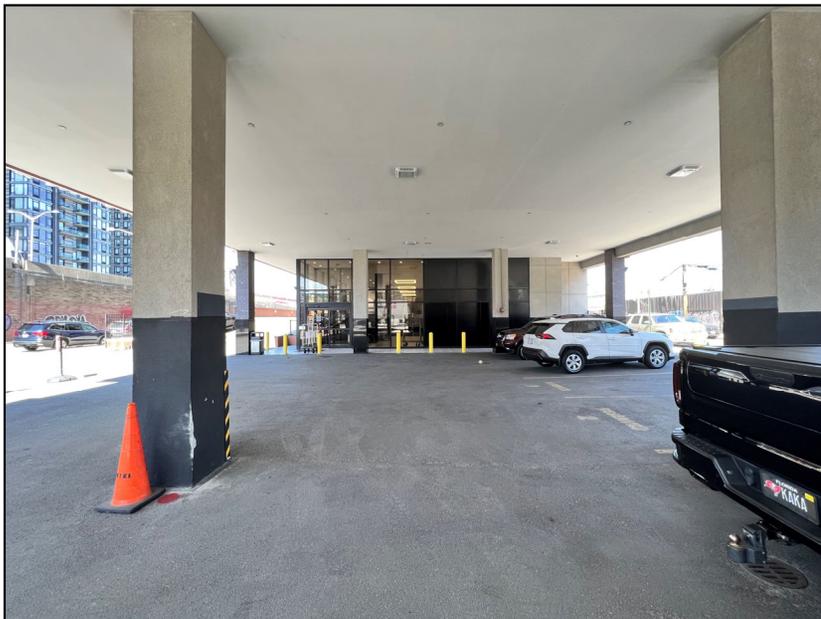
Photograph 3. The Site looking west from Third Avenue (hotel lobby and at-grade parking areas).

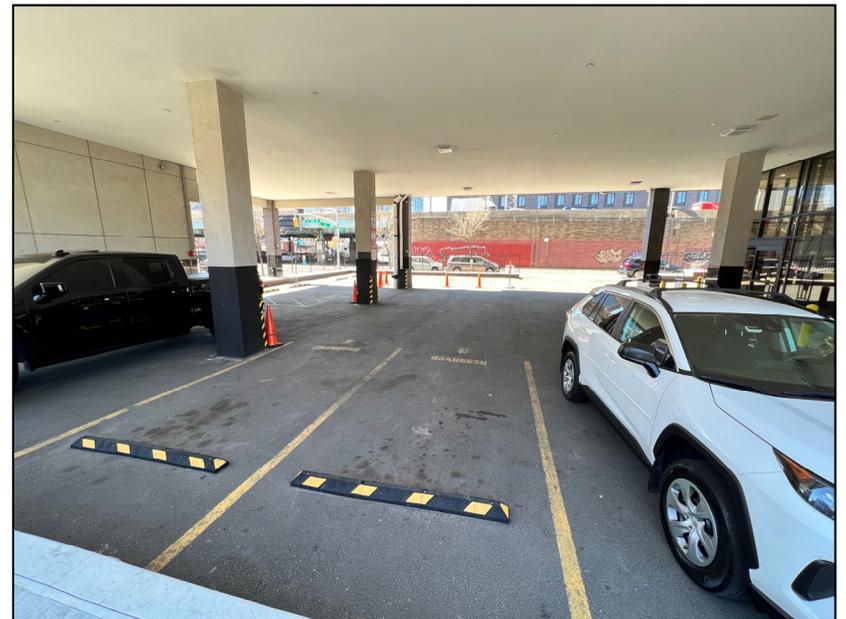
Photograph 4. Parking area looking south towards the Major Deegan Expressway with the monitoring and injection wells in the background.
