Former G & C Services

255 East 138th Street
Bronx, New York 10451

May 28, 2025

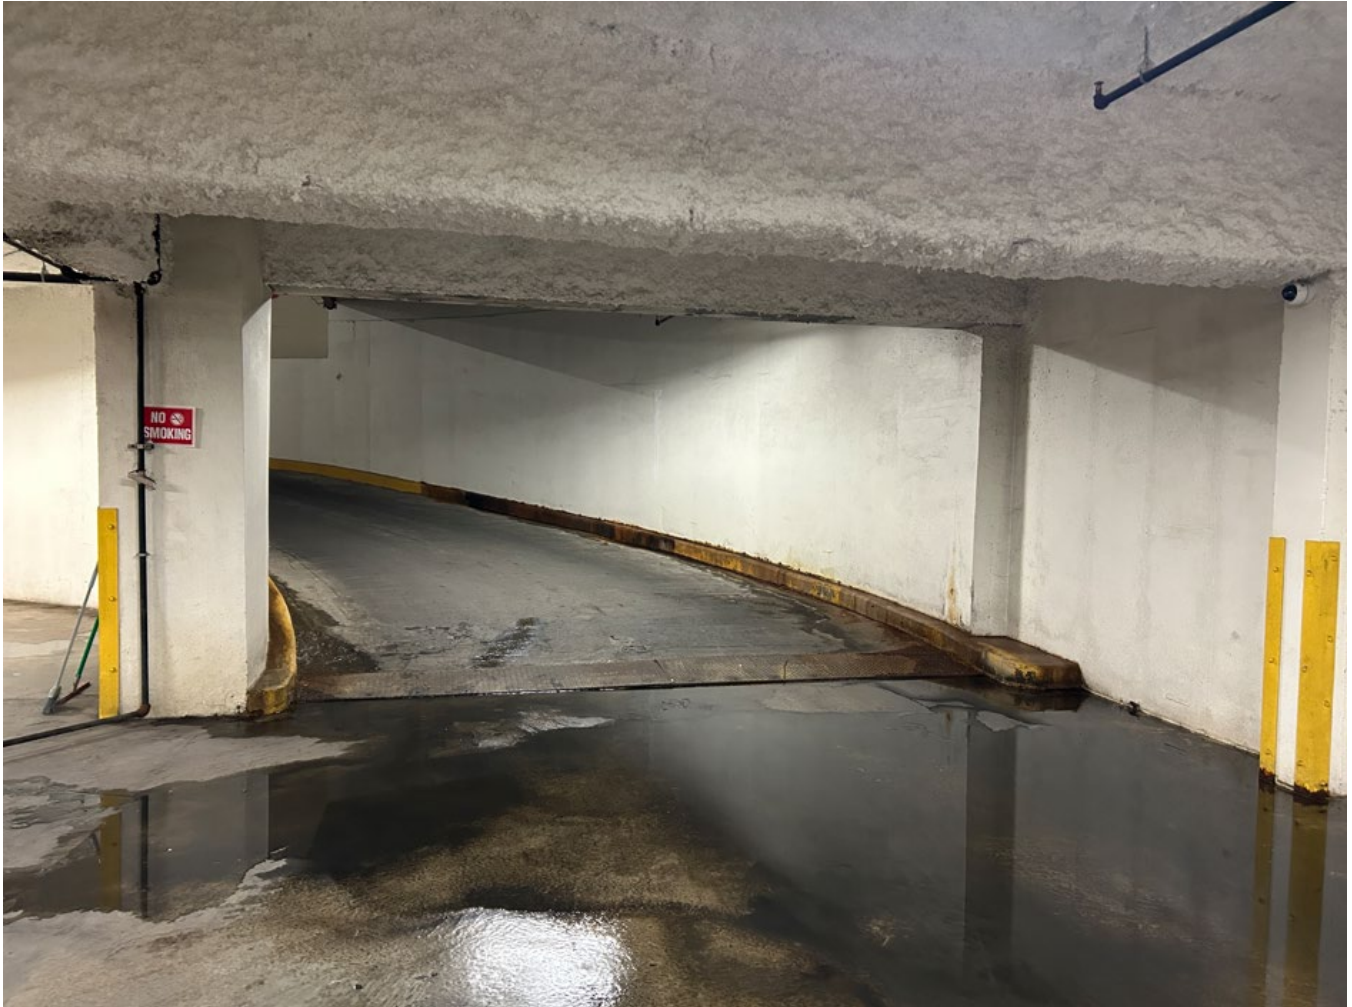
Additional Remarks: Water from a rain event was observed running down the parking garage ramp from East 138th Street.

Photograph No. 1: View of the sub-grade parking garage ramp and sidewalls, facing northeast. Note: The ramp is part of the composite cover system in the Track 4 Remedial Area. Water is from a recent rain event.

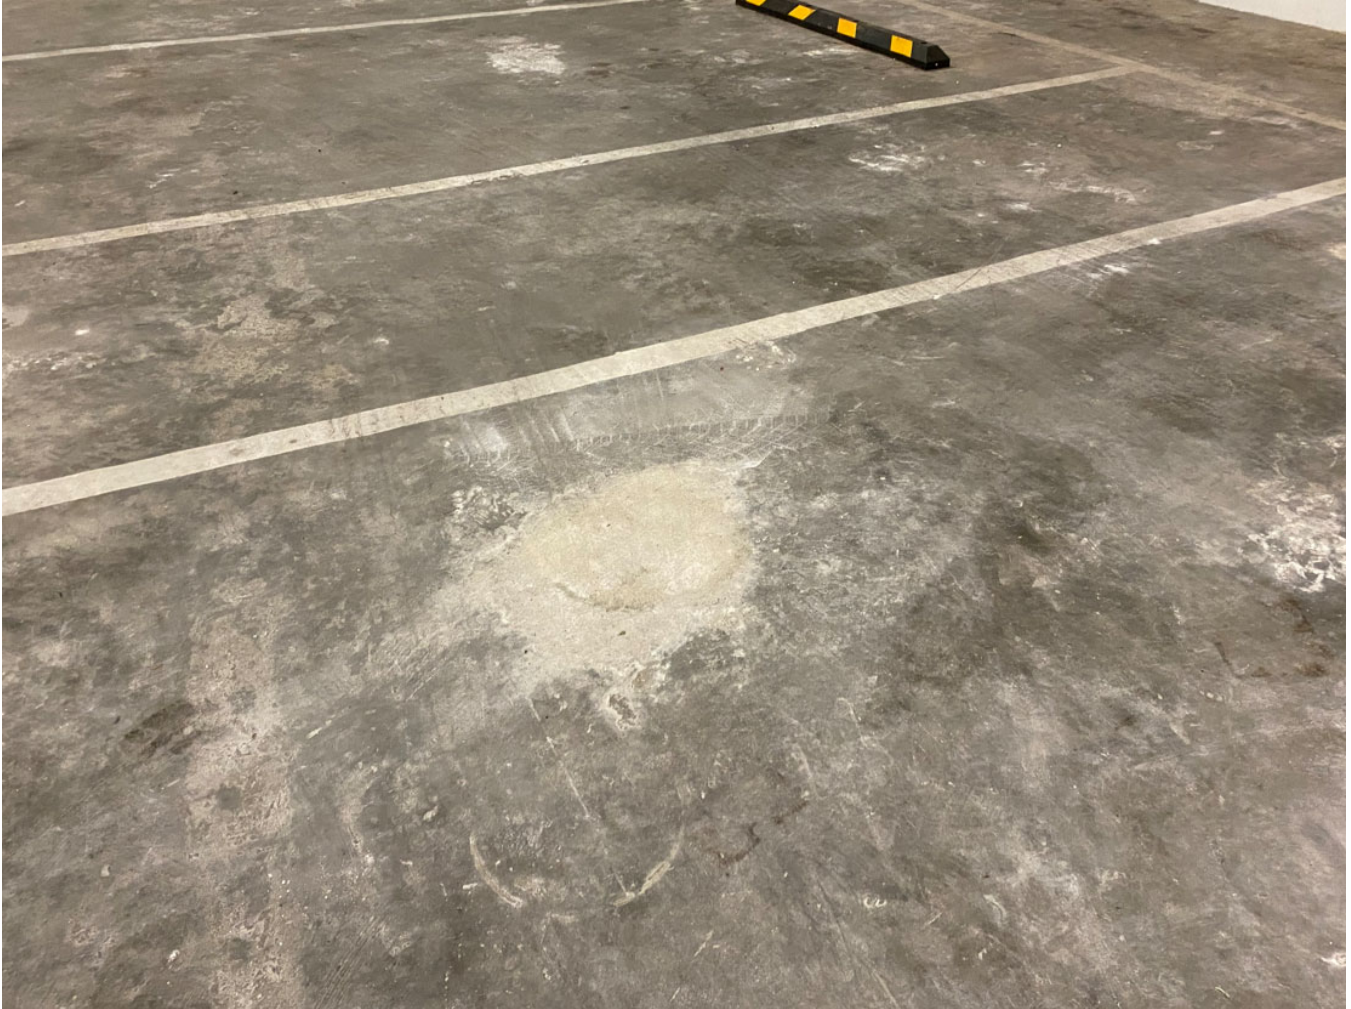
Additional Remarks: Chipped concrete within the basement foundation slab was repaired in 2023. (see photograph log). Water from a rain event was observed in the basement.

Photograph No. 4: Close-up view of an area in the basement where the slab was repaired in 2023.

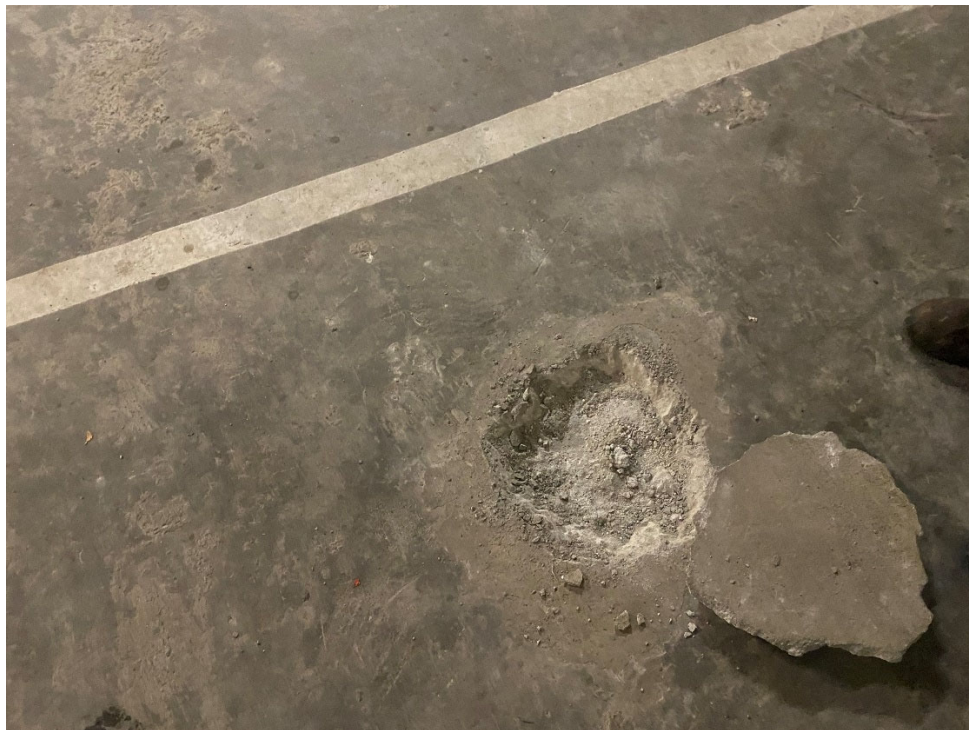
During the 2023 SMP inspection, surficial concrete damage was observed within the foundation slab of the parking garage. VHB documented the concrete foundation repair and is documented in the Site-wide inspection checklists (**Appendix C**) and the photograph logs (**Appendix D**). The damaged concrete was surficial and did not affect the composite cover system; nonetheless, VHB recommended the chipped concrete be repaired to prevent future damage to the composite cover system. During the 2025 inspection, the concrete was observed to be repaired.

Additional Remarks: Chipped concrete was observed in the parking garage foundation slab and should be repaired (see attached photograph log).

Photograph No. 4: Close-up of an area where concrete is chipped in parking garage.
