**PHASE I ENVIRONMENTAL
SITE ASSESSMENT REPORT**

**Vacant Land
3500 Park Avenue
Bronx, NY 10456**

**Date Issued: June 22, 2006
LAC Project Number 06-38210.1**

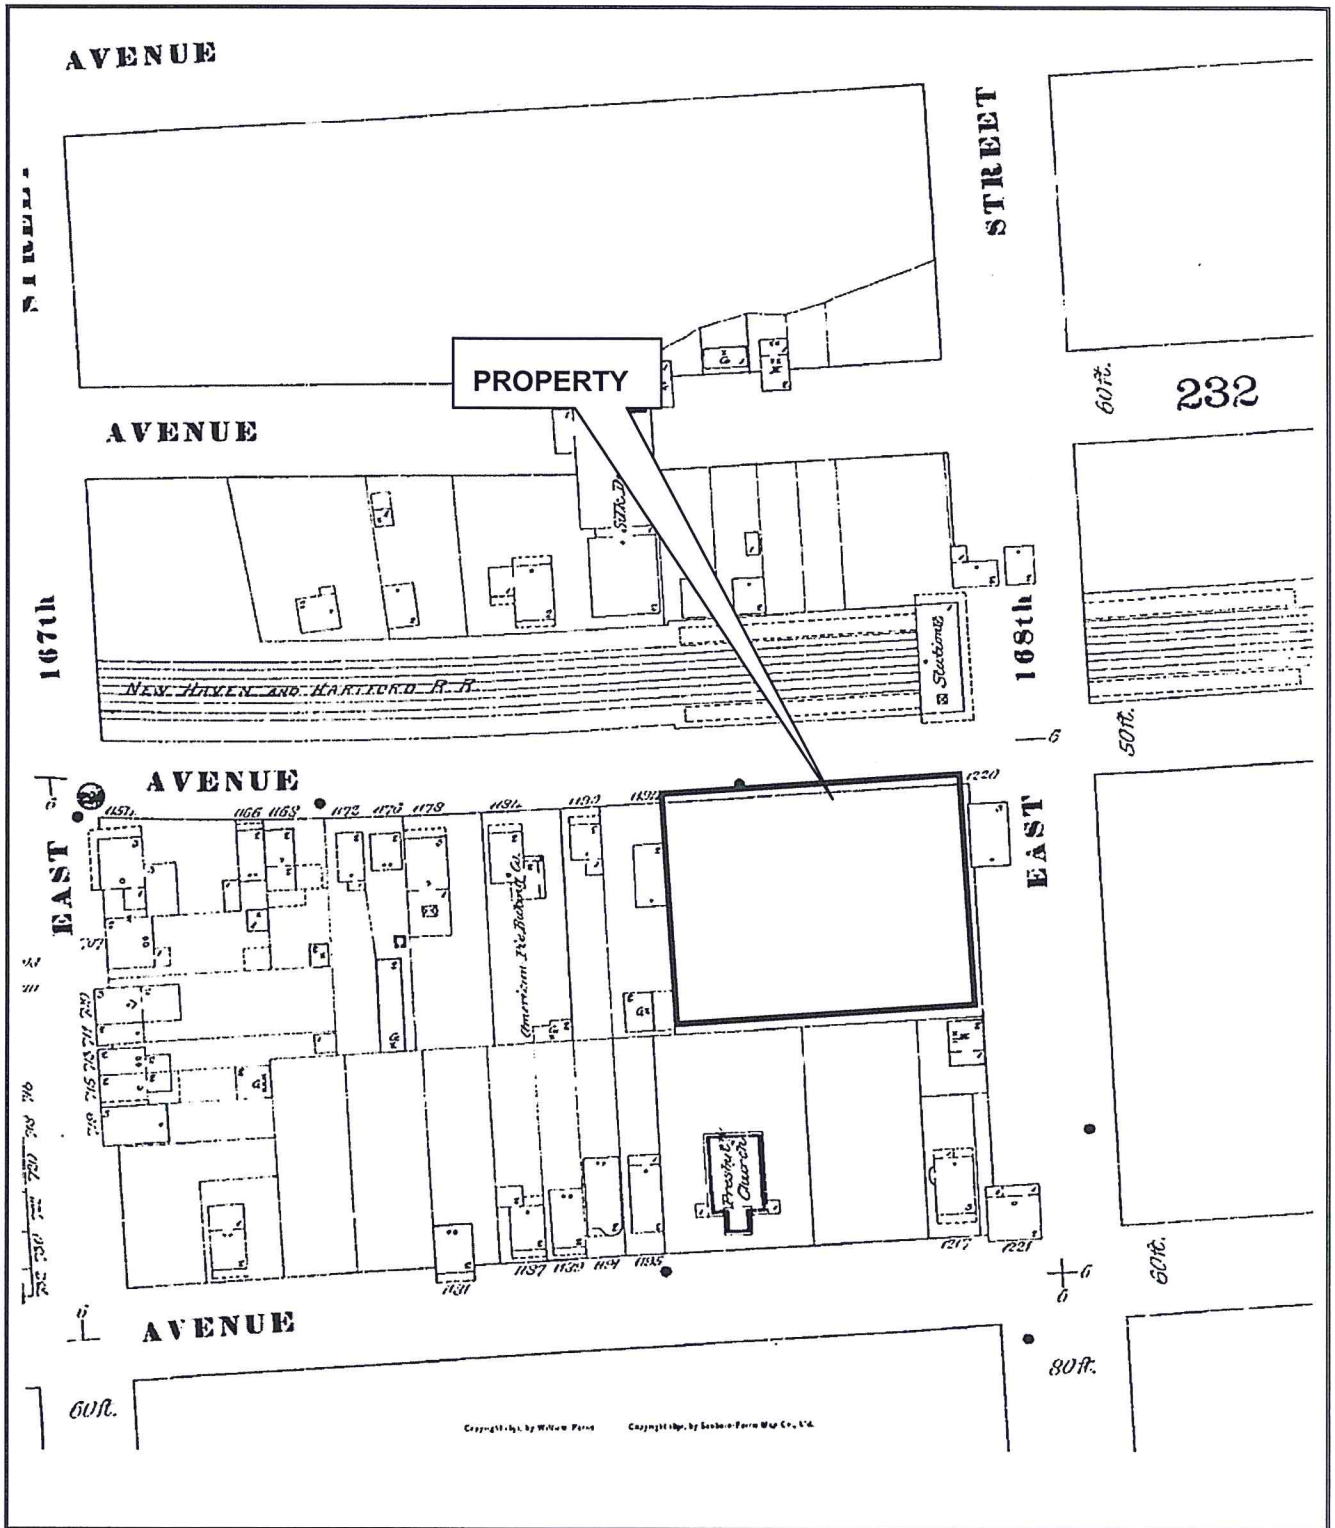
<p>SANBORN MAP</p>	<p>Source: EDR/Sanborn Maps Date: 1891</p>	<p>N↑</p>

- Date:** 1891
Description: The Property is depicted as a vacant undeveloped lot. Scattered residential dwellings are observed in the general vicinity of the Property. A church building is observed to the adjoining east side along Washington Avenue. Park Avenue followed by Railroad tracks are located to the adjoining west side of the Property.

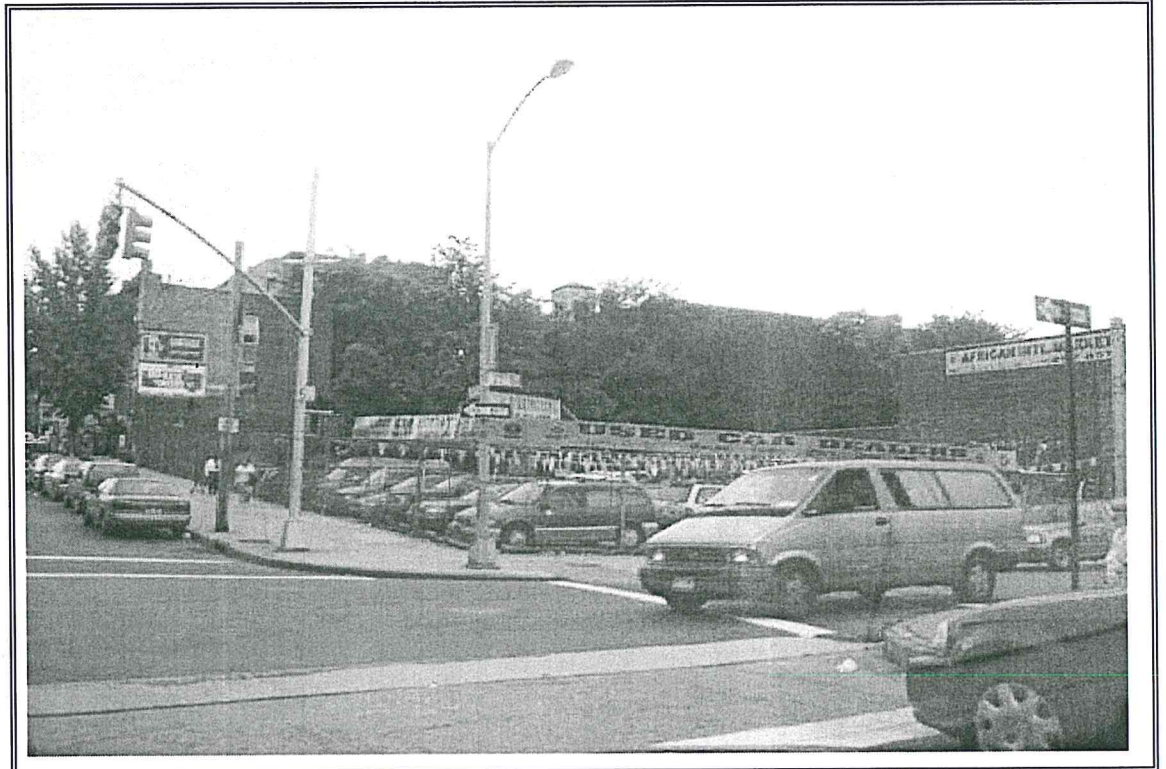
Photograph Number 1: View of the Property from the intersection of Park Avenue and E 168th Street.

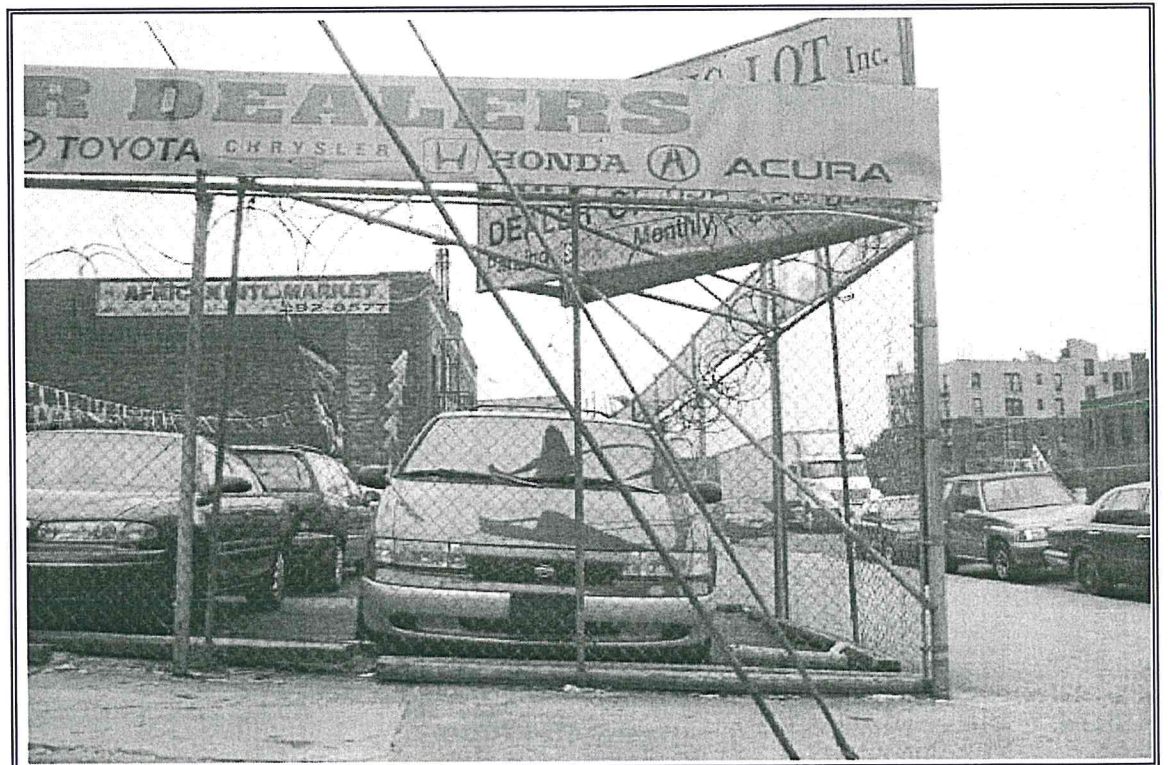
Photograph Number 2: The Property view from E 168th Street.

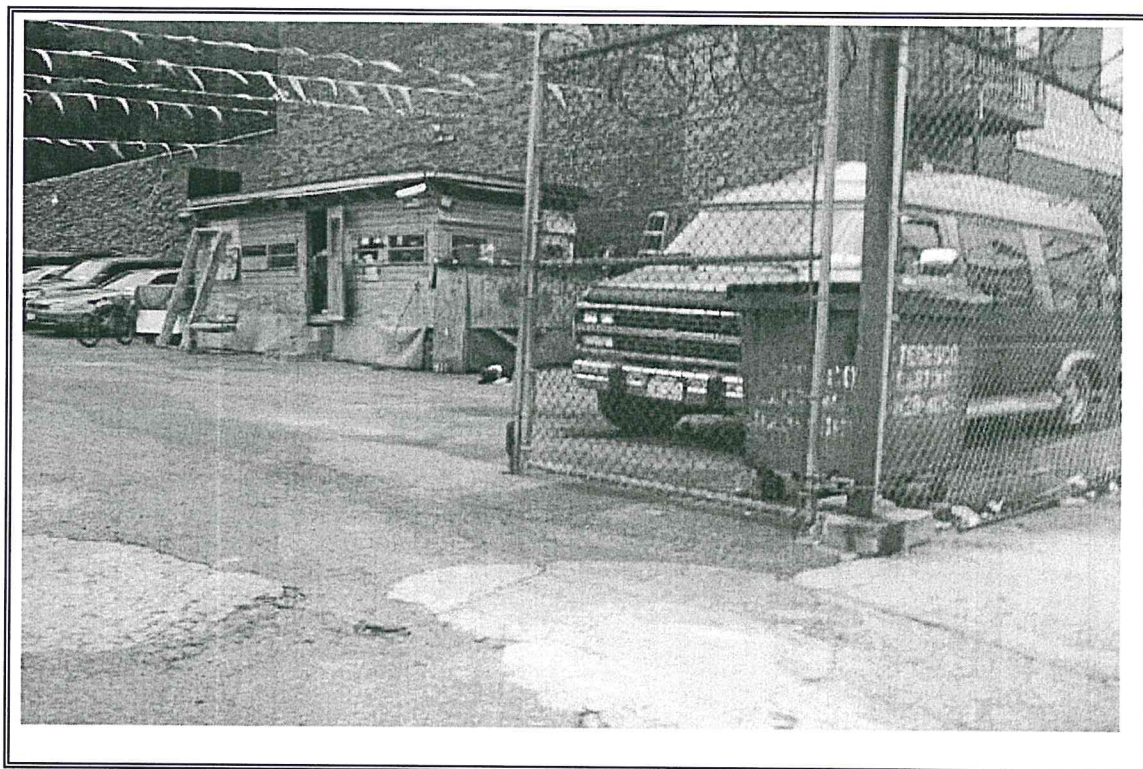
Photograph Number 3: The entrance to the Property parking lot along Park Avenue.

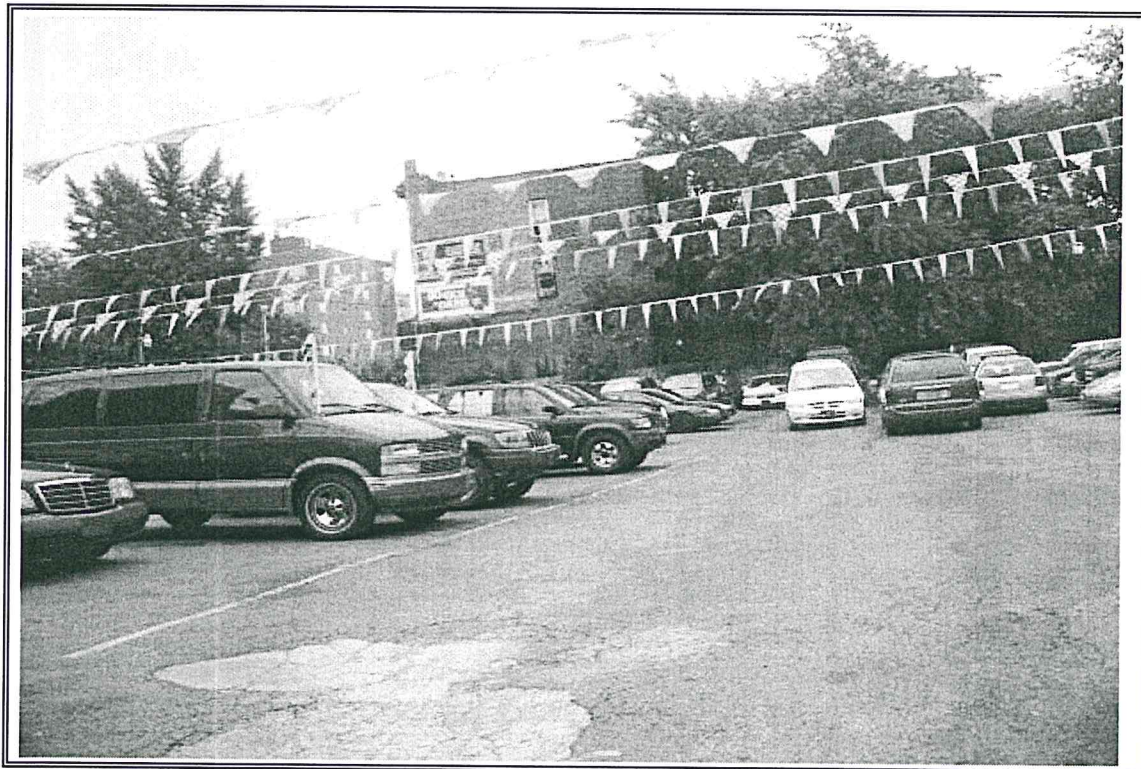
Photograph Number 4: The Property is used as a parking lot.

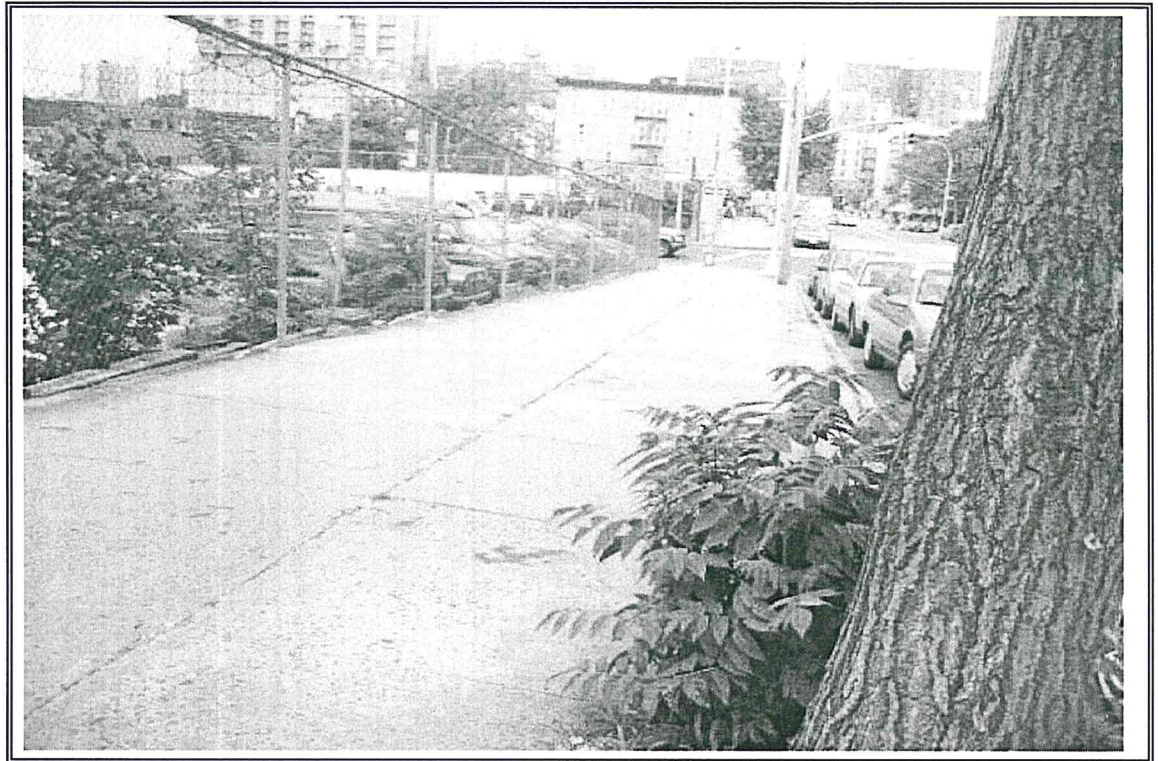
Photograph Number 5: Another view of the Property along E 168th Street. Camera facing west.

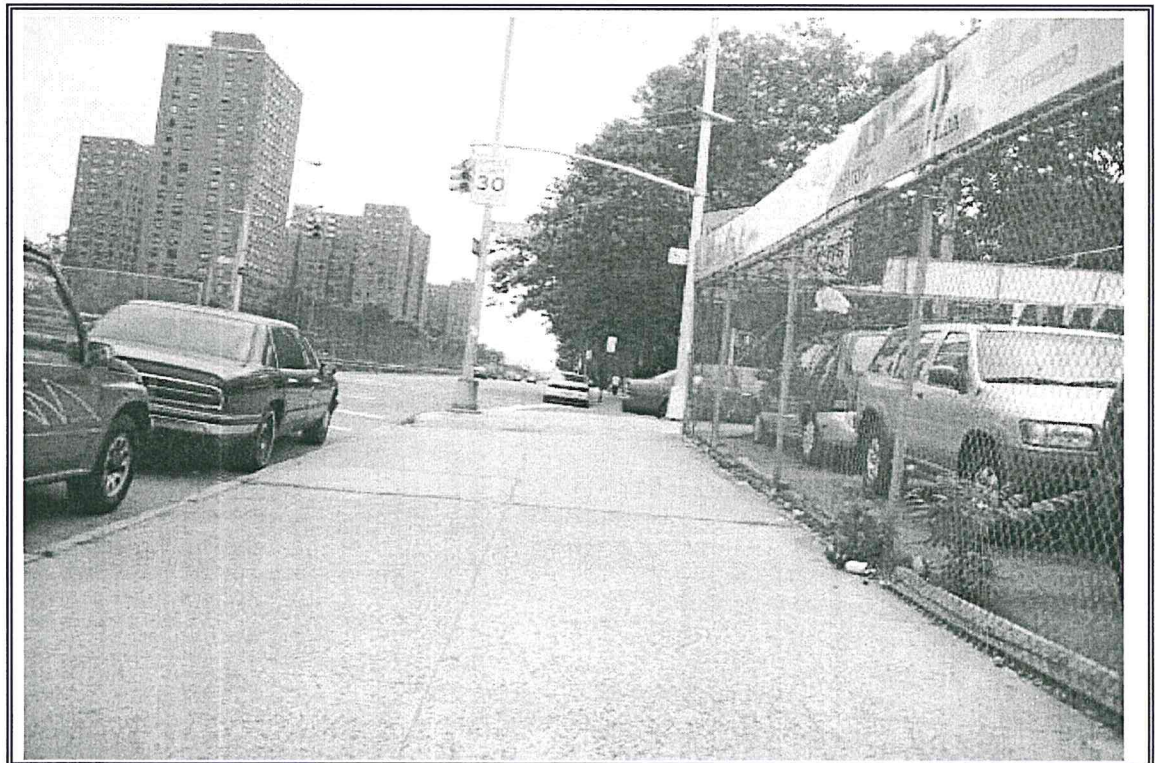
Photograph Number 6 The Property viewed along Park Avenue. Camera facing north.

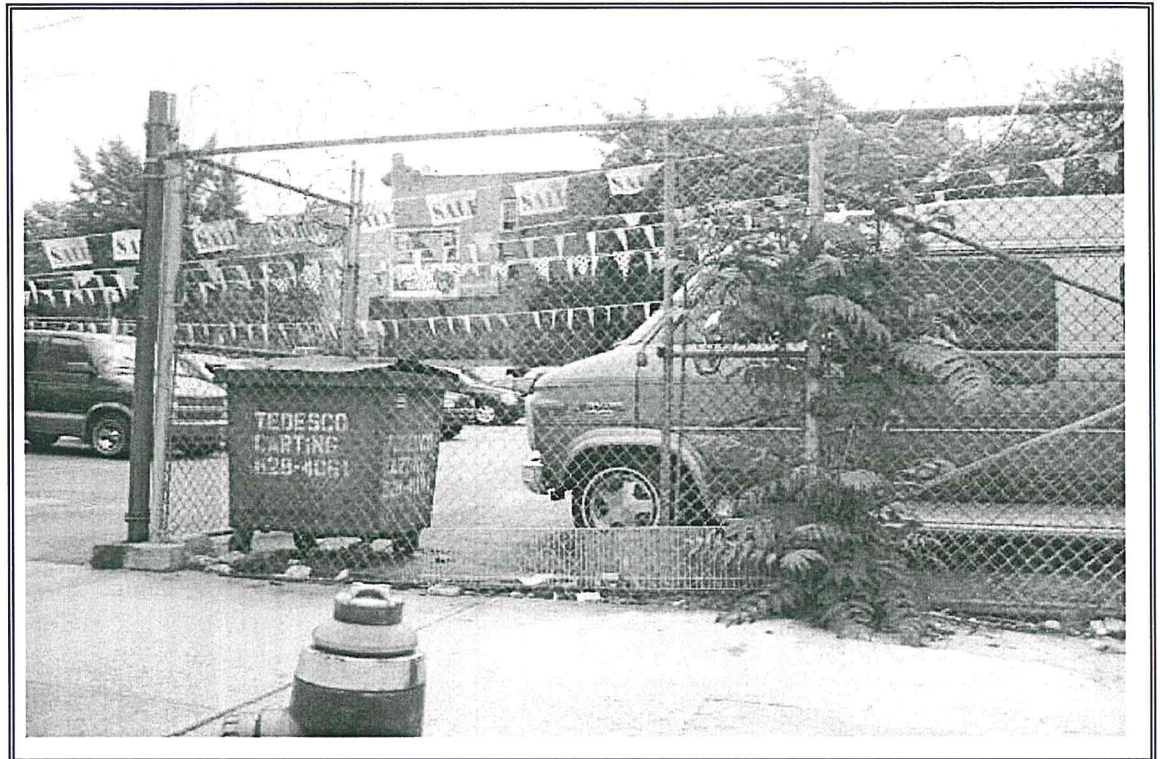
Photograph Number 7: The Property along Park Avenue.

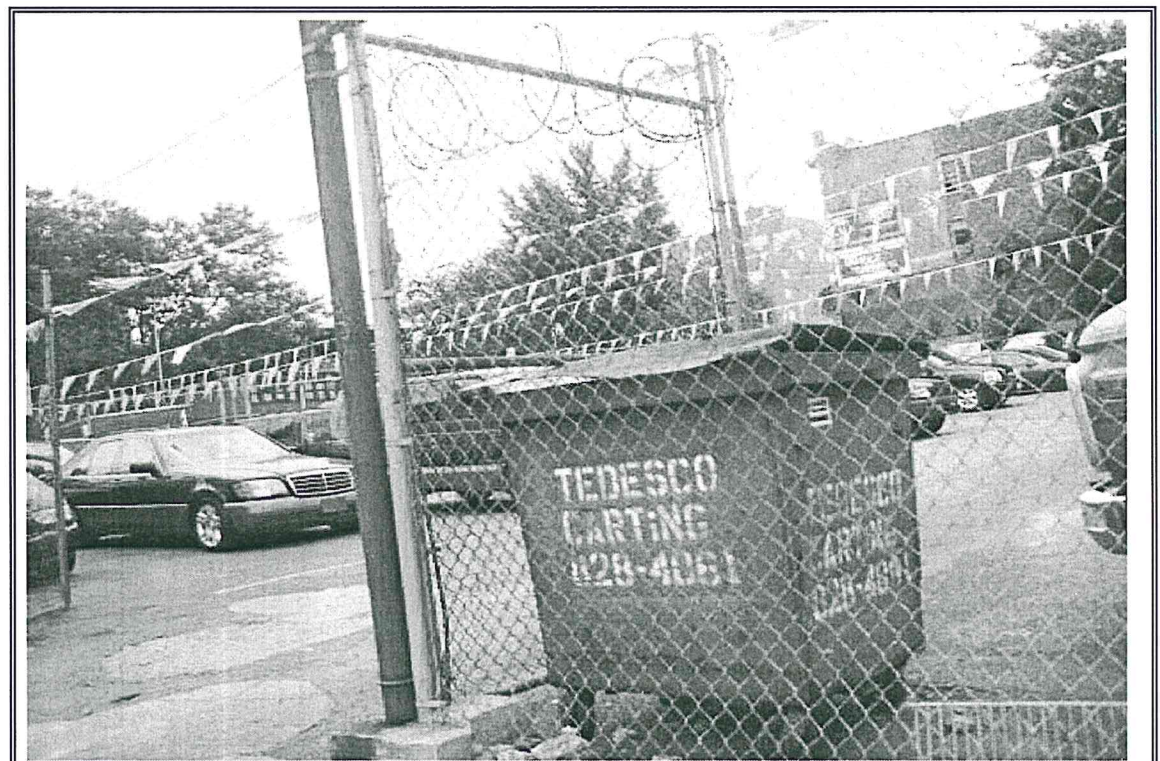
Solid waste on the Property is collected in one dumpster situated on the southwest corner of the Property. The dumpster was noted to contain miscellaneous cardboard at the time of the Property reconnaissance and no indication of potentially hazardous material disposal was noted during LAC's reconnaissance.

Photograph Number 8: A dumpster is placed on the southwestern corner of the Property.

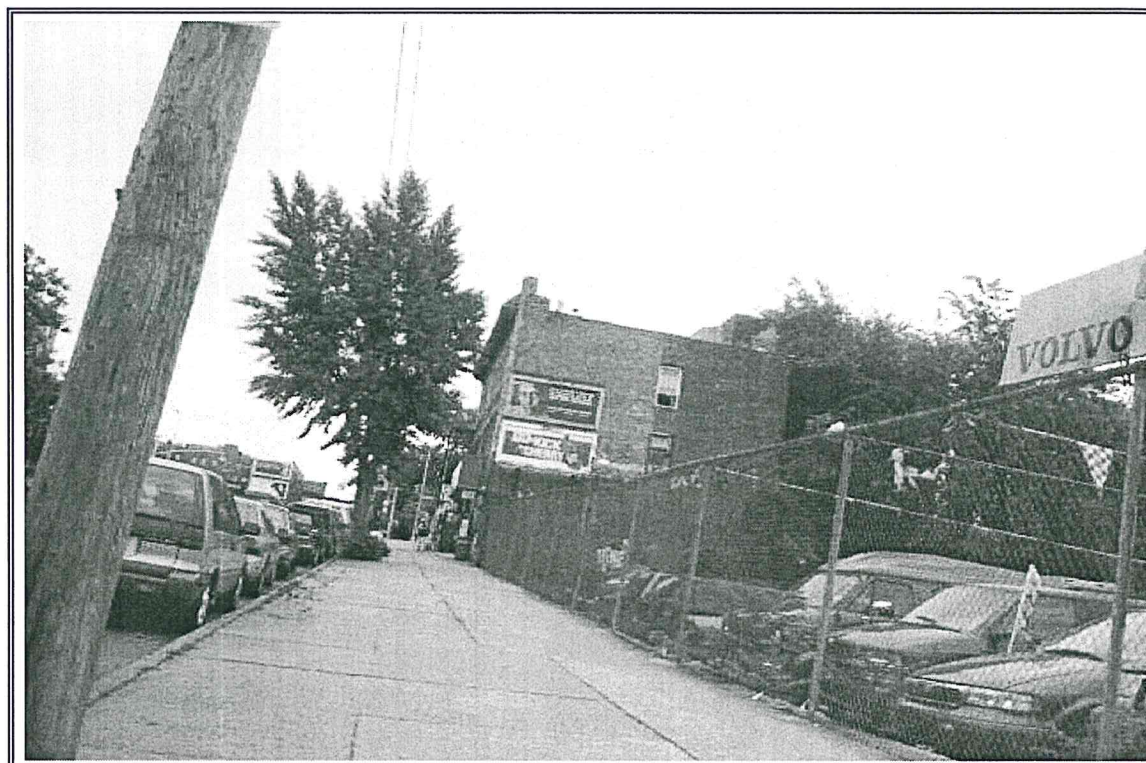
Photograph Number 9: The Property viewed along E 168th Street and adjoining properties to the east of the Property.

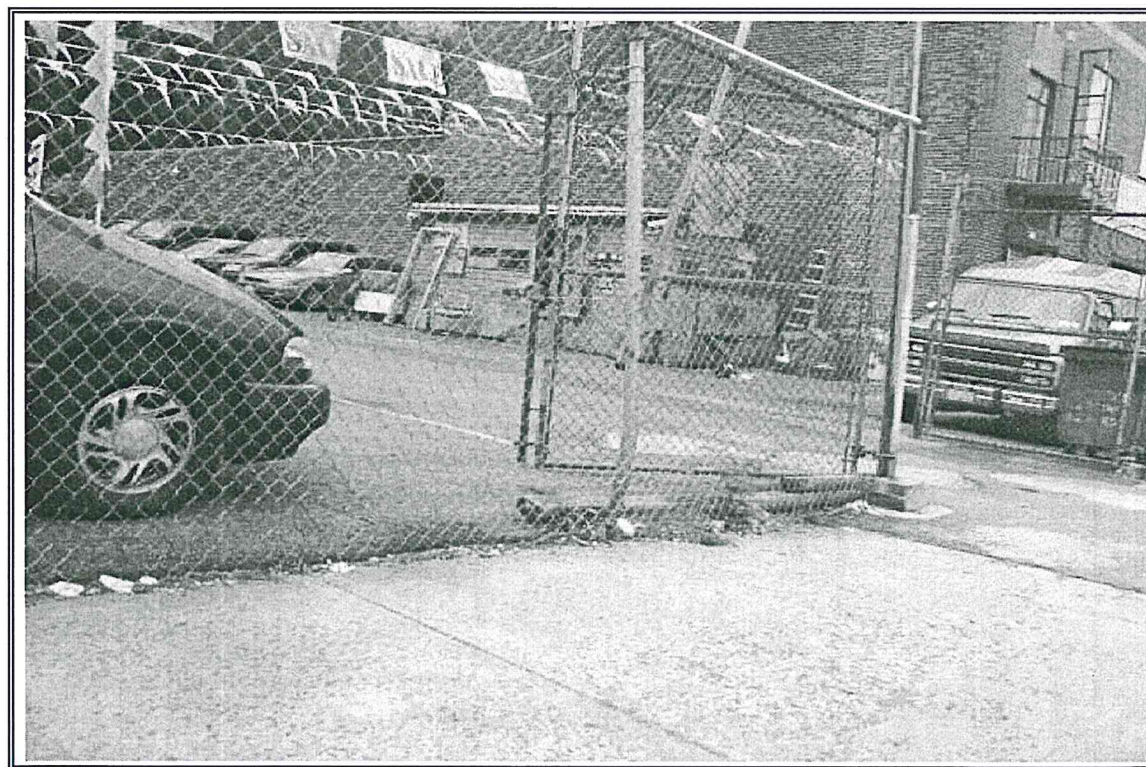
Photograph Number 10: A shed located within the Property.

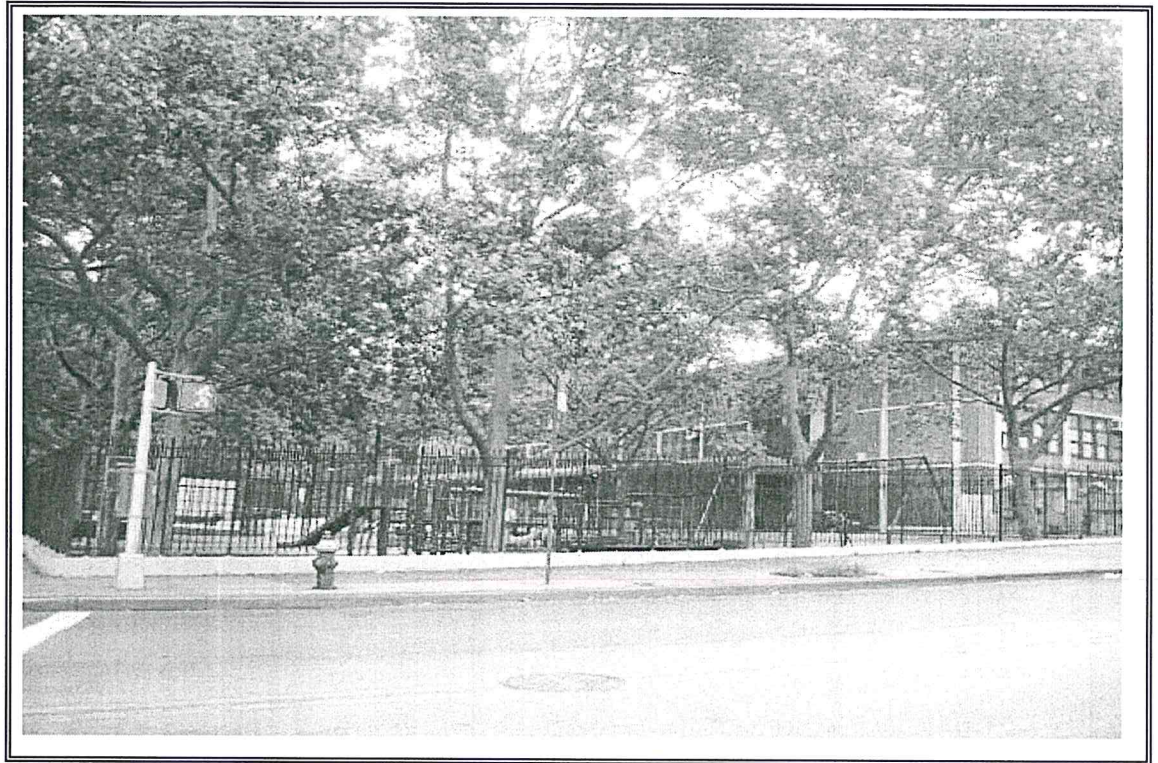
- **PS 132** is located to the adjoining north side of the Property. Review of the database indicated that one (1) 10,000 gallon AST is located at this facility. The database review indicated that no reported leaks or spills are listed at this facility. Based on the absence of any spills or releases, this facility is not expected to pose an environmental concern to the subject Property.

Photograph Number 11: NYC Public School located to the adjoining north side of E 168th Street.

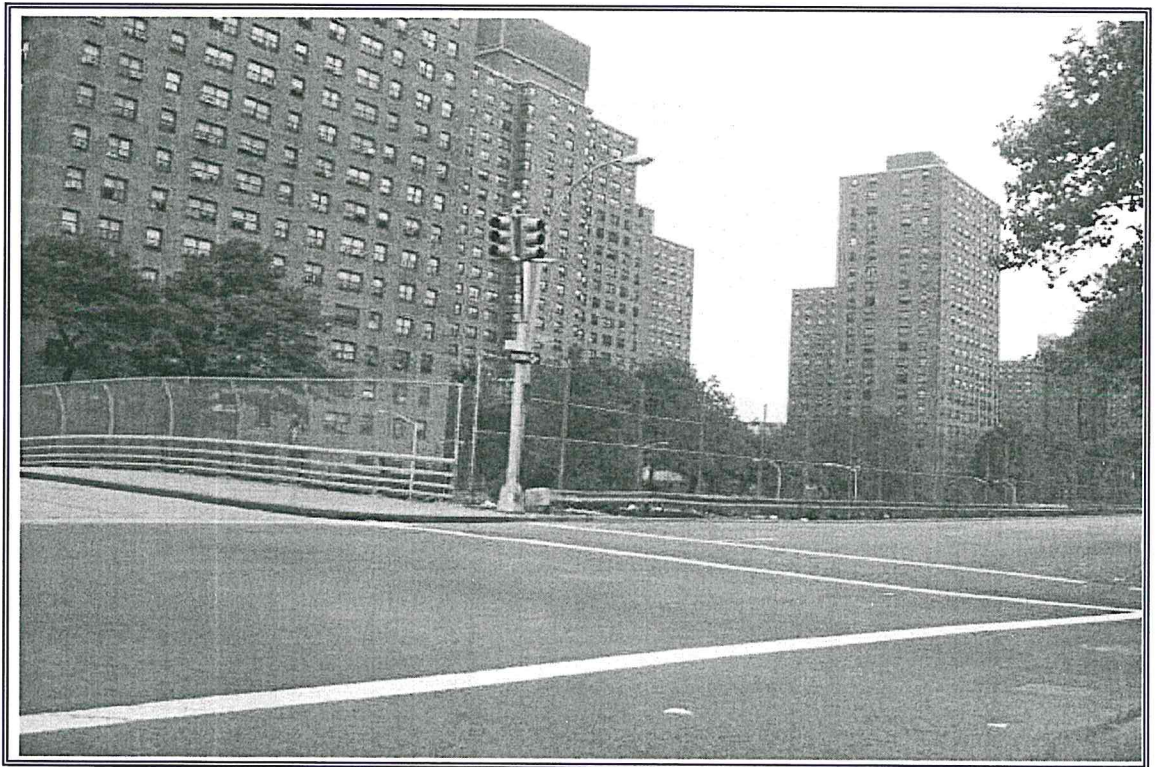
Photograph Number 12: The intersection of Park Avenue and E 168th Street located to the northwest corner of the Property.

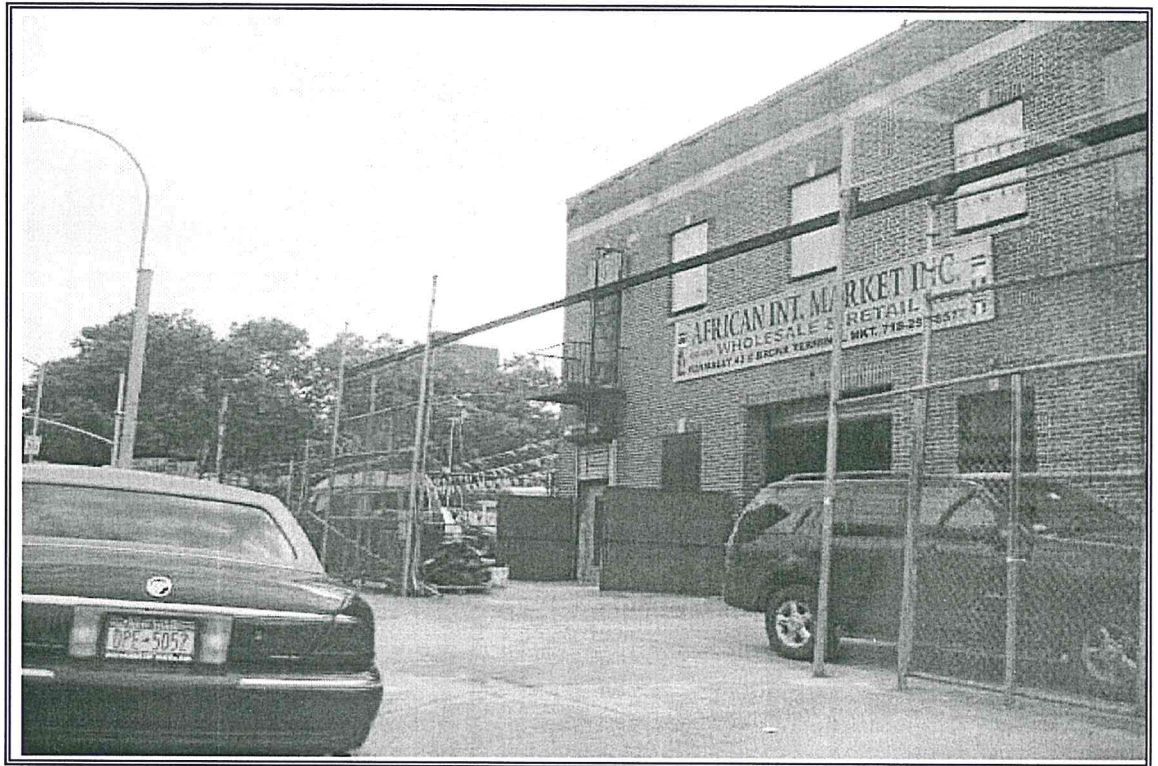
- **3494 Park Avenue** is located to the adjoining south side of the Property. Review of the database indicated that one 1,500 gallon UST was administratively closed at the facility in 1995. The database review indicated that no reported leaks or spills are listed at this facility. Based on the absence of any releases, this facility is not expected to pose an environmental concern to the subject Property.

Photograph Number 13: Warehouse located to the adjoining south side of the Property along Park Avenue.

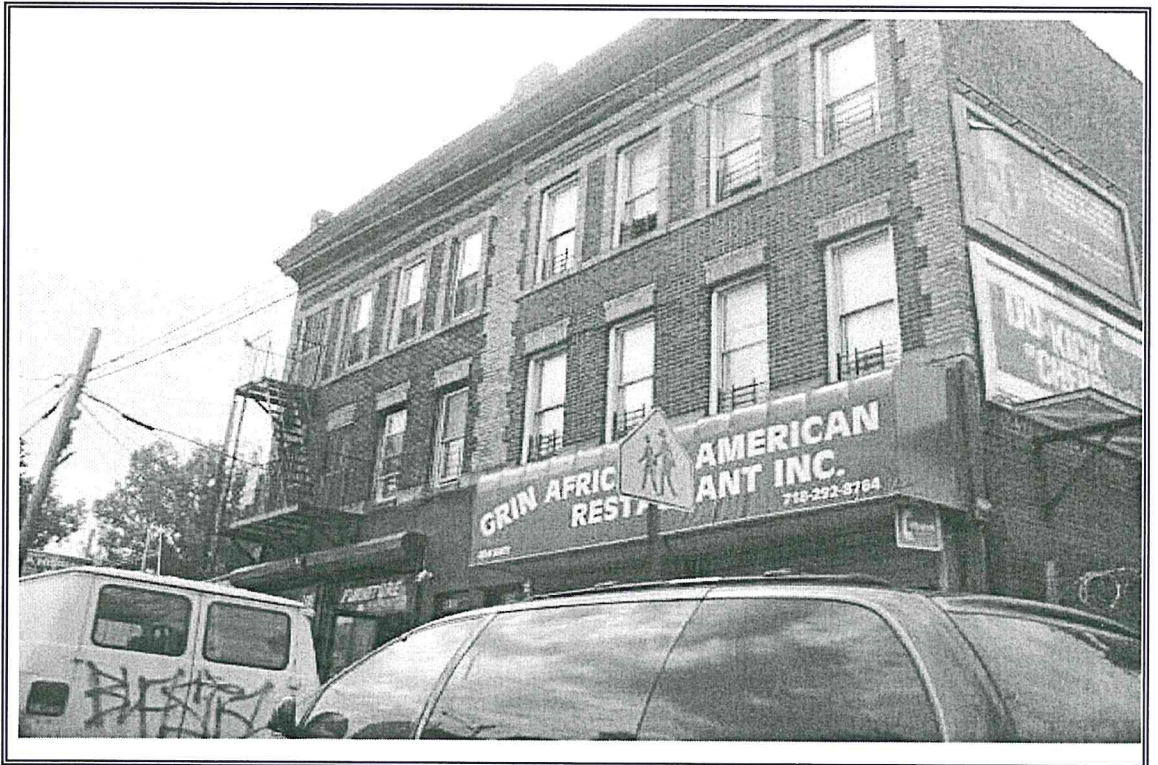
Photograph Number 14: Residential apartment building with street level retail stores located to the adjoining east side of the Property.

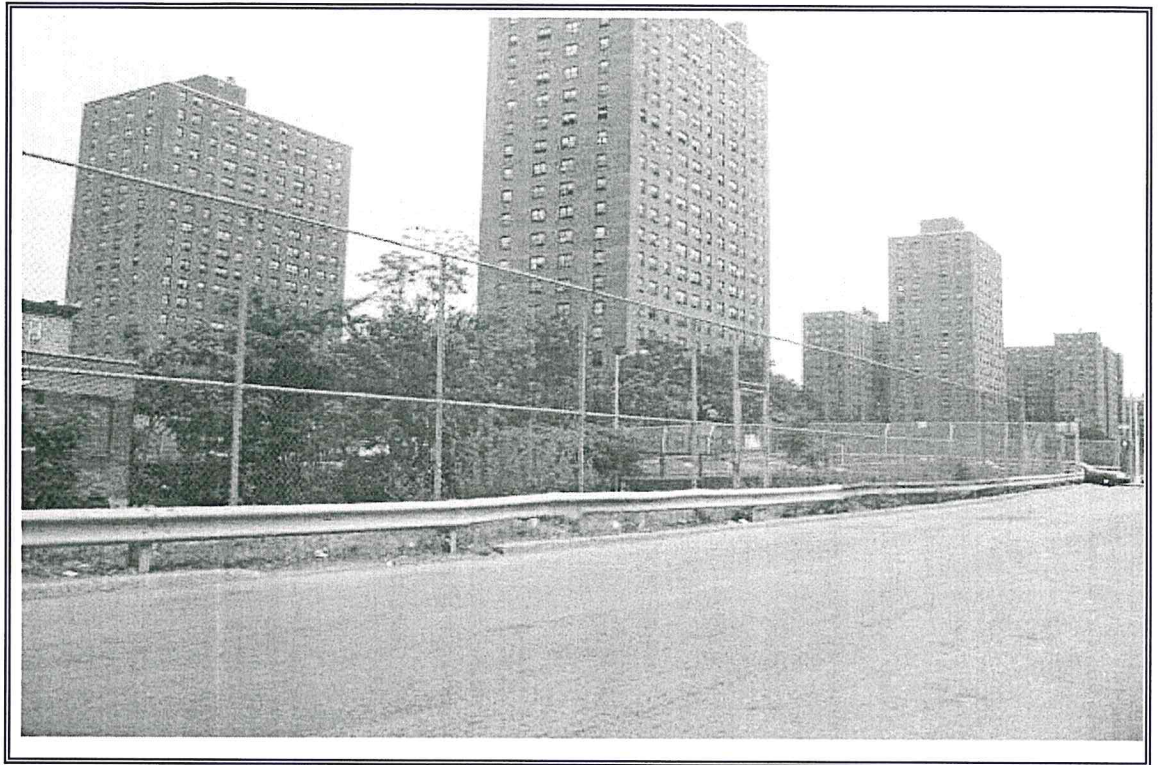
Photograph Number 15: Park Avenue followed by Metro-North Railroad tracks followed by residential apartment buildings to the adjoining west side of the Property.

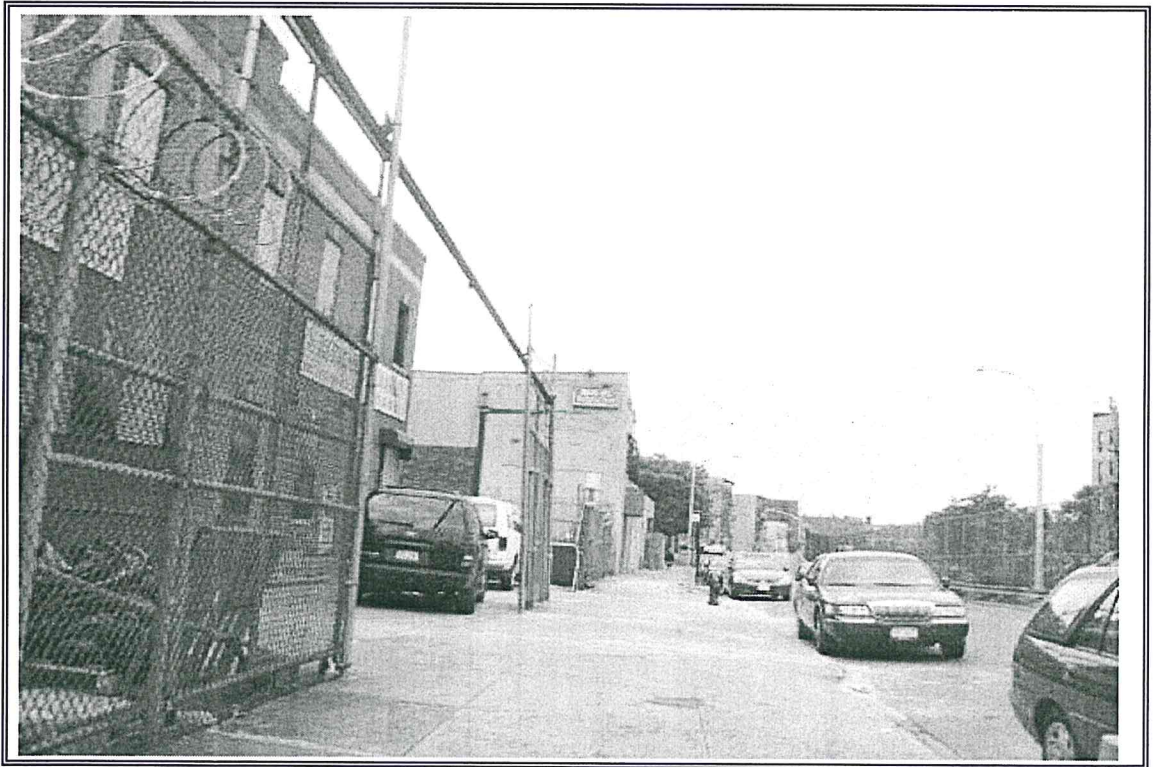
Photograph Number 16: Commercial properties located to the adjoining south side along Park Avenue.
