3500 Park Avenue Apartments Site

3500 Park Avenue

Periodic Review Report

NYSDEC Brownfield Cleanup Program Site Number: C203096

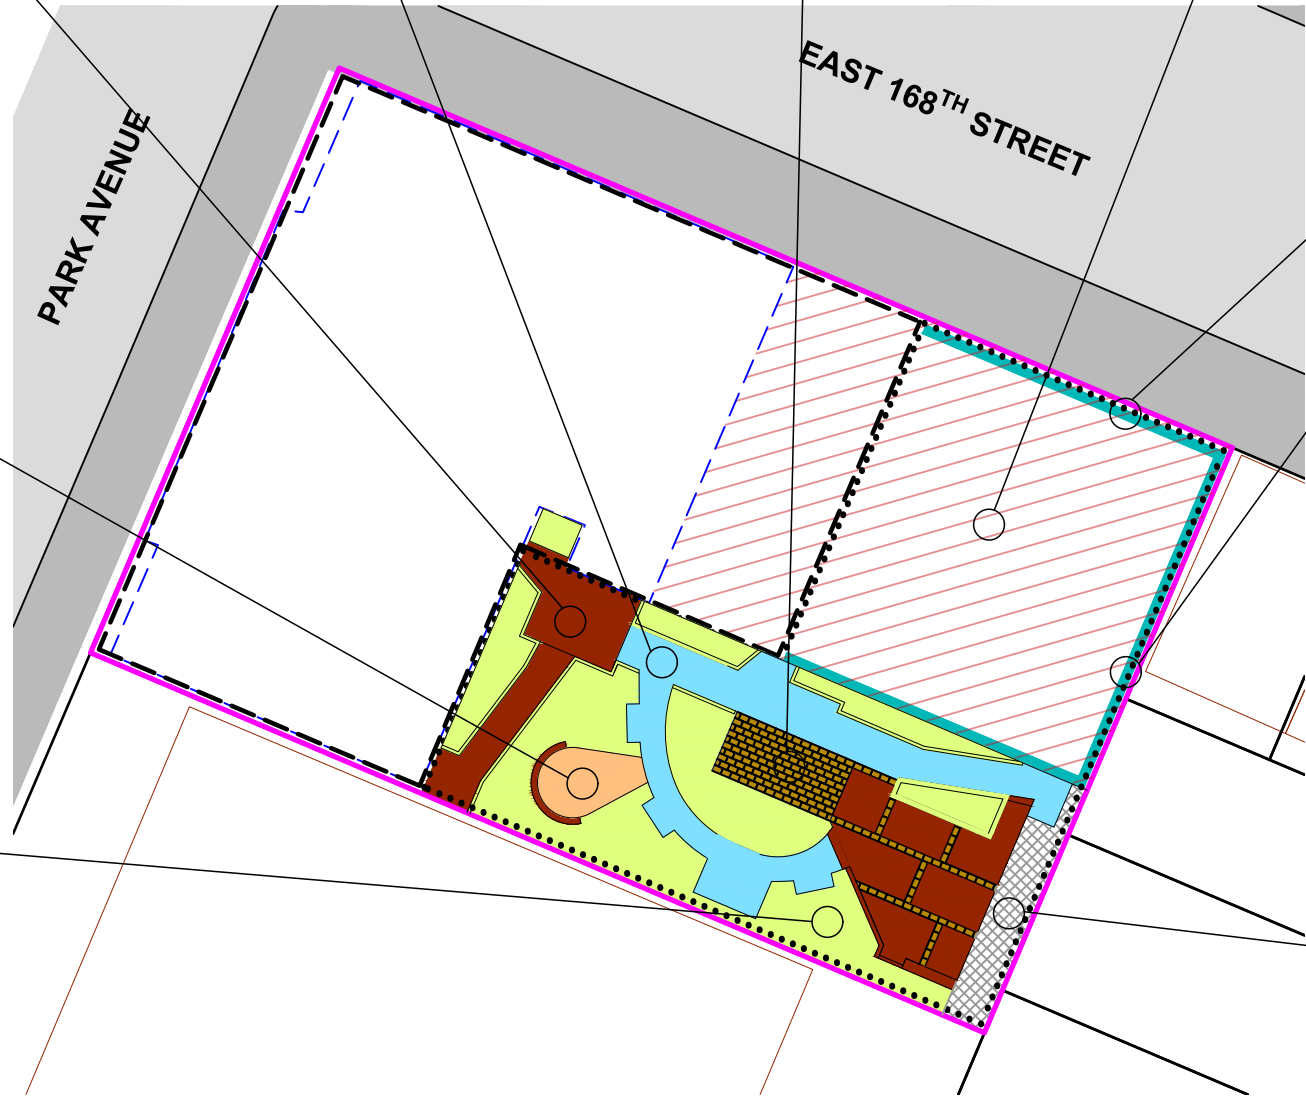
SITE COVER SYSTEM PLAN

The demarcation barrier installed beneath the two-foot clean fill buffer and underlying remaining soil was not disturbed during the additional rear courtyard construction activities performed in 2020 following approval of the SMP and FER and issuance of the COC in 2019. The additional site cover system components installed in the rear courtyard of the Site are included in the revised Site Cover System Plan provided as Figure 3.

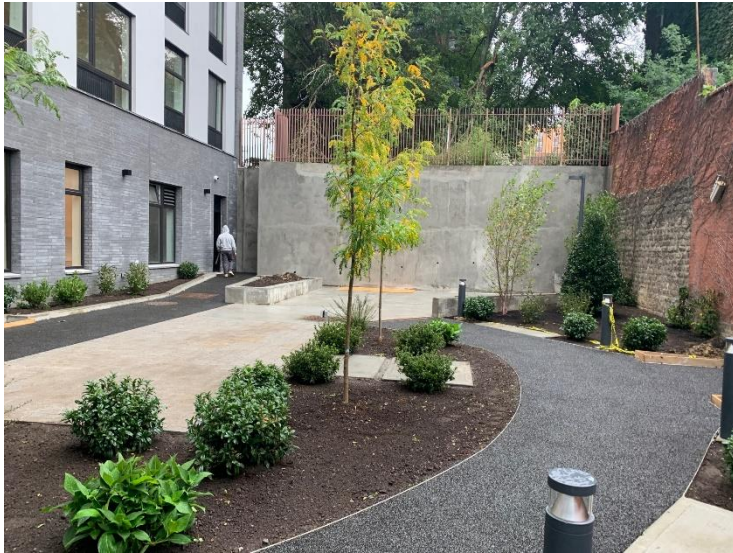
Photograph 1: The completed rear courtyard following installation of additional hardscaping and landscaping components, view facing east.

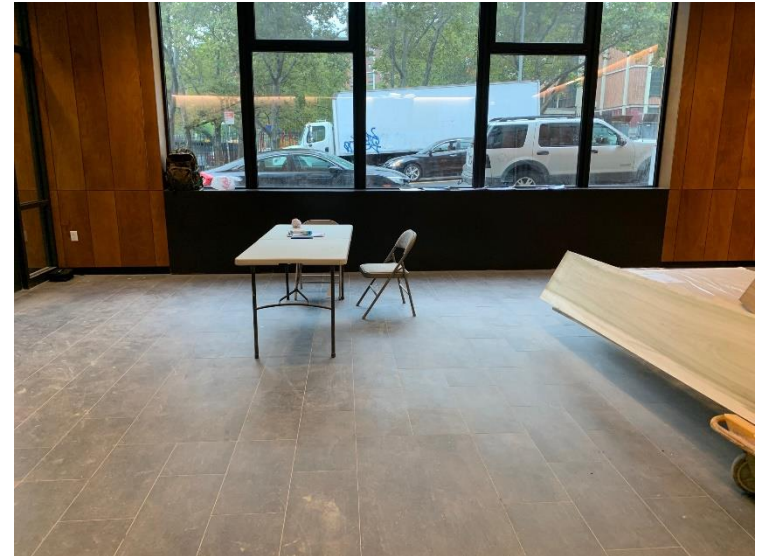
Photograph 2: The main residential lobby on the ground floor along East 168th Street, view facing north.

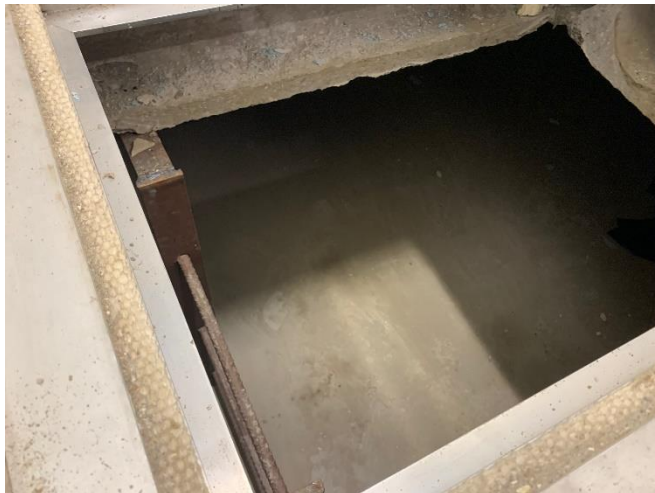
Photograph 3: The crawl space access hatch and crawl space slab located within the northeastern portion of the Track 4 area of the Site.

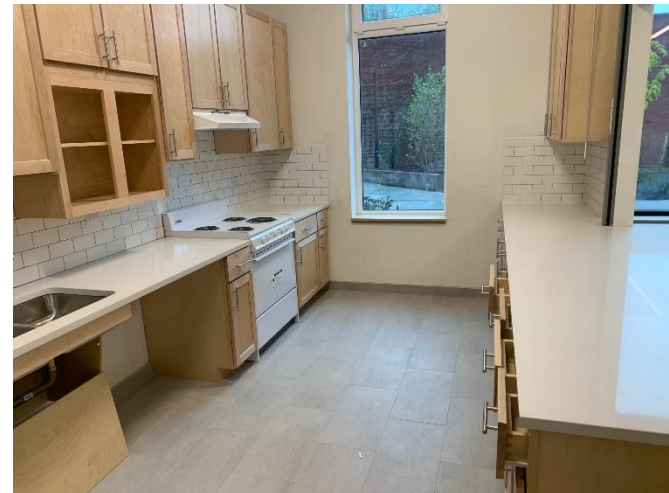
Photograph 4: The kitchen within the residential unit on the ground floor, view facing south.
