Daily Activity Report

2413 Third Avenue
Bronx, New York
BCP No. C203137

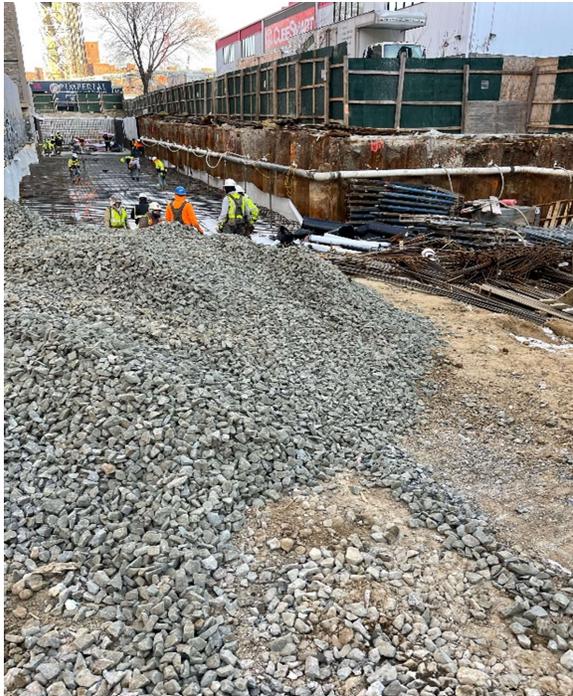
Photograph 1 -
Imported 1.5-inch
stone for site grading.
Redevelopment work
progress can be seen in
the background.

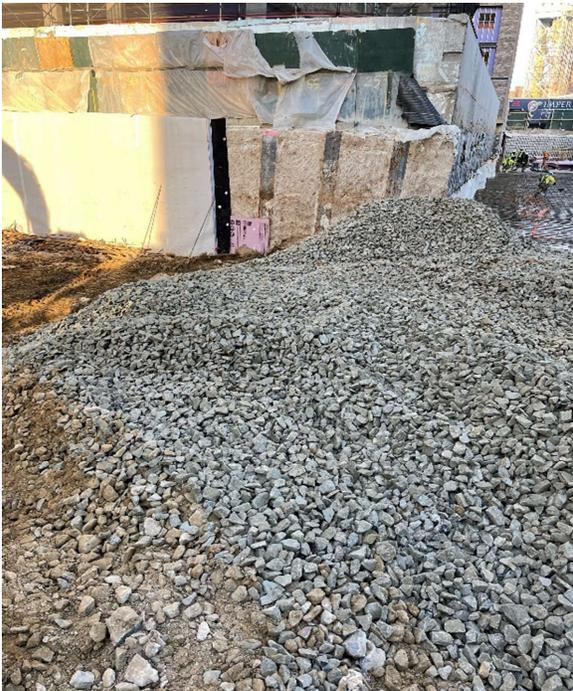
Photograph 2 -
Imported 1.5-inch
stone used for site
grading.
