## Daily Activity Report

2413 Third Avenue  
Bronx, New York  
BCP No. C203137

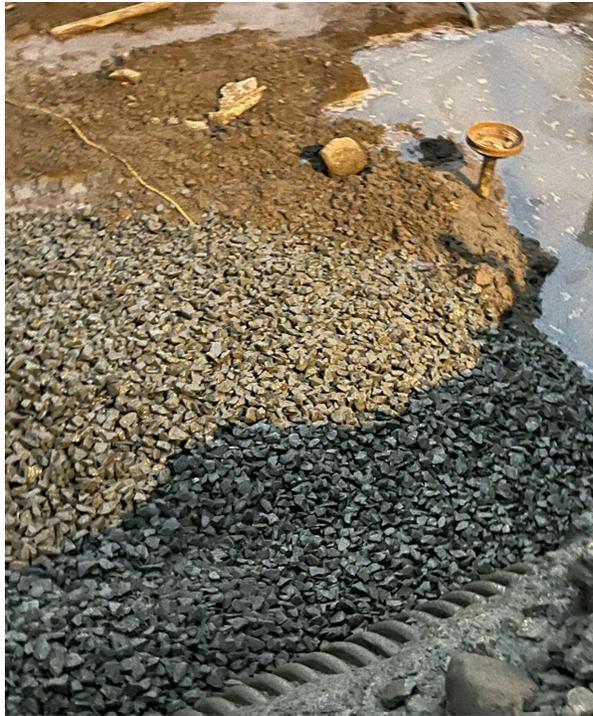
Photograph 1 -  
Close-up view of the  
imported 1.5-inch  
stone. The stone will  
be used for backfilling  
below the Site cap.

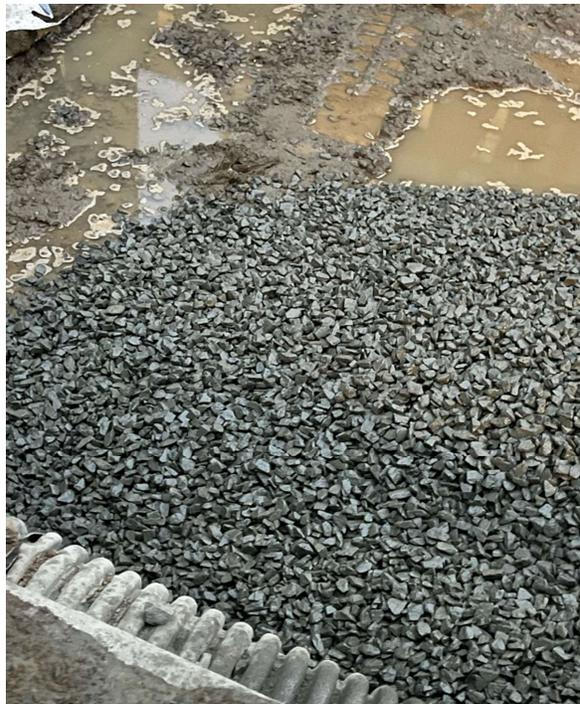
Photograph 2 -  
Close-up view of the  
imported 1.5-inch  
stone. The stone will  
be used for backfilling  
below the Site cap.
