Daily Activity Report	
		100 East 149 th Street Site	
		100 East 149 th Street, Bronx, New York	
		BCP No. C203159	
General Site Information			
Date:	Friday, December 1, 2023		
Weather:	Cloudy, 37-51°F		
Wind Direction/Speed:	NE 7 mph		
Touchstone Personnel on Site:	Firat Ataman		
Touchstone Equipment on Site:	Mini RAE 3000 Photoionization Detectors [(PID) x 2] and DustTrak Aerosol Monitors (x1)		
Visitors:	NYSDEC Project Manager Erick Bower		
Contractor Information			
Contracting Company	Main Personnel	Equipment	
Drilling Contractor: PG Environmental Services, Inc.		Excavator, Jack Hammer	
Description and Location of Work Activities Performed			
<p>The Community Air Monitoring Program (CAMP) was implemented throughout the workday until it began to rain in the afternoon. Upwind CAMP readings were high due to the proximity of the dust monitor to the excavator and due to work/repairs being conducted on the sidewalk.</p> <p>Touchstone performed a Site Investigation in the southern portion of the Site to investigate a suspect underground storage tank (UST) anomaly identified in former investigations of the Site and to investigate the cause of refusals in the area during the implementat

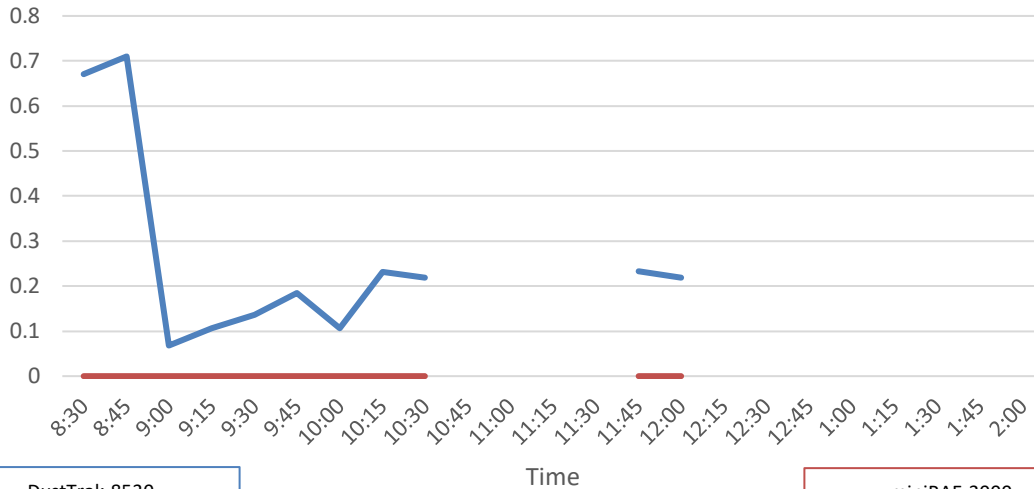
100 East 149th Upwind CAMP Station

Min	Avg	Max
0.068	0.262	0.710

Upwind readings were high because of excavator was close and engine smoke and also site work repair was going on some welding happened during monitoring.

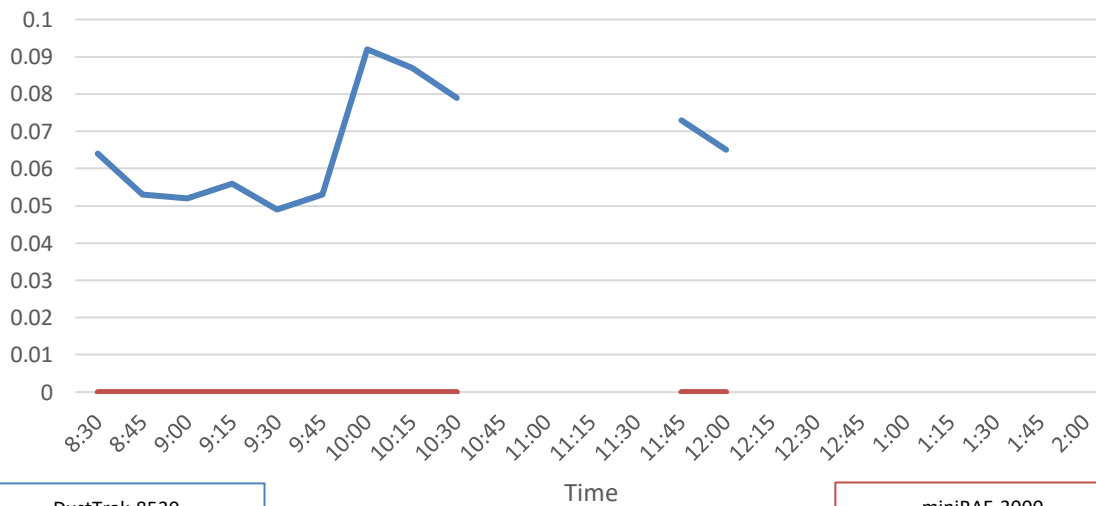
100 East 149th Downwind CAMP Station

Min	Avg	Max
0.049	0.066	0.092

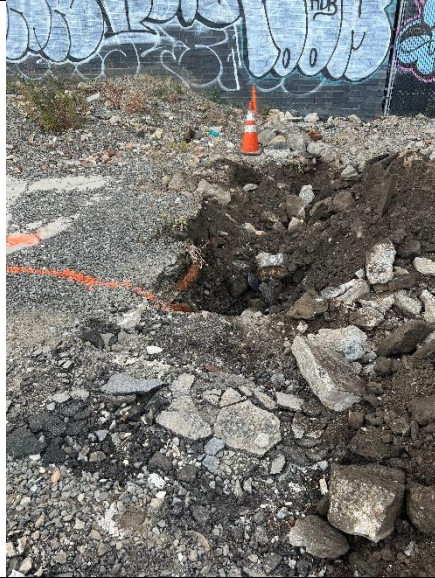
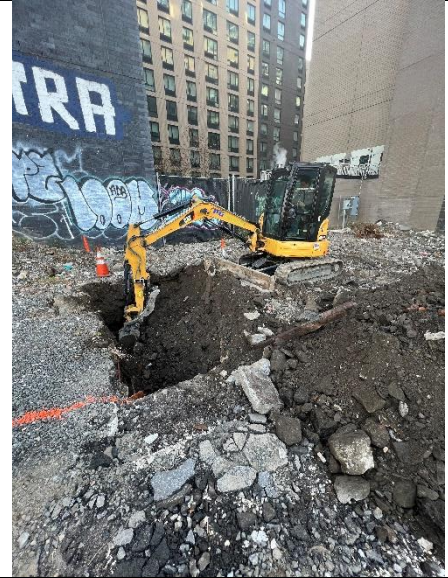
Photograph 1 –
Site Investigation
Excavation

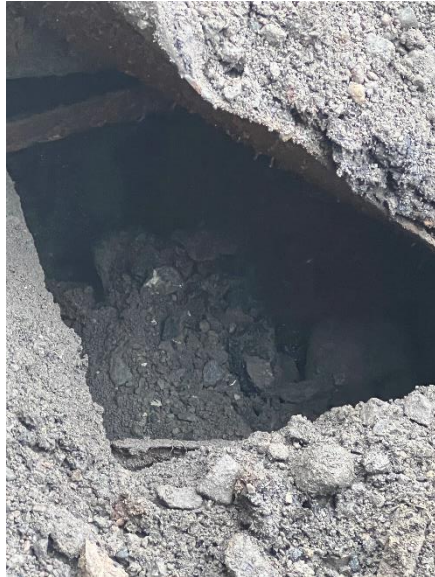
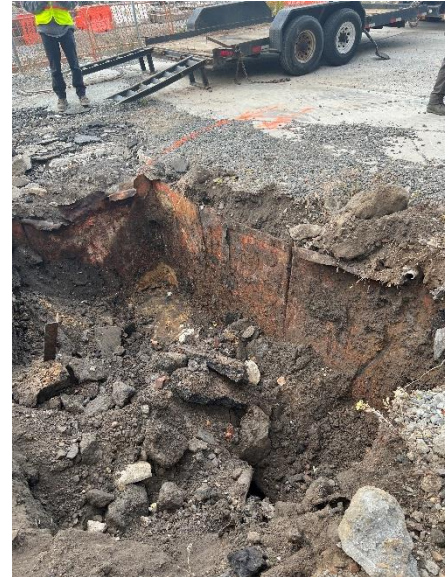
A Site Investigation was performed which included the use of an excavator in the southern portion of the Site. An automotive repair pit and drain pit were identified. Contaminated soil was identified during the excavation and was properly separated and stored in a drum at the Site for disposal. An old hydraulic oil tank was also identified. The tank was dry and was wrapped in plastic. A concrete footing and steel post from a former billboard were identified on the western portion of the Site,

Photograph 2 –
Identification of
Automotive Repair
Pits

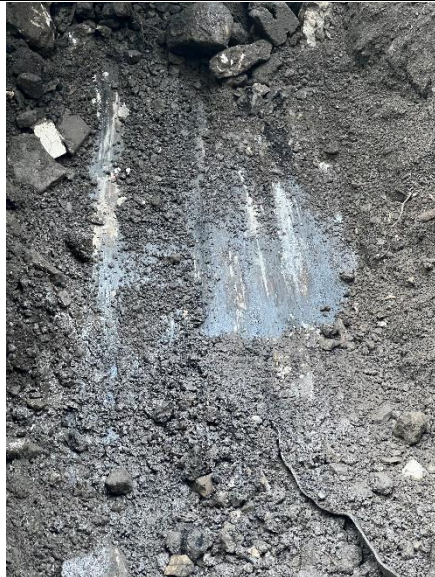
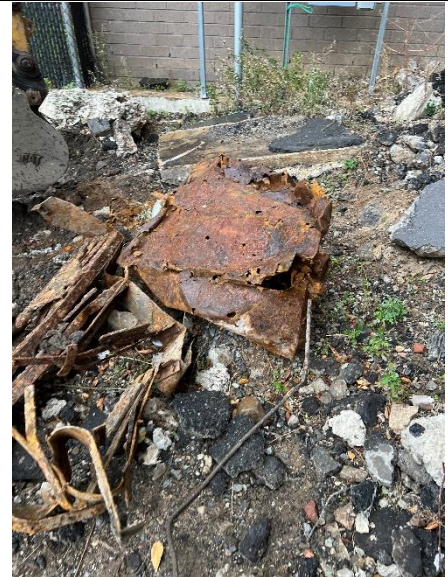
Photograph 3 –
Base of Automotive
Repair Pit and
Identified Old
Hydraulic Oil Tank

39.3 ppm
0.8
