1099 Webster Ave
Supplemental Investigation Results Report
1099 Webster Ave, Bronx, NY

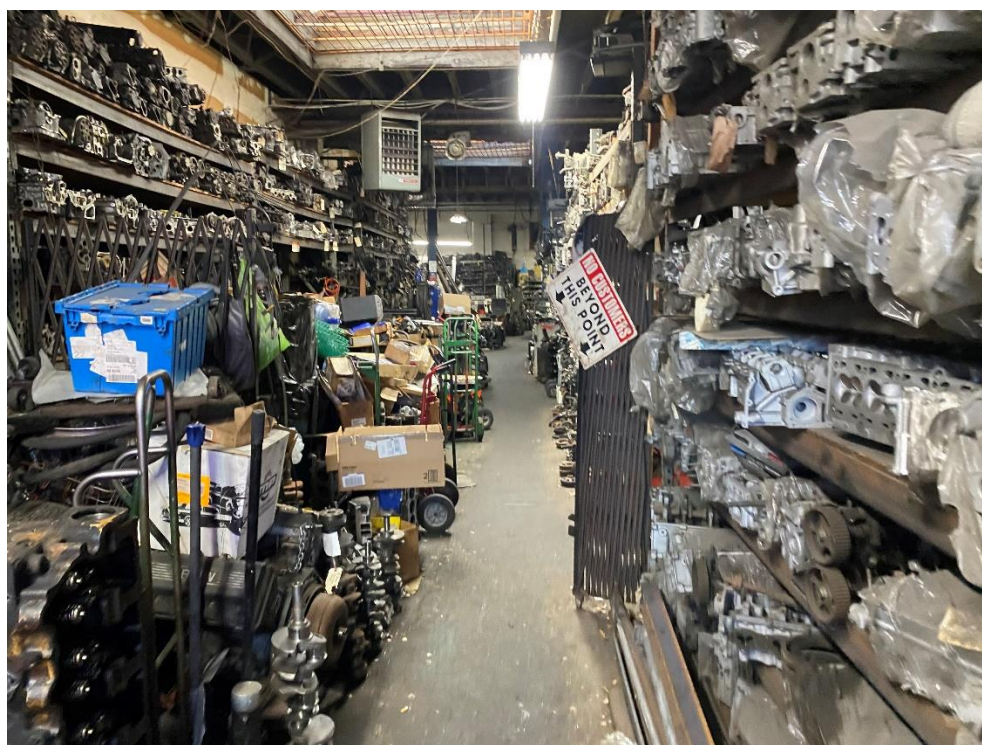
Clutter within the Machine Shop area.

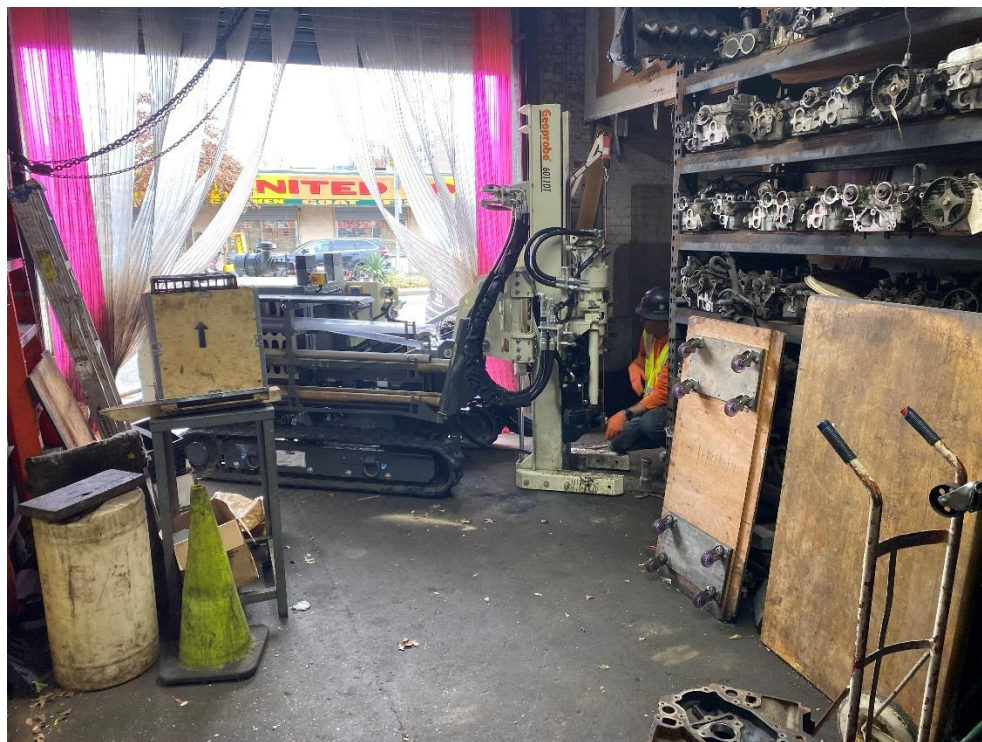
Soil sampling within the Mechanic Shop.

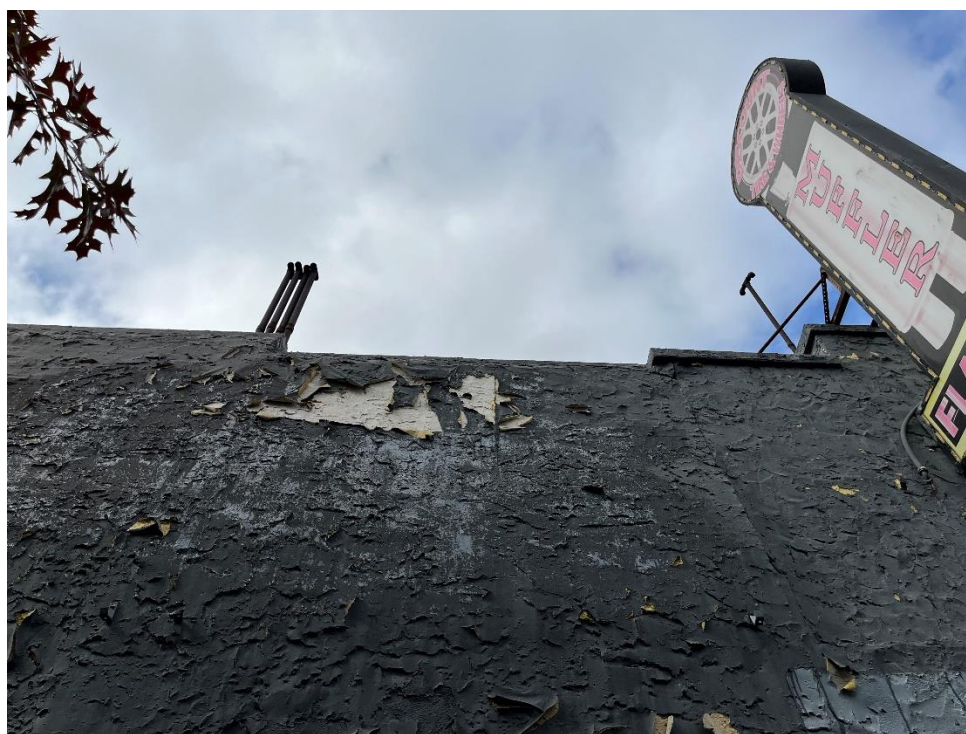
Top of building at the Interior Parking Area, showing UST vent piping.

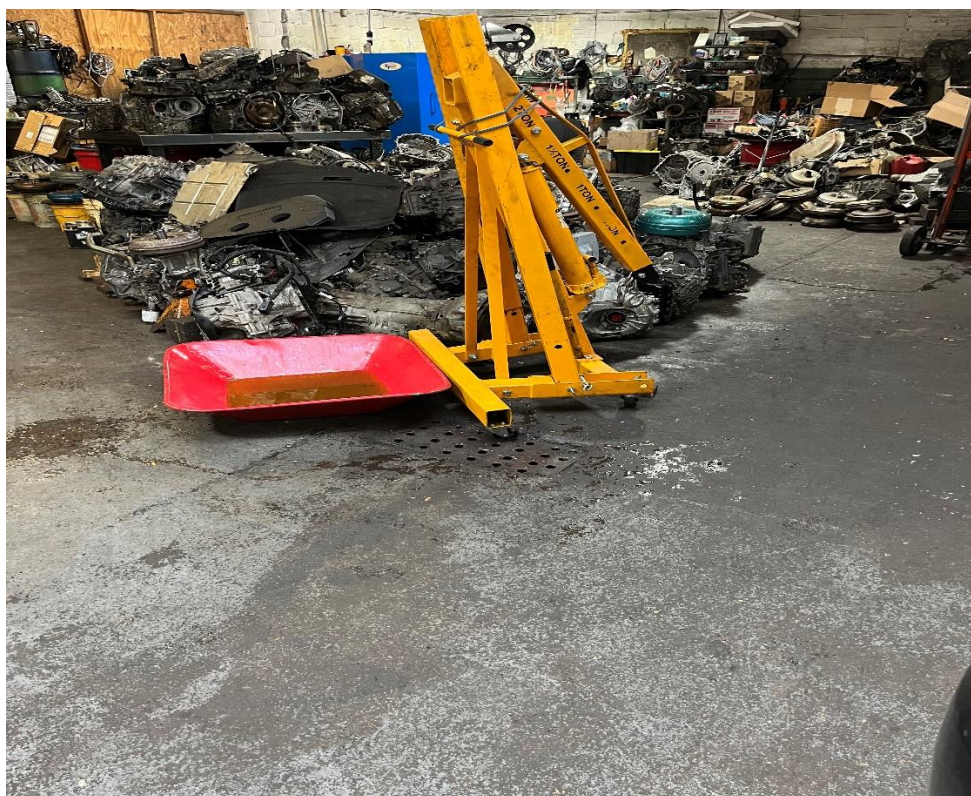
Center drain within the Large Auto Mechanic area.

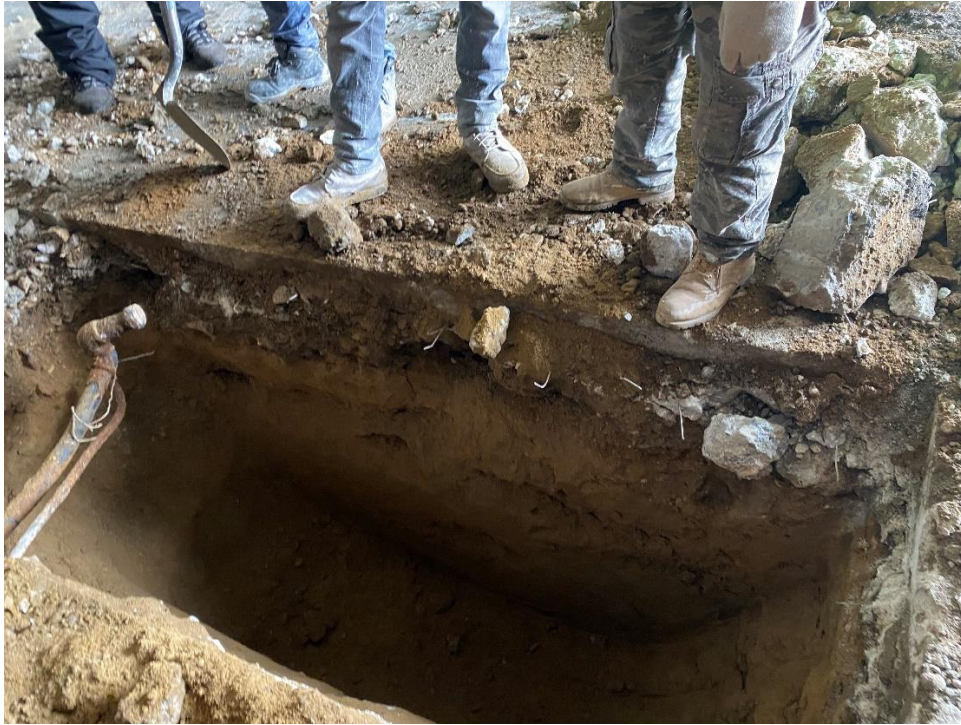
Large Test Pit within the Interior Parking Area, showing corroded below grade piping.

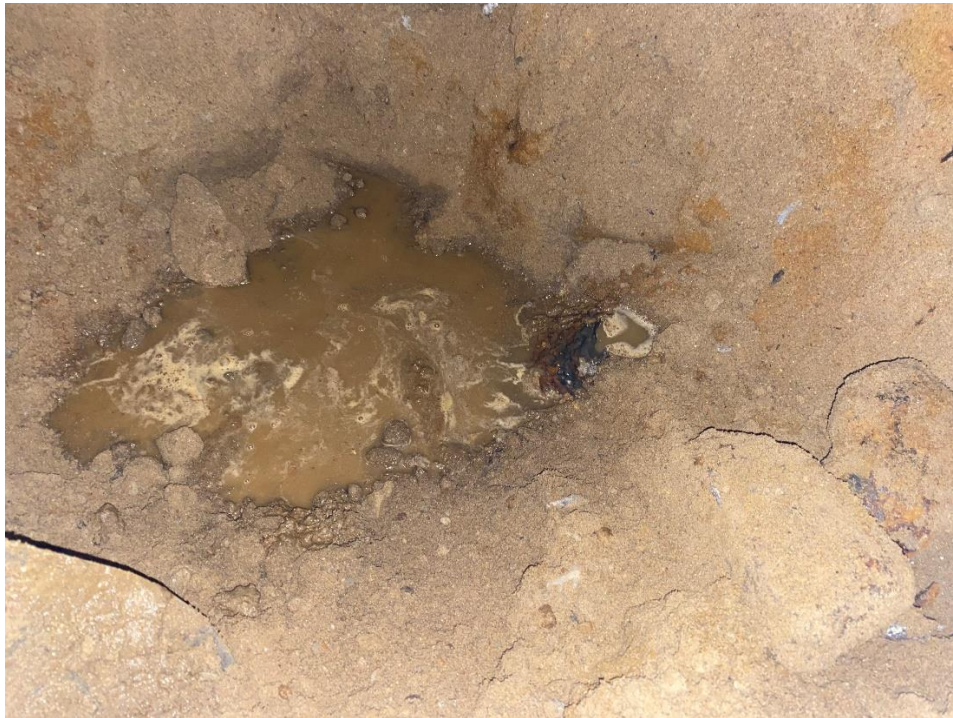
Large Test Pit within the Interior Parking Area, showing leaking UST.

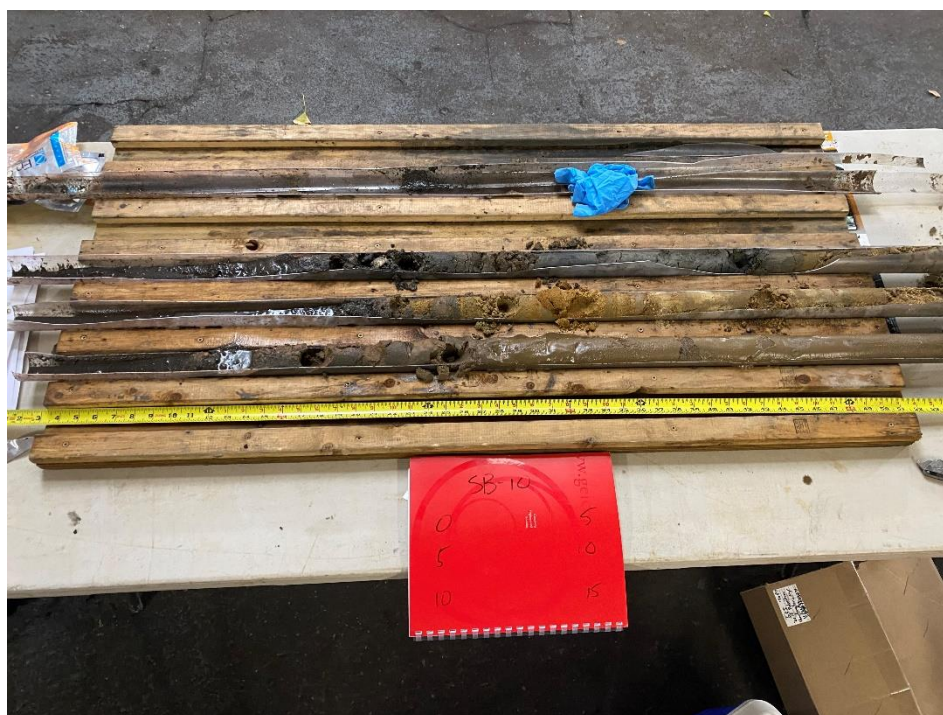
Soil boring SB-10 located within the Large Auto Mechanic area.

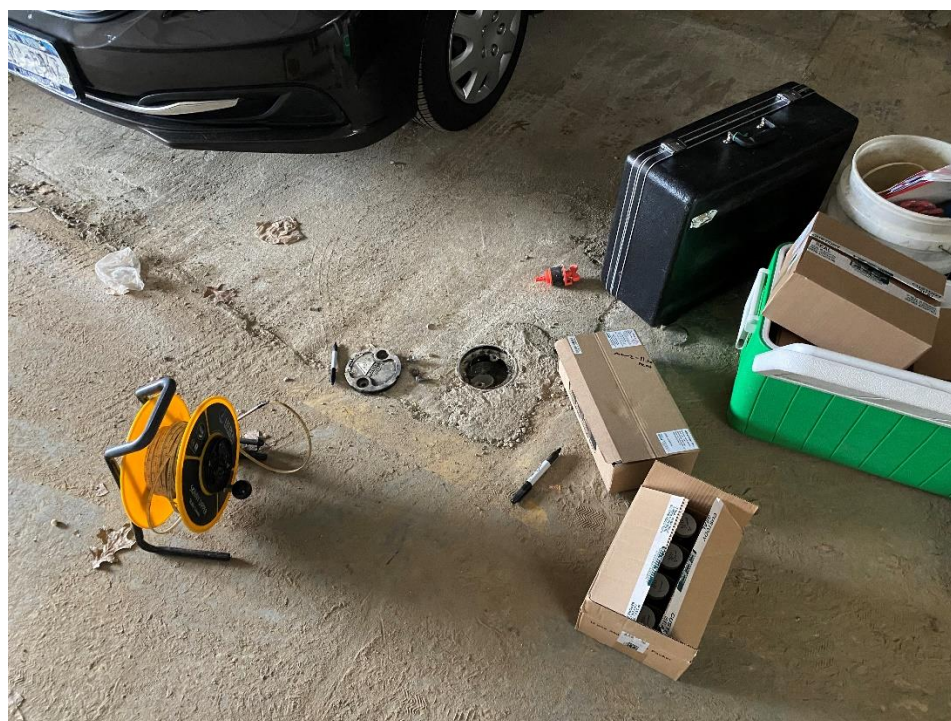
Groundwater sample being collected within the Interior Parking Area.

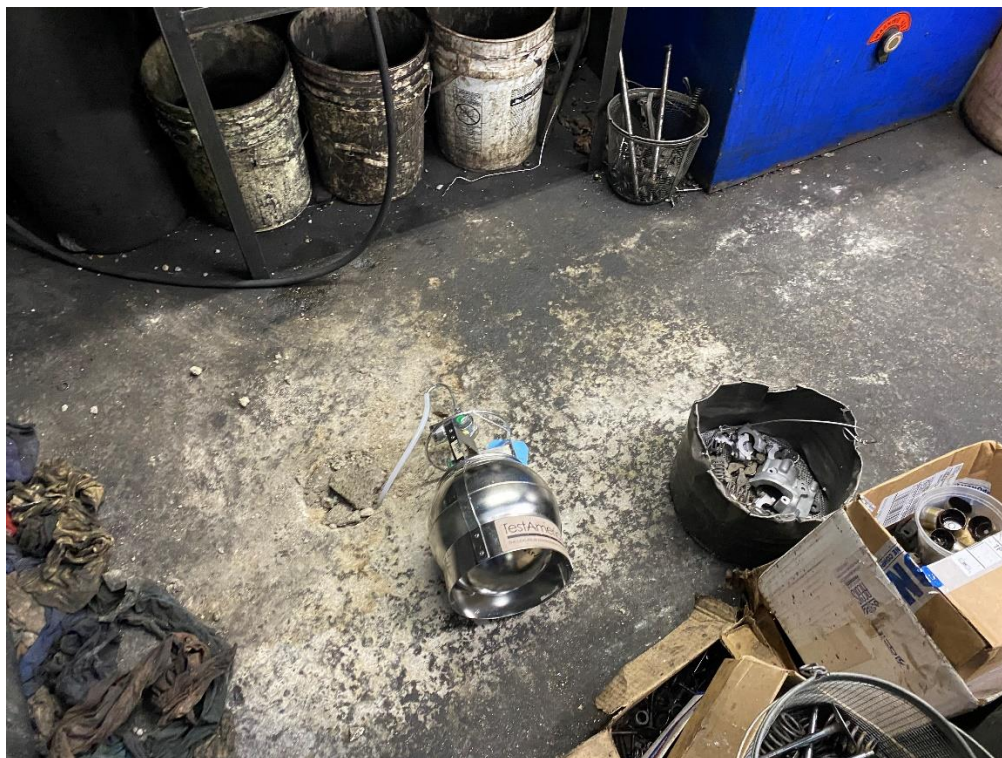
Soil Vapor Sample being collected in the Machine Shop.
