**PERIODIC REVIEW REPORT  
2019/2020**

**353 MCKIBBIN STREET  
BROOKLYN, NEW YORK  
NYSDEC BCP SITE NO. C224102**

**December 10, 2020**

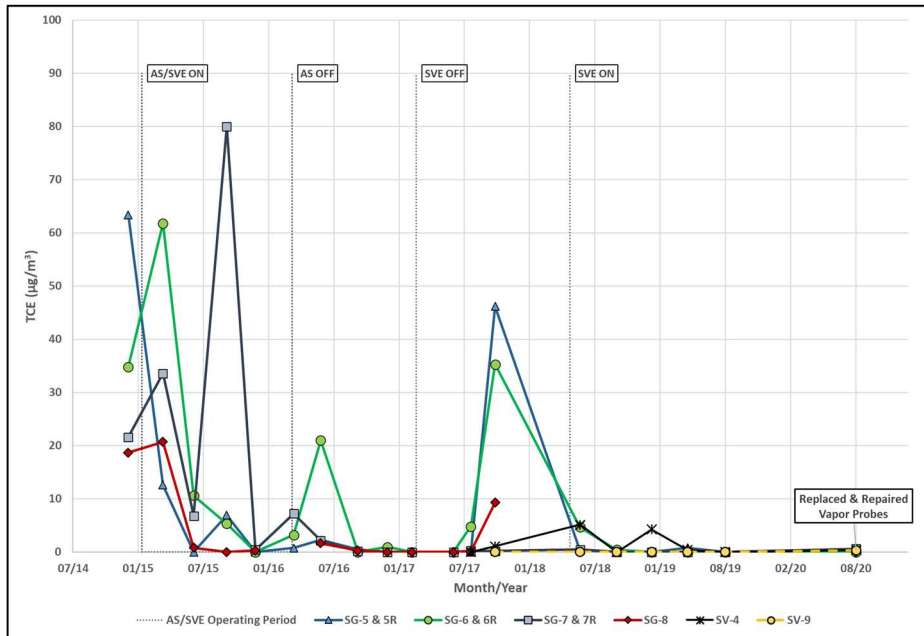
Figure 1 TCE in Soil Vapor

Vapor concentrations fluctuate with variable conditions but are generally decreasing. Figure 1 is a chart of TCE concentrations in soil vapor probes of which SV-4 and SV-9 are located off-Site.

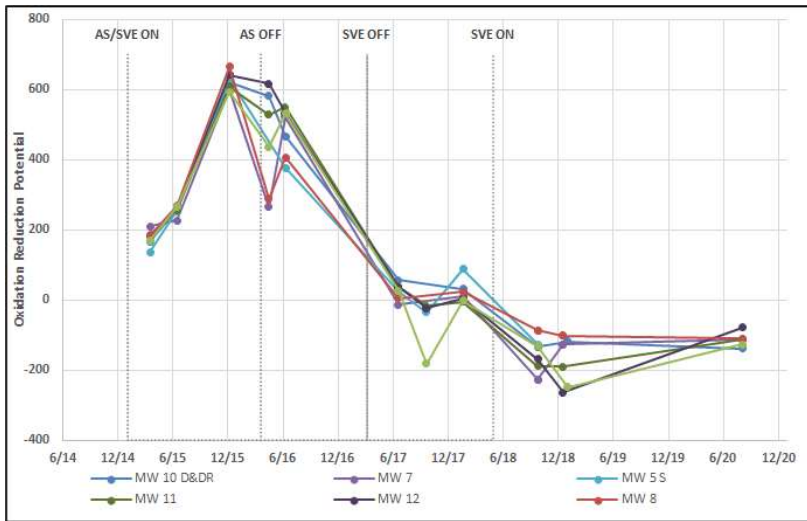
**Figure 2 Oxidation Reduction Potential**

The air sparging system effectively introduce dissolved oxygen into the groundwater which was enough to eliminate or reduce below standards the non-chlorinated (petroleum related) contaminants. The non-chlorinated contaminants readily degrade with elevated dissolved oxygen at this site. By increasing the dissolved oxygen in the groundwater; however, the AS system also reduced the degradation of chlorinated contaminants by dehalogenation that requires an anaerobic environment. Figure 2 shows the increase in the oxidation potential (reflecting an increase in dissolved oxygen) during the operation of the AS system, and the return to low oxidation potential after the AS system was turned off. The August 2020 data are consistent with this historic trend in dissolved oxygen.

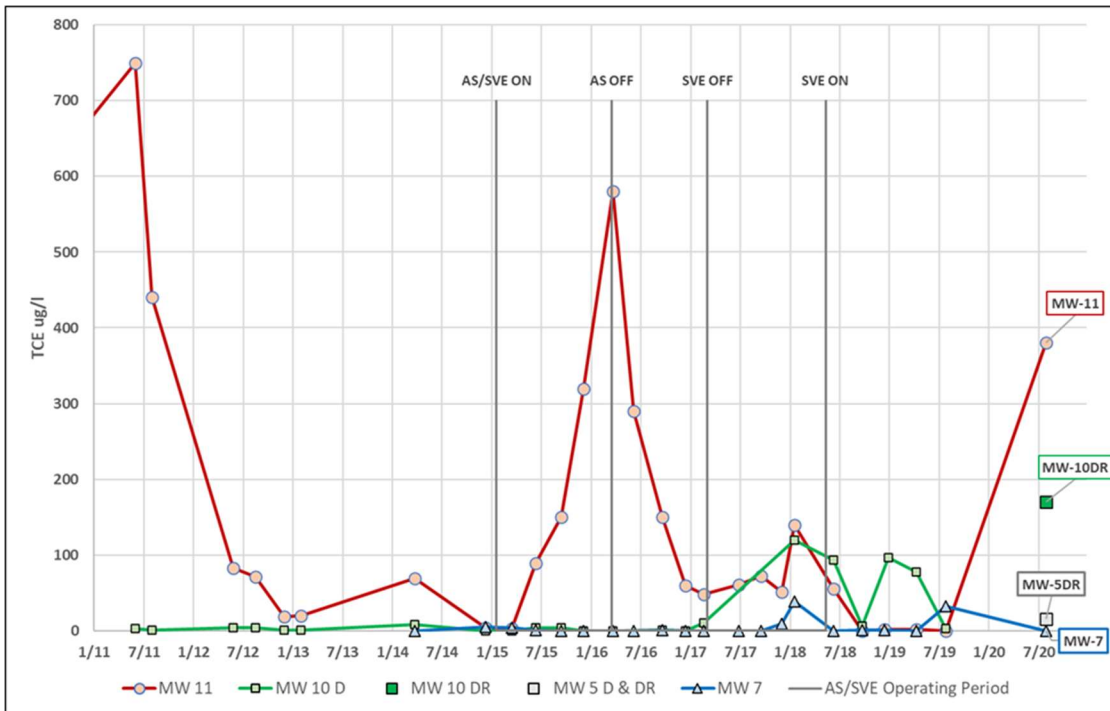
Figure 3 TCE in Groundwater

In August 2020, the highest concentrations of TCE were in MW-11 (280 µg/l) which is near the source, the “hot spot” identified in Remedial Investigation and excavated as part of the Remedial Action. This value is elevated compared to concentrations in 2019. Lower concentrations of TCE were detected in the newly installed monitoring well MW-10DR downgradient of MW-11 (170 µg/l). MW-5DR was successfully relocated to the outer edge of the plume resulting in a sample concentration of TCE of 16 µg/l. Sentinel well MW-7 had no detectable amounts of TCE.

PCE concentrations were approximately 1/10<sup>th</sup> of the respective TCE concentrations in MW-11 and MW-10-DR (20 and 3.5 µg/l, respectively). PCE was less than half the TCE concentration in MW-5DR (6.7 µg/l). PCE was not detected in MW-7.

Although erratic, the relative proportion of cis-1,2 DCE to TCE has increased with time and distance downgradient from the source area around MW-11, indicating degradation parent compound PCE and TCE; Vinyl chloride concentrations were not detected.

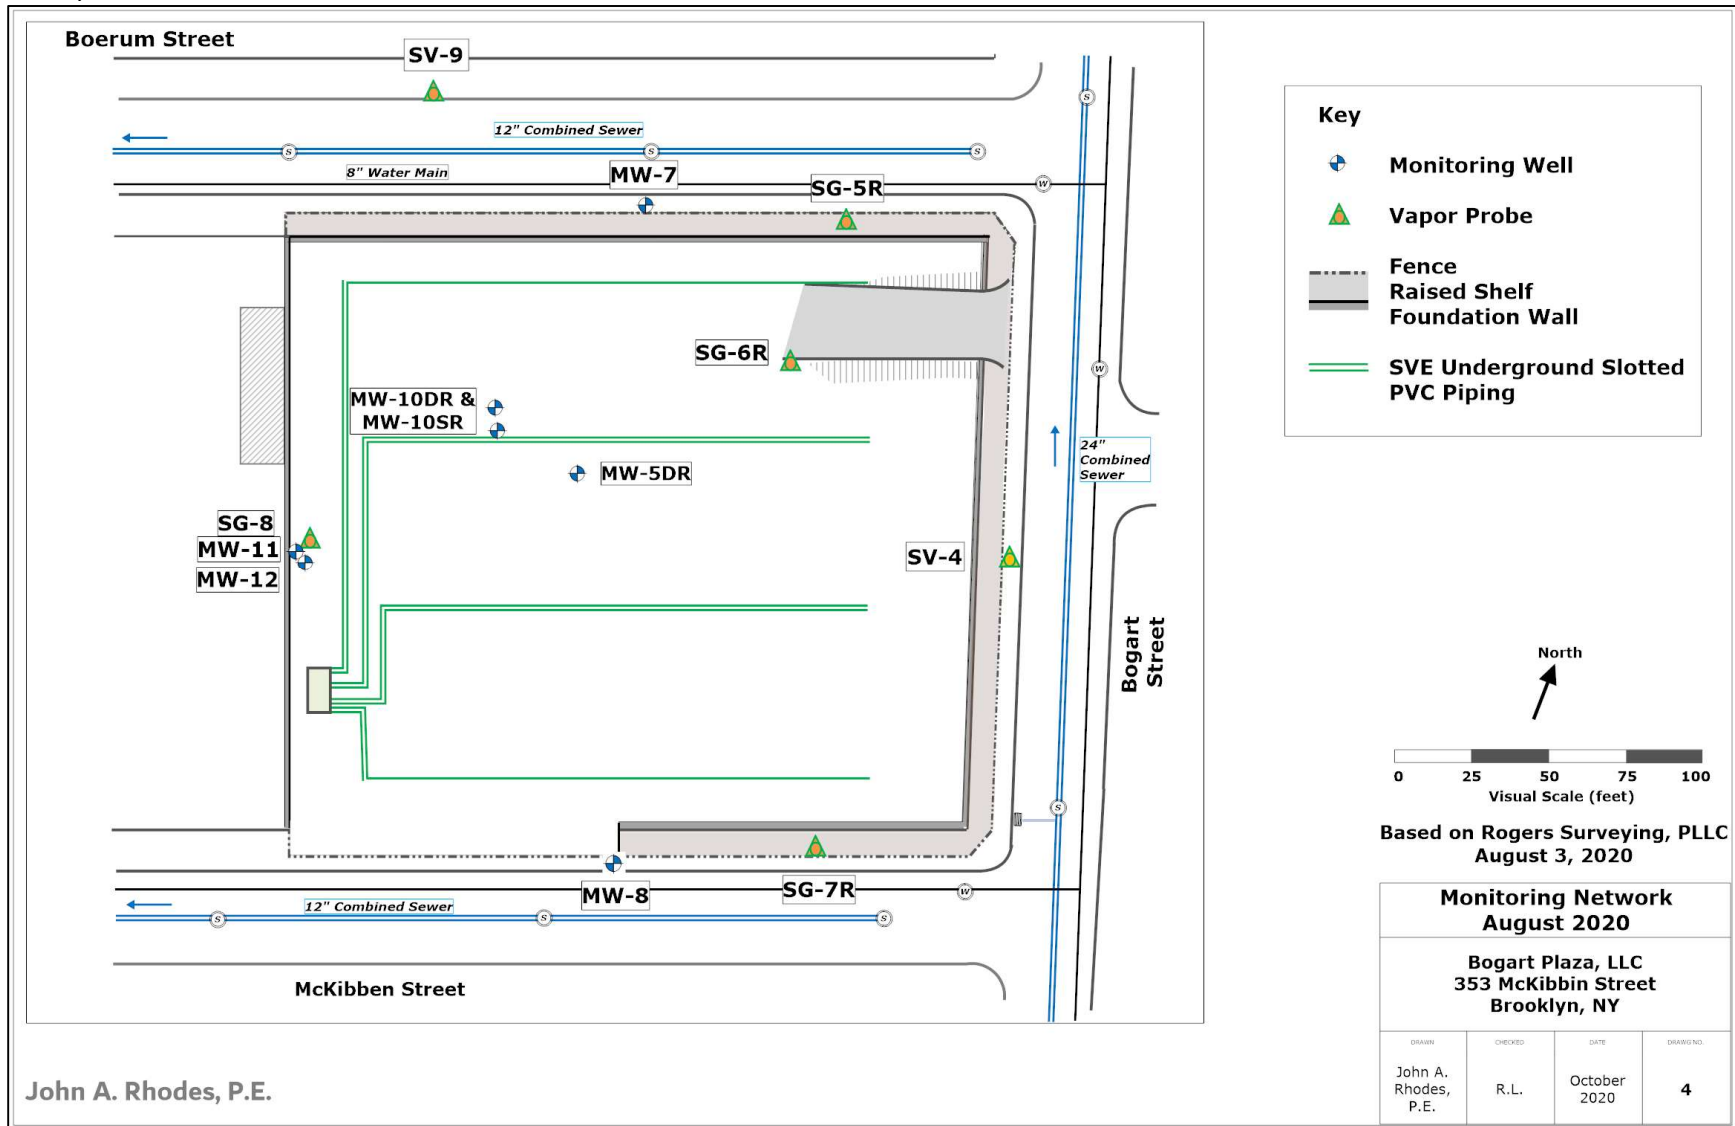
Figure 4 Site Plan & Monitoring Network Updated August 2020

Figure 4 illustrates the current monitoring well and vapor probe locations. Figure 5 and Figure 6 show both current and prior monitoring well and vapor probe locations. The CMR provides boring logs, well and vapor probe construction details, procedures for well abandonment, and development procedures. All wells and vapor probes were surveyed by a NYS licensed surveyor.

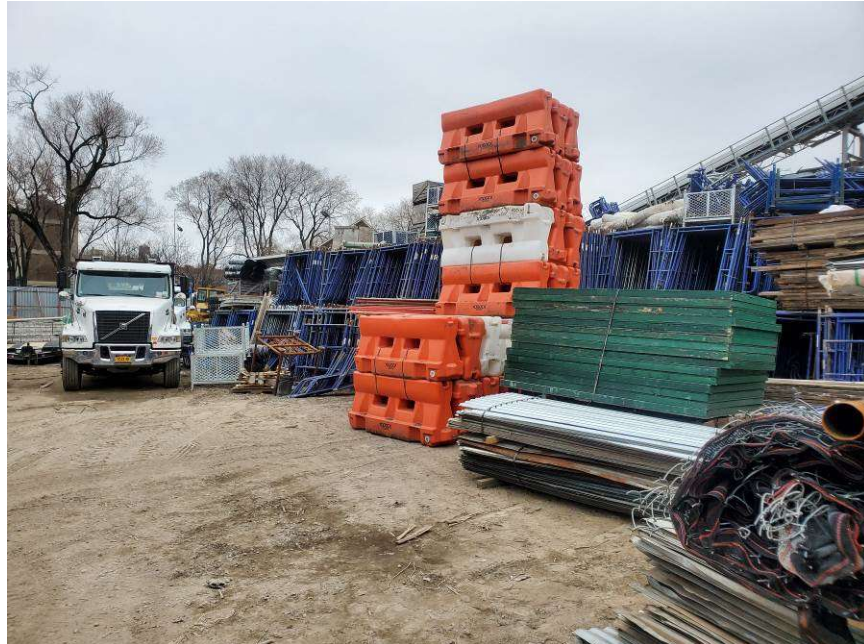
Activity near MW-11, MW-12, and SG-8; cement plant in background

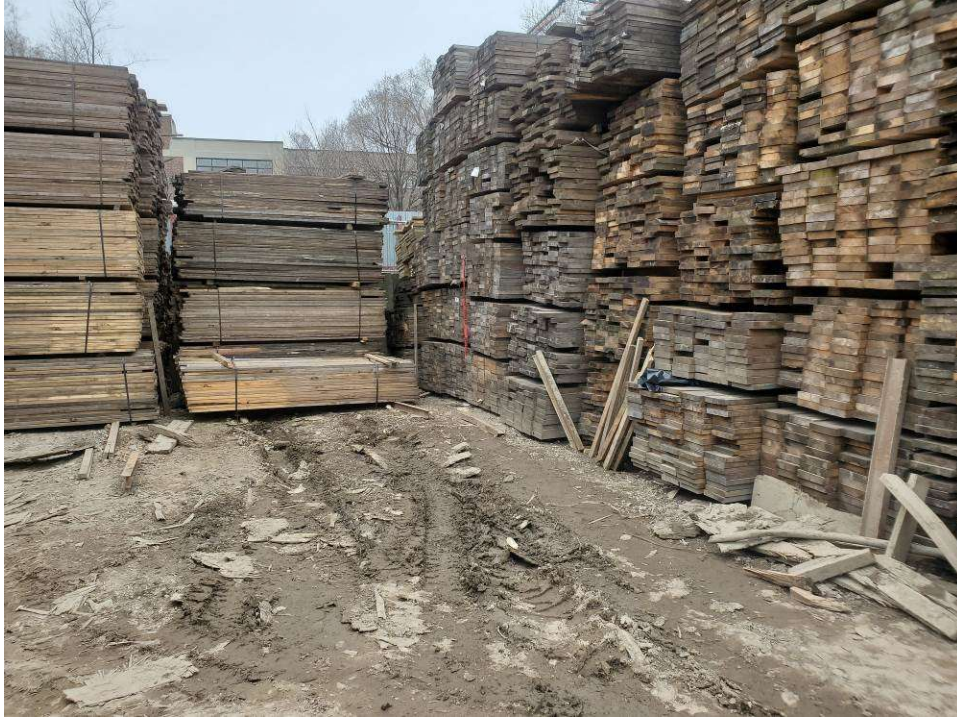
Storage near SG-7

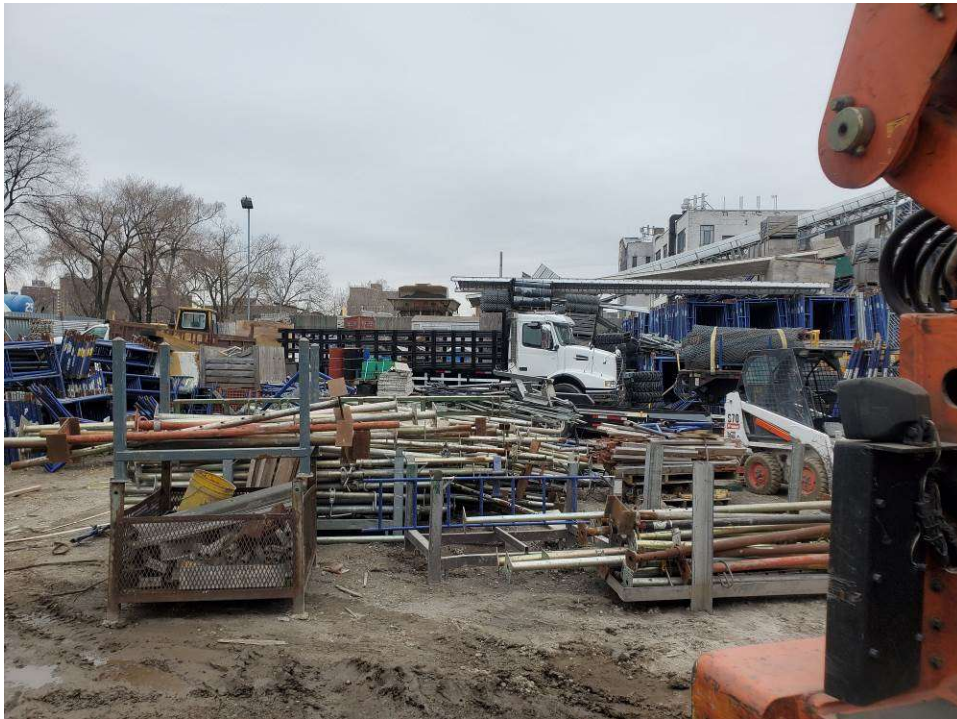
Activity near MW-10; MW-11, MW-12, and SG-8 in background

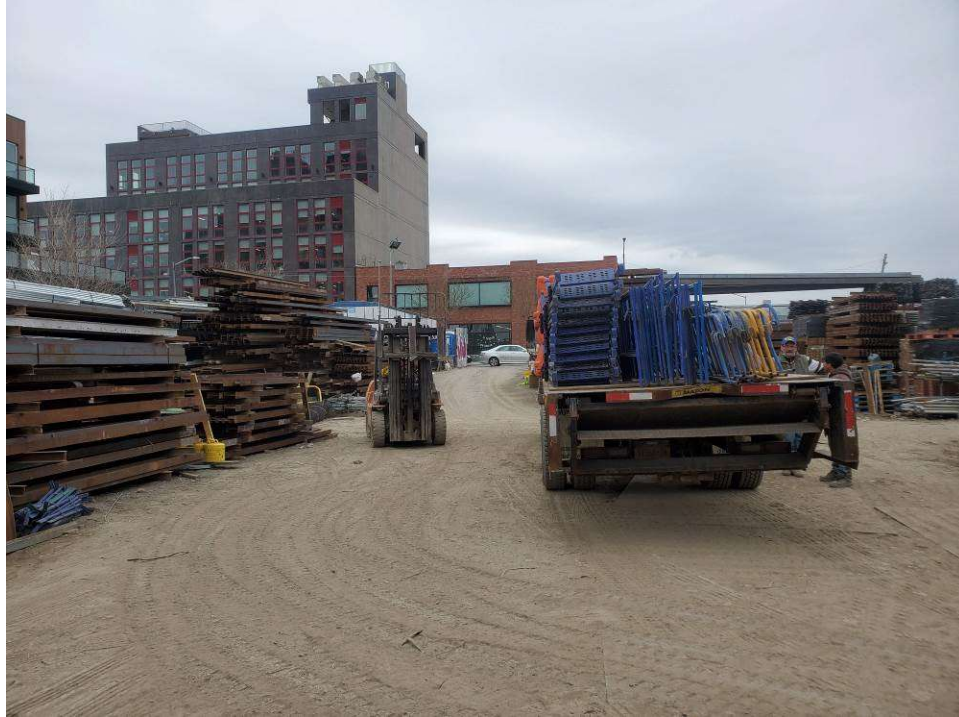
Activity in yard near MW-10; looking toward Boerum Street

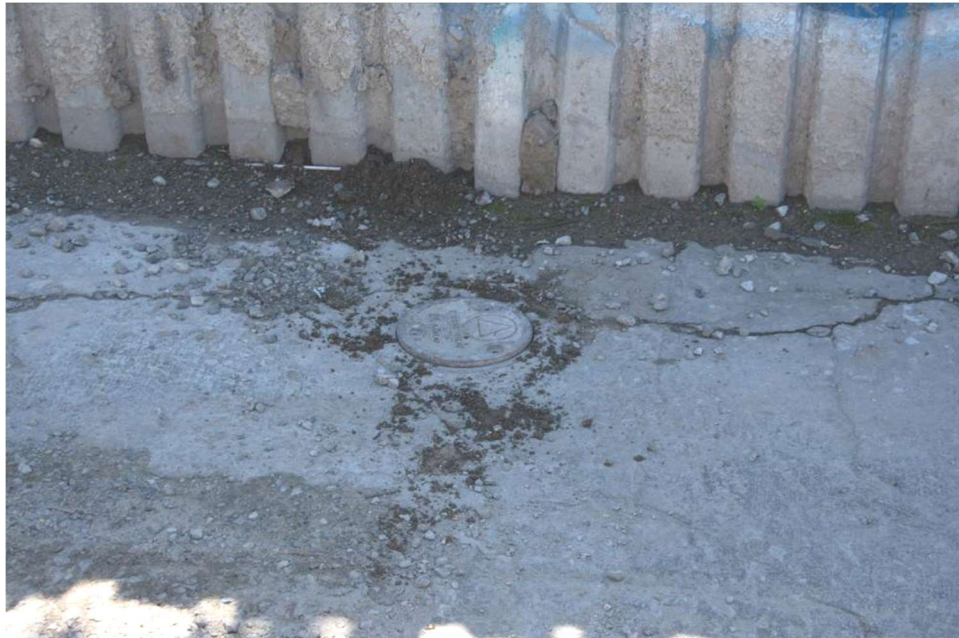
Sidewalk Bogart is in fair condition, McKibbin is in fair condition with trash piles, and Boerum is in poor condition with heavy construction continuing across the street. MW-7 appears damaged.

Photo from 2018 showing deterioration of sidewalk and MW-7 in Boerum Street

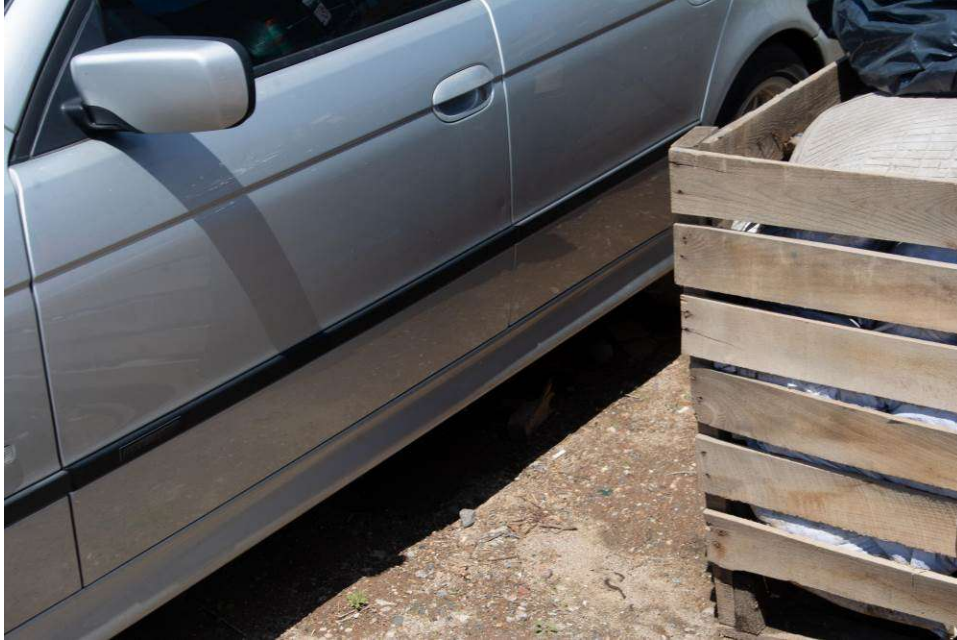
SV-5 under car

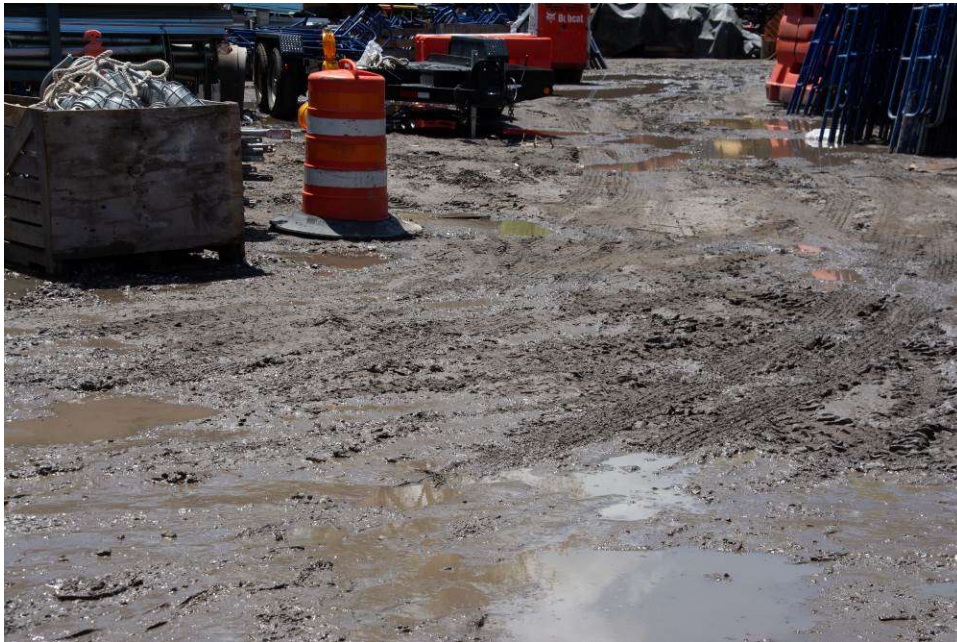
Condition of yard near MW-10D

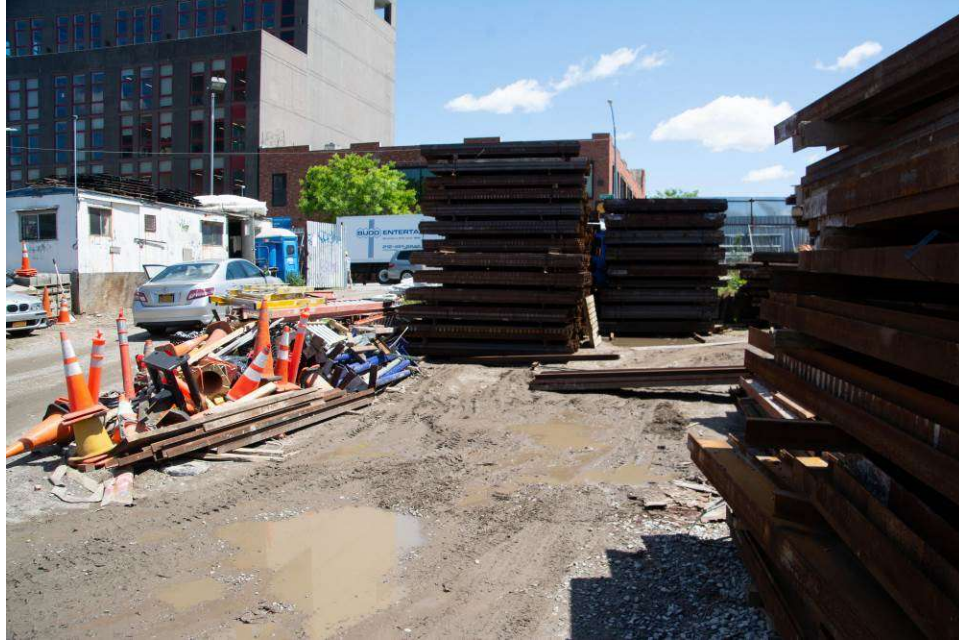
Condition of yard near SV-6; entrance ramp in background
