PERIODIC REVIEW REPORT NOV. 2, 2020 TO NOV. 2, 2021

353 MCKIBBIN STREET BROOKLYN, NEW YORK NYSDEC BCP SITE NO. C224102

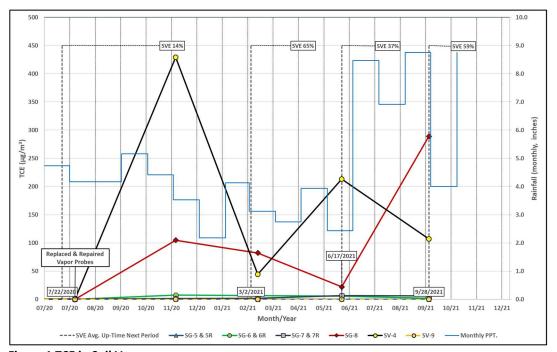
Figure 1 TCE in Soil Vapor

Concentrations in vapor probes were dependent on groundwater levels and system operations. SG-8 in the source area increased contaminant concentration with rising groundwater levels as illustrated in Figure 1 using the average monthly rainfall as a measure of groundwater levels and focusing on TCE, the major remaining contaminant. Other on-site vapor probes contained relatively low levels of contaminants, but also fluctuated with groundwater levels.

SV-4 located just off the property was more responsive to SVE system operations with the highest concentration of TCE occurring on December 3, 2020, after a period of numerous shutdowns caused an average up-time of only 14%. Improved operations (65% up-time) lowered the concentration of TCE in the next sample, but the concentration rose again when average up-time dropped to 37%. With the increase in up-time to 59%, TCE concentration in SV-4 again fell. No contaminants were found in off-site probe SV-9.

While the SVE system prevents off-site migration of contaminated vapors when operating, a better up-time record is needed. The capping of the severed SVE pipe immediately allowed for continuous system operation.

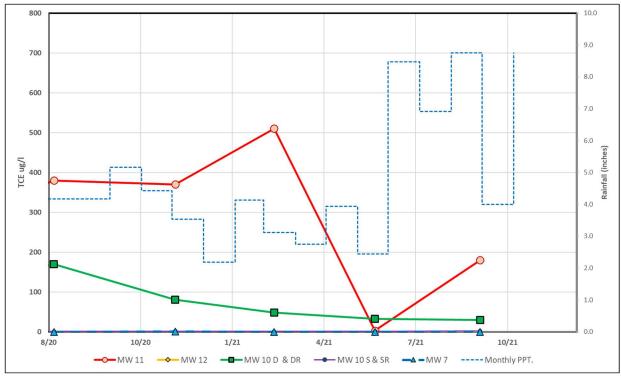
Figure 2 TCE in Groundwater

TCE is the bellwether of groundwater contaminants. Figure 2 shows the trends of TCE concentrations in groundwater in wells MW-11 (source area), MW-10DR and MW-7 (downgradient and off-site). Other wells are also shown but their trends are equivalent to and indistinguishable from MW-7. Monthly rainfall amounts (inches) are also shown. As groundwater levels are correlated with rainfall, monthly rainfall gives an indication of groundwater levels during the period of testing.

Contaminants in the MW-11 area may be responsive to groundwater levels as a result of transfer from the smear zone. Contaminated groundwater near MW-11 moves toward MW-10DR. Degradation, dispersion and soil vapor extraction reduce the concentration before the groundwater reaches 10-DR and in turn MW-7 located just off the property. Therefore, the remedy is preventing

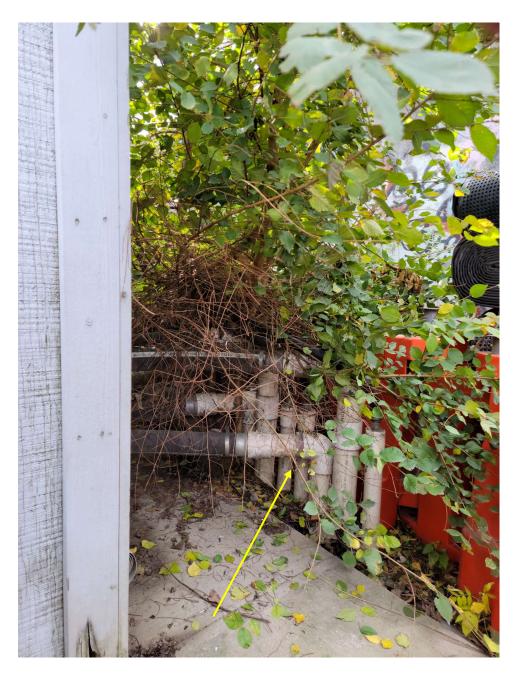
Automatic system shutdowns were frequent throughout the reporting period. A break in SVE Line 1B was discovered during the Annual Site Wide Inspection on November 15, 2021. This break allowed air to enter the SVE system at atmospheric pressure thereby reducing the suction (negative gage) pressure throughout the system. In turn, this caused frequent "Low Pressure" system alarms that would shut down the system. This condition was exacerbated by high groundwater levels that further reduced the negative pressures. Shutdowns associated with high groundwater occurred more frequently in the latter half of this reporting period due to unusually heavy rainfall. By looking at past records, we concluded that this condition had been causing shutdowns throughout this reporting period without our knowledge. The condition appears to have been alleviated by capping of the severed SVE pipe thereby preventing air entering at atmospheric pressures but monitoring of the effect of the repair is ongoing. The zone serviced by the severed header pipe has a second SVE pipe which maintained suction in the zone. The severed line will be repaired after material storage for the business operating on the property is modified.

Broken Pipe SVE 1B

- SVE Line 1B was closed (capped) to eliminate associated low-pressure alarms. The Line will be repaired and returned to service.
- A remote warning system has been installed (AD-2000 Automatic Voice/Pager Dialer manufactured by United Securities Products) to remotely advise system managers of system shutdowns, upgrading the on-site alarms.

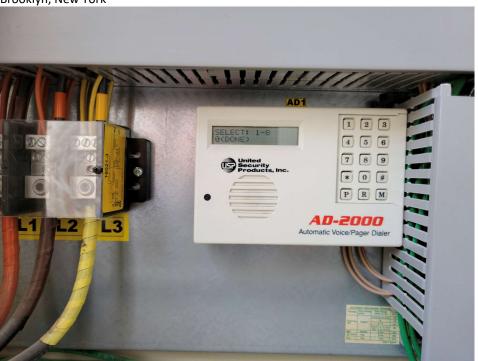
On-site warnings including a warning light have been tried to advise site personnel that the system has stopped. However, this has proven inadequate. Therefore, a remote warning system has been added (AD-2000 Automatic Voice/Pager Dialer manufactured by United Securities Products).

Automatic System Status Warning

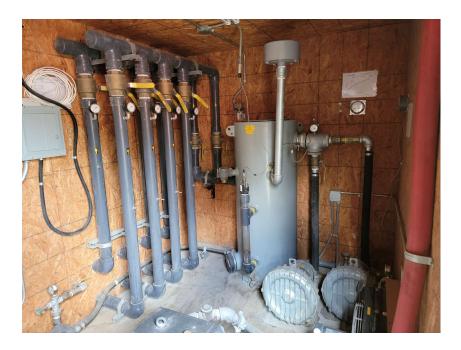
SVE Line 1B: front pipe to right; position of frozen valve shown
