**PERIODIC REVIEW REPORT  
NOV. 2, 2021 TO NOV. 2, 2022**

**353 MCKIBBIN STREET  
BROOKLYN, NEW YORK  
NYSDEC BCP SITE NO. C224102**

**March 6, 2023**

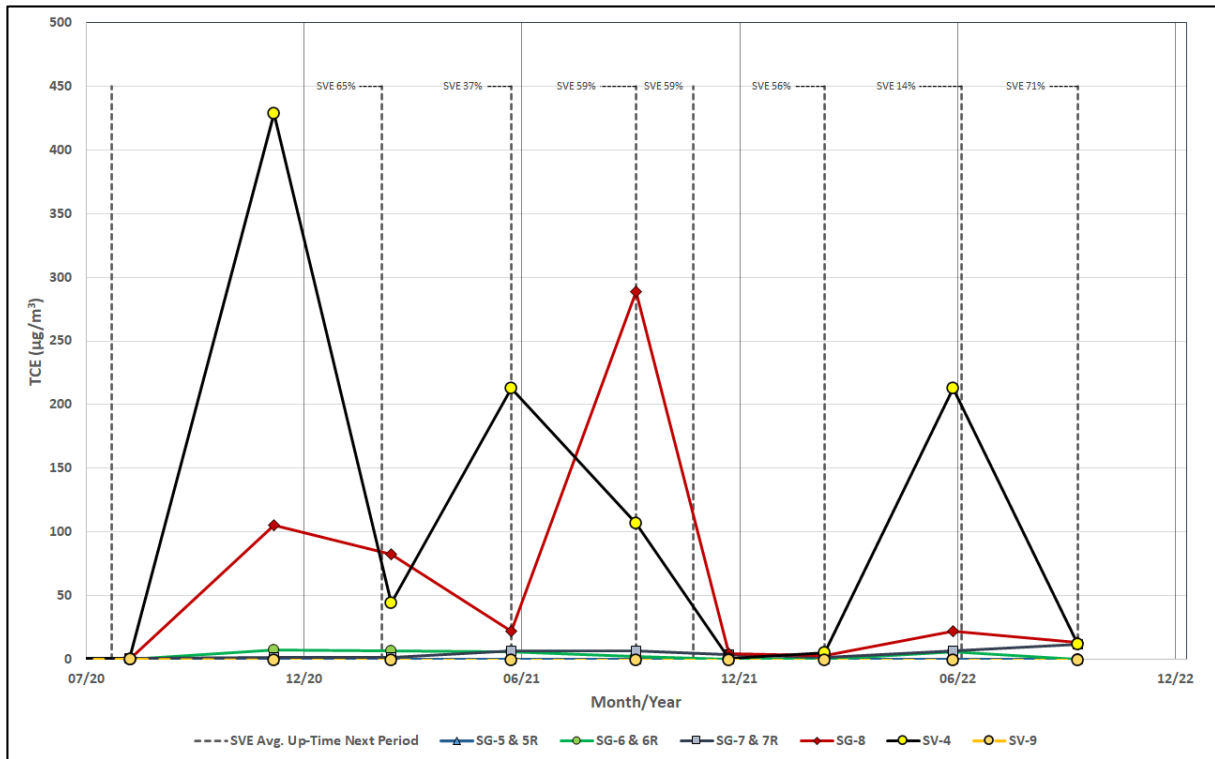
**Figure 1 TCE in Soil Vapor**

Concentrations in vapor probes were dependent on groundwater levels and system operations. SG-8 in the source area increased contaminant concentration with rising groundwater levels, for example.

SV-4 located just off the property was more responsive to SVE system operations with the highest concentration of TCE occurring in December 2020, June 2021 and June 2022 after periods of low up-times. Concentrations returned to low levels after system up-times were restored. No contaminants were found in off-site probe SV-9.

While the SVE system prevents off-site migration of contaminated vapors when operating, a better up-time record is needed.

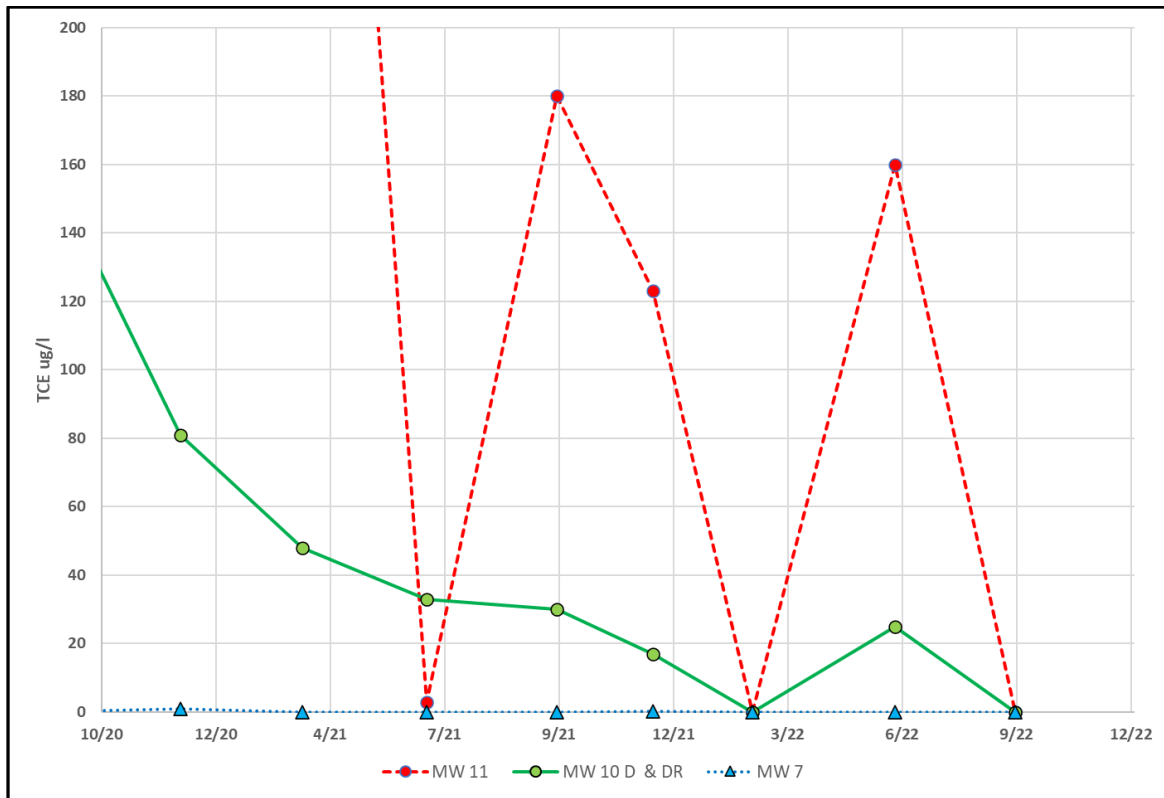
Figure 2 TCE in Groundwater

TCE is the bellwether of groundwater contaminants. Figure 2 shows the trends of TCE concentrations in groundwater in wells MW-11 (source area), MW-10DR and MW-7 (downgradient and off-site). Other wells are also shown but their trends are equivalent to and indistinguishable from MW-7. Monthly rainfall amounts (inches) are also shown. As groundwater levels are correlated with rainfall, monthly rainfall gives an indication of groundwater levels during the period of testing.

Contaminants in the MW-11 area may be responsive to groundwater levels because of transfer from the smear zone. Contaminated groundwater near MW-11 moves toward MW-10DR. Degradation, dispersion and soil vapor extraction reduce the concentration before the groundwater reaches 10-DR and in turn MW-7 located just off the property. Therefore, the remedy is preventing the migration of contaminated groundwater off the property, and slowly reducing the concentrations.

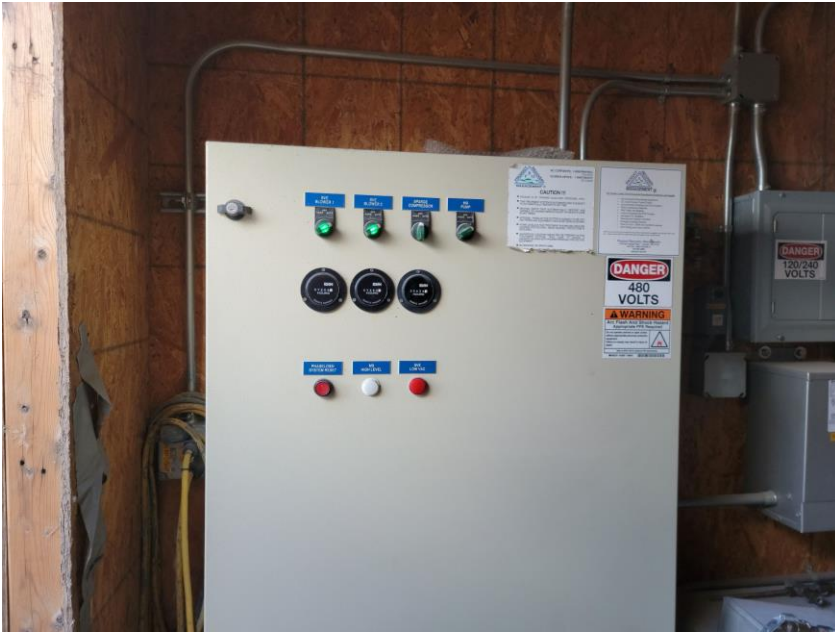
SVE System functioning

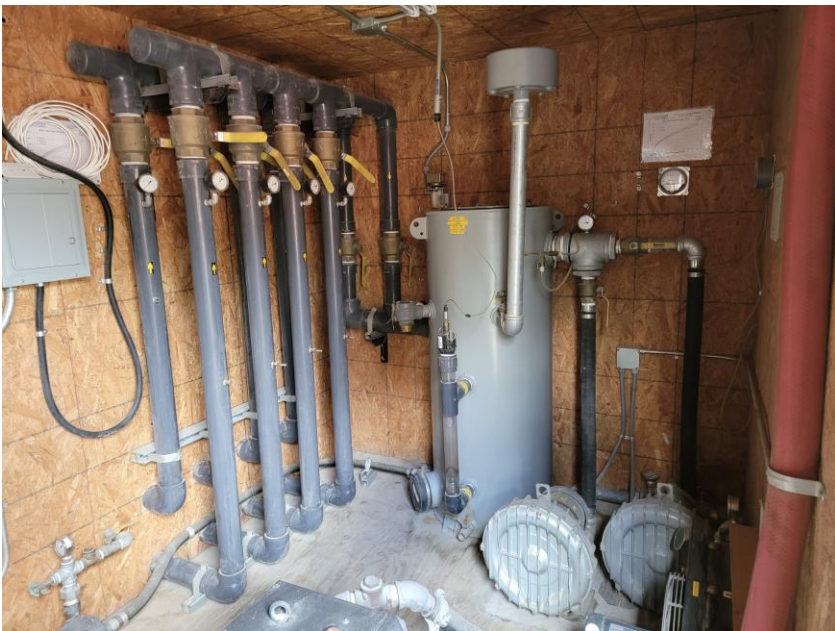
SVE Lines 1 through 3 open

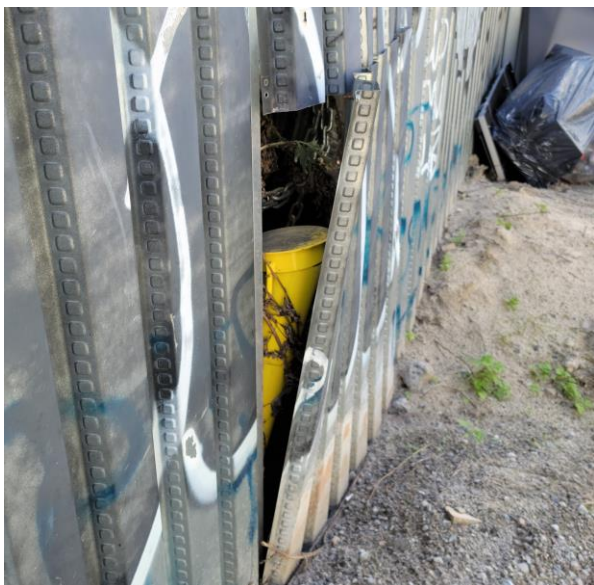
**Sidewalk** Bogart is in fair condition, McKibbin is in fair condition with trash piles, and Boerum is improved after heavy construction across the street. MW-8 is in good condition. MW-7 needs a cover replacement and to be cleaned of debris. Doors in fence to reach vapor probes are functional.

MW-7 needing cover replacement and cleaning
