388 Bridge Street
Brooklyn, New York

NYSDEC BCP Site No. C224134

2017 ANNUAL PERIODIC REVIEW REPORT AND ENGINEERING CERTIFICATION

FLS Project Number: 10149-001

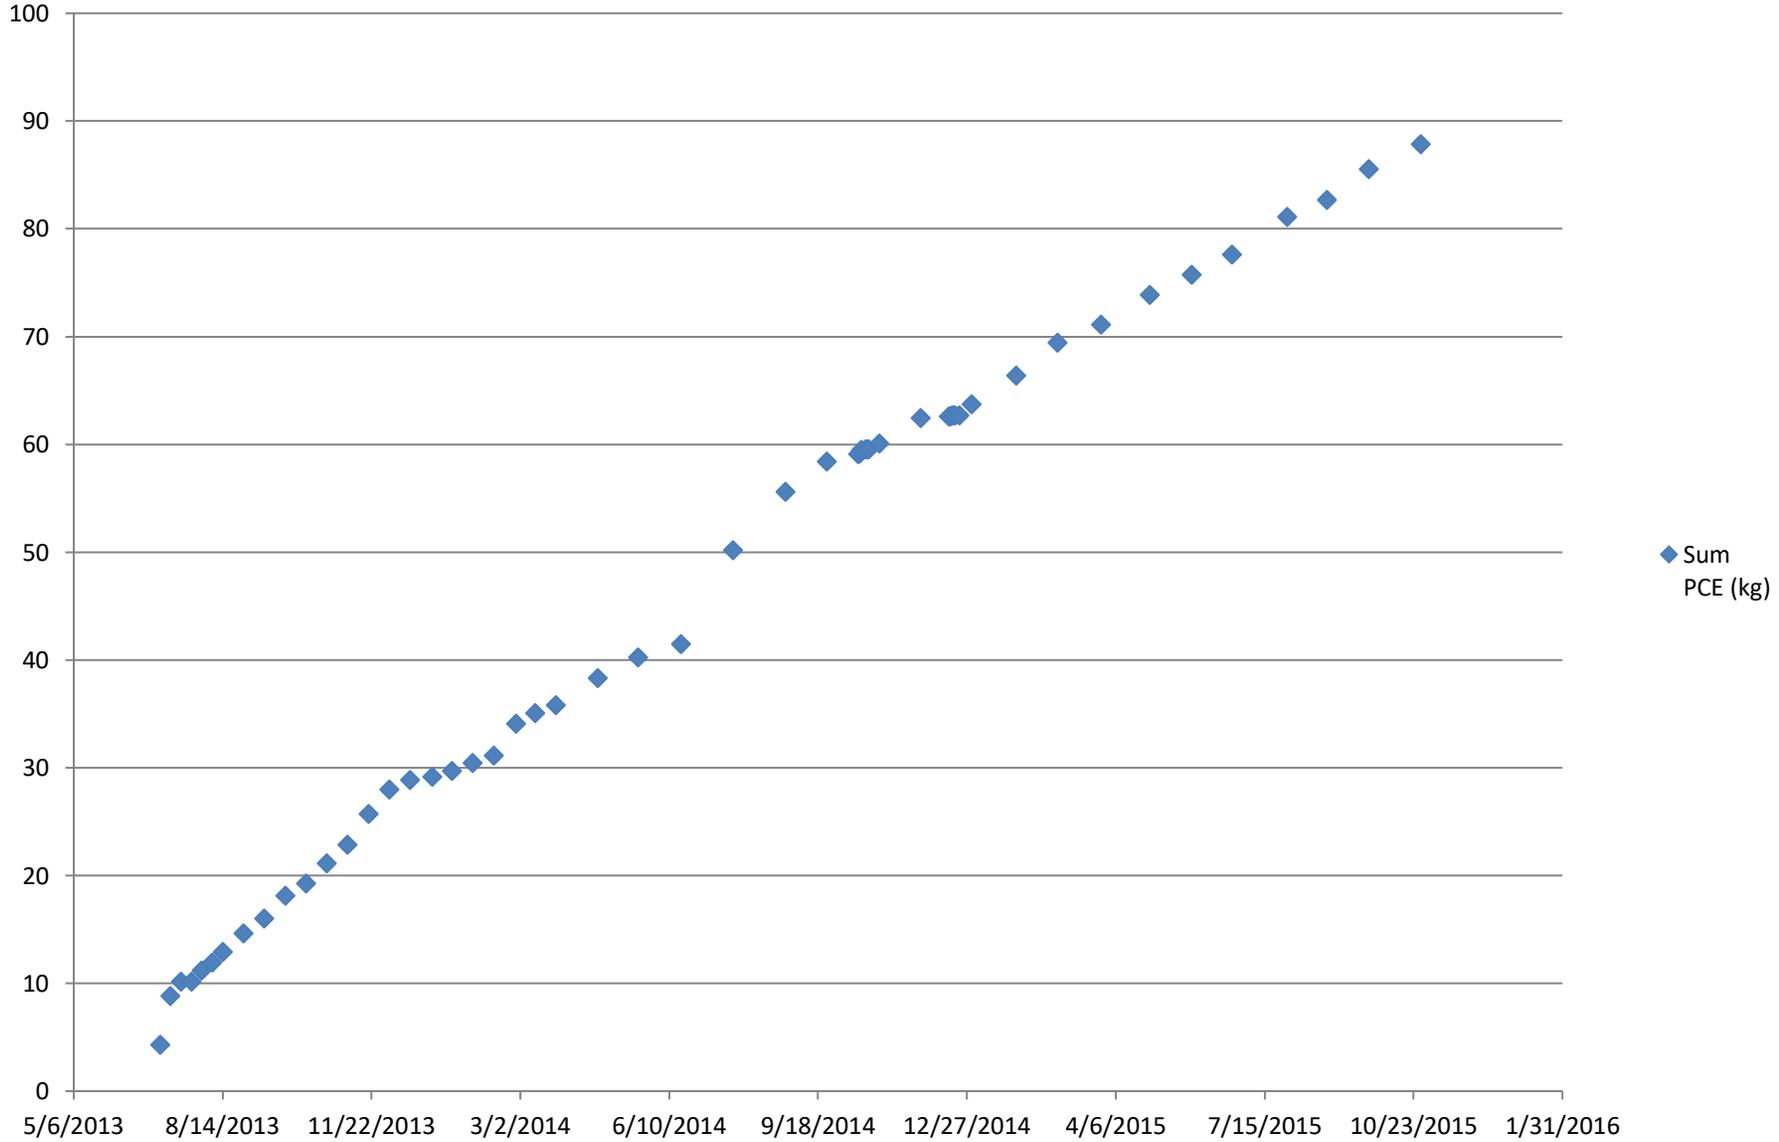
**Figure 4. 2013 SVE System
Contaminant Mass Removal - PCE**

- The highest historical concentrations of PCE ($39,700 \mu\text{g}/\text{m}^3$) and TCE ($120 \mu\text{g}/\text{m}^3$) detected at the 2013 SVE system inlet were recorded on July 3, 2013, one week after the system was turned on.
- In overall, the system installed in 2013 effectively removed 87.88 kilograms (kg) of PCE and 0.30 kg of TCE from June 2013 through October 2016. Graphs showing the accumulative mass removal for PCE and TCE are presented in Figure 4 and 5, respectively.
- Eight (8) quarterly events have been completed since the installation of the 2016 SVE system.
- New carbon was installed in the lead and lag carbon vessels in December prior to the collection of the December 21, 2017 SVE samples. Spent carbon will be disposed to an approved facility under EPA ID No. NYD981079932.

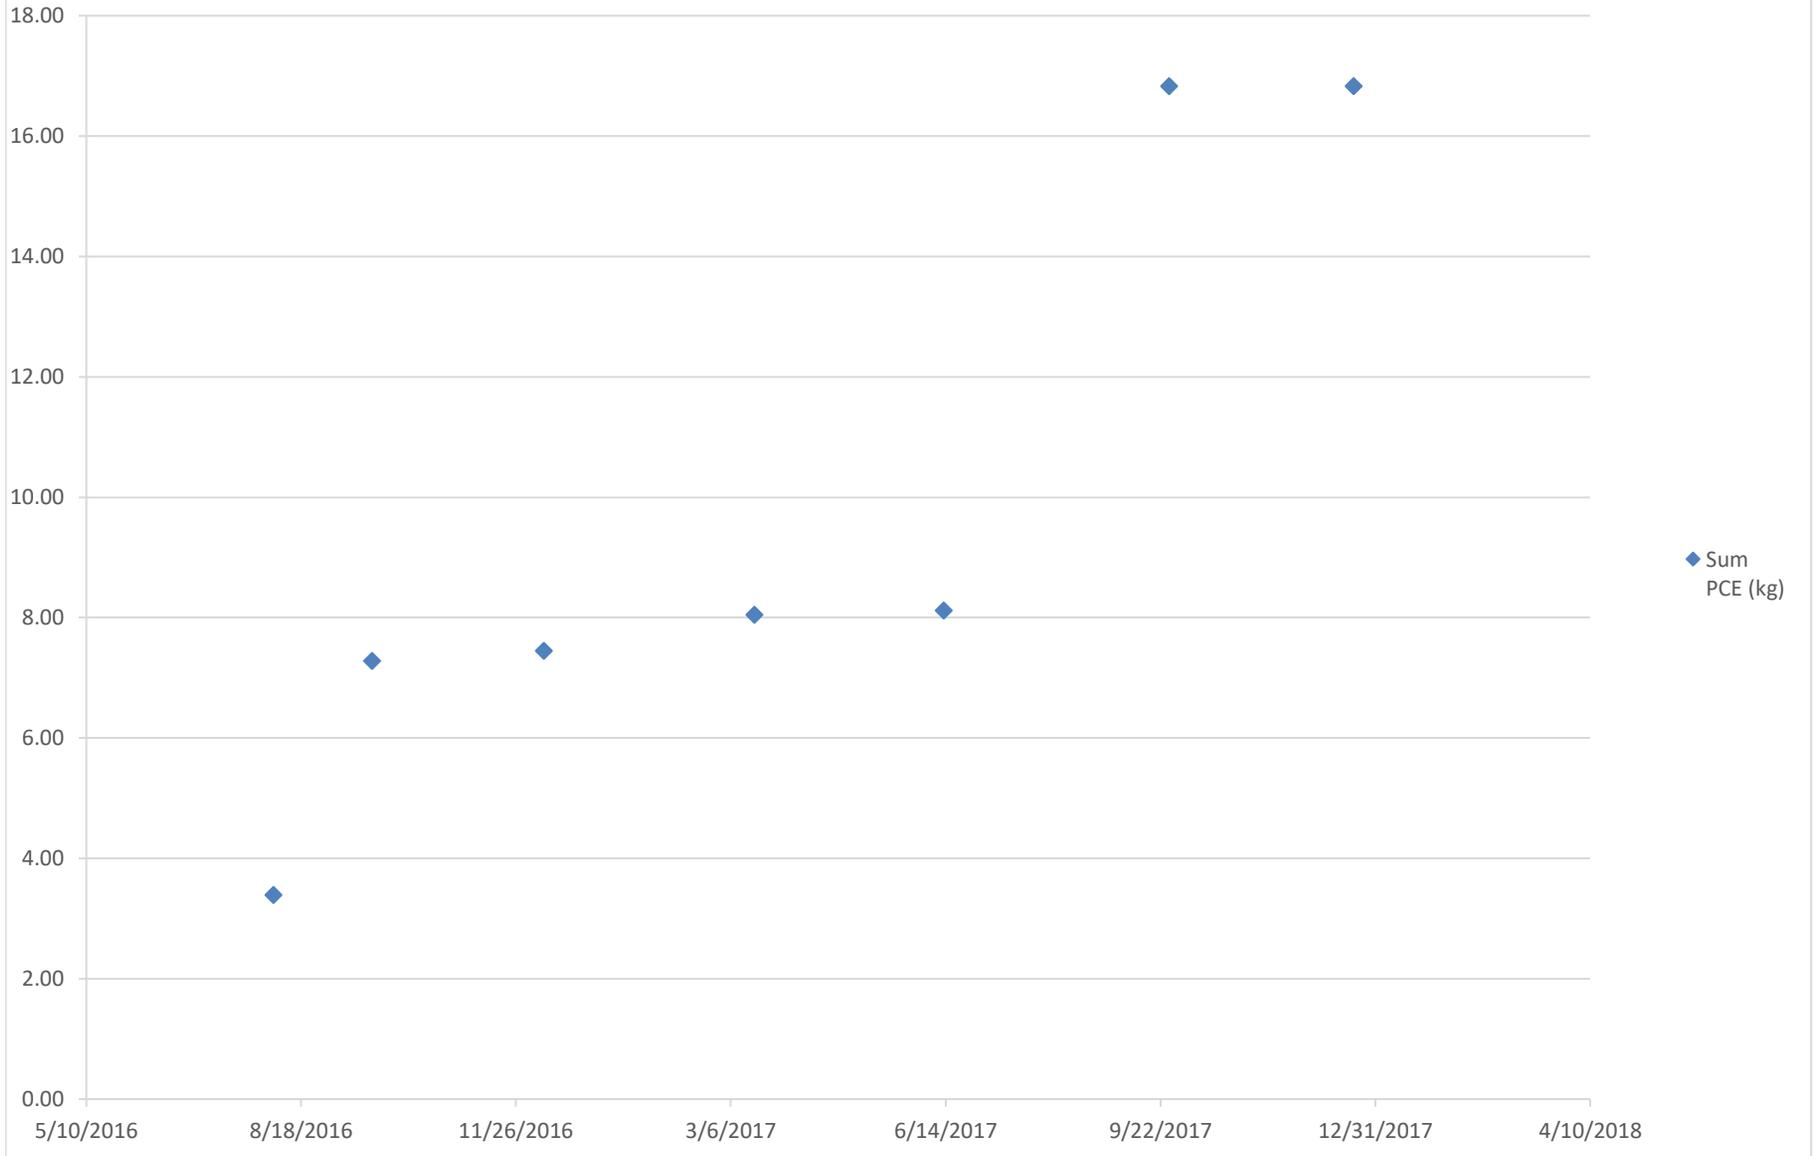
**Figure 6. 2016 SVE System
Contaminant Mass Removal - PCE**

- To date, a total of sixty three (63) soil vapor sampling (monthly/quarterly) events have been completed. In the most recent sampling event, the SVE inlet readings of PCE and TCE were 4.7 and 6.4 $\mu\text{g}/\text{m}^3$, respectively. When comparing to the highest concentrations detected (sample collected July 3, 2013), there is a reduction in concentrations of PCE and TCE of 99.9% and 94.7%, respectively.
- As of the date of the last SVE sampling event, December 21, 2017, 2016 SVE system has removed a total of 16.86 kg of PCE and 0.13 kg of TCE.
- As of the date of the last SVE sampling event, December 21, 2017, 104.73 Kg of PCE and 0.37 Kg of TCE have been removed and treated from the Site.

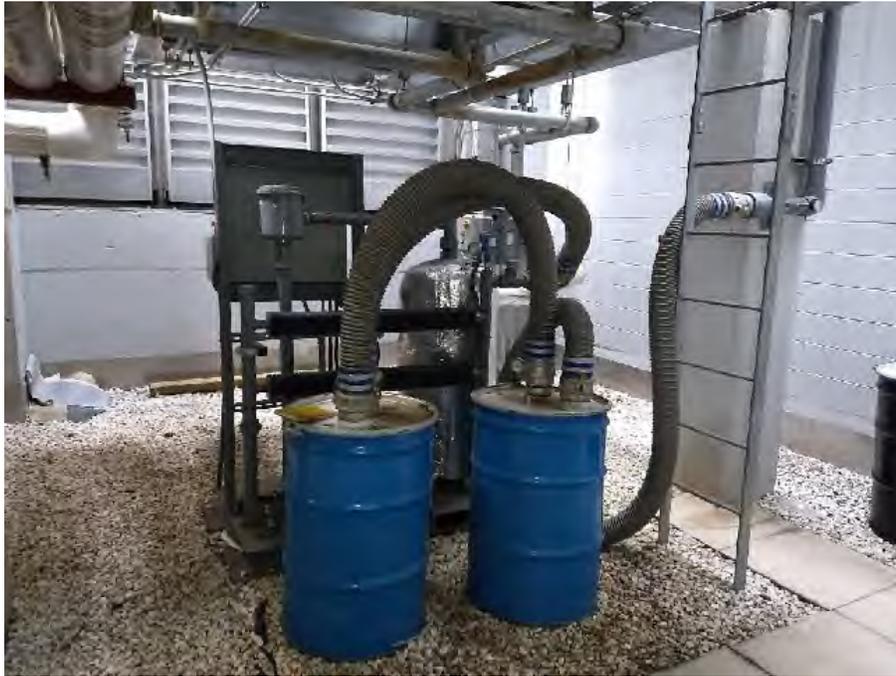
Photo 3: SVE system carbon drums

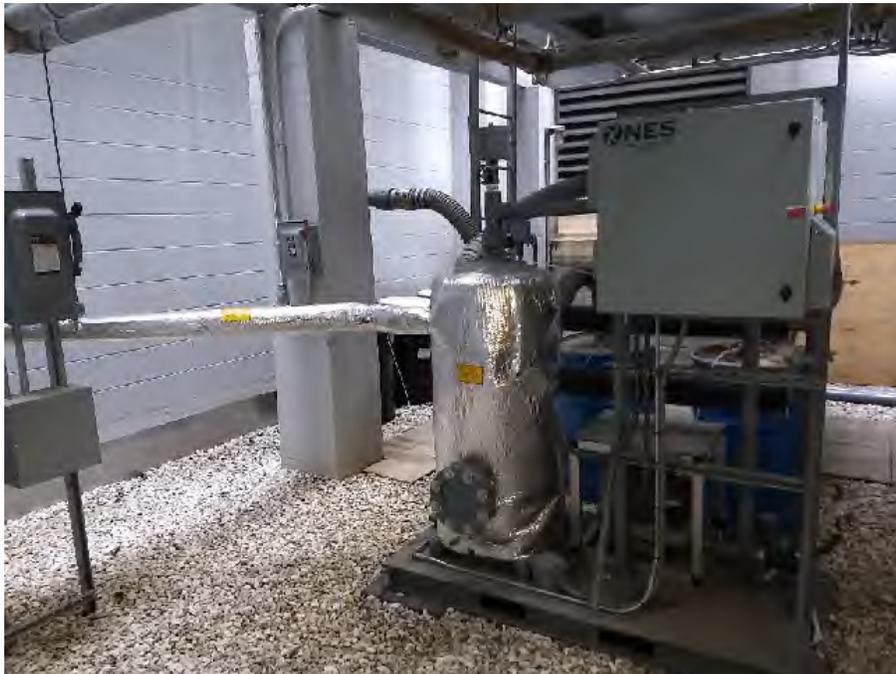
During the winter of 2016-2017, FLS observed that the on-Site SVE system did not shut after a high moisture separator alarm was triggered, upon further inspection FLS noted that water in the moisture separator was frozen. This was remedied by updating the system's control panel and installing heat trace and insulation on the inlet pipe and moisture separator.

Photo 4: SVE system control panel and insulated moisture separator

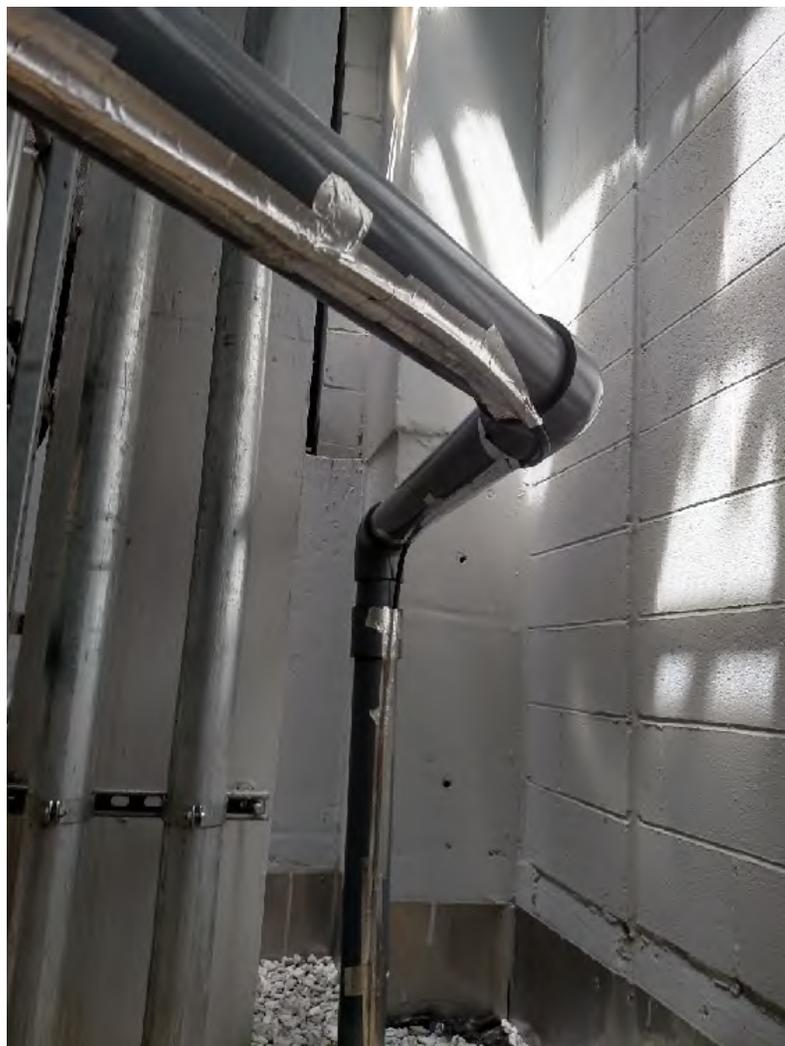
Photo 1: Heat trace on inlet pipe

In addition to repairing the alarm functionality, FLS wanted to prevent any future freezing of moisture. On May 16, FLS oversaw the installation of heat trace and insulation. As shown on the photograph log, heat trace was installed on the system inlet pipe, on the MS tank itself, and secured with aluminum foil tape. Following heat trace installation, the inlet

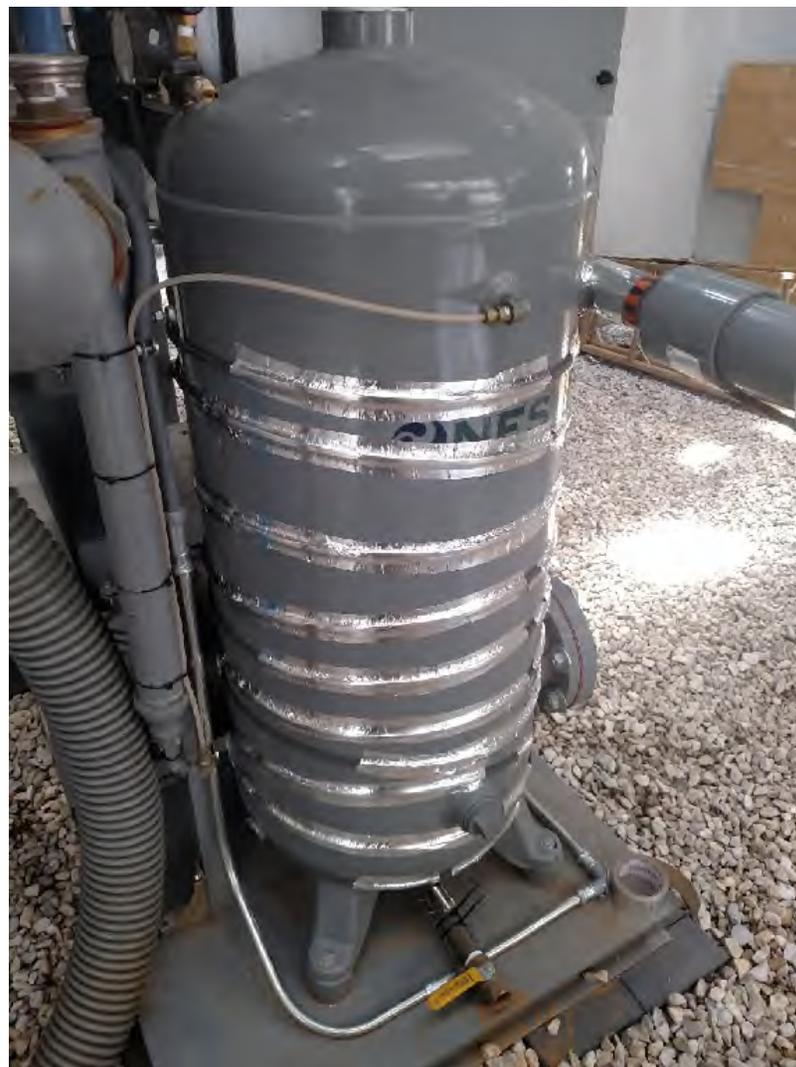
Photo 2: Heat trace on moisture separator

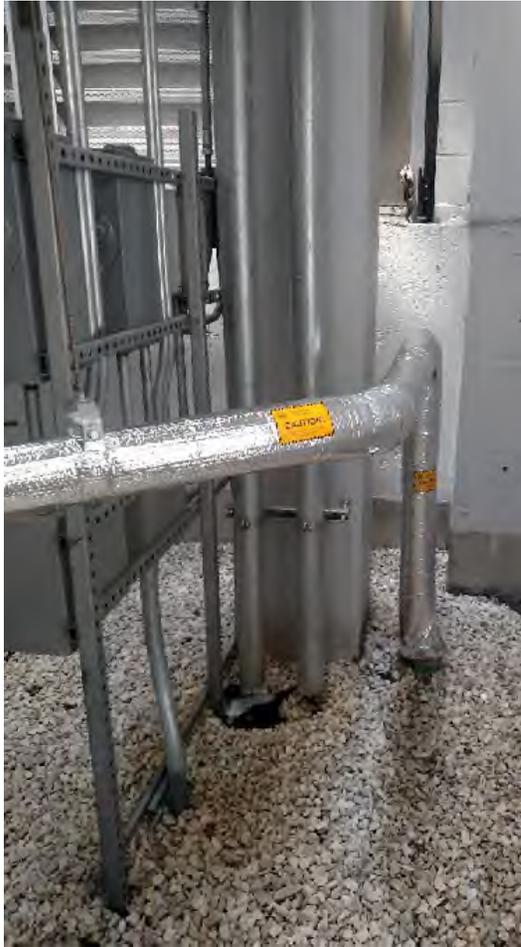
Photo 3: Insulation on inlet pipe

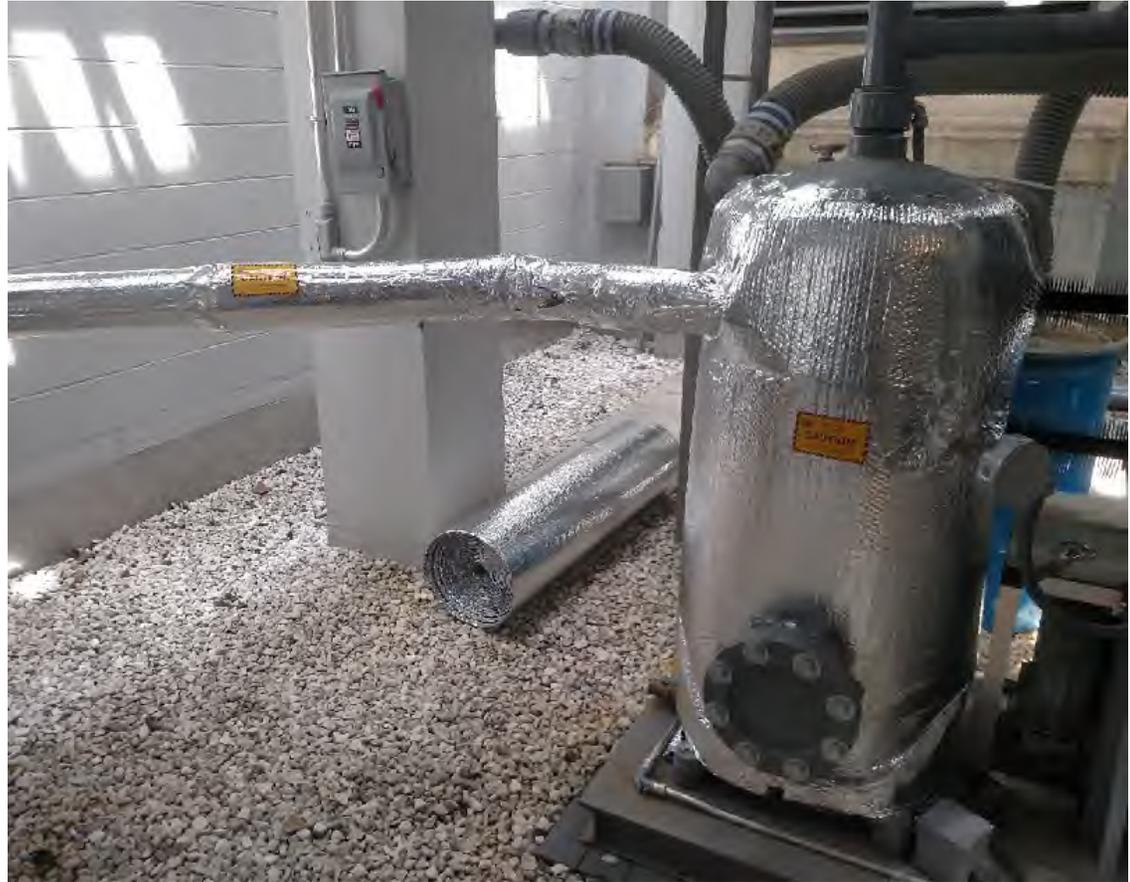
Photo 4: Insulation on moisture separator and inlet pipe
