# **Huxley Envelope Industrial Site**

**BROOKLYN, NEW YORK**

## **2020 Periodic Review Report**

**June 1, 2019 through May 31, 2020**

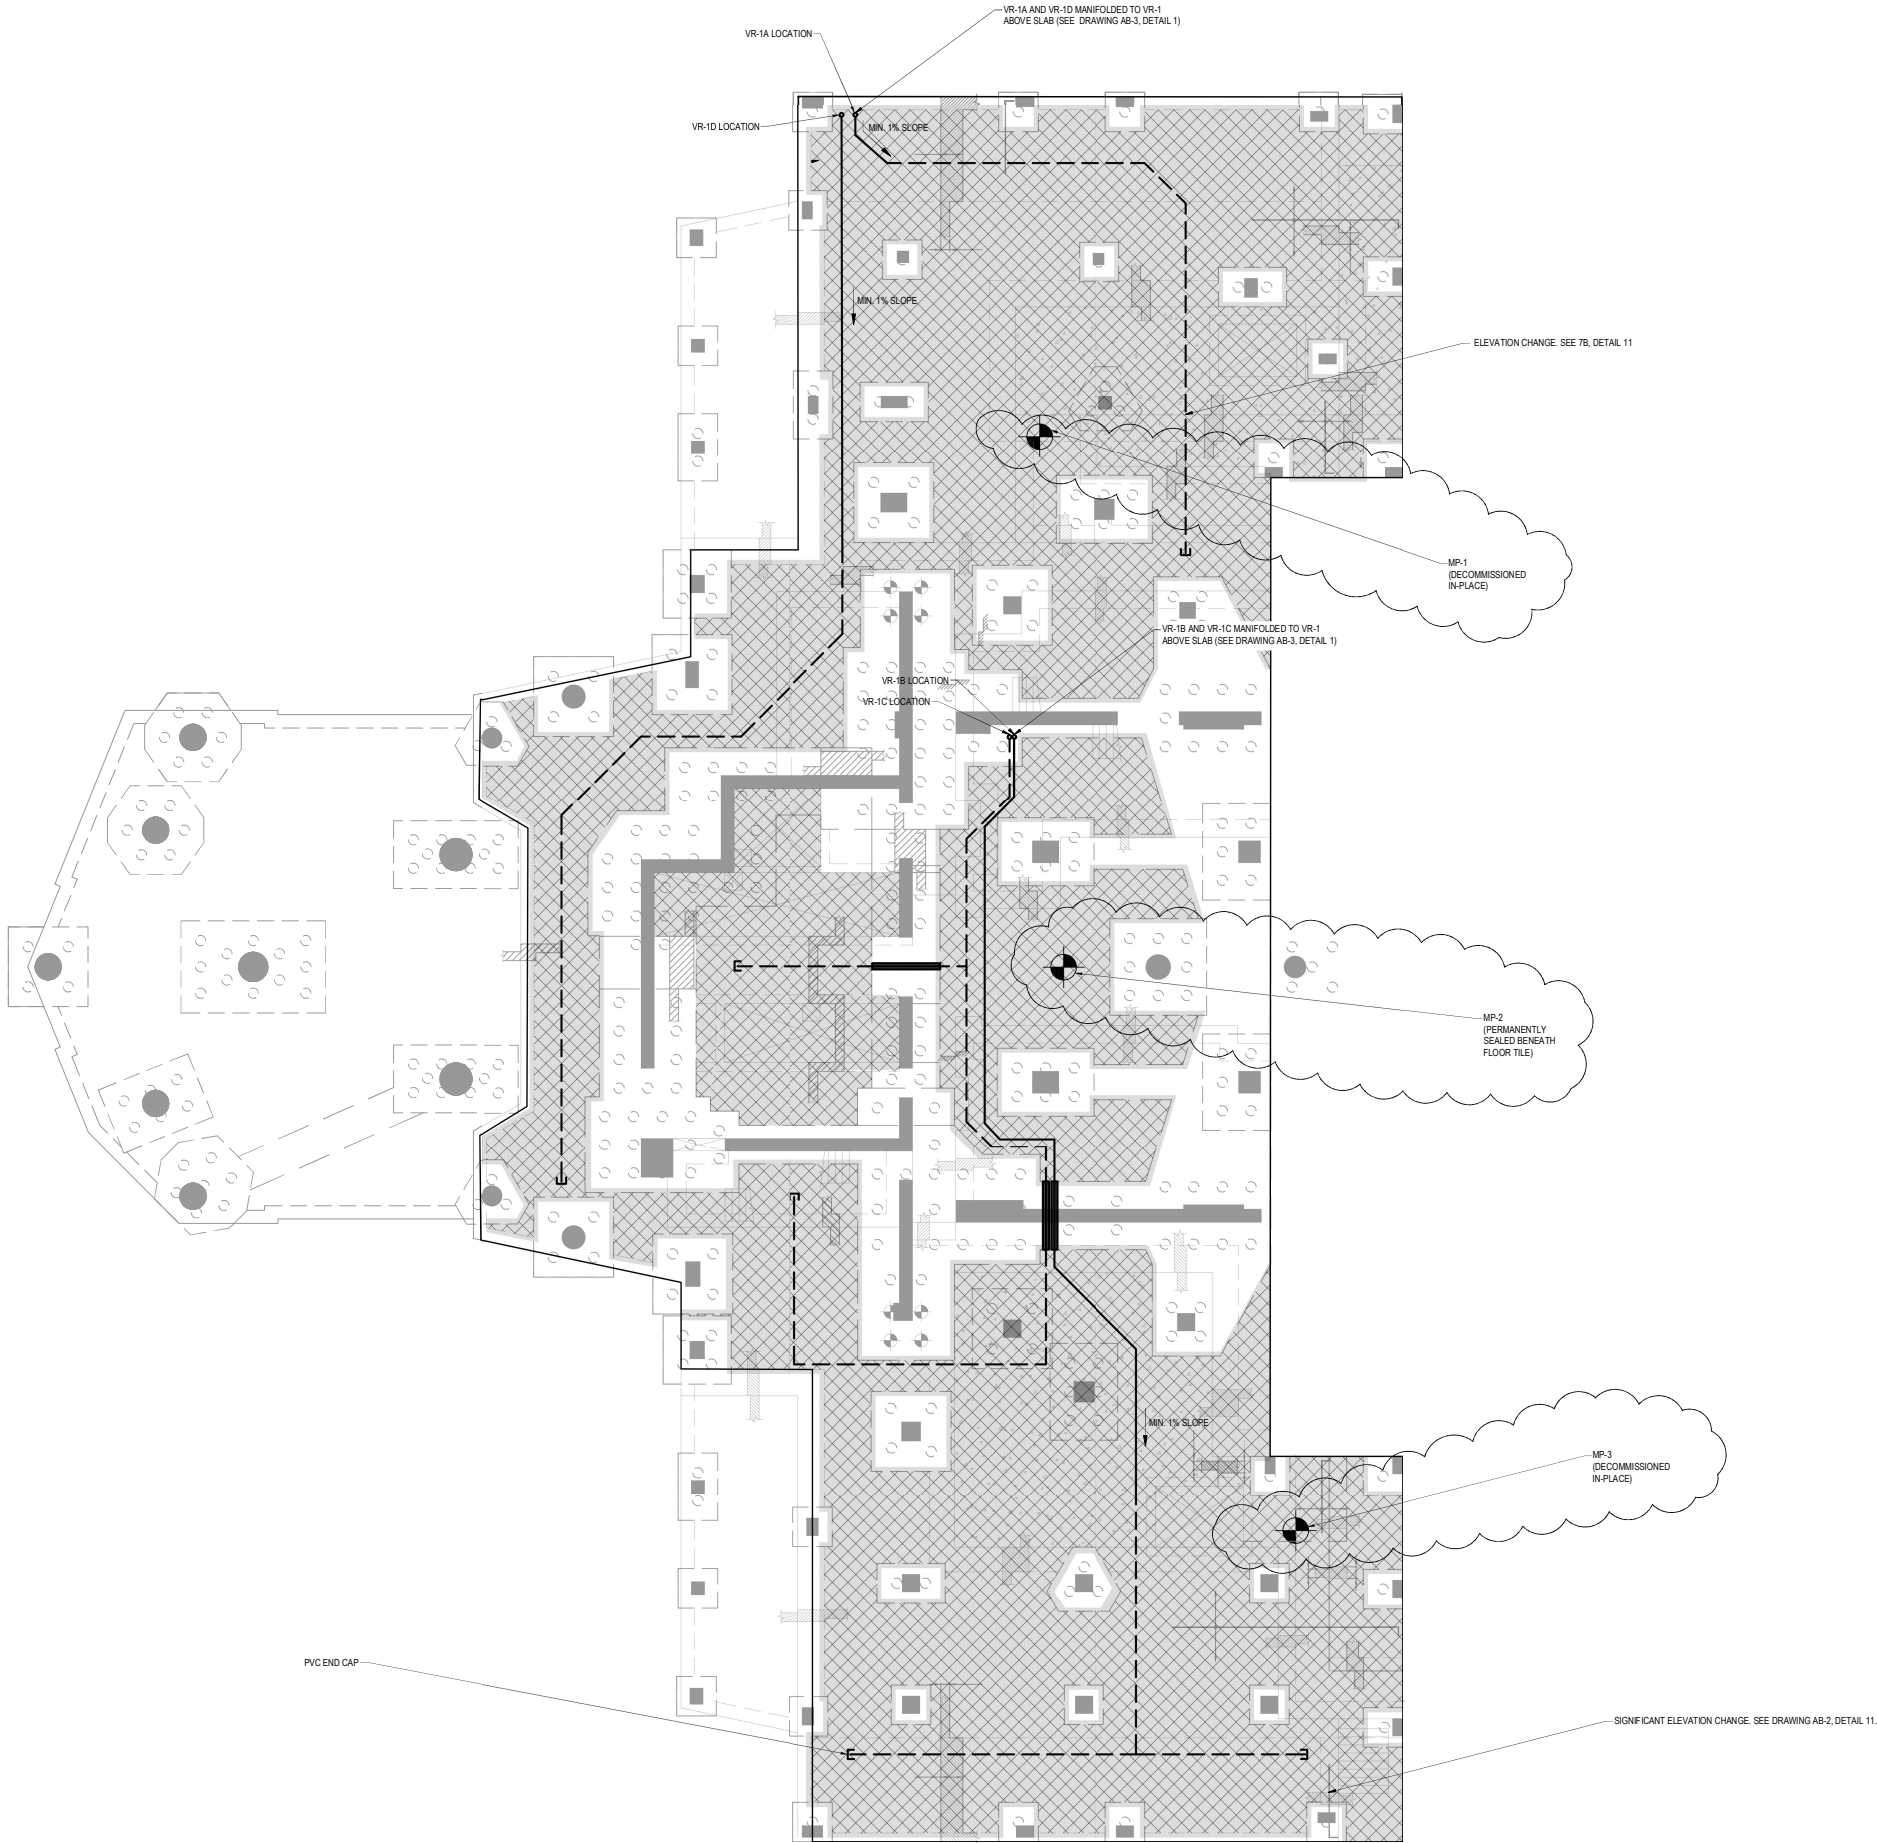
**BUILDING A - VAPOR BARRIER AND SUBSLAB VENTING SYSTEM  
LAYOUT AND DESIGN DETAILS**

A sub-slab venting system was installed underneath the Building A floor slab to minimize the potential for soil vapor intrusion into the Site building by sealing potential vapor entry points through the slab and providing a preferred pathway for any sub-slab vapor to vent above the roof. The system layout is shown on Figure 3.

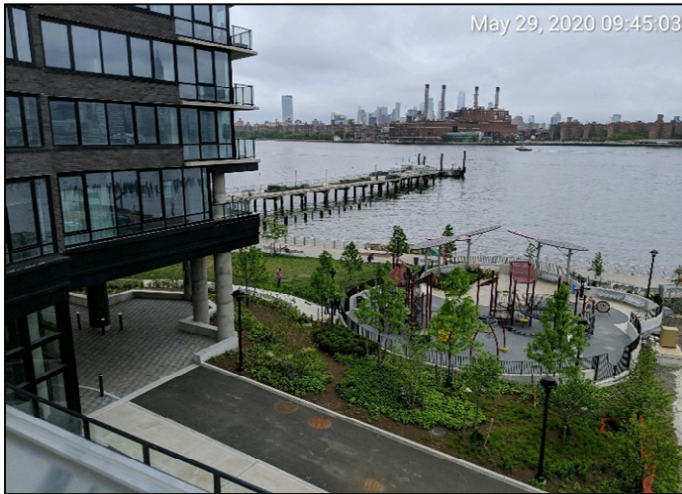
- No observed work or activities taking place within the park that would penetrate the cover system.
- Soil cover was in good condition.

**Photograph 1:** Completed Park construction in the western portion of the Site.

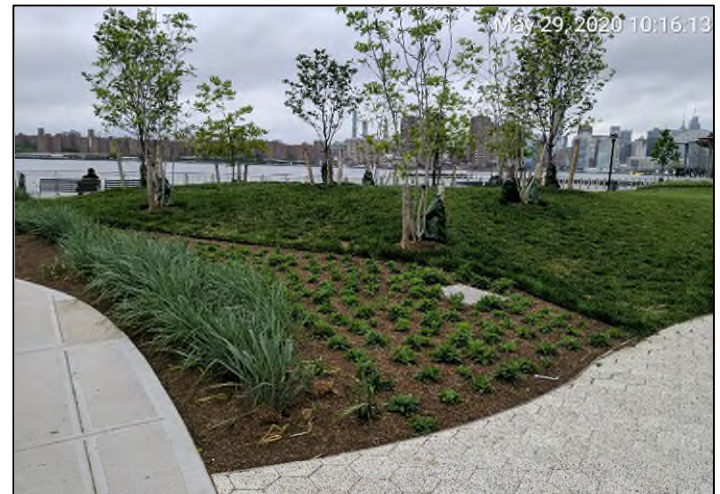
**Photograph 2:** Topsoil and paver installation and landscaping in the Park.

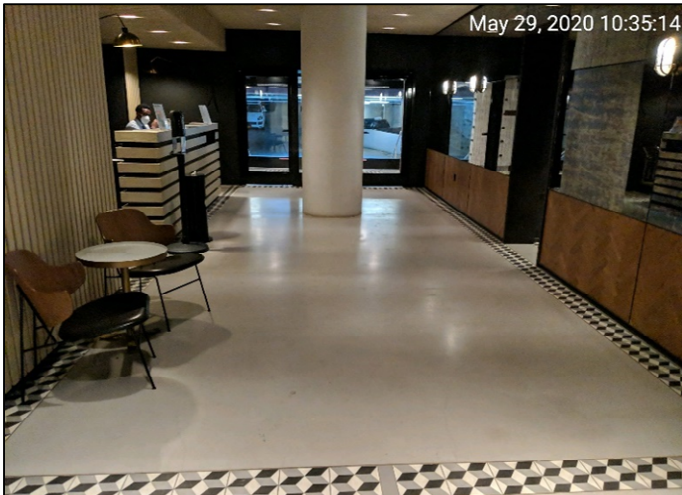
- Concrete floor slab appeared in good condition, with no visible cracks or unusual conditions.
- Some areas of the slab were covered with ceramic tile or carpeting.
- Construction materials covered portions of the eastern floor surfaces (boxes, 5-gallon buckets, trash containers).

**Photograph 3:** Typical Building A finished floor conditions over first floor concrete slab-on-grade.

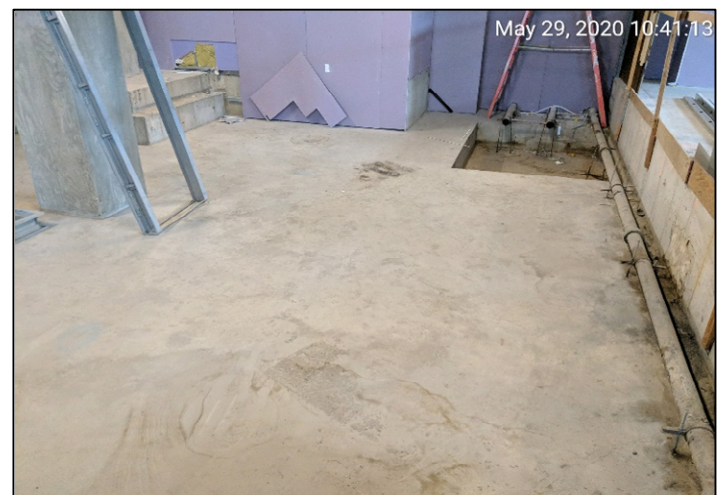
**Photograph 4:** Typical Building A first floor unfinished slab-on-grade.

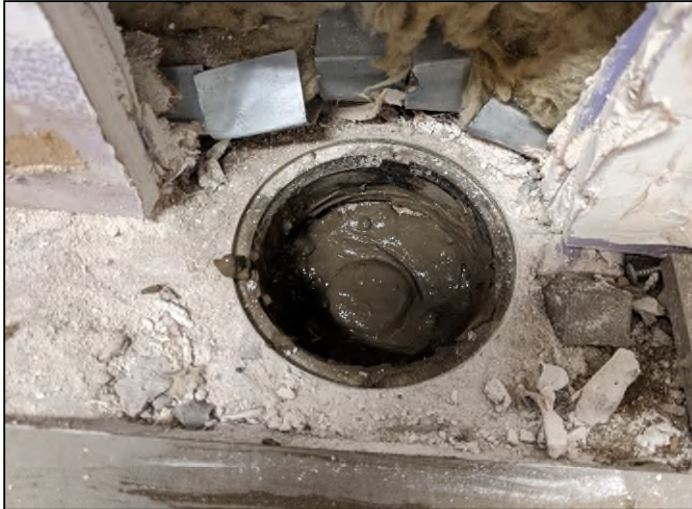
During the May 29, 2020 inspection, AKRF successfully located and decommissioned monitoring points MP-1 and MP-3. AKRF filled the PVC pipe and interior of the flush-mounted 6-inch cleanout with cement grout to surface grade of monitoring points MP-1 and MP-3. Monitoring point MP-2 was determined to be permanently covered by floor tiles, and is effectively sealed in place.

**Photograph 5:** Sub-slab vacuum monitoring MP-1 following decommissioning with concrete.

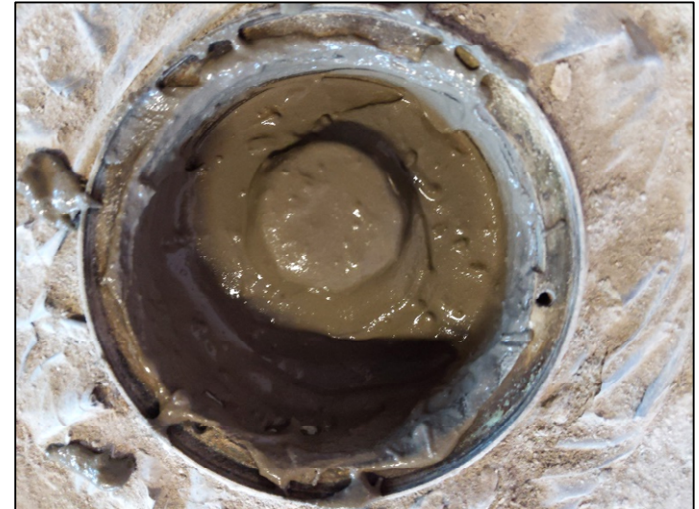
**Photograph 6:** Sub-slab vacuum monitoring MP-3 following decommissioning with concrete.

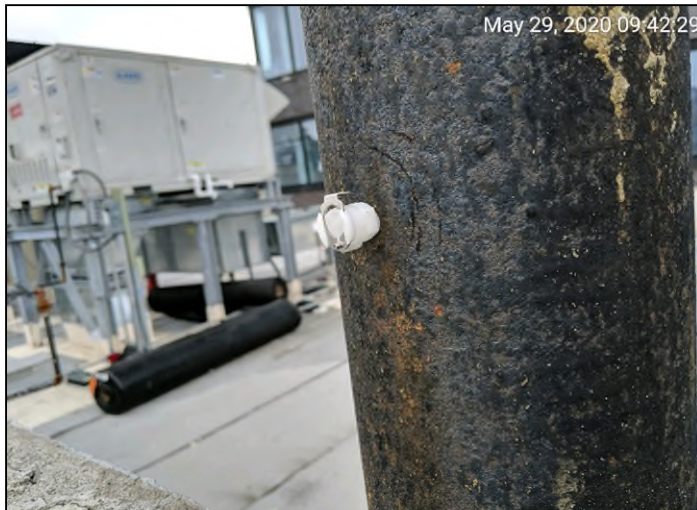
AKRF personnel drilled into the effluent stack using hand tools and installed a permanent sample port approximately 4 feet above the fourth floor roof slab.

Aboveground portions of the sub-slab venting system, including the manifold, are enclosed behind drywall and were inaccessible. The exhaust stack located on the fourth floor roof of Building A appeared to be in good condition, with no visible issues or deficiencies. The newly installed sample port was screened for VOCs using a PID, and no readings above background concentrations were detected. This sample port will continue to be screened for VOCs on an annual basis.

**Photograph 5:** Sub-slab venting system exhaust stack with newly installed sample port.

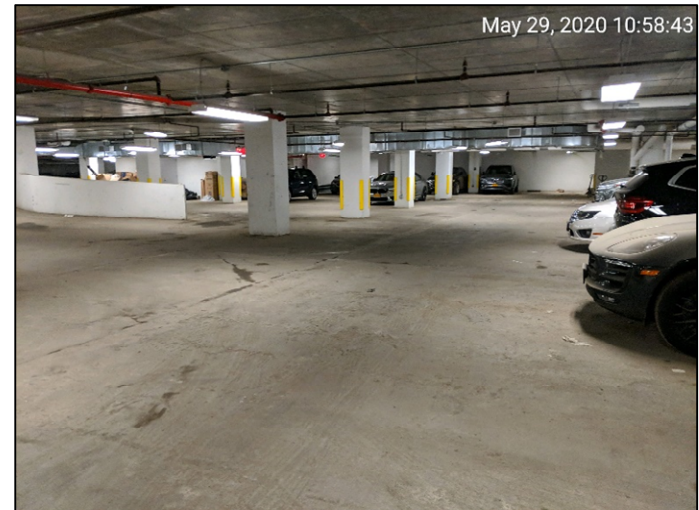
During the inspection, some surficial cracks were noted in the Building B floor slabs, which were being repaired with concrete or grout. None of the surficial cracks breached the Site cover and, as such, no corrective measures are recommended at this time. Repairs of the identified cracks are expected to be completed as part of ongoing building maintenance.

- Some surficial cracks were noted in the Building B floor slabs which were being repaired with concrete or grout. None of the surficial cracks breached the Site cover.
- Storage of construction materials and vehicles covered portions of the floor slab.

**Photograph 6:** Typical Building B basement floor slab.

- Concrete crack repair is ongoing as part of building construction and maintenance.
