# **Huxley Envelope Industrial Site**

## **2022 Periodic Review Report**

**June 1, 2021 through May 31, 2022**

**NYSDEC Site Number: C224147**

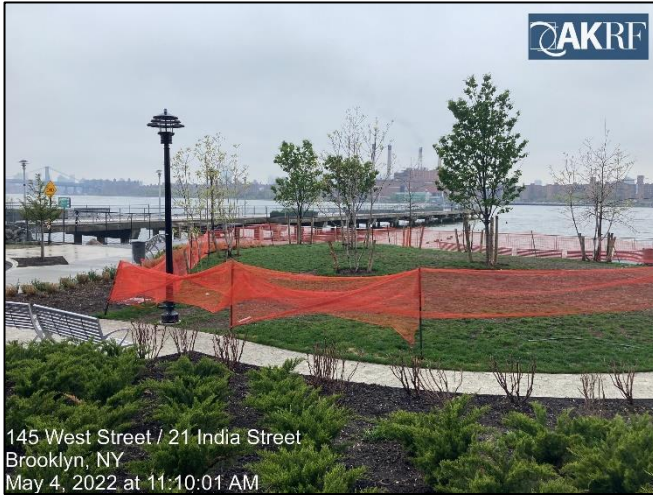
**Photograph 1:** The Park in the western portion of the Site; facing southwest.

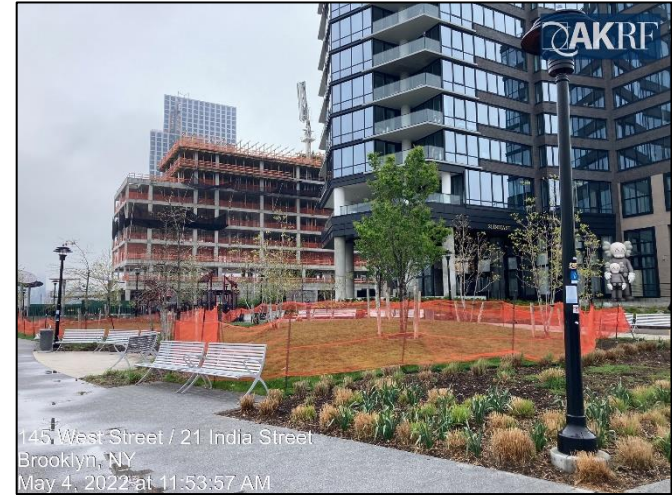
**Photograph 2:** Landscaped and impervious hardscaped areas; view facing north.

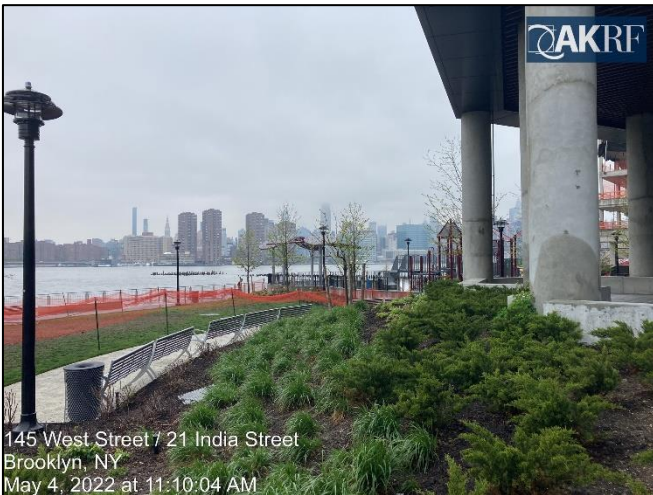
**Photograph 3:** Landscaping and impervious pavers in the Park; view facing west.

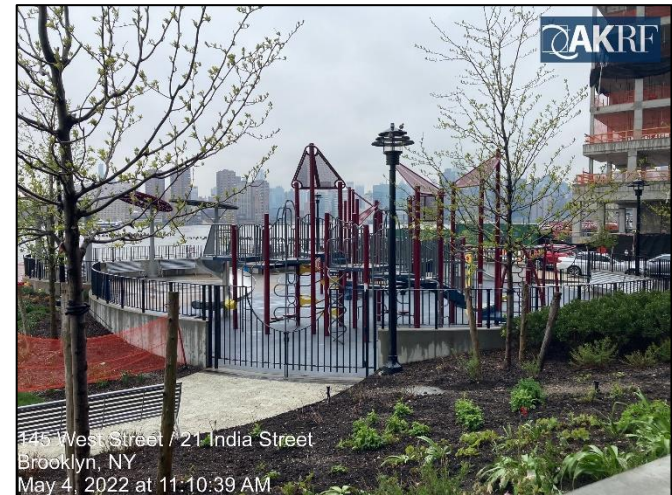
**Photograph 4:** Park hardscaped recreational area, facing west.

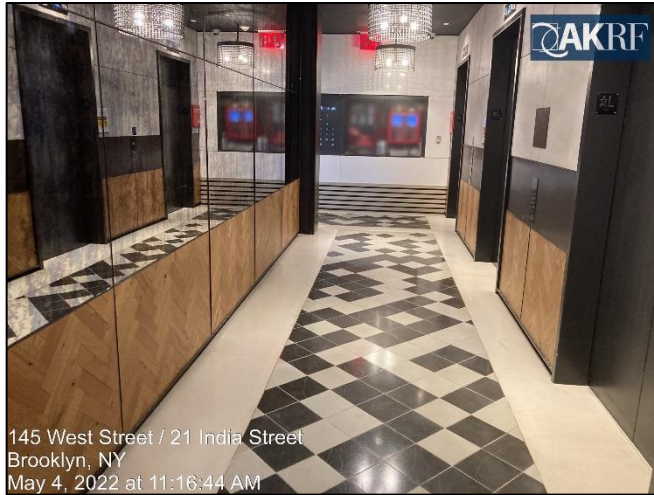
**Photograph 5:** Typical interior hallway on the first floor of Building A.

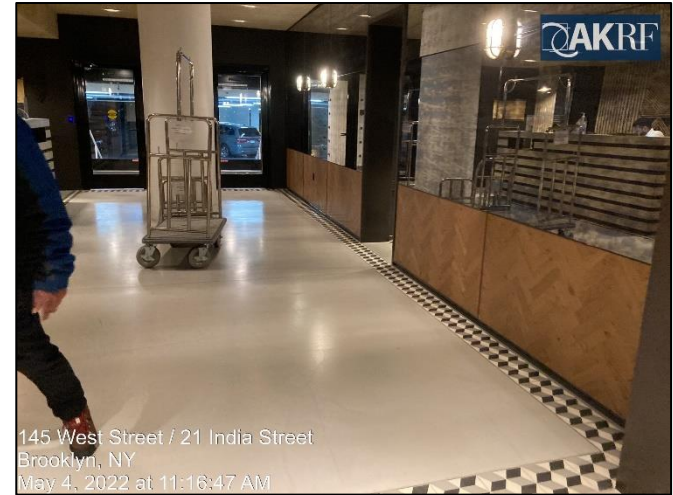
**Photograph 6:** First floor lobby in Building A.

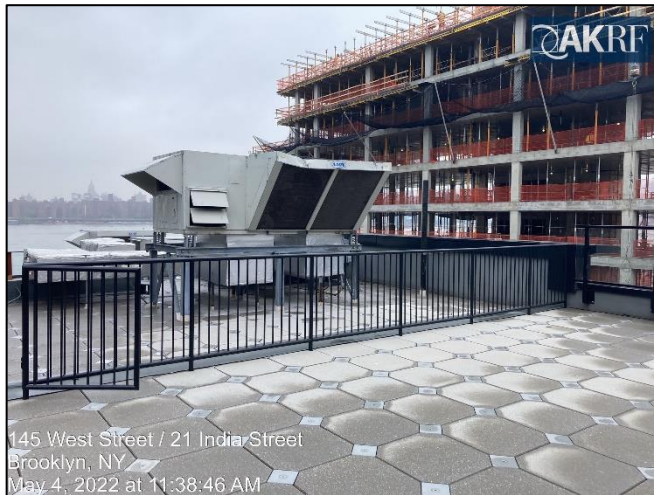
Aboveground portions of the sub-slab venting system, including the manifold, are enclosed behind drywall and inaccessible. The exhaust stack located on the fourth floor roof of Building A appeared to be in good condition, with no visible issues or deficiencies. The sample port was screened for VOCs using a calibrated PID, and no readings above background concentrations were detected. This sample port will continue to be screened for VOCs on an annual basis in accordance with the SMP.

**Photograph 7:** Sub-slab venting system exhaust stack; view facing northwest.

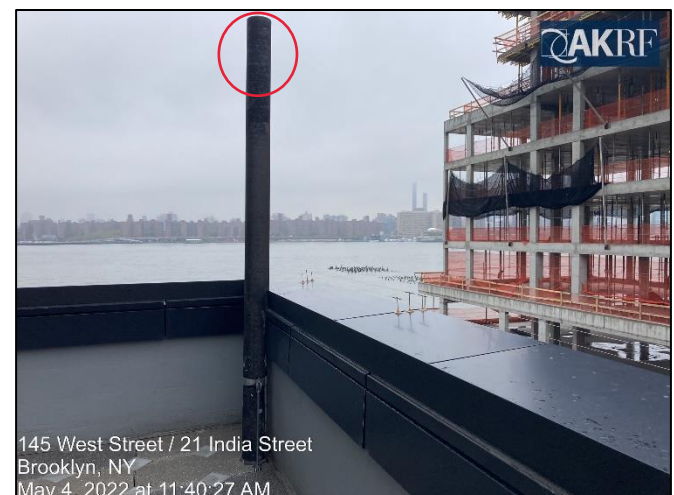
**Photograph 8:** Exhaust stack sample port.

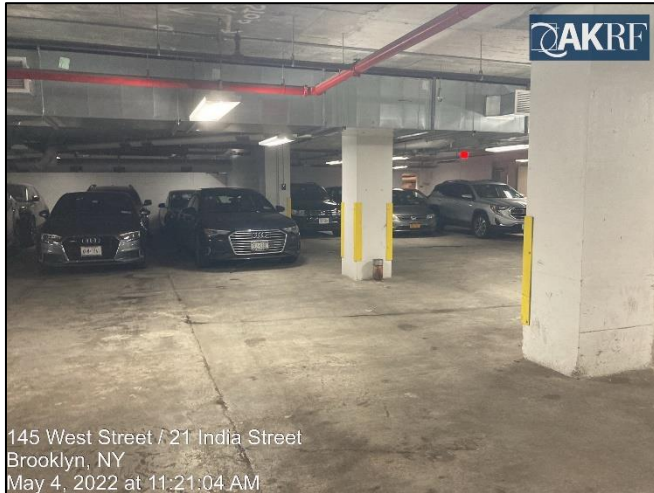
**Photograph 9:** Building B below-grade parking garage; view facing south.

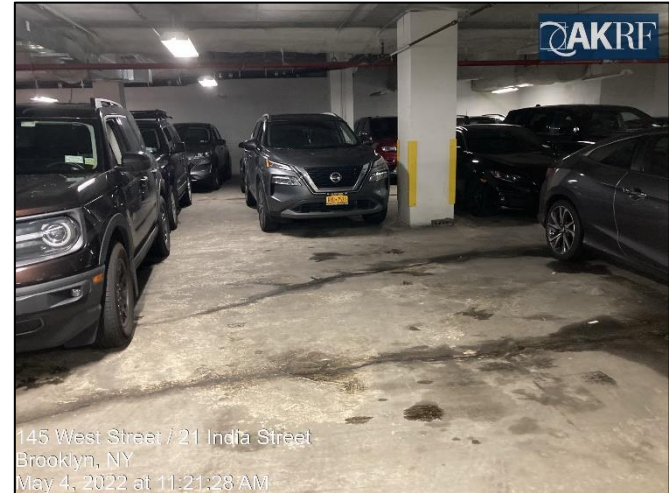
- No Site cover construction work was conducted in Buildings A or B. Minor surficial cracking was observed in the Building B floor slab, which appeared to have been patched and sealed. None of the surficial cracks breached the Site cover and as such, no corrective measures are recommended at this time.

- Some surficial cracks were noted in the Building B floor slab. None of the surficial cracks breached the Site cover.
- Storage of building maintenance materials and parked vehicles covered portions of the floor slab.

**Photograph 10:** Surficial cracks observed in Building B floor slab.

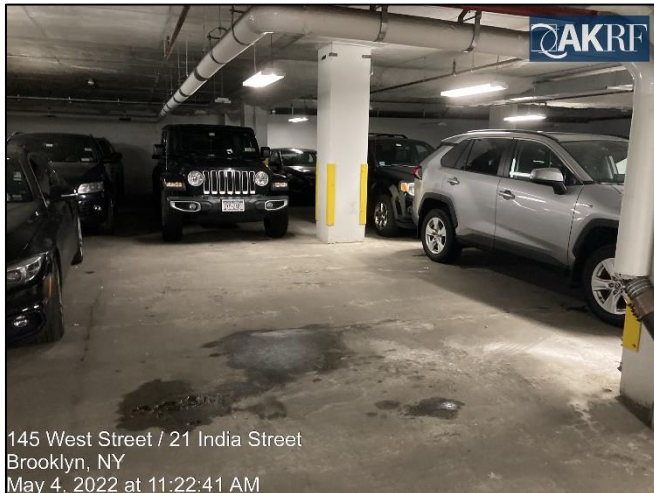
**Photograph 11:** Interior of Building B parking garage.

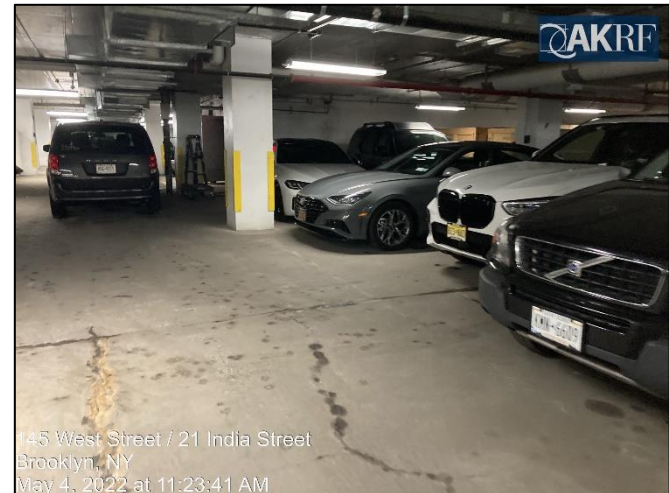
- Previous repairs to the concrete floor slab were made during the 2020 PRR inspection. During the 2020 PRR inspection, repairs to the concrete floor slab were ongoing. Based on the 2021 inspection, visible cracks were repaired and no ongoing work was being conducted. No changes in condition were noted during the 2022 inspection.

**Photograph 12:** Sealed surficial cracks in Building B floor slab.
