Huxley Envelope Industrial Site

2023 Periodic Review Report

April 27, 2022 through April 27, 2023

NYSDEC Site Number: C224147

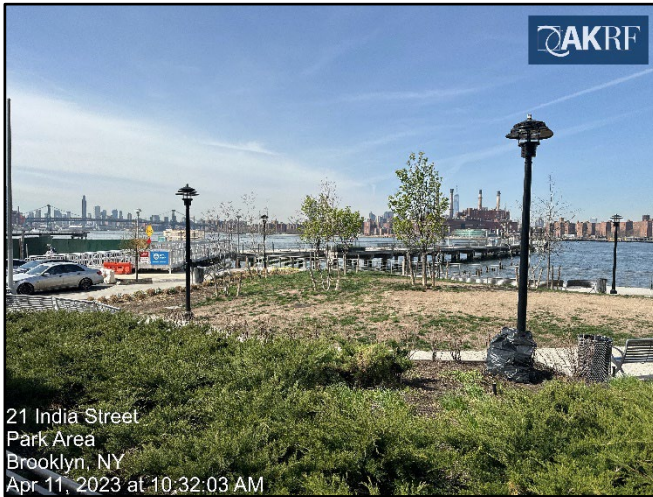
- No activities or work observed taking place within the Park that would penetrate the cover system.
- Soil and vegetation cover was in good condition.

Photograph 1: The Park in the western portion of the Site; facing southwest.

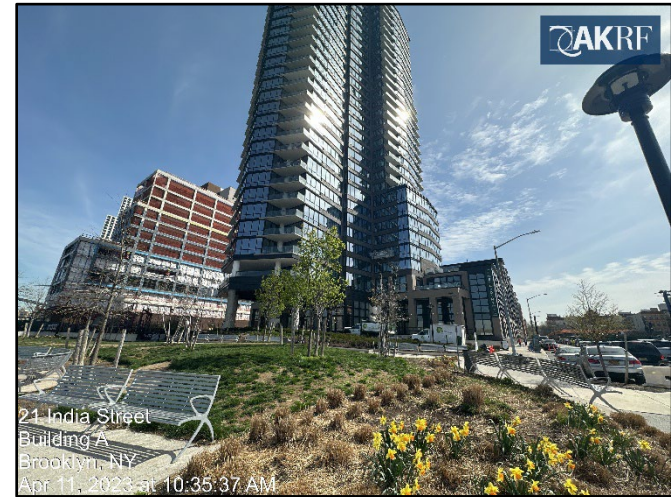
Photograph 2: Landscaped and impervious hardscaped areas; view facing northeast. Building A in background.

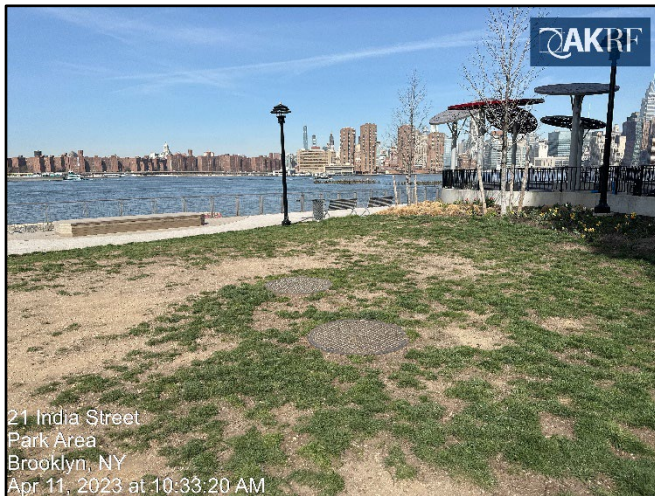
Photograph 3: Landscaping, hardscape, and hardscaped recreational area (to the right) in the Park; view facing west.

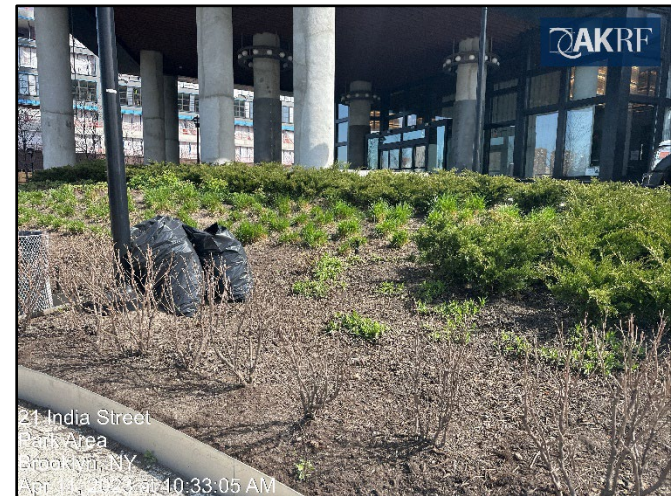
Photograph 4: Park landscaping and hardscaping areas, facing northeast.

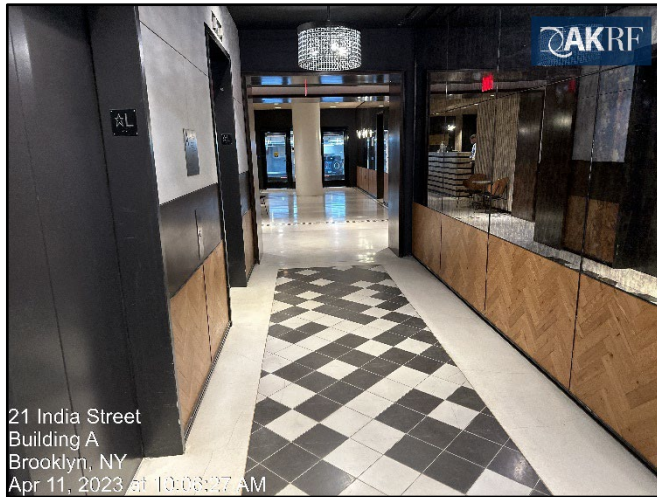
- Concrete floor slab appeared in good condition, with no visible cracks or unusual conditions.
- Some areas of the slab were covered with ceramic tile or carpeting.

Photograph 5: Typical interior hallway on the first floor of Building A.

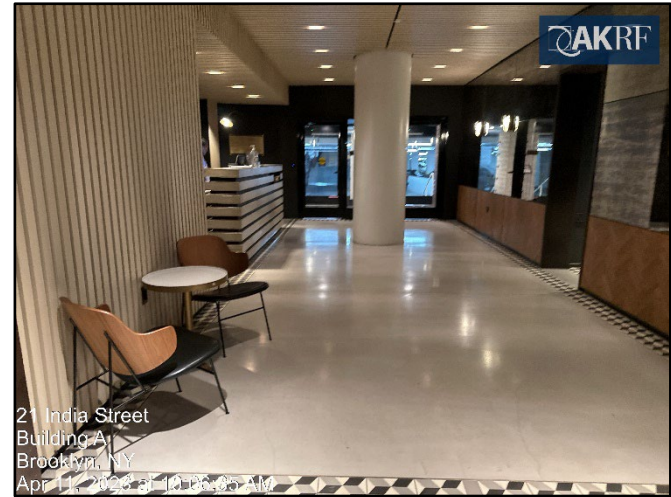
Photograph 6: First floor lobby in Building A.

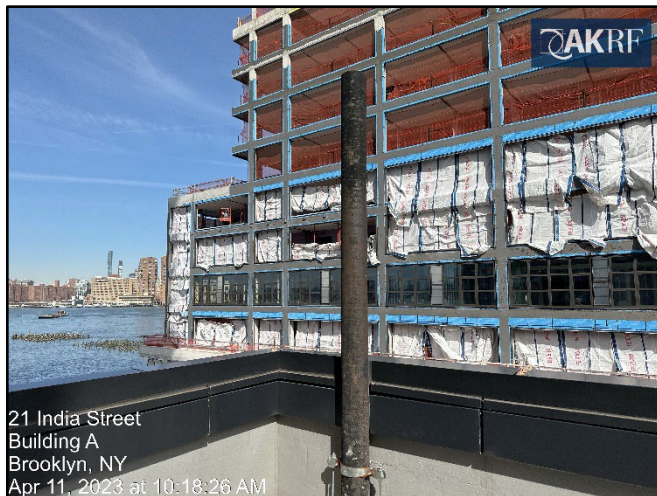
Aboveground portions of the sub-slab venting system, including the manifold, are enclosed behind drywall and inaccessible. The exhaust stack located on the fourth-floor roof of Building A appeared to be in good condition, with no visible issues or deficiencies. The sample port was screened for VOCs using a calibrated PID. PID readings collected from the effluent stack were non-detect. This sample port will continue to be screened for VOCs on an annual basis in accordance with the SMP.

Photograph 7: Passive sub-slab venting system exhaust stack; view facing northwest.

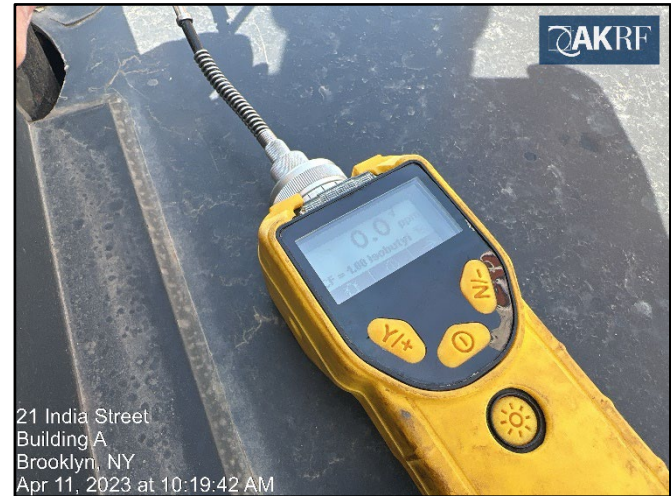
- In accordance with the NYSDEC-approved July 2020 revision to the SMP, AKRF screened the sample port on the exhaust stack using a photoionization detector (PID). PID readings collected from the effluent stack were non-detect.

Photograph 8: Exhaust stack sample port PID measurement.

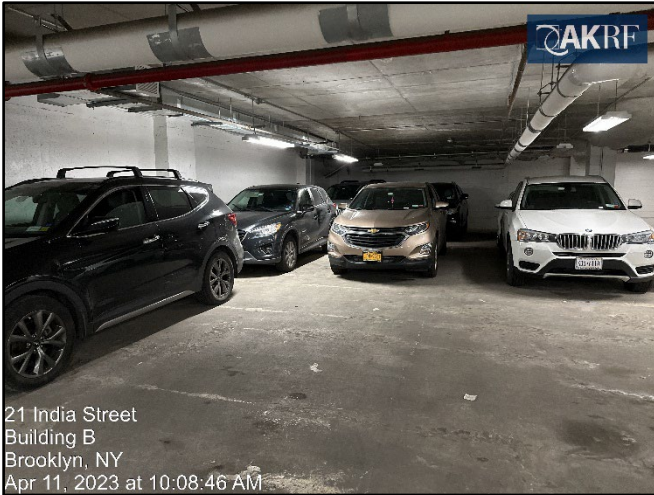
Photograph 9: Building B below-grade parking garage.

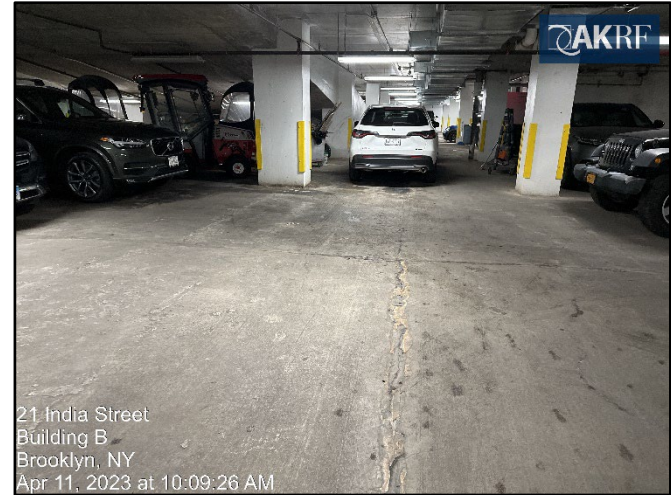
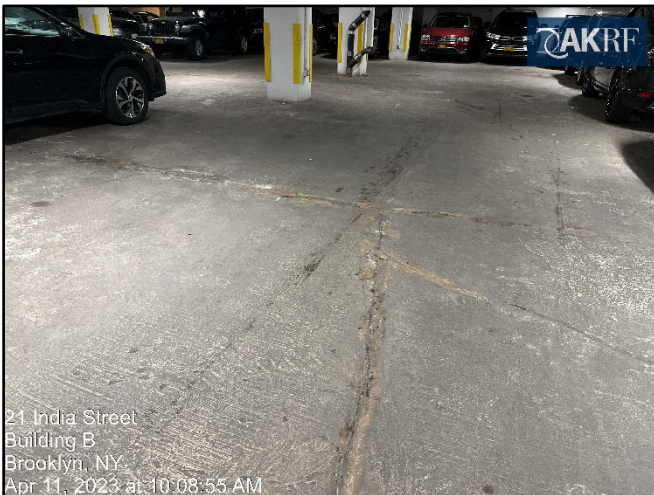
No significant cracking in the concrete foundation slab was observed in Buildings A or B. Minor surficial cracking was noted in the Building B basement-level floor slab; however, all visible cracks were observed to be repaired with concrete or grout. Though parked vehicles throughout the below-grade garage limited visibility during the inspection, none of the identified surficial cracks breached the Site cover and, as such, no corrective measures are recommended at this time.

Photograph 10: Sealed surficial cracks observed in Building B floor slab.

Photograph 11: Sealed surficial cracks observed in Building B floor slab.

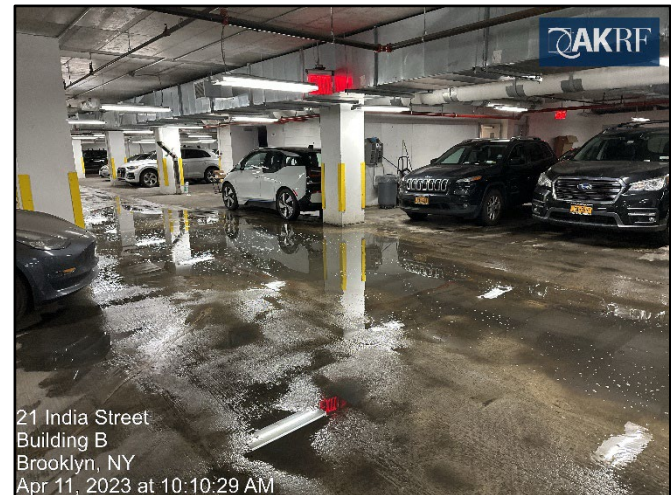
Some pooled rainwater was observed on the Building B basement parking garage concrete slab, which was reportedly the result of malfunctioning sump pumps. According to building personnel, the sump pumps were repaired and the pooled water had been removed in late April 2023. The pooled rainwater is not expected to have had any impacts on the Site cover system, nor was it reflective of any issues with the integrity of the cover system. As such, no corrective measures are recommended at this time.

Photograph 12: Pooled rainwater noted on Building B floor slab (attributed to sump pumps not in operation at time of inspection).
