# Huxley Envelope Industrial Site

## 2024 Periodic Review Report

April 27, 2023 through July 1, 2024

**NYSDEC Site Number: C224147**

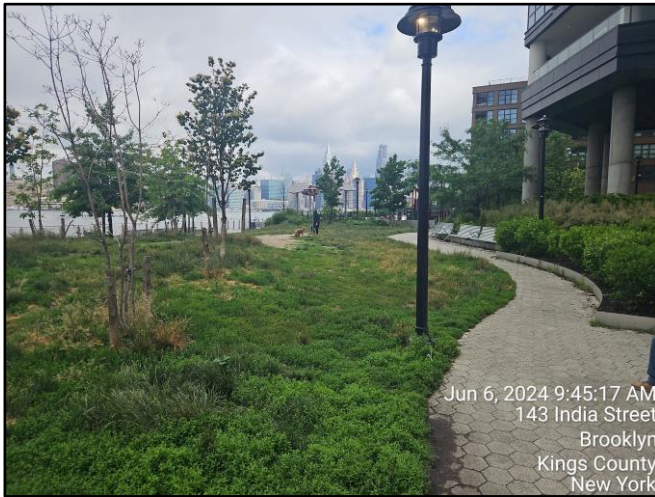
- No activities or work observed taking place within the Park that would penetrate the cover system.
- Soil and vegetation cover was in good condition.

**Photograph 1:** The Park in the western portion of the Site; facing northwest.

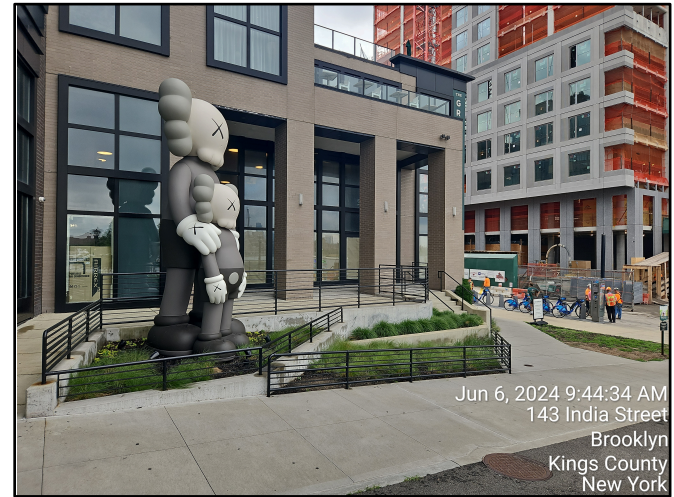
**Photograph 2:** Main entrance to Building A and off-site, south-adjacent construction site; view facing southeast.

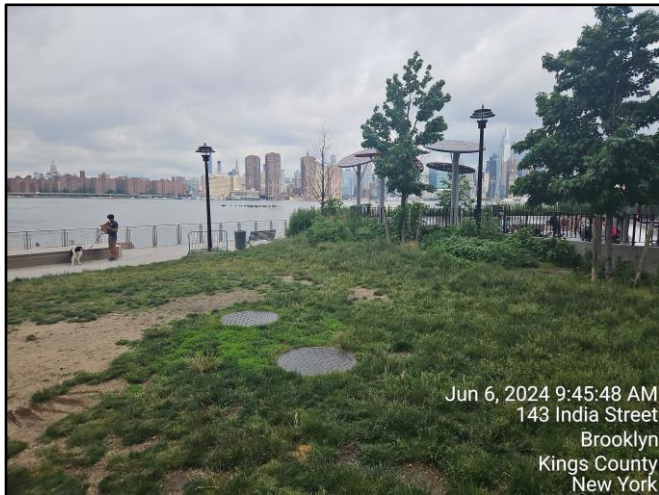
**Photograph 3:** Landscaping in the Park; view facing west.

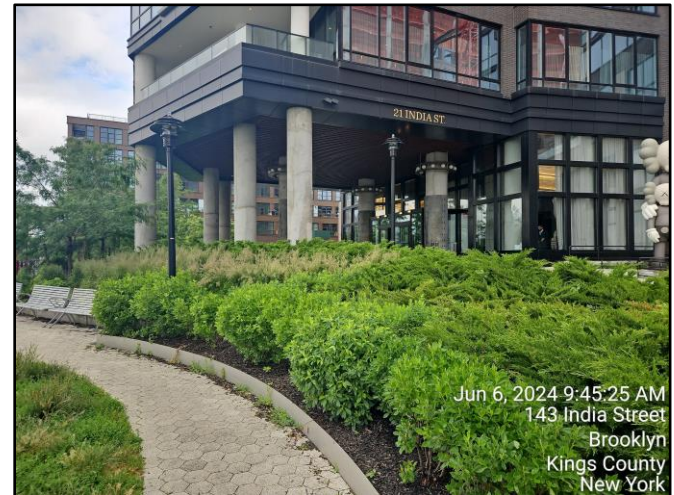
**Photograph 4:** Park landscaping and hardscaping areas, facing northeast.

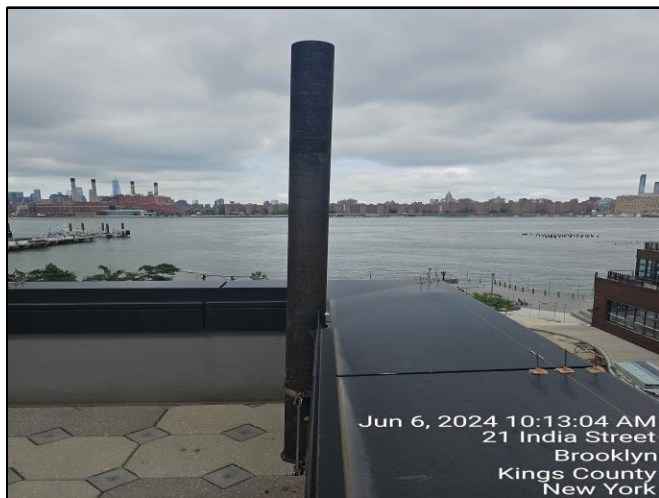
Aboveground portions of the sub-slab venting system, including the manifold, are enclosed behind drywall and inaccessible. The exhaust stack located on the fourth-floor roof of Building A appeared to be in good condition. The rain cap on the exhaust stack was observed to be missing. The exhaust stack sample port was screened for VOCs using a calibrated PID. PID readings collected from the effluent stack were non-detect. This sample port will continue to be screened for VOCs on an annual basis in accordance with the SMP.

- Piping manifold was covered by drywall and not accessible for inspection.
- The exhaust stack on the fourth-floor mechanical roof was inspected – no visual issues/deficiencies observed, other than the rain cap was observed to be missing.
- Sample port on fourth floor roof riser pipe was observed to be intact and in good condition.

**Photograph 5:** Passive sub-slab venting system exhaust stack; view facing northwest.

- No changes or unusual conditions observed. Conditions of the aboveground components were consistent with the previous PRR. The rain cap was observed to be missing and will be replaced.

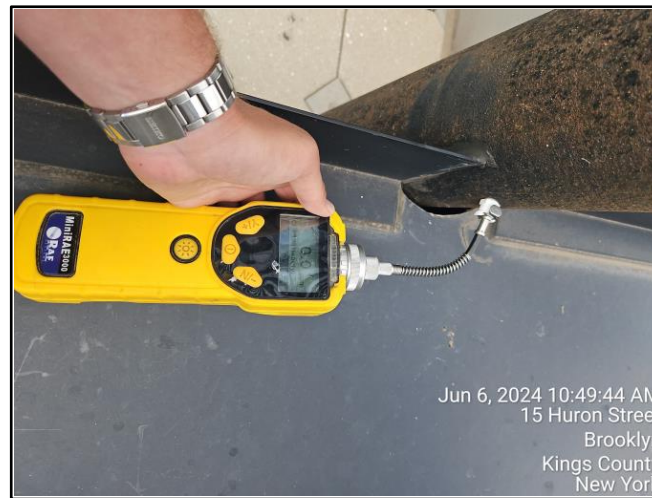
- In accordance with the NYSDEC-approved July 2020 revision to the SMP, AKRF screened the sample port on the exhaust stack using a photoionization detector (PID). PID readings collected from the effluent stack were non-detect.

**Photograph 6:** Exhaust stack sample port PID measurement.

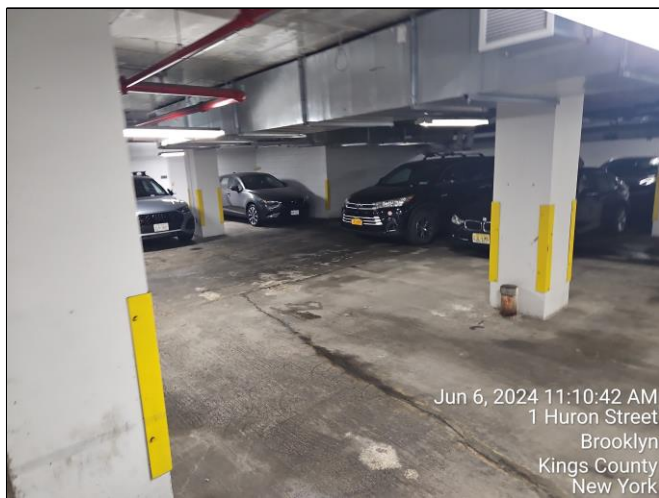
No significant cracking in the concrete foundation slabs was observed in Buildings A or B. Minor surficial cracking was noted in the Building B basement-level floor slab; however, all visible cracks were observed to be repaired with concrete or grout. Though parked vehicles throughout the below-grade garage limited visibility in some areas during the inspection, none of the identified surficial cracks breached the Site cover and, as such, no corrective measures are recommended at this time. The surface also appeared dry, and no evidence of pooling water was observed throughout the below-grade parking garage.

- Some surficial cracks were noted in the Building B floor slab. None of the surficial cracks breached the Site cover.
- Storage of building maintenance materials and parked vehicles covered portions of the floor slab.

**Photograph 7:** Sealed surficial cracks observed in Building B floor slab.

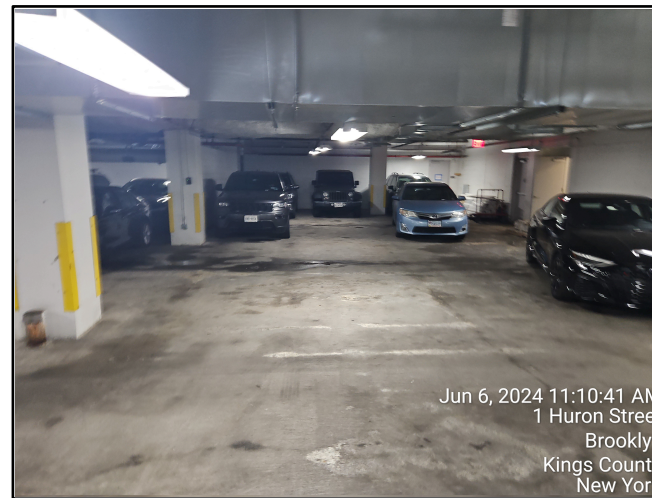
**Photograph 8:** Interior view of Building B parking garage

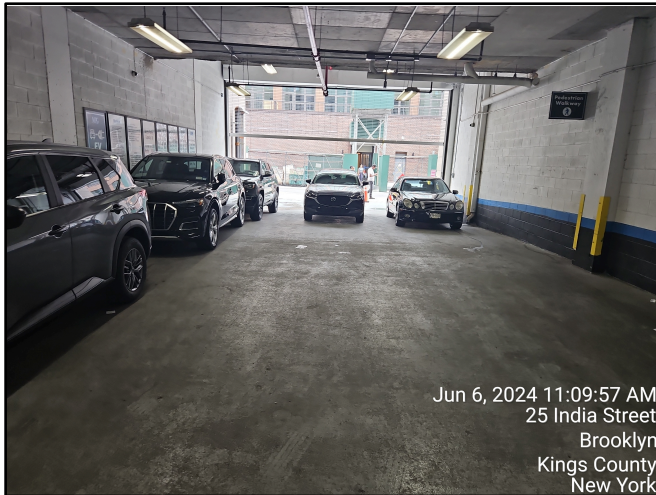
**Photograph 9:** Entrance to Building B below-grade parking garage.

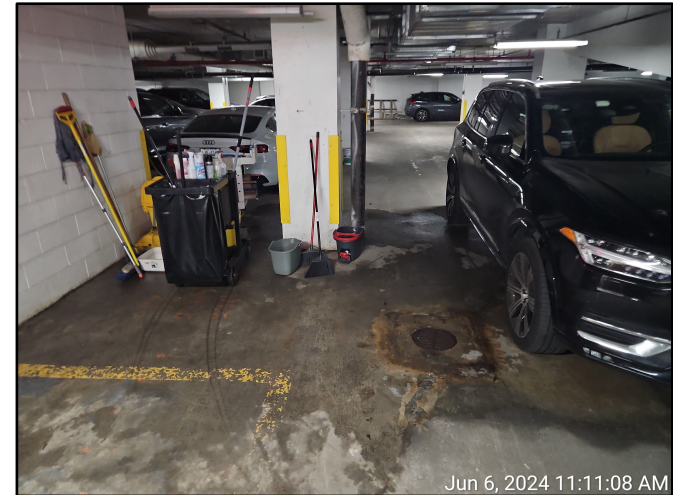
**Photograph 10:** Floor drain and cleaning supplies located in the Building B garage.
