Huxley Envelope Industrial Site

2025 Periodic Review Report

July 1, 2024 through July 1, 2025

NYSDEC Site Number: C224147

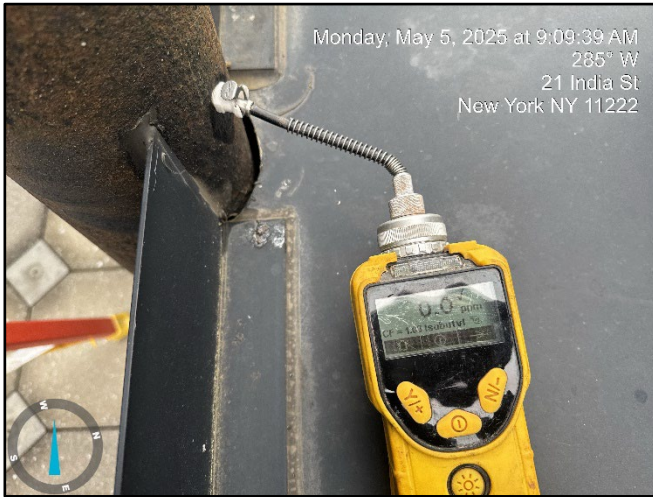
- In accordance with the NYSDEC-approved July 2020 revision to the SMP, AKRF screened the sample port on the exhaust stack using a photoionization detector (PID). PID readings collected from the effluent stack were non-detect.

Photograph 1: Exhaust riser pipe sample port PID measurement.

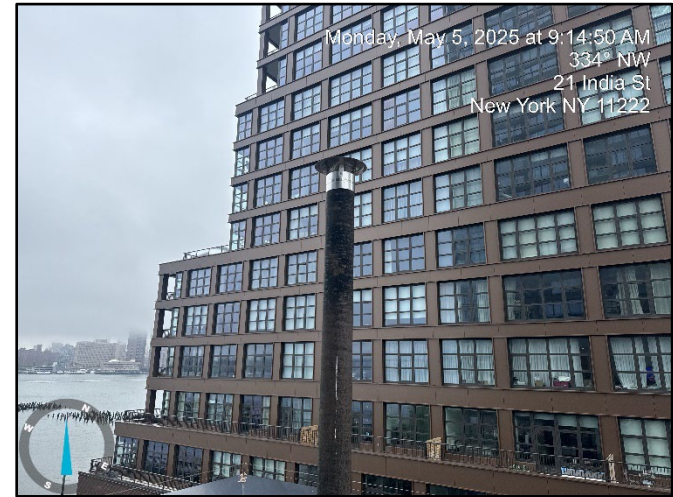
- Portions of the aboveground piping for the sub-slab venting system in Building A are enclosed behind sheetrock walls and inaccessible. The riser pipe and exhaust stack located on the Building A fourth floor mechanical roof were observed to be in good condition. The rain cap on the exhaust stack was replaced during the annual Site inspection.

Photograph 2: Installed rain cap on fourth-floor exhaust riser pipe; view facing northwest.

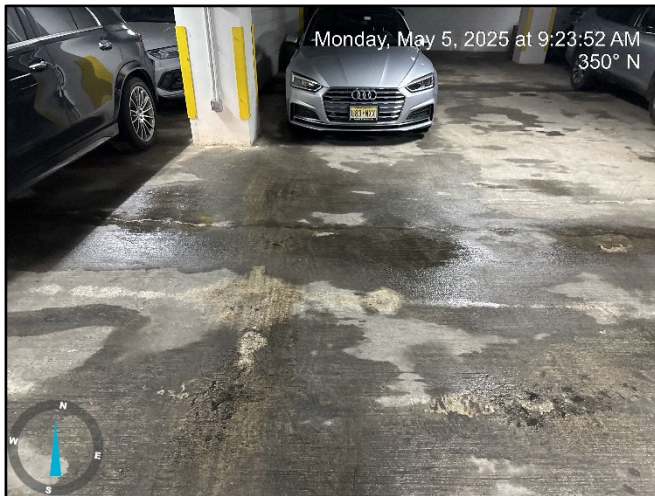
Photograph 3: Building B below-grade parking garage.

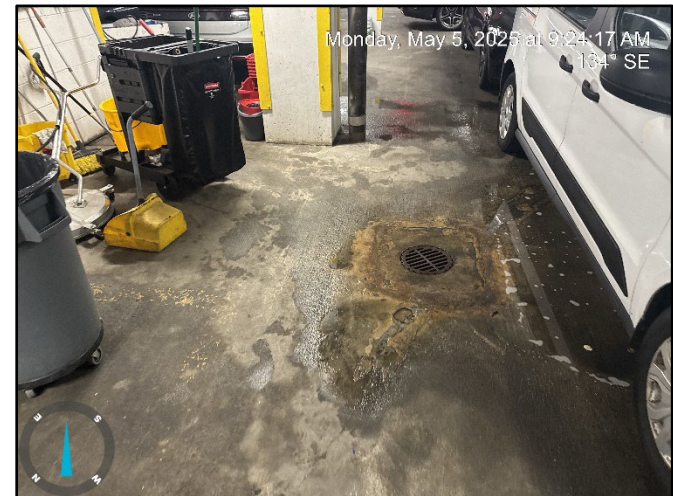
- Some standing rainwater was observed on the Building B basement concrete slab. The rainwater is not expected to have any impacts on the Site cover system, nor was it reflective of any issues with the integrity of the cover system.

Photograph 4: Standing rainwater noted on Building B floor slab near floor drain.

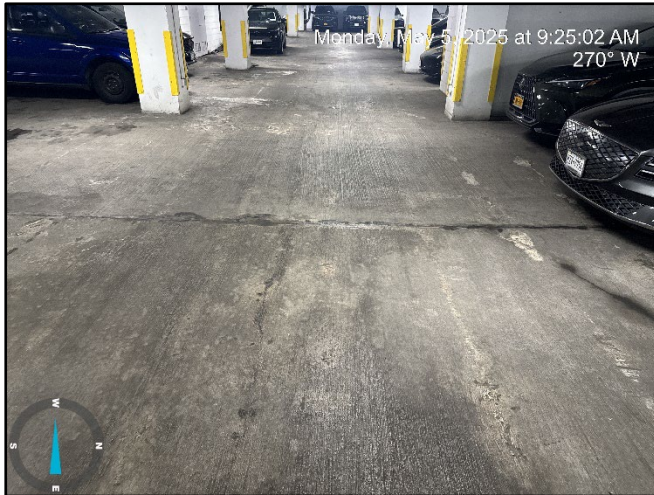
No significant cracking in the concrete foundation slabs was observed in Buildings A or B. Minor surficial cracking was noted in the Building B basement-level floor slab; however, all visible cracks were observed to be repaired with concrete or grout. Though parked vehicles throughout the below-grade garage limited visibility in some areas during the inspection, none of the identified surficial cracks breached the Site cover and, as such, no corrective measures are recommended at this time. Standing rainwater was observed on the Building B concrete slab. The rainwater is not expected to have any impacts on the Site cover system, nor was it reflective of any issues with the integrity of the cover system. As such, no corrective measures are recommended at this time.

Photograph 5: Sealed surficial cracks observed in Building B floor slab.

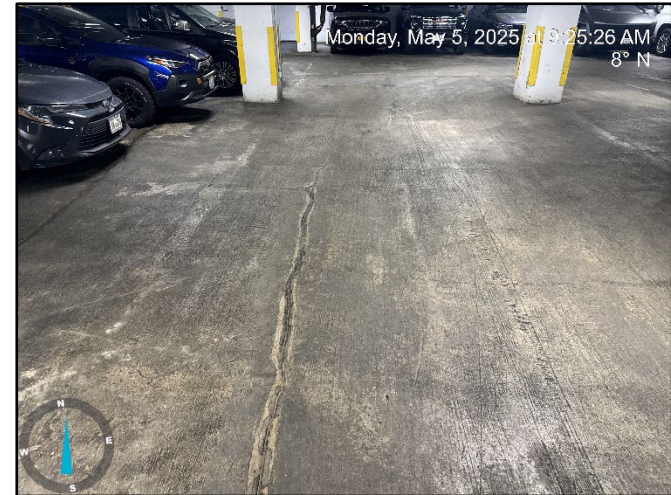
Photograph 6: Sealed surficial cracks observed in Building B floor slab.

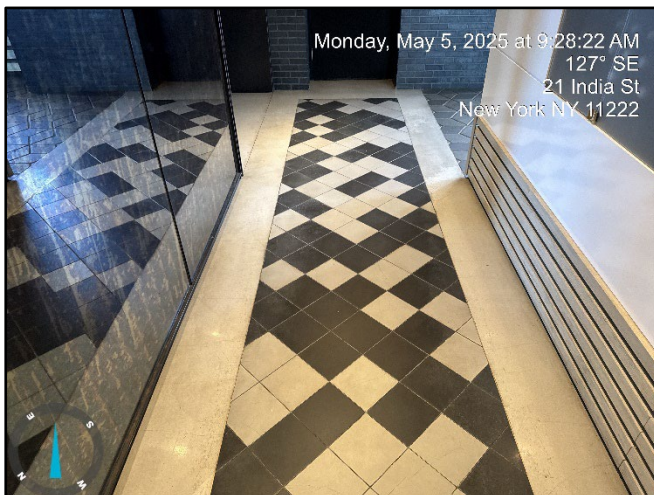
Photograph 7: Typical interior hallway on the first floor of Building A.

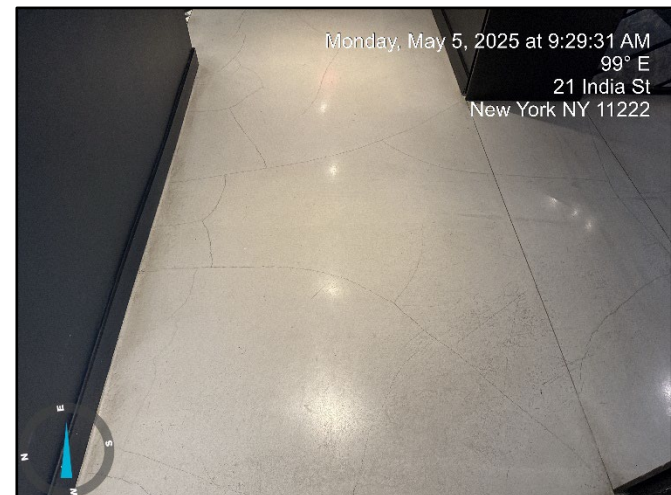
Photograph 8: Typical interior hallway on the first floor of Building A.

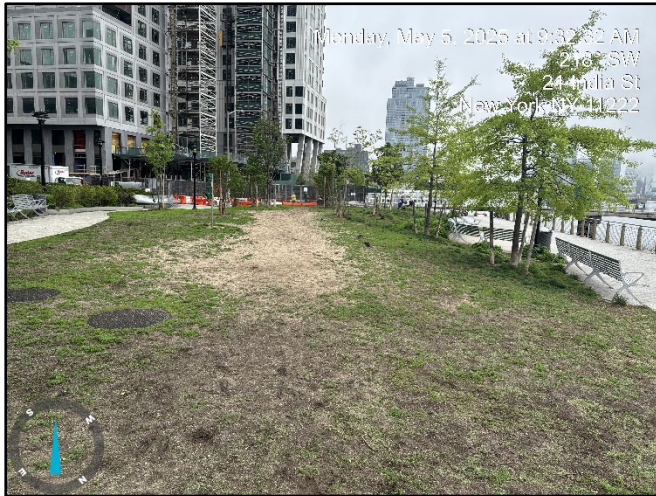
Photograph 9: Landscaping and hardscape areas in the Park; view facing south.

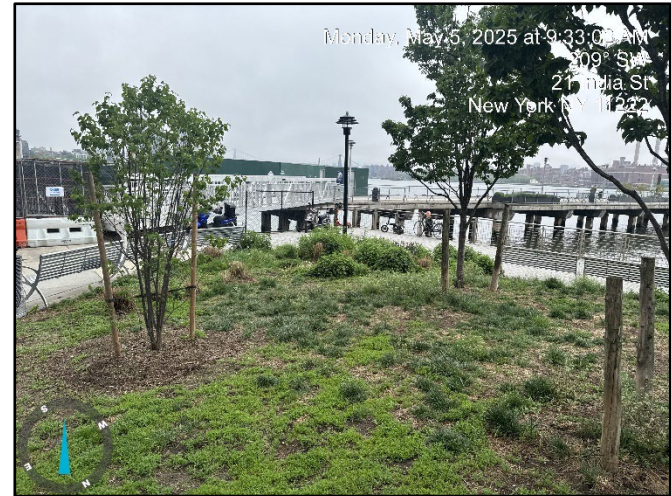
Photograph 10: Park landscaping and hardscape areas; view facing southwest.
