**DAILY ACTIVITY REPORT**  
FYN Paint & Lacquer Co.  
**Site No. C224154**  
Sheet 1 of 3

Project/Site Name: FYN Paint & Lacquer Co.

Location: 230 Kent Ave Brooklyn,  
NY

Date: July 9, 2026

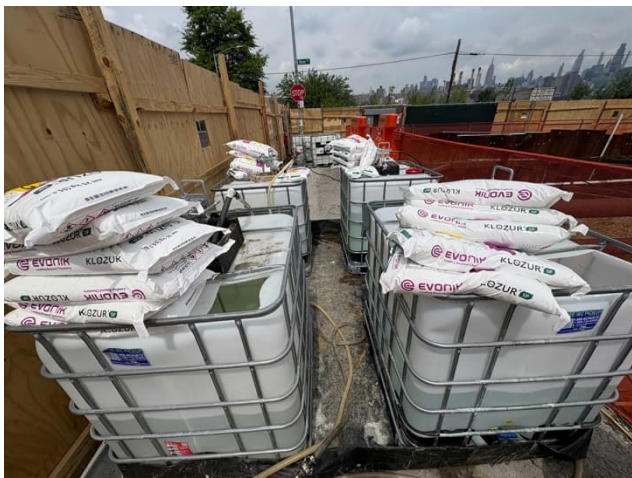
Photo 1 – ISCO treatment mixing and injection water totes.

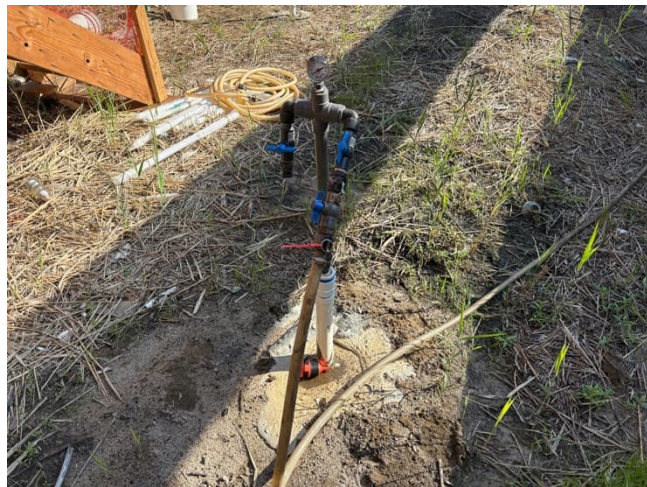
Photo 2 – ISCO treatment pumping at IW-9

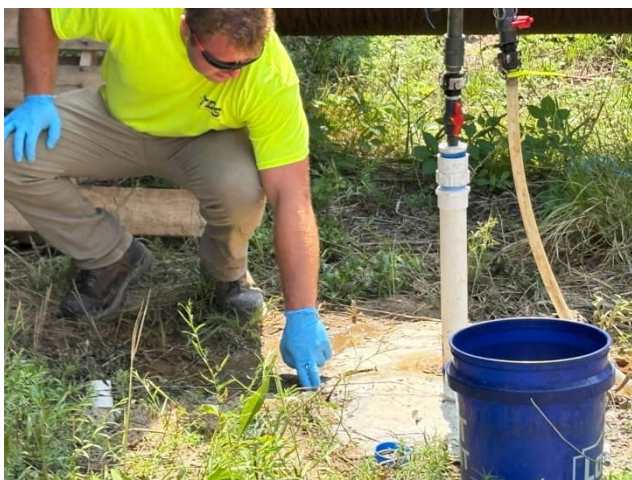
ISCO treatment surfacing/daylighting in IW-1, IW-4, IW-11, and IW-14, Injections paused upon treatment surfacing, injections will continue at lower volumes/rates, left over treatment in totes from daylighting wells was pumped into the remaining three wells from the group of four being treated at the time.

Photo 3 – Treatment surfacing/ daylighting at IW-12.

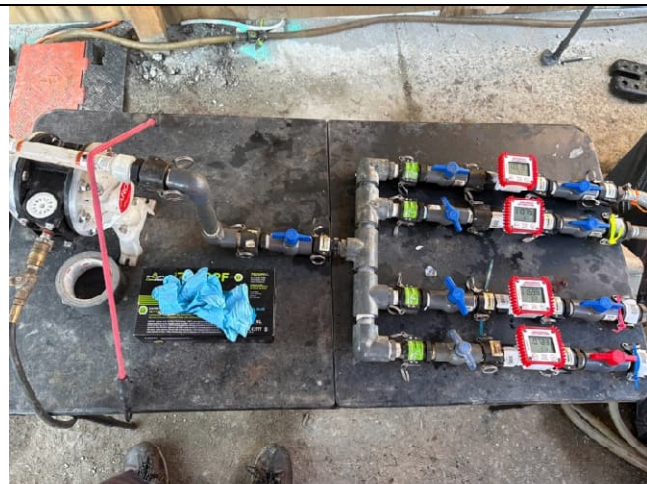
Photo 4 – Pump and flow/volume meters
