**DAILY ACTIVITY REPORT**  
FYN Paint & Lacquer Co.  
**Site No. C224154**  
Sheet 1 of 3

Project/Site Name: FYN Paint & Lacquer Co.

Location: 230 Kent Ave Brooklyn,  
NY

Date: July 13, 2026

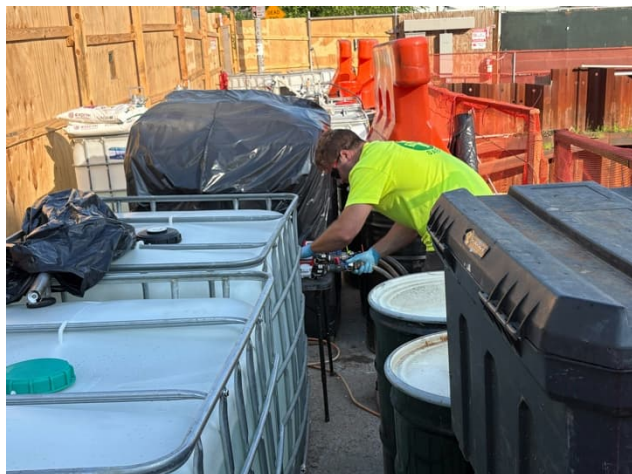
Photo 1 – Hookup of tubing to pump manifold.

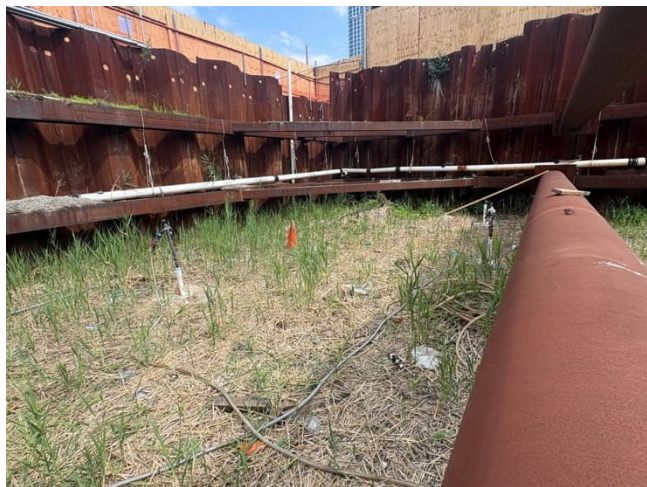
Photo 2 – Chemical injections at IW-3 and IW-5

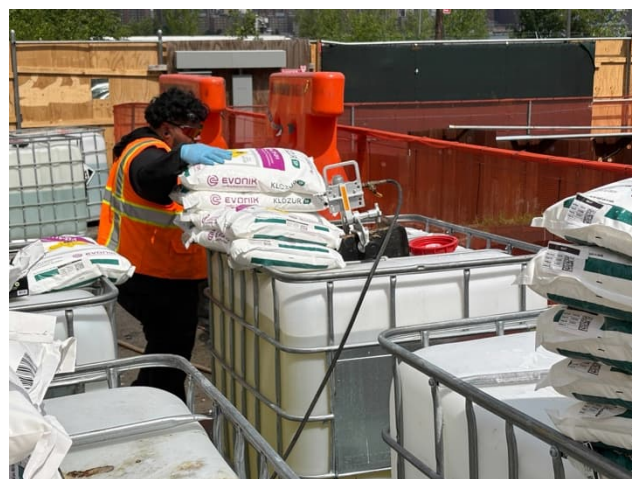
Photo 3 – Chemical batch mixing.

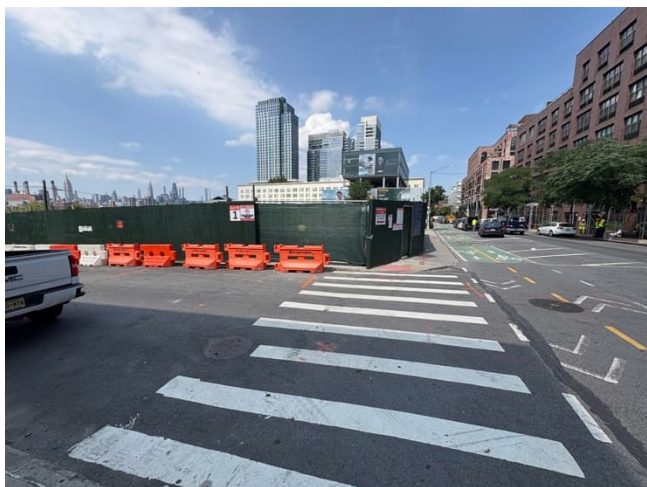
Photo 4 – Site exterior after demobilization.
