**DAILY ACTIVITY REPORT**  
FYN Paint & Lacquer Co.  
**Site No. C224154**  
Sheet 1 of 4

Project/Site Name: FYN Paint & Lacquer Co.

Location: 230 Kent Ave Brooklyn,  
NY

Date: July 15, 2026

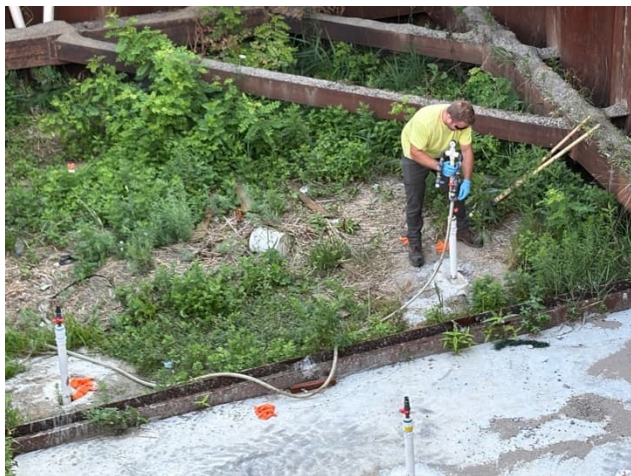
Photo 1 – Hook up of injection well head to IW- 14.

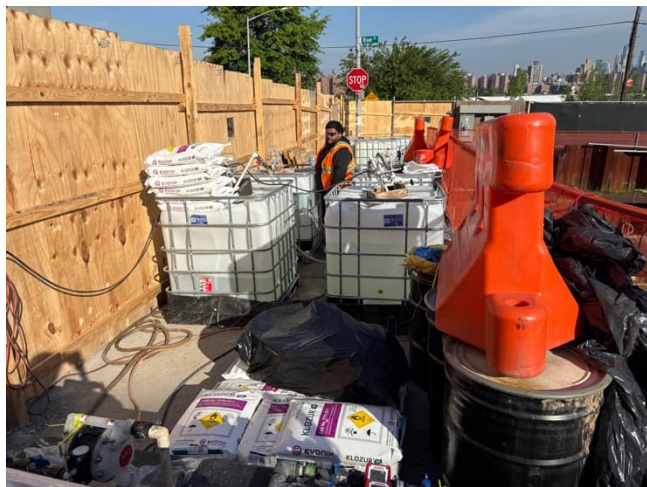
Photo 2 – Mixing of chemical batch.

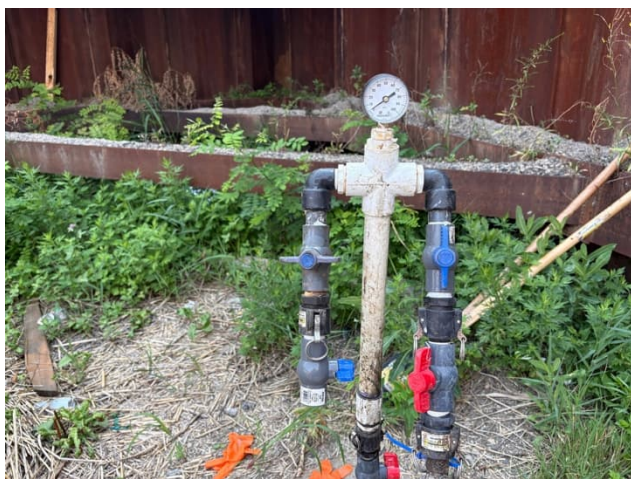
Photo 3 – Injections at IW-14.

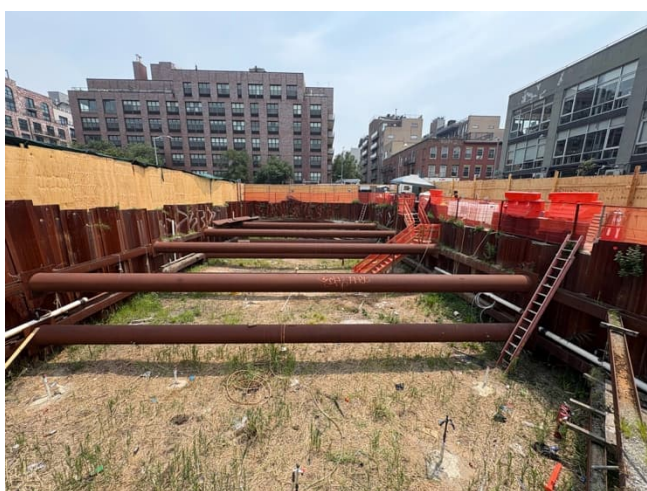
Photo 4 – Site overview taken from the River St. end of the site.
