**SITE INSPECTION
FYN PAINT FACILITY
230 KENT AVENUE
BROOKLYN, NEW YORK**

Fyn Paint & Lacquer Co., Inc.

November 2004

LEGGETTE, BRASHEARS & GRAHAM, INC.
Professional Ground-Water and Environmental Engineering Services
110 Corporate Park Drive, Suite 112
White Plains, NY 10604
(914) 694-5711

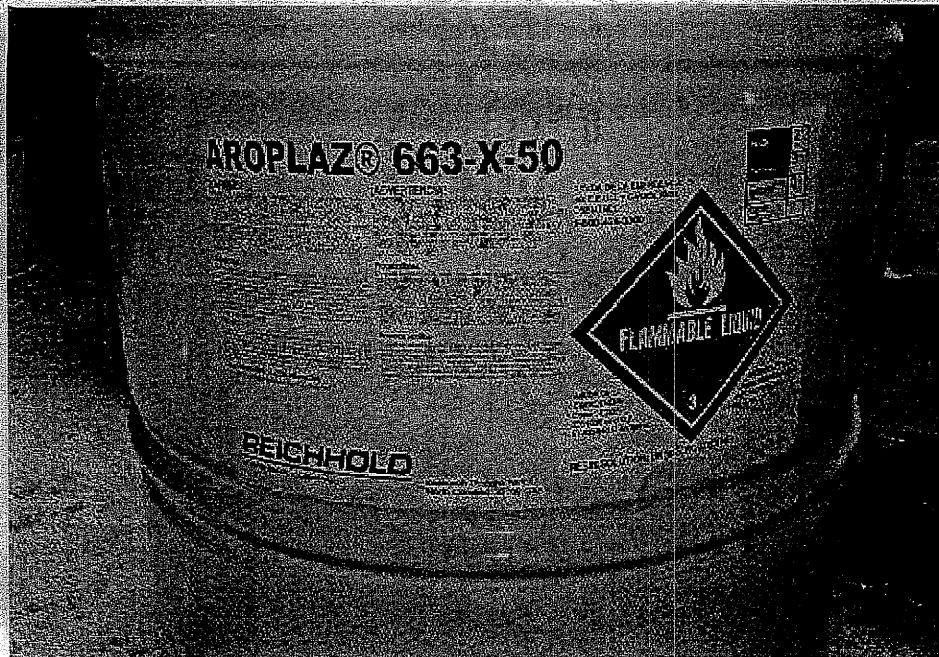
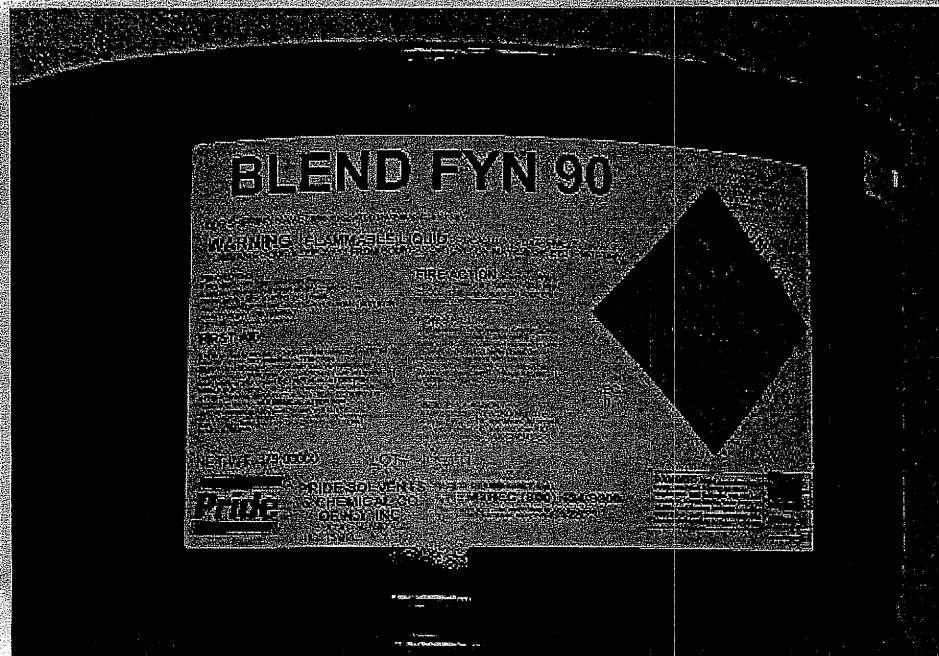
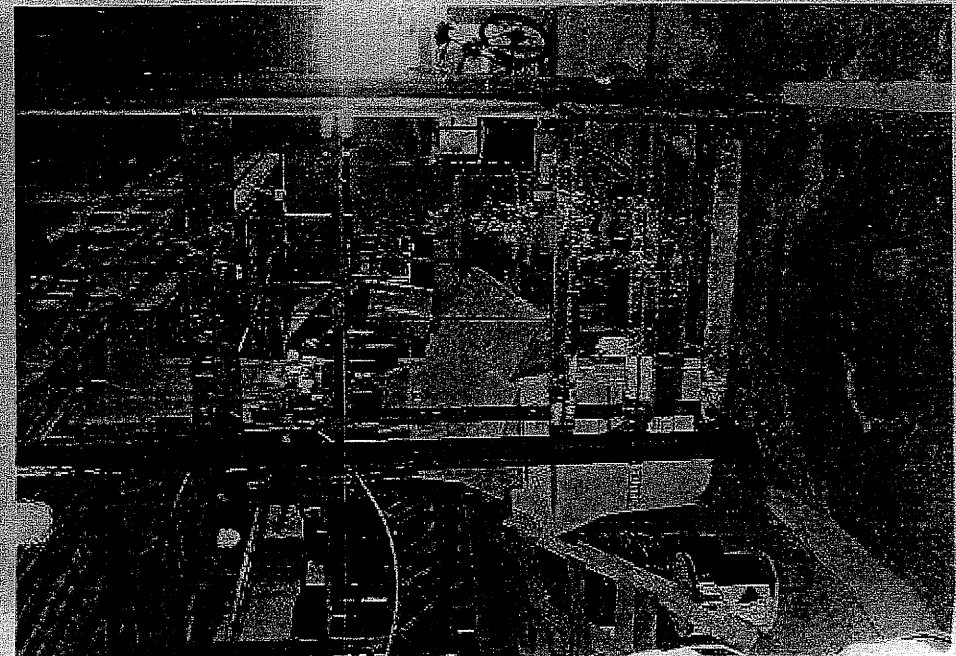
FINAL PRODUCT

VIEW TO SECOND FLOOR

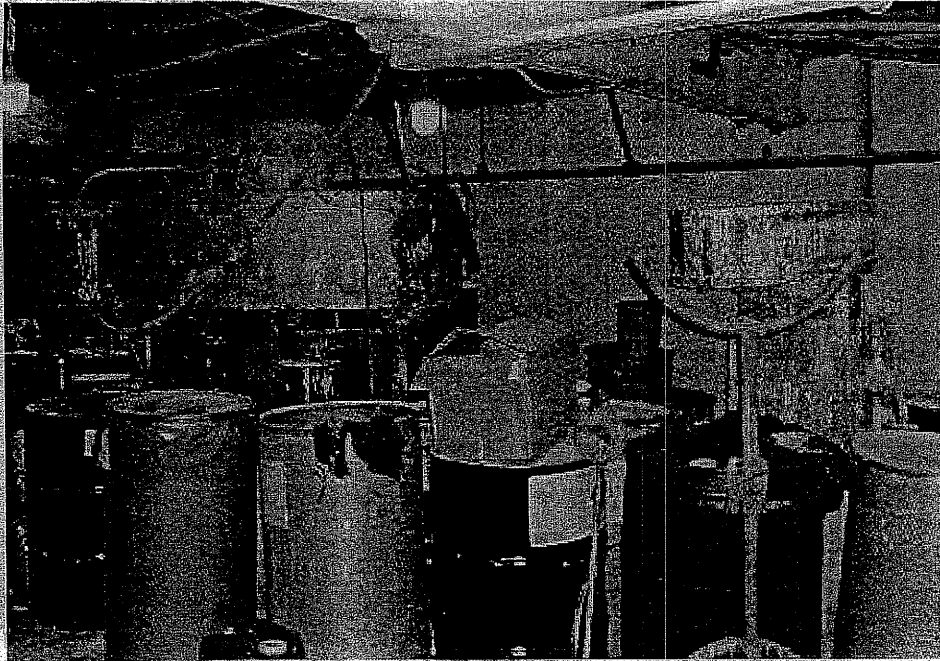
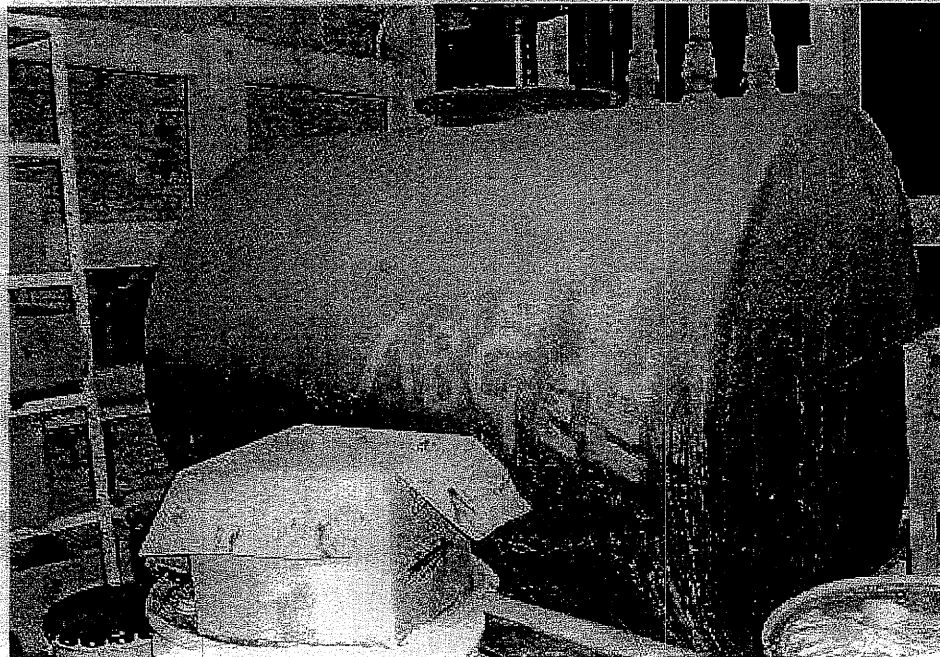
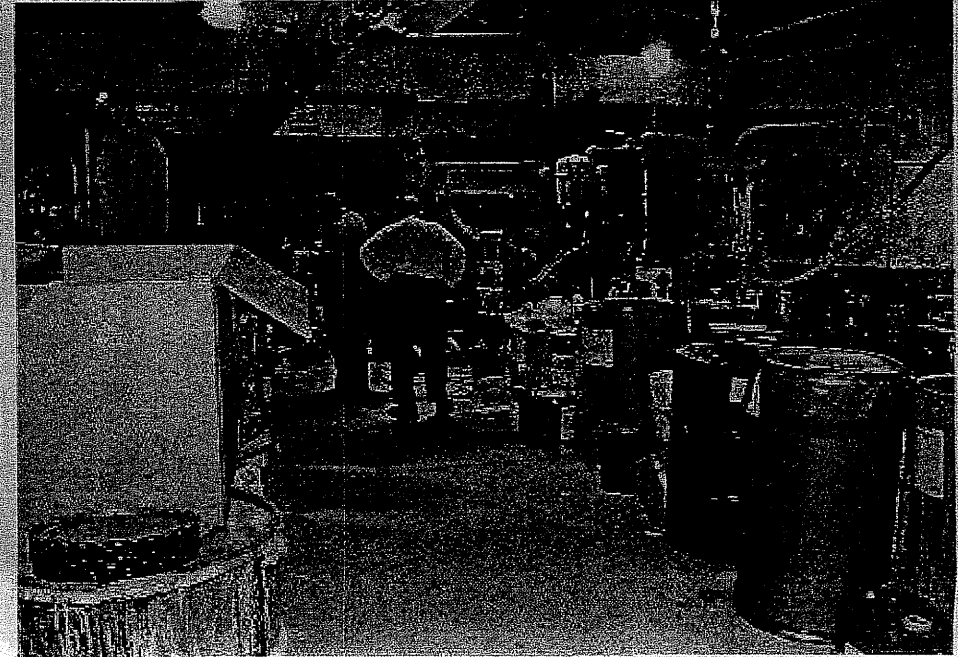
TANK NOT IN USE
