**FORMER EAST COAST INDUSTRIAL UNIFORM
35, 43 AND 49 SKILLMAN STREET, BROOKLYN, NEW YORK 11205**

PERIODIC REVIEW REPORT

NYSDEC BCP Number: C224156

JUNE 30, 2024 TO AUGUST 29, 2025

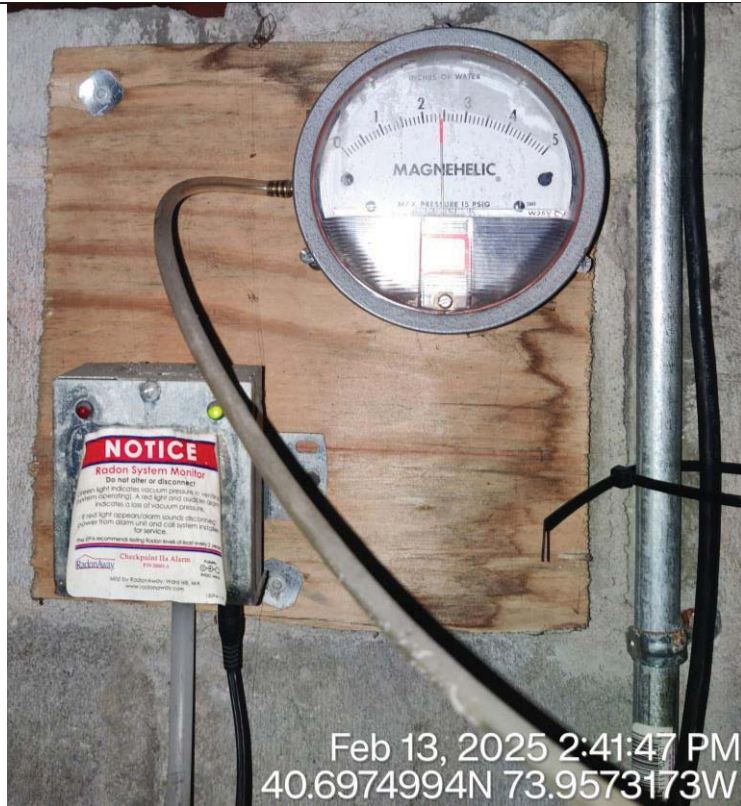
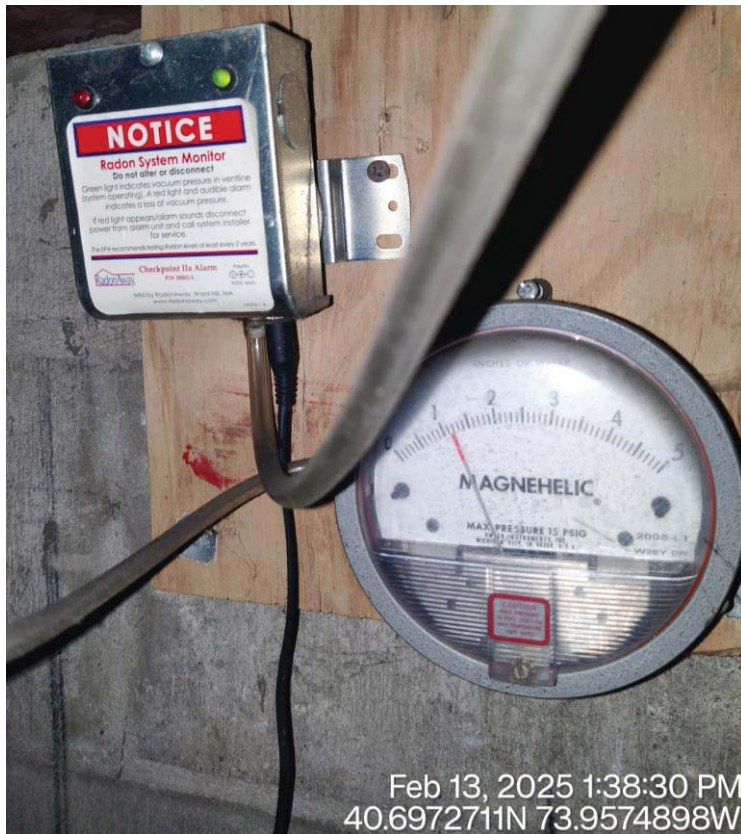
Magnehelic meters

Fans 1-3 (Top to bottom).

Fans 1-3 (Top to bottom) continued

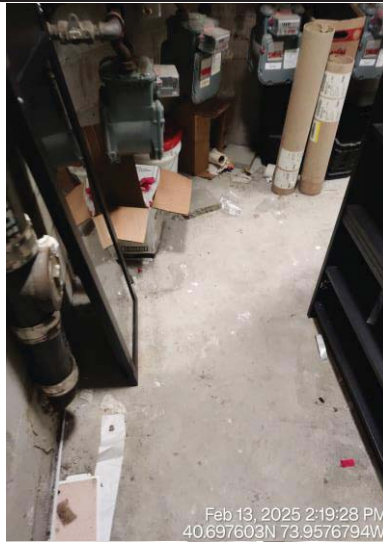
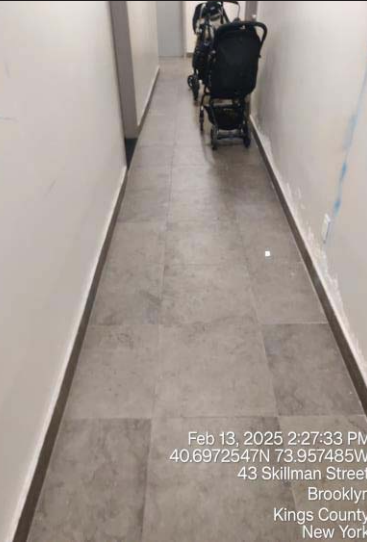
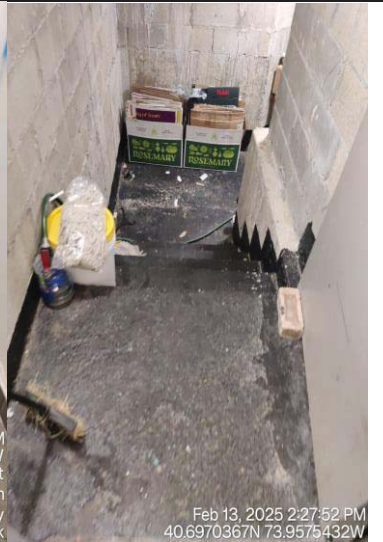
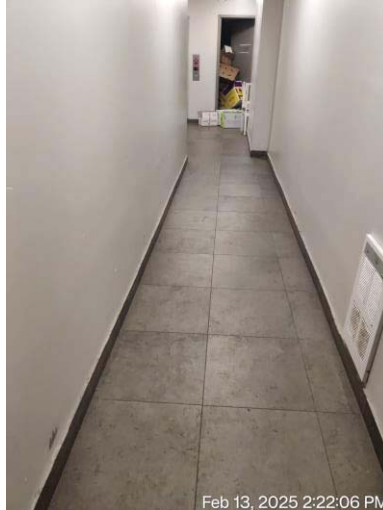
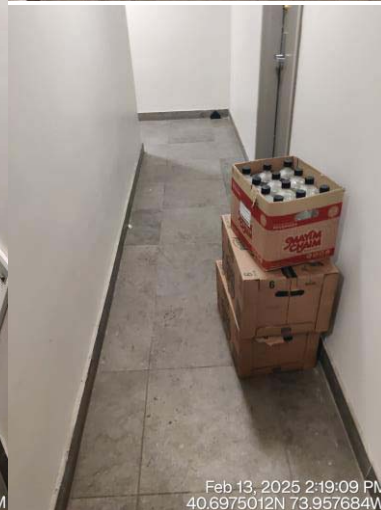
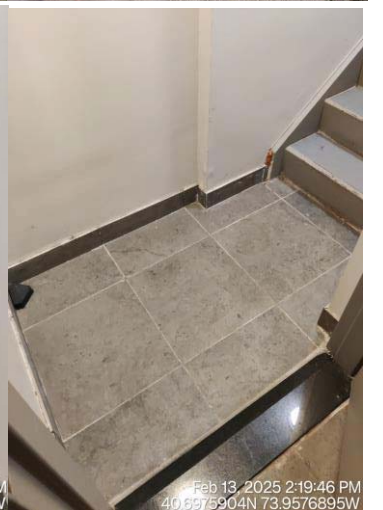
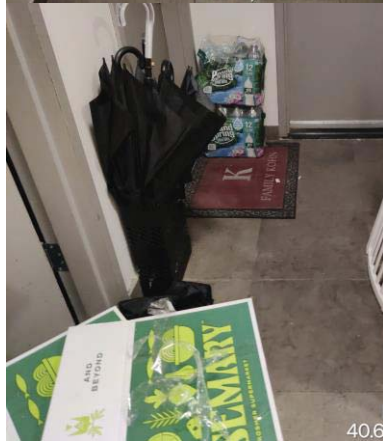
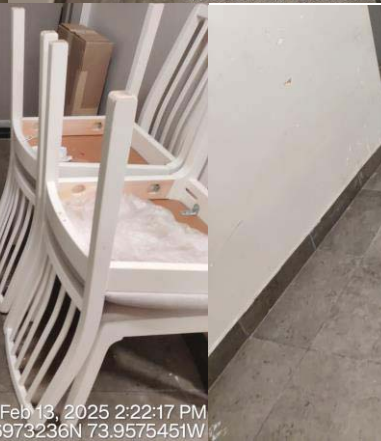
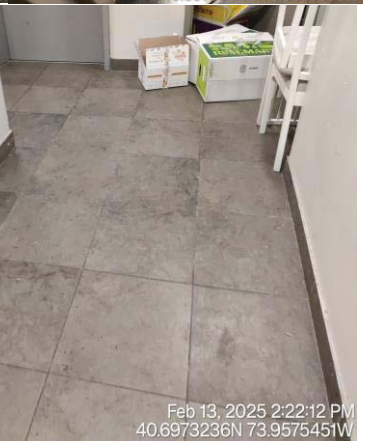
**Photo 5 – Basement
Apartment floors**

In the current reporting period, no perforations were noted and consequently it can be inferred that no damage had occurred to the sub-slab vapor barrier.

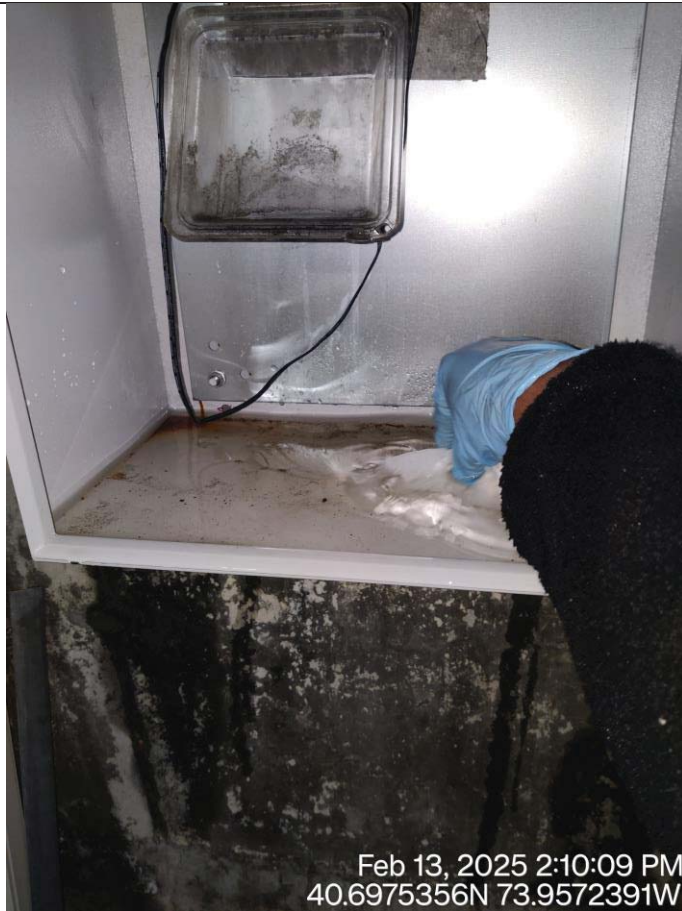
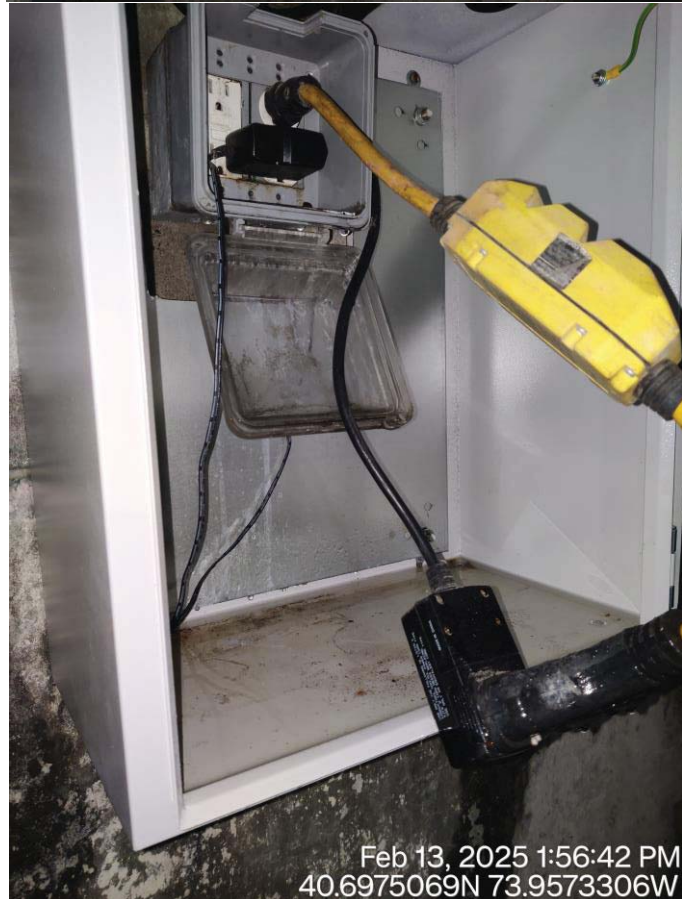
Photo 7 –

**Drainage Holes in
Lockbox to Prevent
Moisture
Accumulation**

Each of the SSD systems was operating during the current reporting period. Drainage holes were added to the lockbox for Fan 1 in Building A to prevent moisture accumulation. It is recommended that the ECs remain in place, unless otherwise specified by the NYS DEC.
