**RE: Corrective Measures Work Plan
C224156 - Former East Coast Uniforms Site
35, 43 and 49 Skillman Street, Brooklyn, NY**

SITE INSPECTION CHECKLIST

Site Inspection Checklist - Subslab Depressurization System
39 Skillman Street
Brooklyn, NY

DAILY STATUS REPORT

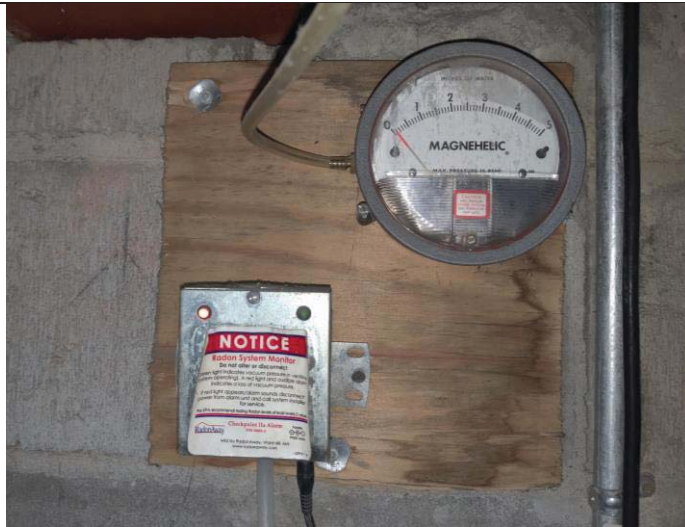
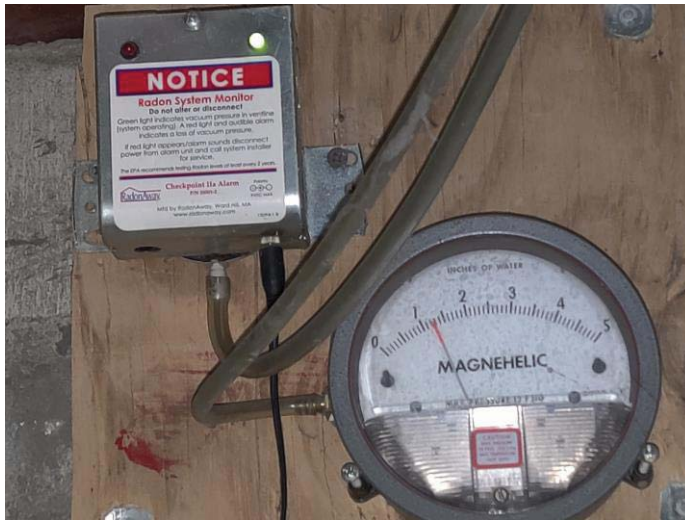
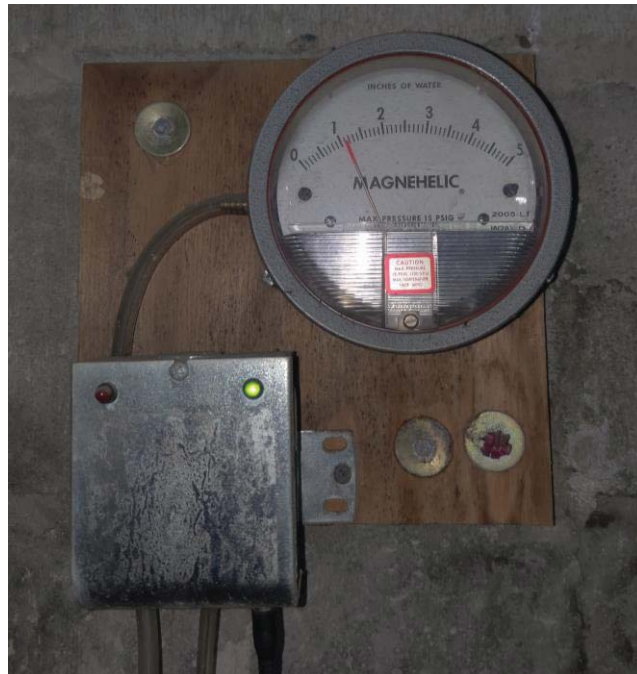
Photo 1 –

Magnehelic meters

Fans 1-3 (Top to bottom).

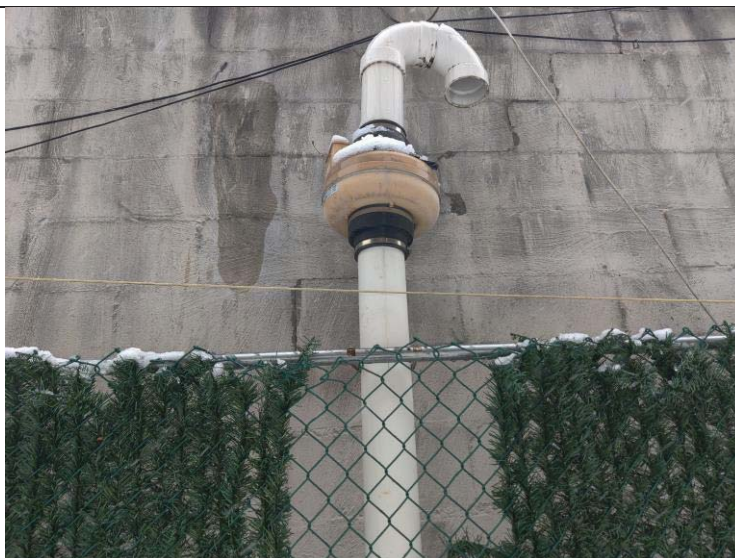
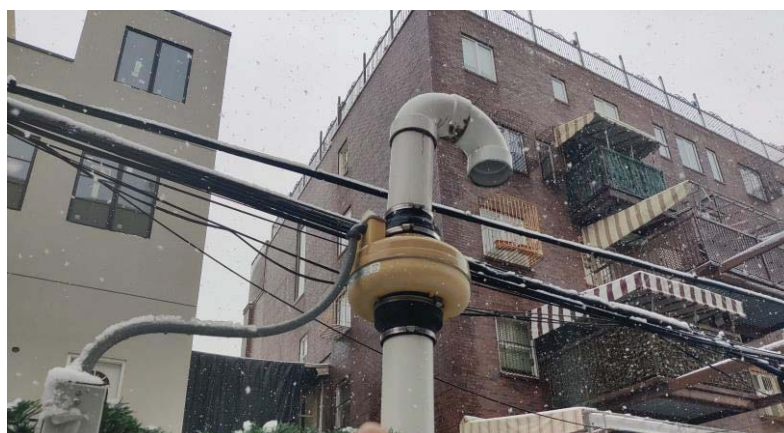
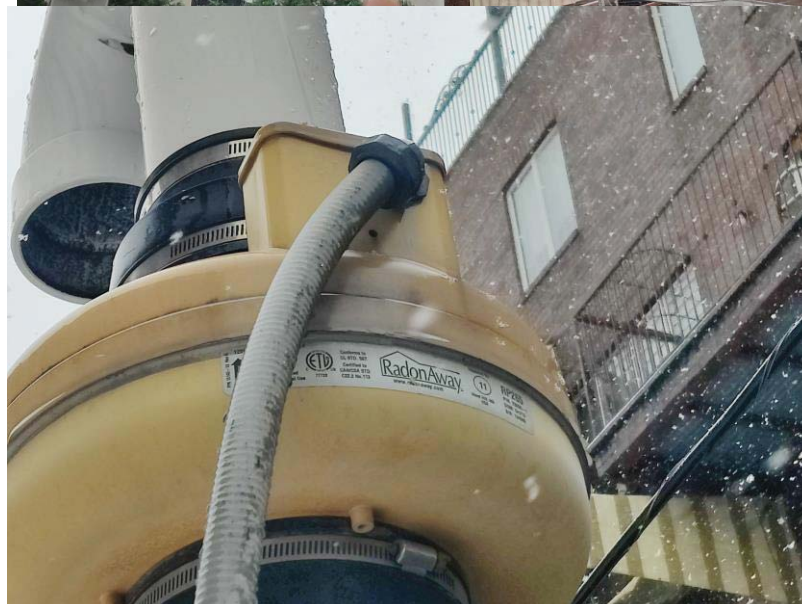
Photo 2 –

Fan outlets on the roof of the parking garage.

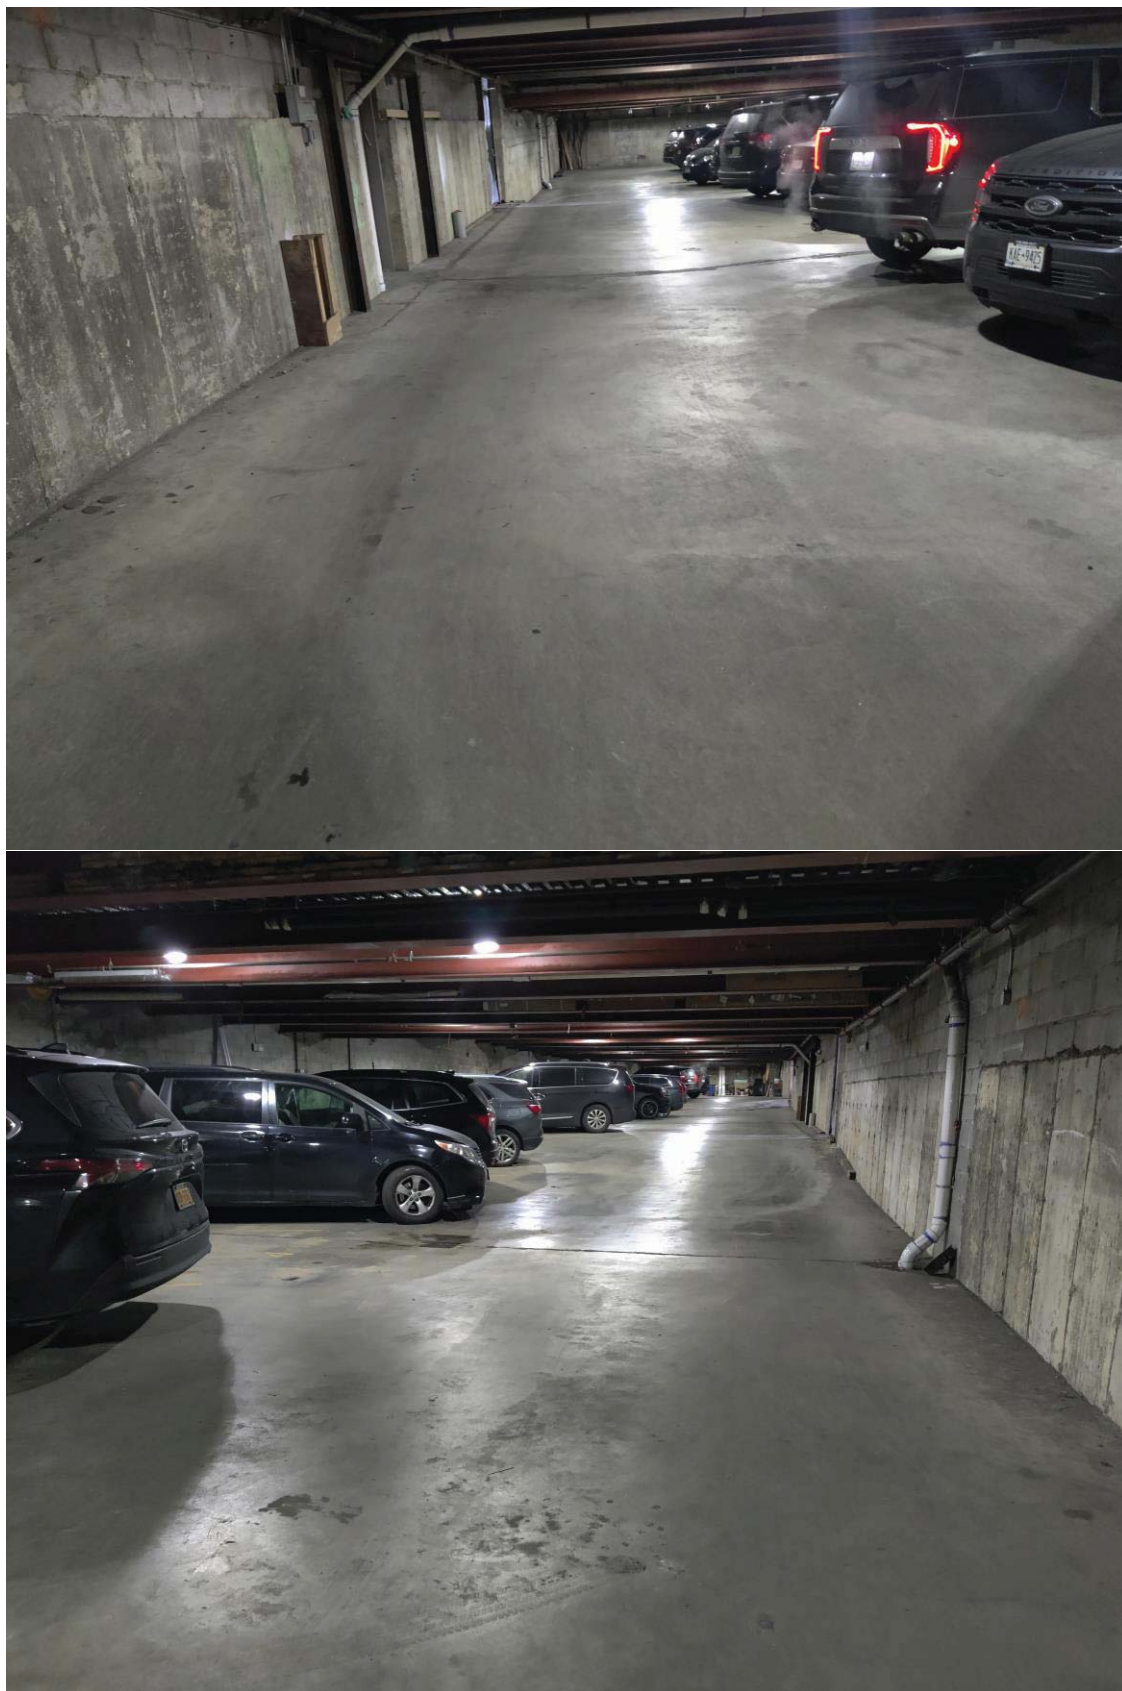
Photo 3 –
Parking area

Parking area is okay

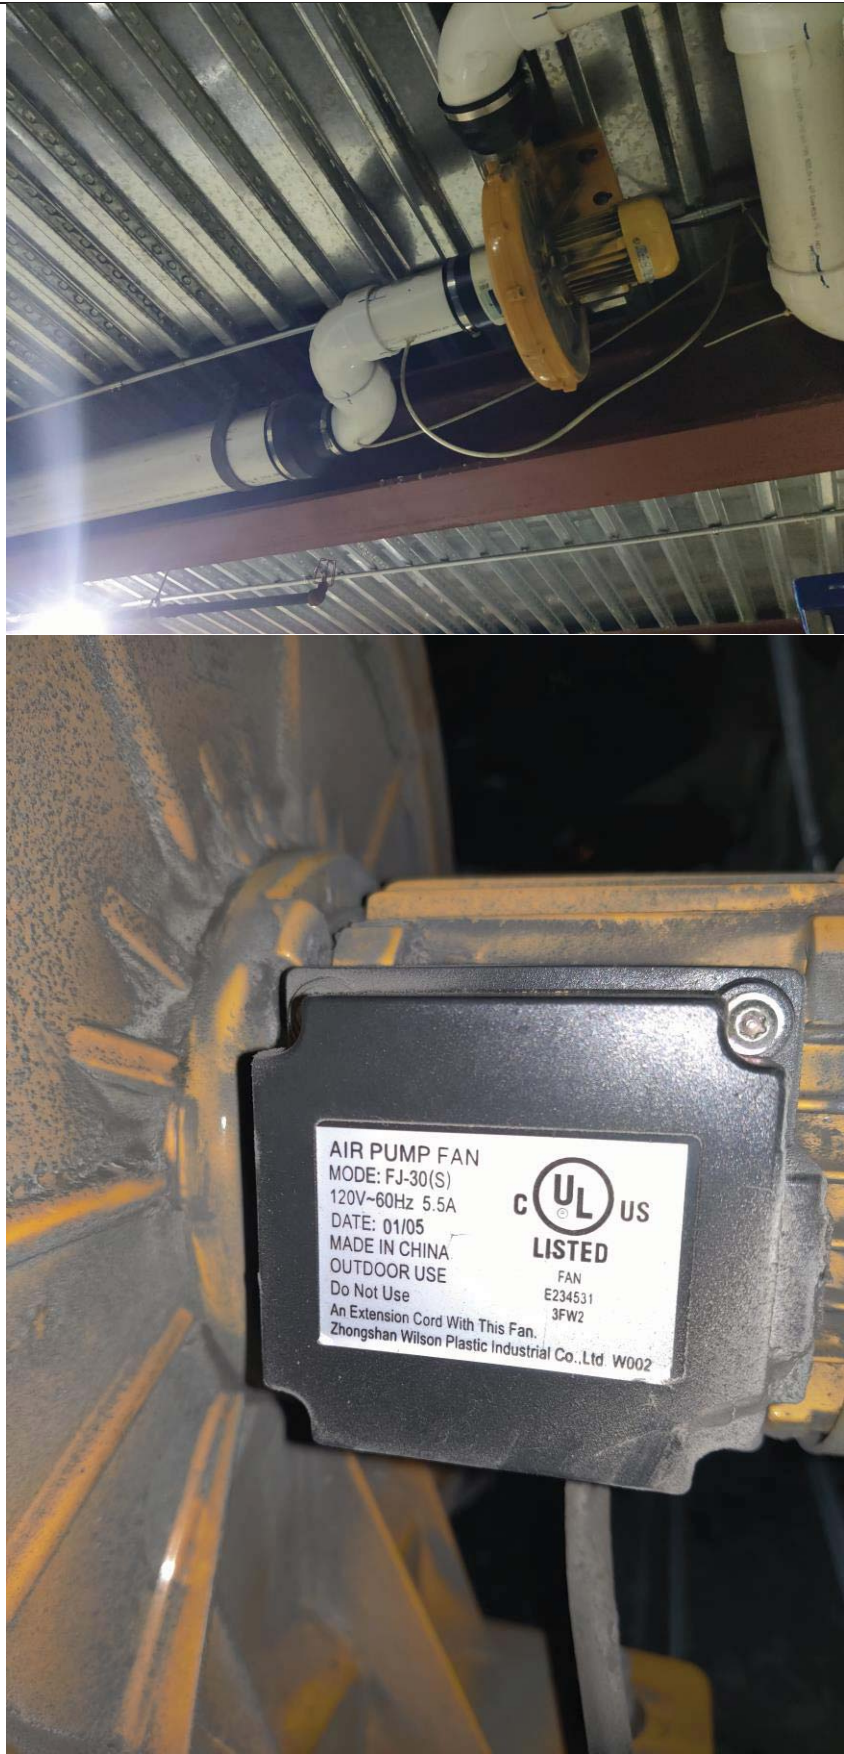
The fan was not generating any vacuum. No leaks were observed at seals.
The fan needs repair or replacement.

Fan 1 in building A, model Zhongshan, is operating but it is not generating any vacuum. Fan 1, needs to be repaired or replaced.

- **Fan 1, model ZhongShan, in Building A was working but it was not generating any vacuum. The alarm is operational and there is airflow at the exhaust of the fan. No obvious leaks in the seals were observed. The fan in Building A needs to be replaced or repaired.**

Photo 6 – Fan 1
(Building A) needs
repairs

- Troubleshoot or replace the fan with in-kind.
- Re-inspect the site to ensure the system is operational. Submit a Corrective Measures Report together with the 2023 PRR.
- Install a lockbox enclosing the power outlets and wires supplying the fans.
