Periodic Review Report

149 Kent Avenue
Brooklyn, New York
Site Number C224159

March 4, 2022

**Roux Environmental Engineering
and Geology, D.P.C.**
209 Shafter Street
Islandia, New York 11749

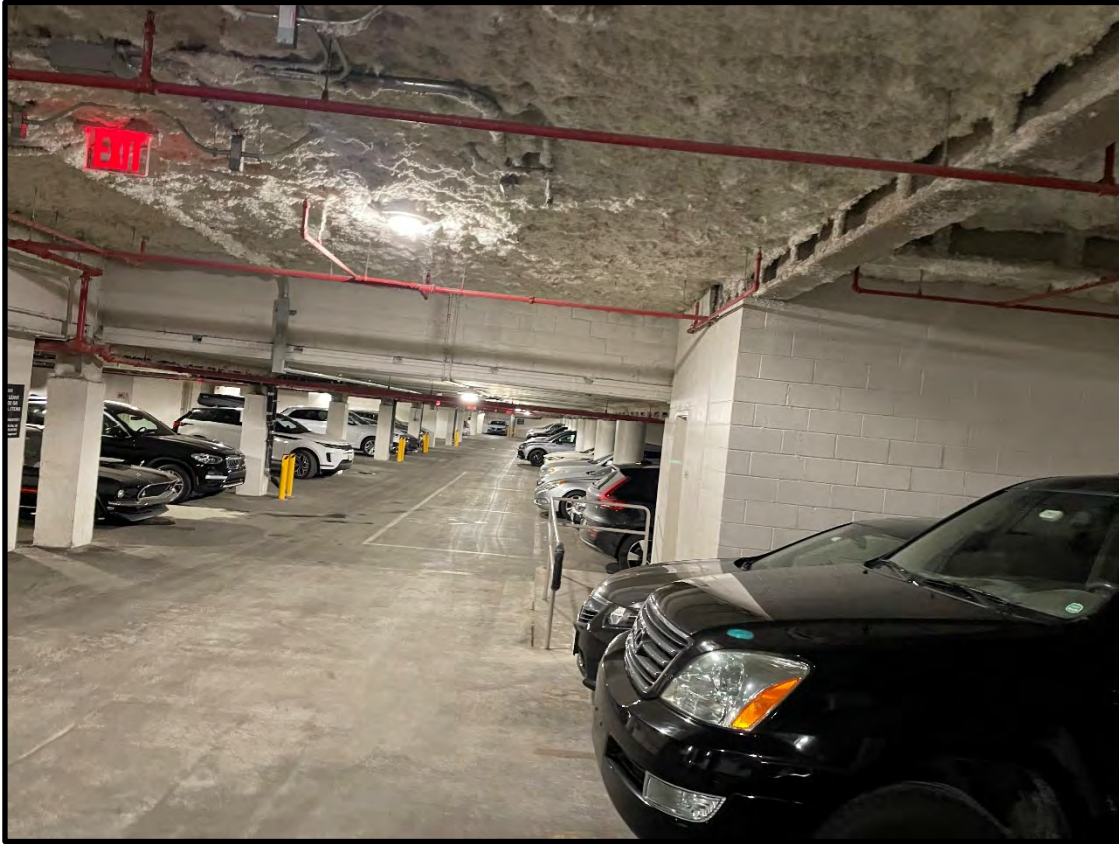
Photograph 1: View of cellar parking garage, looking west. All visible foundation elements were inspected.

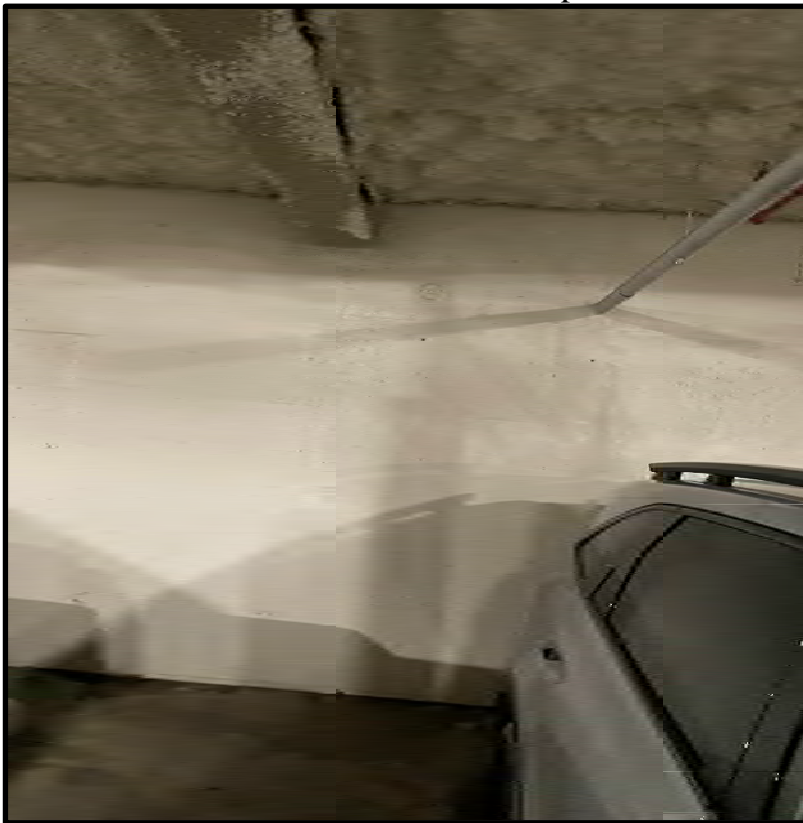
Photograph 2: View of MP-2 location and protective cover located in on the east side of the cellar parking garage.

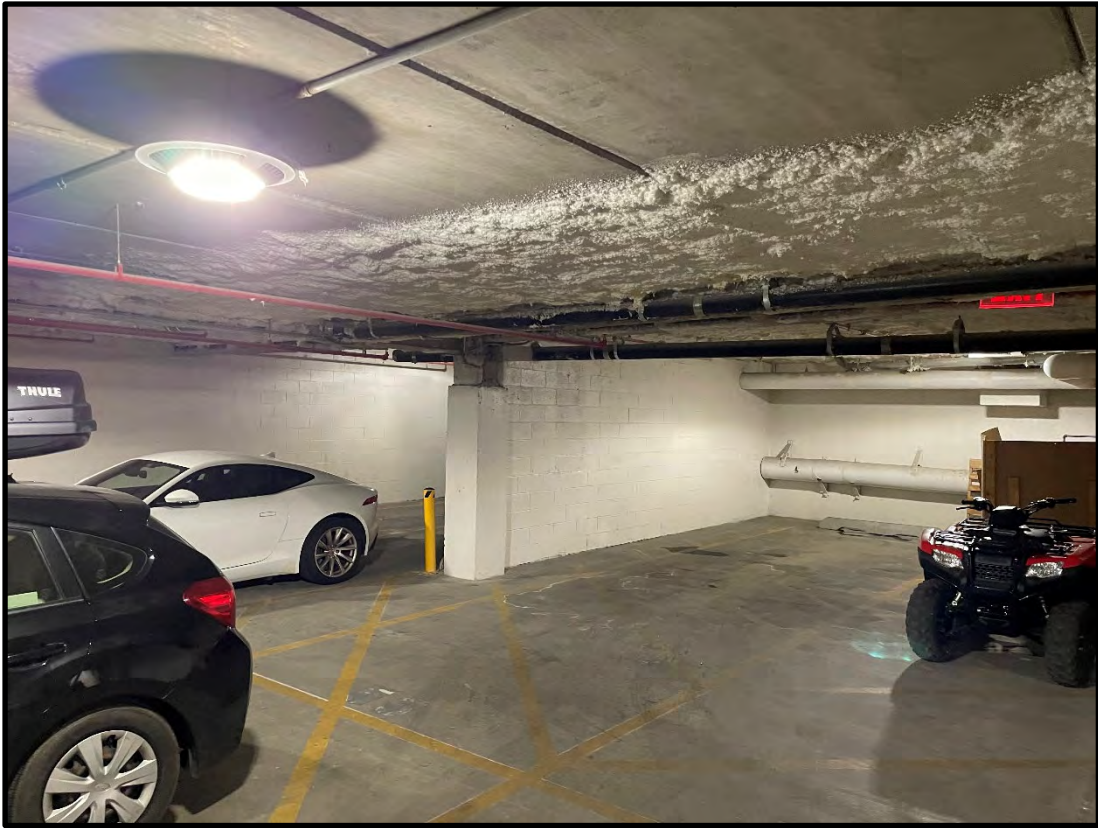
Photograph 3: Looking south, view of cellar in the southwest corner. All site cover components were intact.

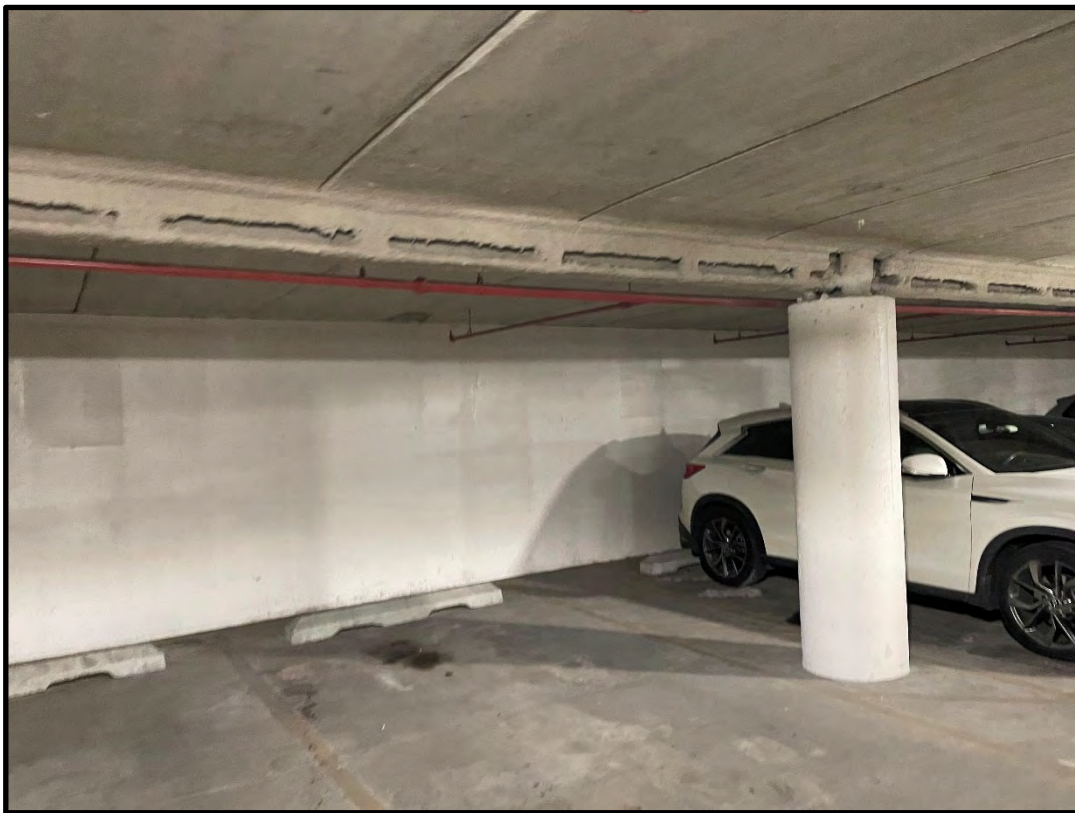
Photograph 4: View of north cellar wall approximately in the middle of the cellar during annual inspection.

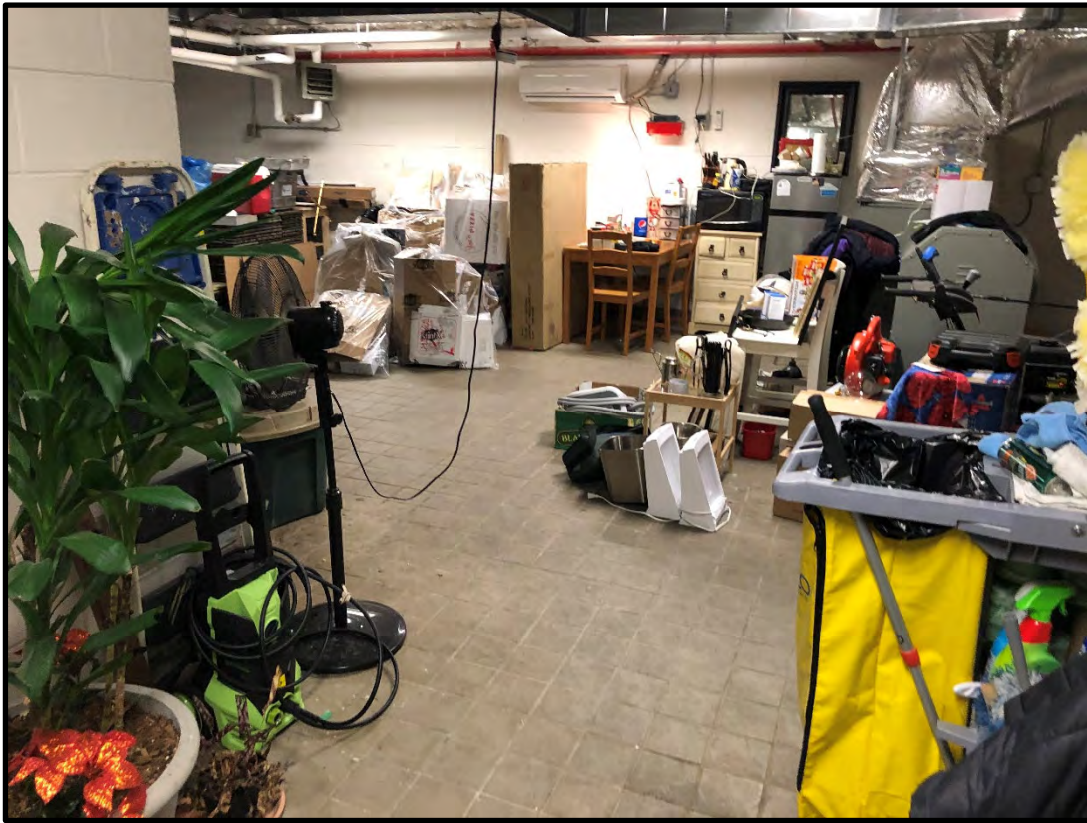
Photograph 5: Photo of refuse/maintenance room during inspection.

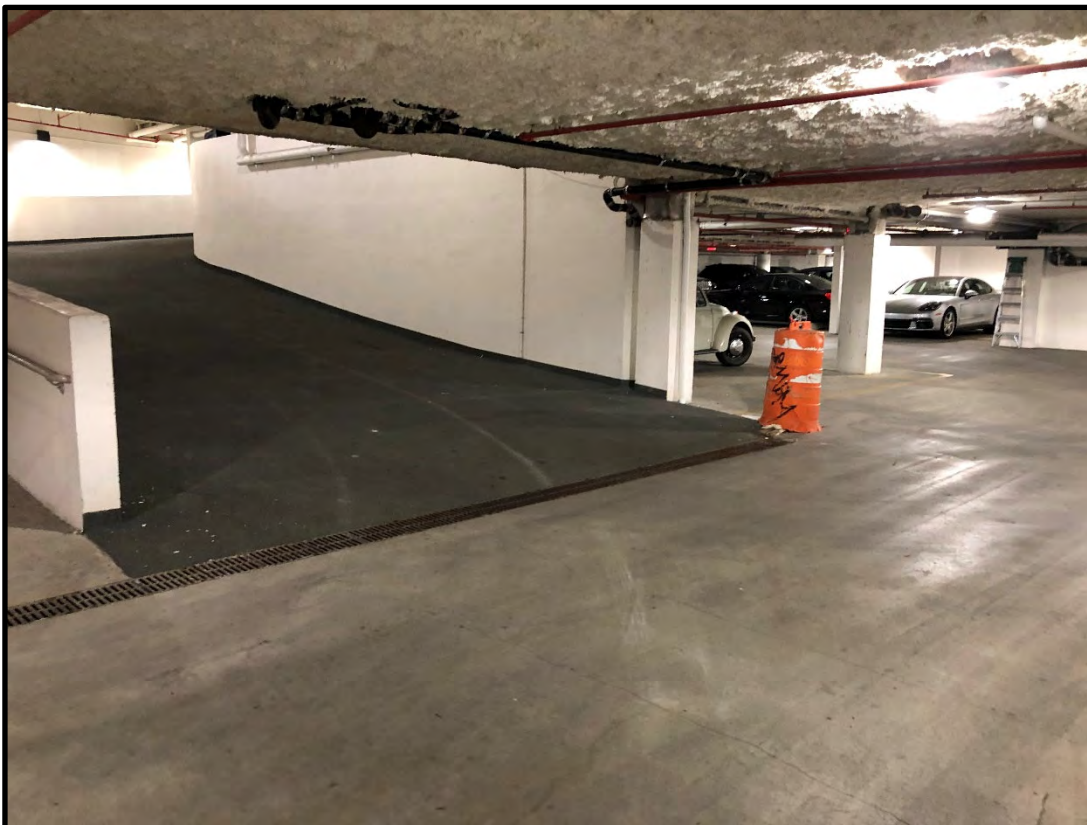
Photograph 6: View of the asphalt ramp leading to ground floor.

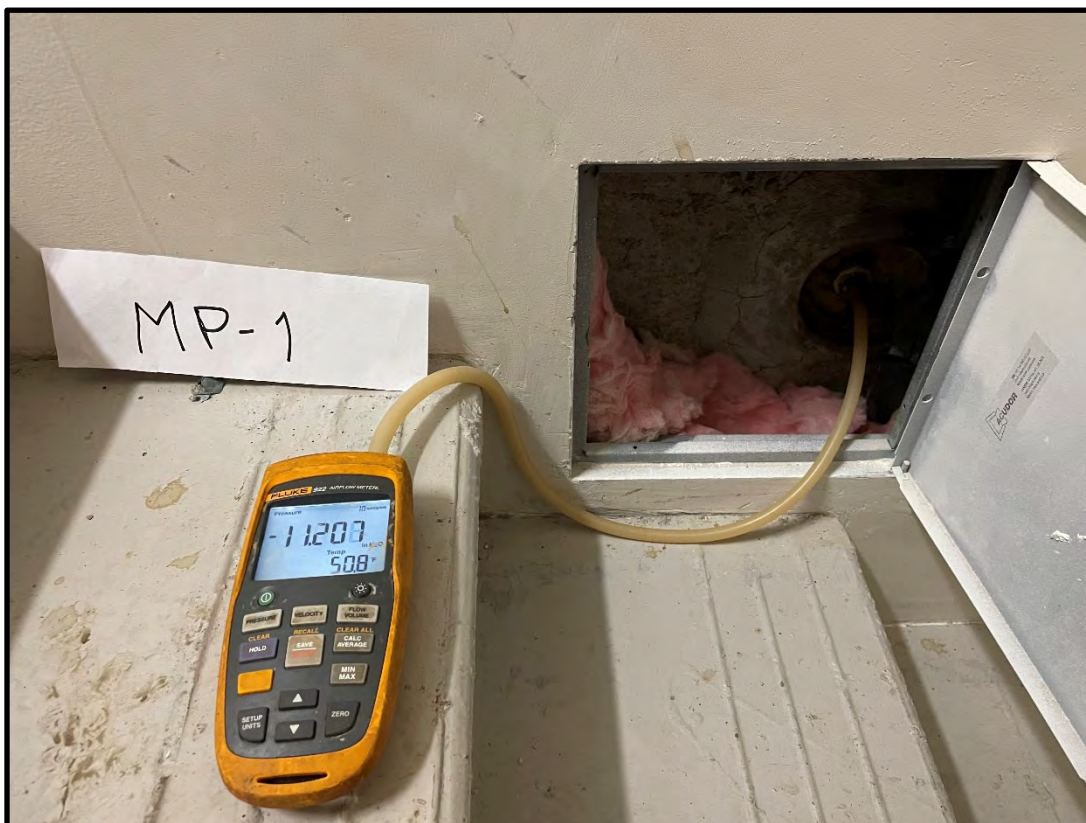
Photograph 7: Photo of MP-1 (west SSDS) within lock box within stairwell between first floor to the cellar.

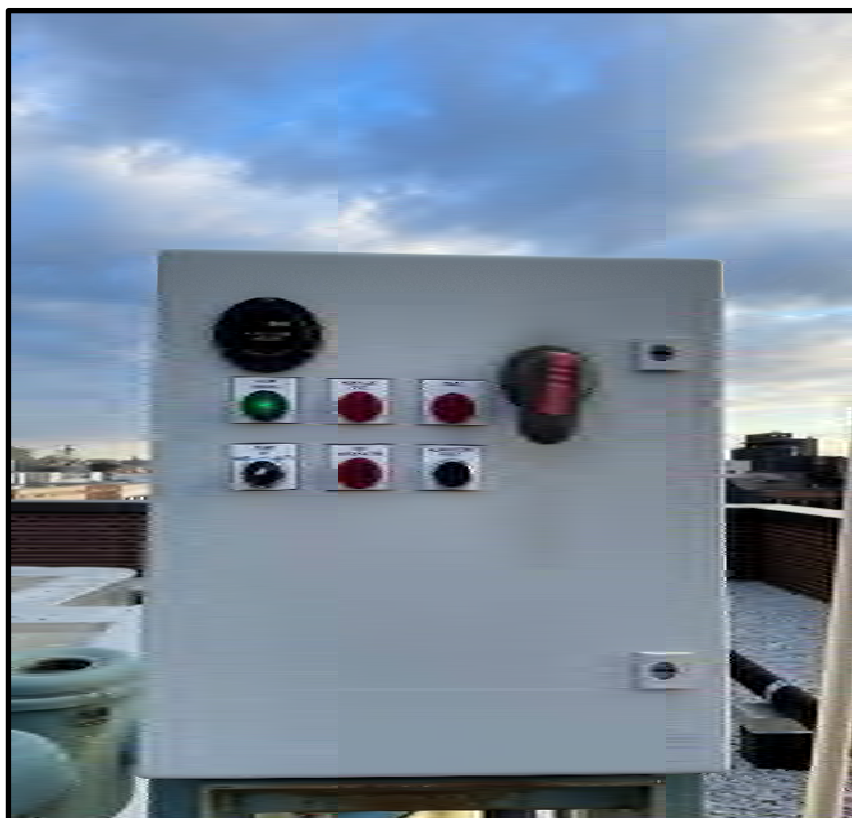
Photograph 8: View of SSDS Blower 1 (west) control panel; green pilot light is on showing system is operational.

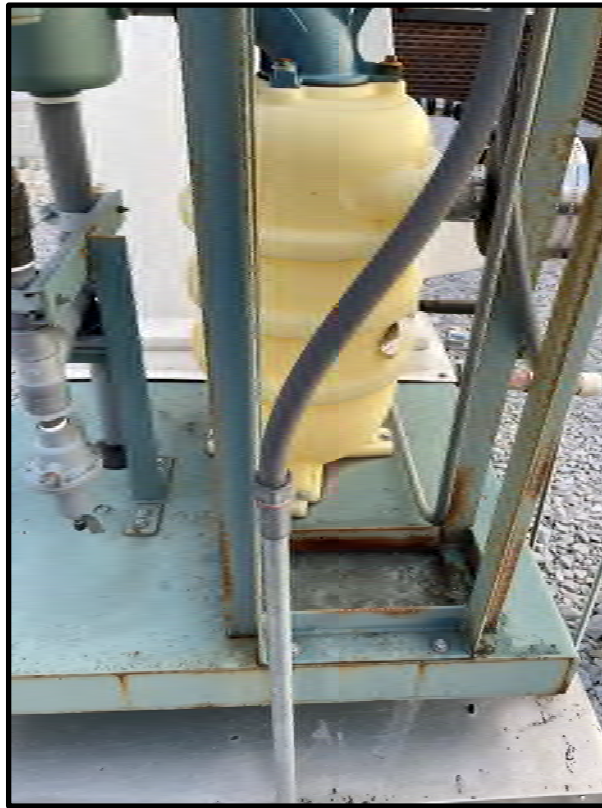
Photograph 9: SSDS Blower 1 (west) knock out tank in view.

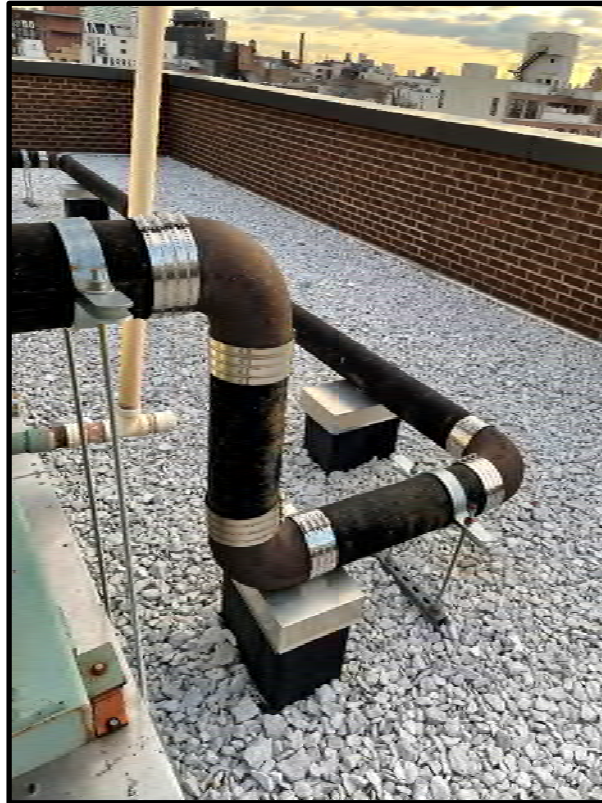
Photograph 10: Representative view of aboveground piping located on the roof leading to the SSDS Blower 1. All piping and couplings were intact.

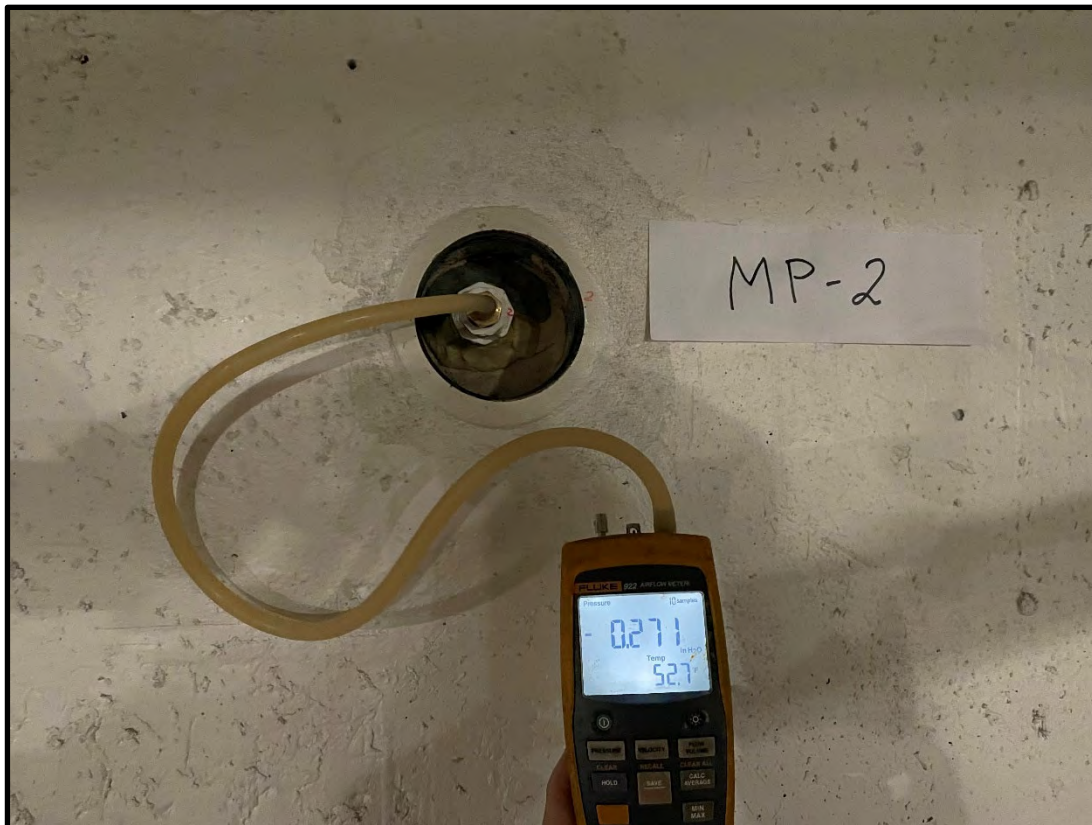
Photograph 11: View of MP-2 (east SSDS) field pressure test.

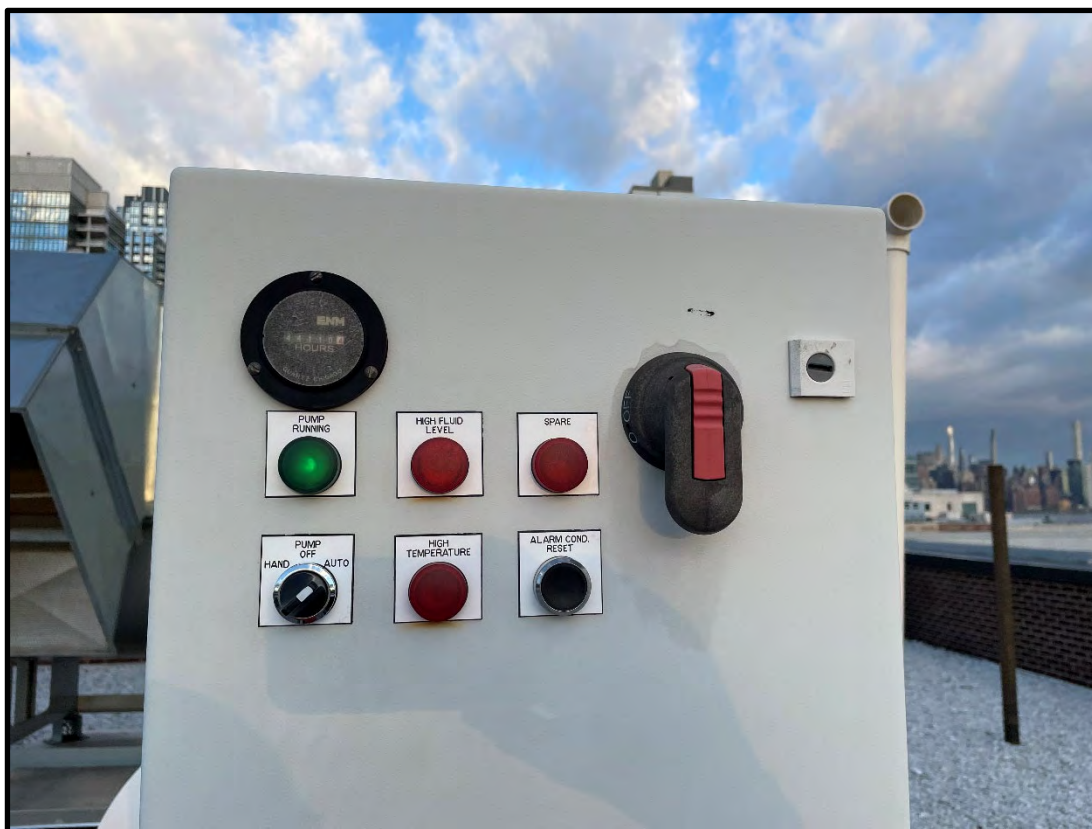
Photograph 12: Photo of SSDS Blower 2 (east) control panel.

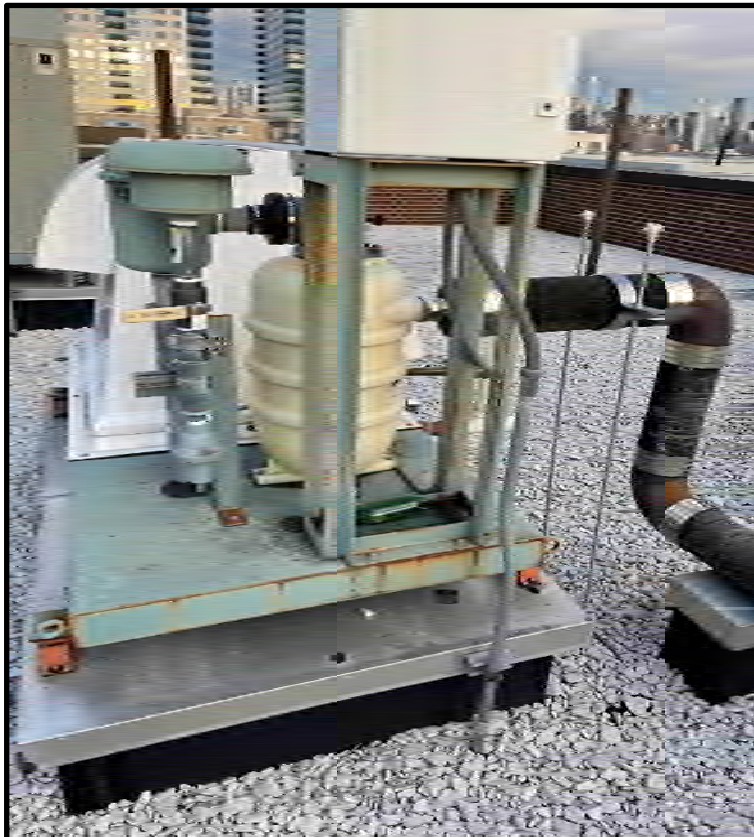
Photograph 13: Photo of the SSDS Blower 2 (east) configuration.

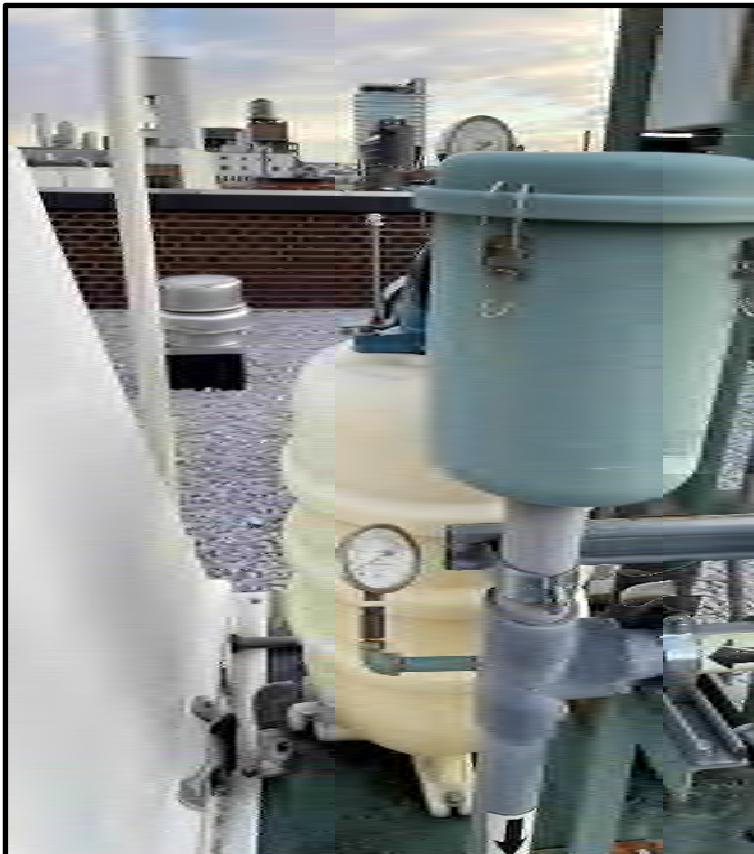
Photograph 14: Photo of SSDS Blower 2 (east) inlet and knockout tank vacuum readings.
